**Bull Trout Redd Monitoring Report for the Wallowa Falls  
Hydroelectric Project**

**(FERC No. P-308)**

**December 18, 2017**

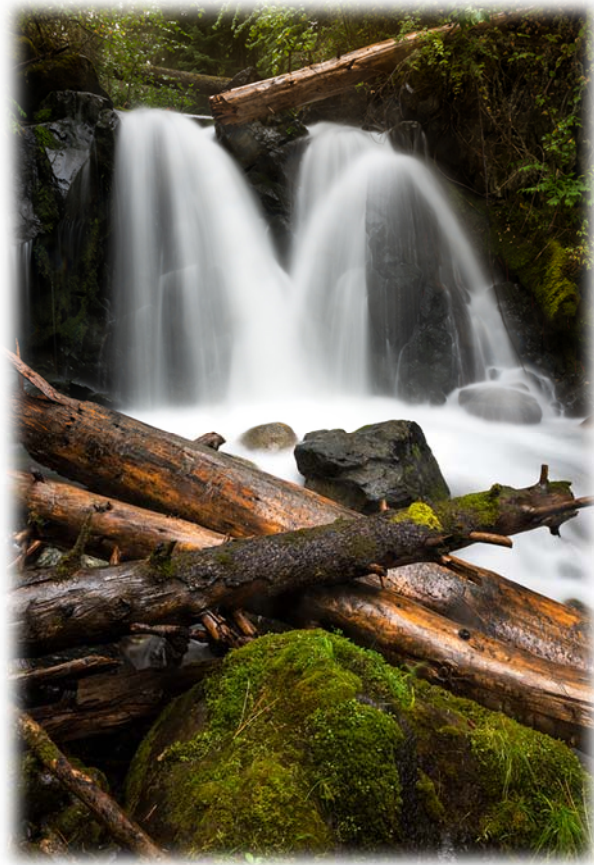
East Fork Wallowa River barrier to upstream fish migration, photo courtesy of Kendrick Moholt

The bypassed portion of the East Fork Wallowa River within and near the Project area is approximately 2,800 meters (m) long from the Project diversion dam to its confluence with the Wallowa River (Figure 1). Gradient in this reach is high, with the upper 1,600 m averaging 19 percent and the lower 1,200 m averaging 8.5 percent. Channel morphology within most of the upper reach is dominated mainly by steep bedrock, vertical waterfalls, and cascades over boulders; though the upper reaches are steep, the lower 800 m to the confluence with the Wallowa River has a shallower gradient, consisting of numerous riffles and pools. Over the course of its length, the bypassed East Fork Wallowa River drops approximately 365 m from the dam to the confluence with the Wallowa River. The upper and lower portions are divided by a 3.7 m vertical falls (Report cover photo), an impassible upstream migration fish barrier.

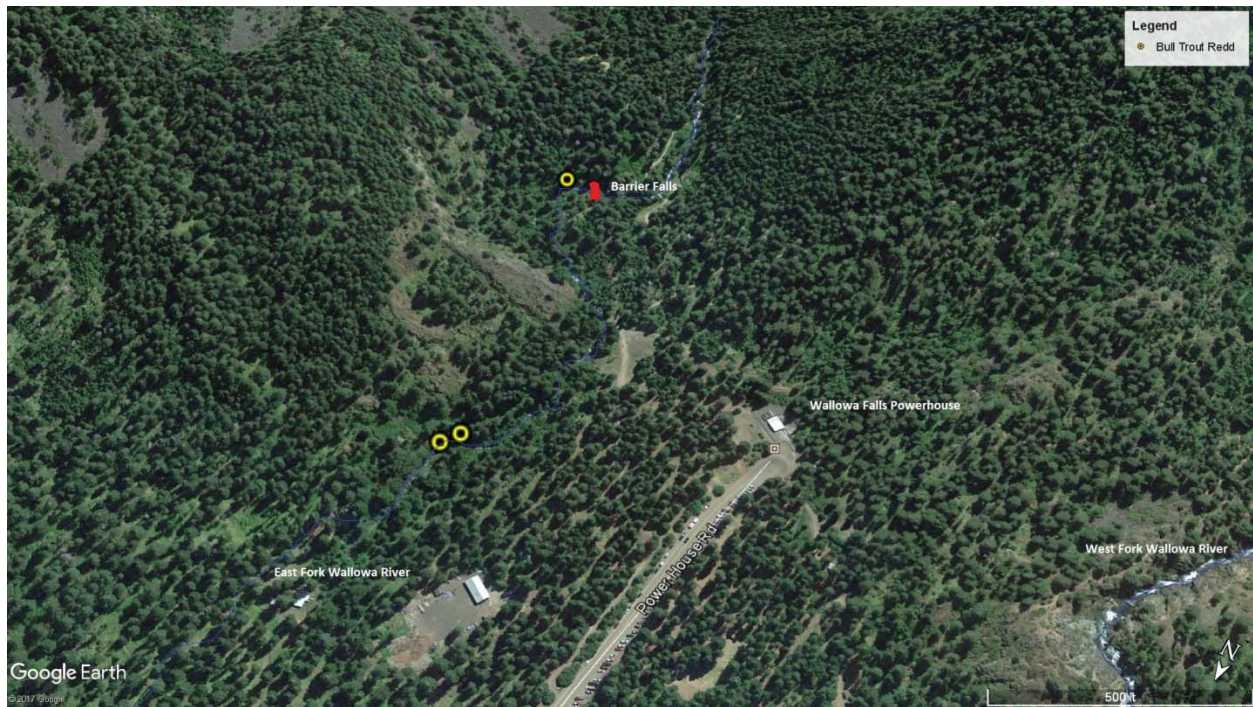
Three bull trout redds were identified and marked by GPS during the nine redd surveys performed of the East Fork Wallowa River in 2017 (Figure 2). All three bull trout redds were large and indicative of being constructed by large migratory-sized fish. Two of the three redds were identified during the very first survey on September 12. Both of these redds had a single bull trout in very near proximity. Four other bull trout lives were also observed during the September 12 survey, all six observed live bull trout were estimated to range in fork length between 350 millimeters - 600 millimeters (Figure 3 and Figure 4). The third redd was identified on September 25 and was found to also have a pair of bull trout actively over the top and in the process of constructing the redd, these fish were estimated to have been ~400 millimeters in fork length. An additional bull trout live was observed during a survey on October 2 and was estimated to have been ~350 millimeters in fork length. No other bull trout redds or lives were observed during the study period (Table 1).

**Figure 2. GPS marked locations (yellow dots, n=3) of bull trout redds within the East Fork Wallowa River**

All three bull trout redds were in the upper portion of available habitat below the barrier, with the uppermost redd ~ 20 meters below the impassible falls. Redd 1 visually persisted for 20 days, while redd 2 and redd 3 both persisted for 13 and 10 days, respectively. The average time redds in 2017 were found to still be visually distinguishable within the stream was 14 days.
