**Bull Trout Redd Monitoring Report for the Wallowa Falls
Hydroelectric Project**

(FERC No. P-308)

December 20, 2018

PacifiCorp

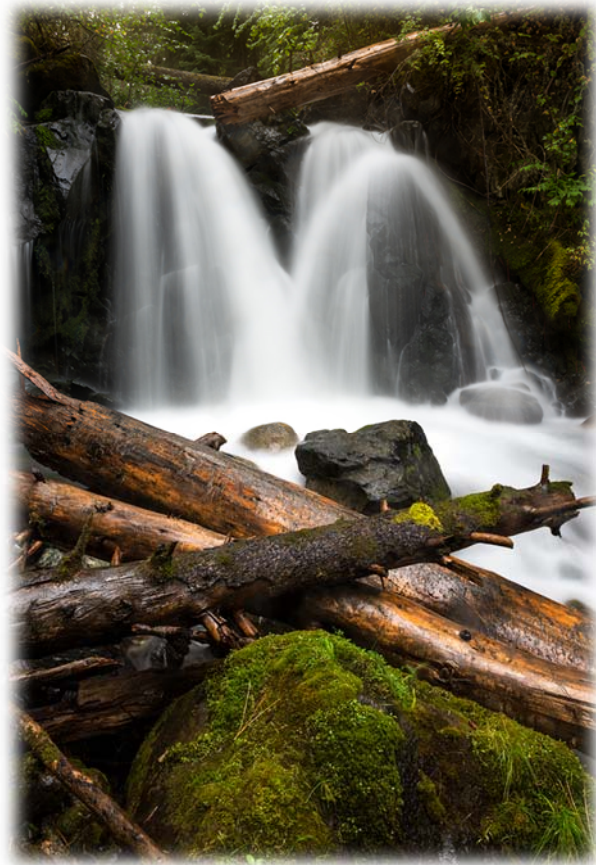
East Fork Wallowa River barrier to upstream fish migration, photo courtesy of Kendrick Moholt

The bypassed portion of the East Fork Wallowa River within and near the Project area is approximately 2,800 meters (m) long from the Project diversion dam to its confluence with the Wallowa River (Figure 1). Gradient in this reach is high, with the upper 1,600 m averaging 19 percent and the lower 1,200 m averaging 8.5 percent. Channel morphology within most of the upper reach is dominated mainly by steep bedrock, vertical waterfalls, and cascades over boulders; though the upper reaches are steep, the lower 800 m to the confluence with the Wallowa River has a shallower gradient, consisting of numerous riffles and pools. Over the course of its length, the bypassed East Fork Wallowa River drops approximately 365 m from the dam to the confluence with the Wallowa River. The upper and lower portions are divided by a 3.7 m vertical falls (Report cover photo), an impassible upstream migration fish barrier.

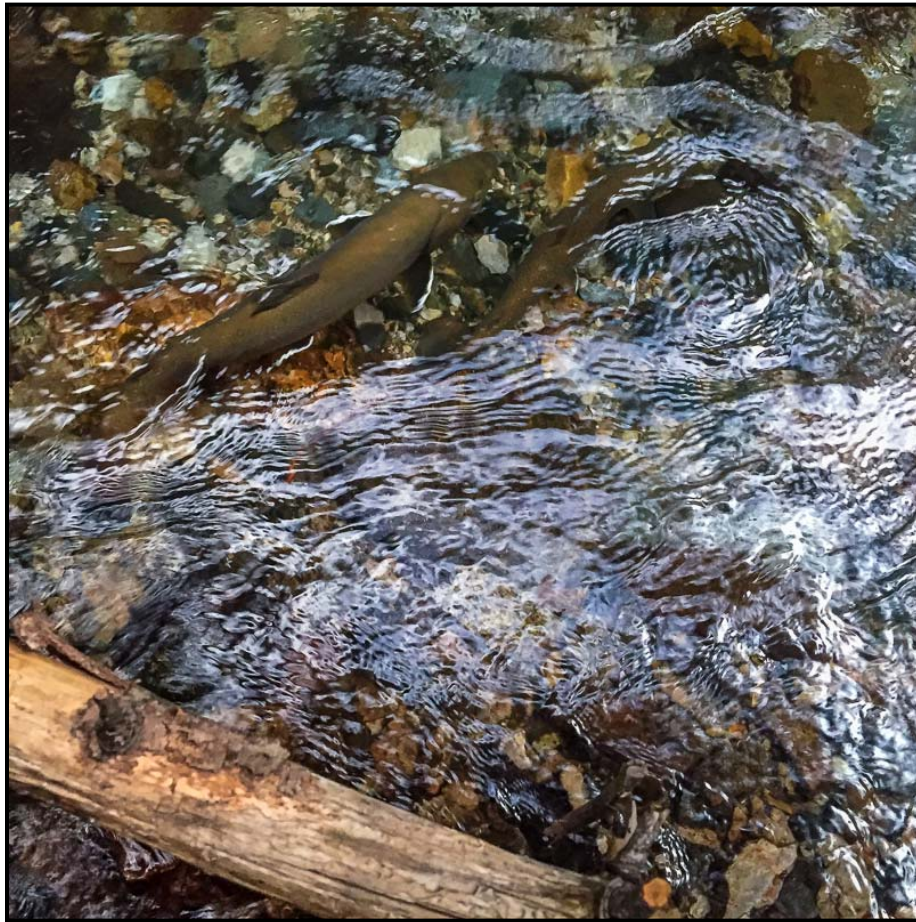
pair (Figure 3), one male/one female, associated with the redd; while the fourth identified redd only had a single fish in close proximity (Table 1).

Figure 3. Bull trout paired over the top of redd #3.
