**Fish Salvage & Temporary Tailrace Barrier Report for the
Wallowa Falls Hydroelectric Project Tailrace**

(FERC No. P-308)

December 18, 2017

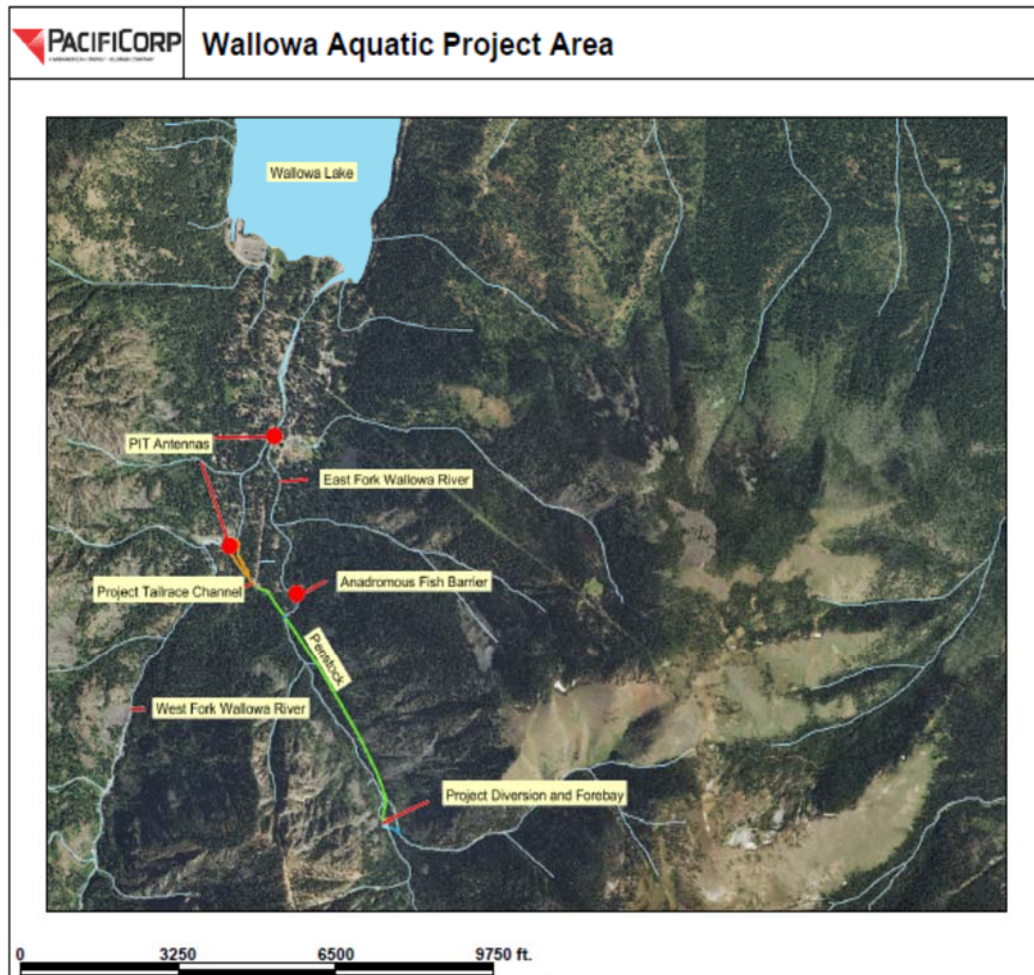
Figure 1 Wallowa Falls Hydroelectric Project.

The Project is located on the East Fork Wallowa River approximately 11 miles outside of the City of Joseph in Northeastern Oregon. The Project (Figure 1) reservoir/forebay lies over 1,600 meters (m) above mean sea level (msl) and is approximately 0.2 surface acres (0.08 ha) in size and averages 5 feet (1.5 m) deep. Because the Project operates as run of river, there is no measurable storage. Though no measurable storage is present in the forebay, habitat in this area is lacustrine, and given the shallow water depth no thermal stratification is present. Substrate in the forebay consists of deposited silt, sand, and other glacial fines.

Water diverted at the forebay travels through the flow line and penstock to the generating turbine in the Project powerhouse. Water exits the turbine and is discharged into an approximately 985-foot (300 m) long tailrace discharge channel that empties into the West Fork Wallowa River. This channel has an average wetted-width of 10 feet (3.1 m) and an average depth of one foot

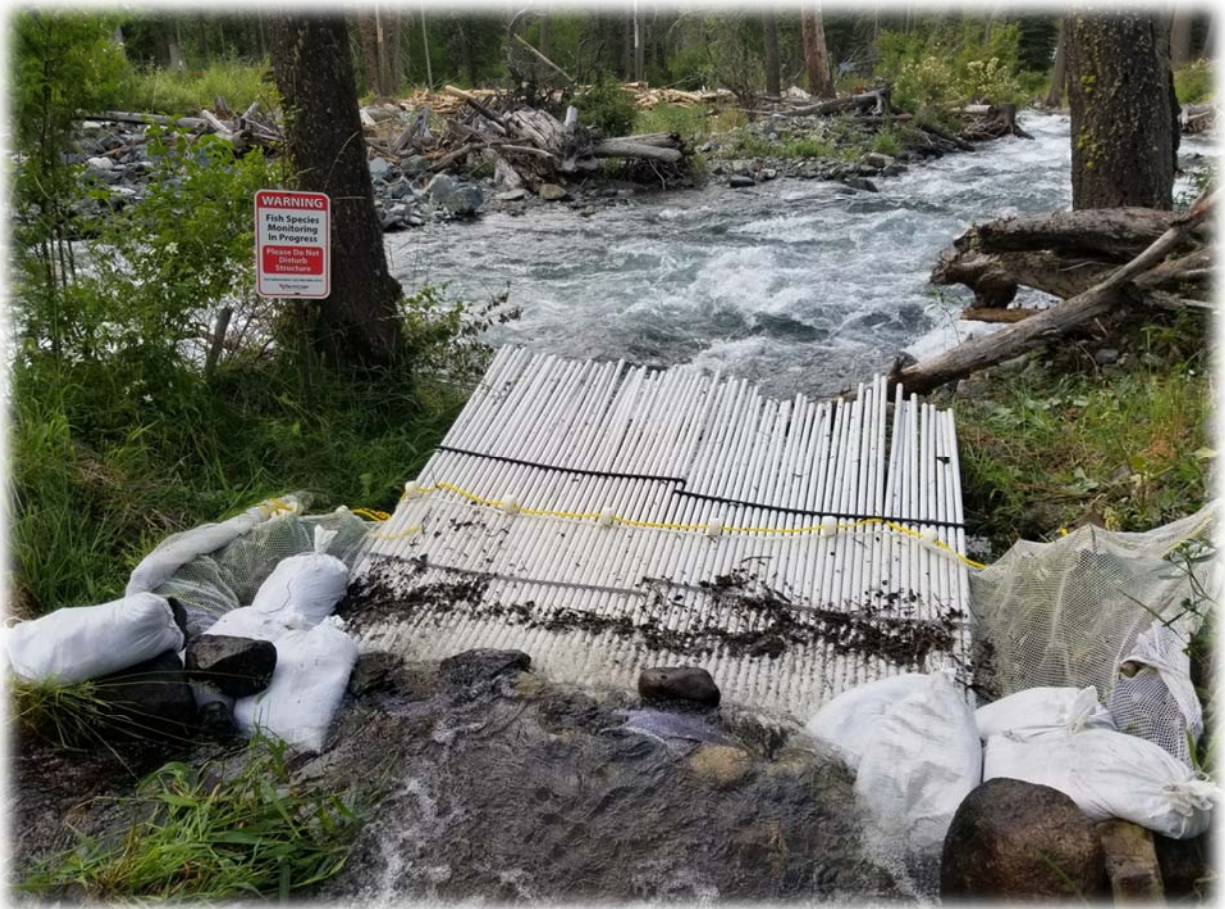
Figure 2

Also in 2017, a resistance type weir was constructed to serve as a temporary fish exclusionary device at the outlet of the tailrace channel and it's confluence with the West Fork Wallowa River. The resistance weir utilized 25.4 millimeter (mm) diameter polyvinyl chloride (PVC) set to a length of 2.4 meters (m) and spaced apart 6.35 mm by mechanically constructed stringers, the weir was stream-spanning (Figure 2). As extra precaution, a barrier net was also laid across the entire bottom of the upstream side of the weir. The openings of this barrier net were also 6.35 mm and the net was held in place by large sandbags placed end to end along the stream bottom and spanning the entire stream-width.

Per Article 410 of the operating license, a temporary fish barrier was installed at the outlet of the Wallowa Falls Tailrace Channel on July 24, 2017. This tailrace fish barrier was visually inspected twice per week until taken out on November 15, 2017. At no time during weekly inspections was the barrier visually assessed to be ineffective in precluding fish from entering the tailrace (Appendix A).
