DRAFT
WATER RESOURCES S TECHNICAL REPORT
WEBER HYDROELECTRIC PROJECT RELICENSING
FERC PROJECT NO. 1744

Prepared for
PacifiCorp
1407 West North Temple, Room 110
Salt Lake City, Utah 84116

Prepared by
SWCA Environmental Consultants
257 East 200 South, Suite 200
Salt Lake City, Utah 84111
(801) 322-4307
www.swca.com

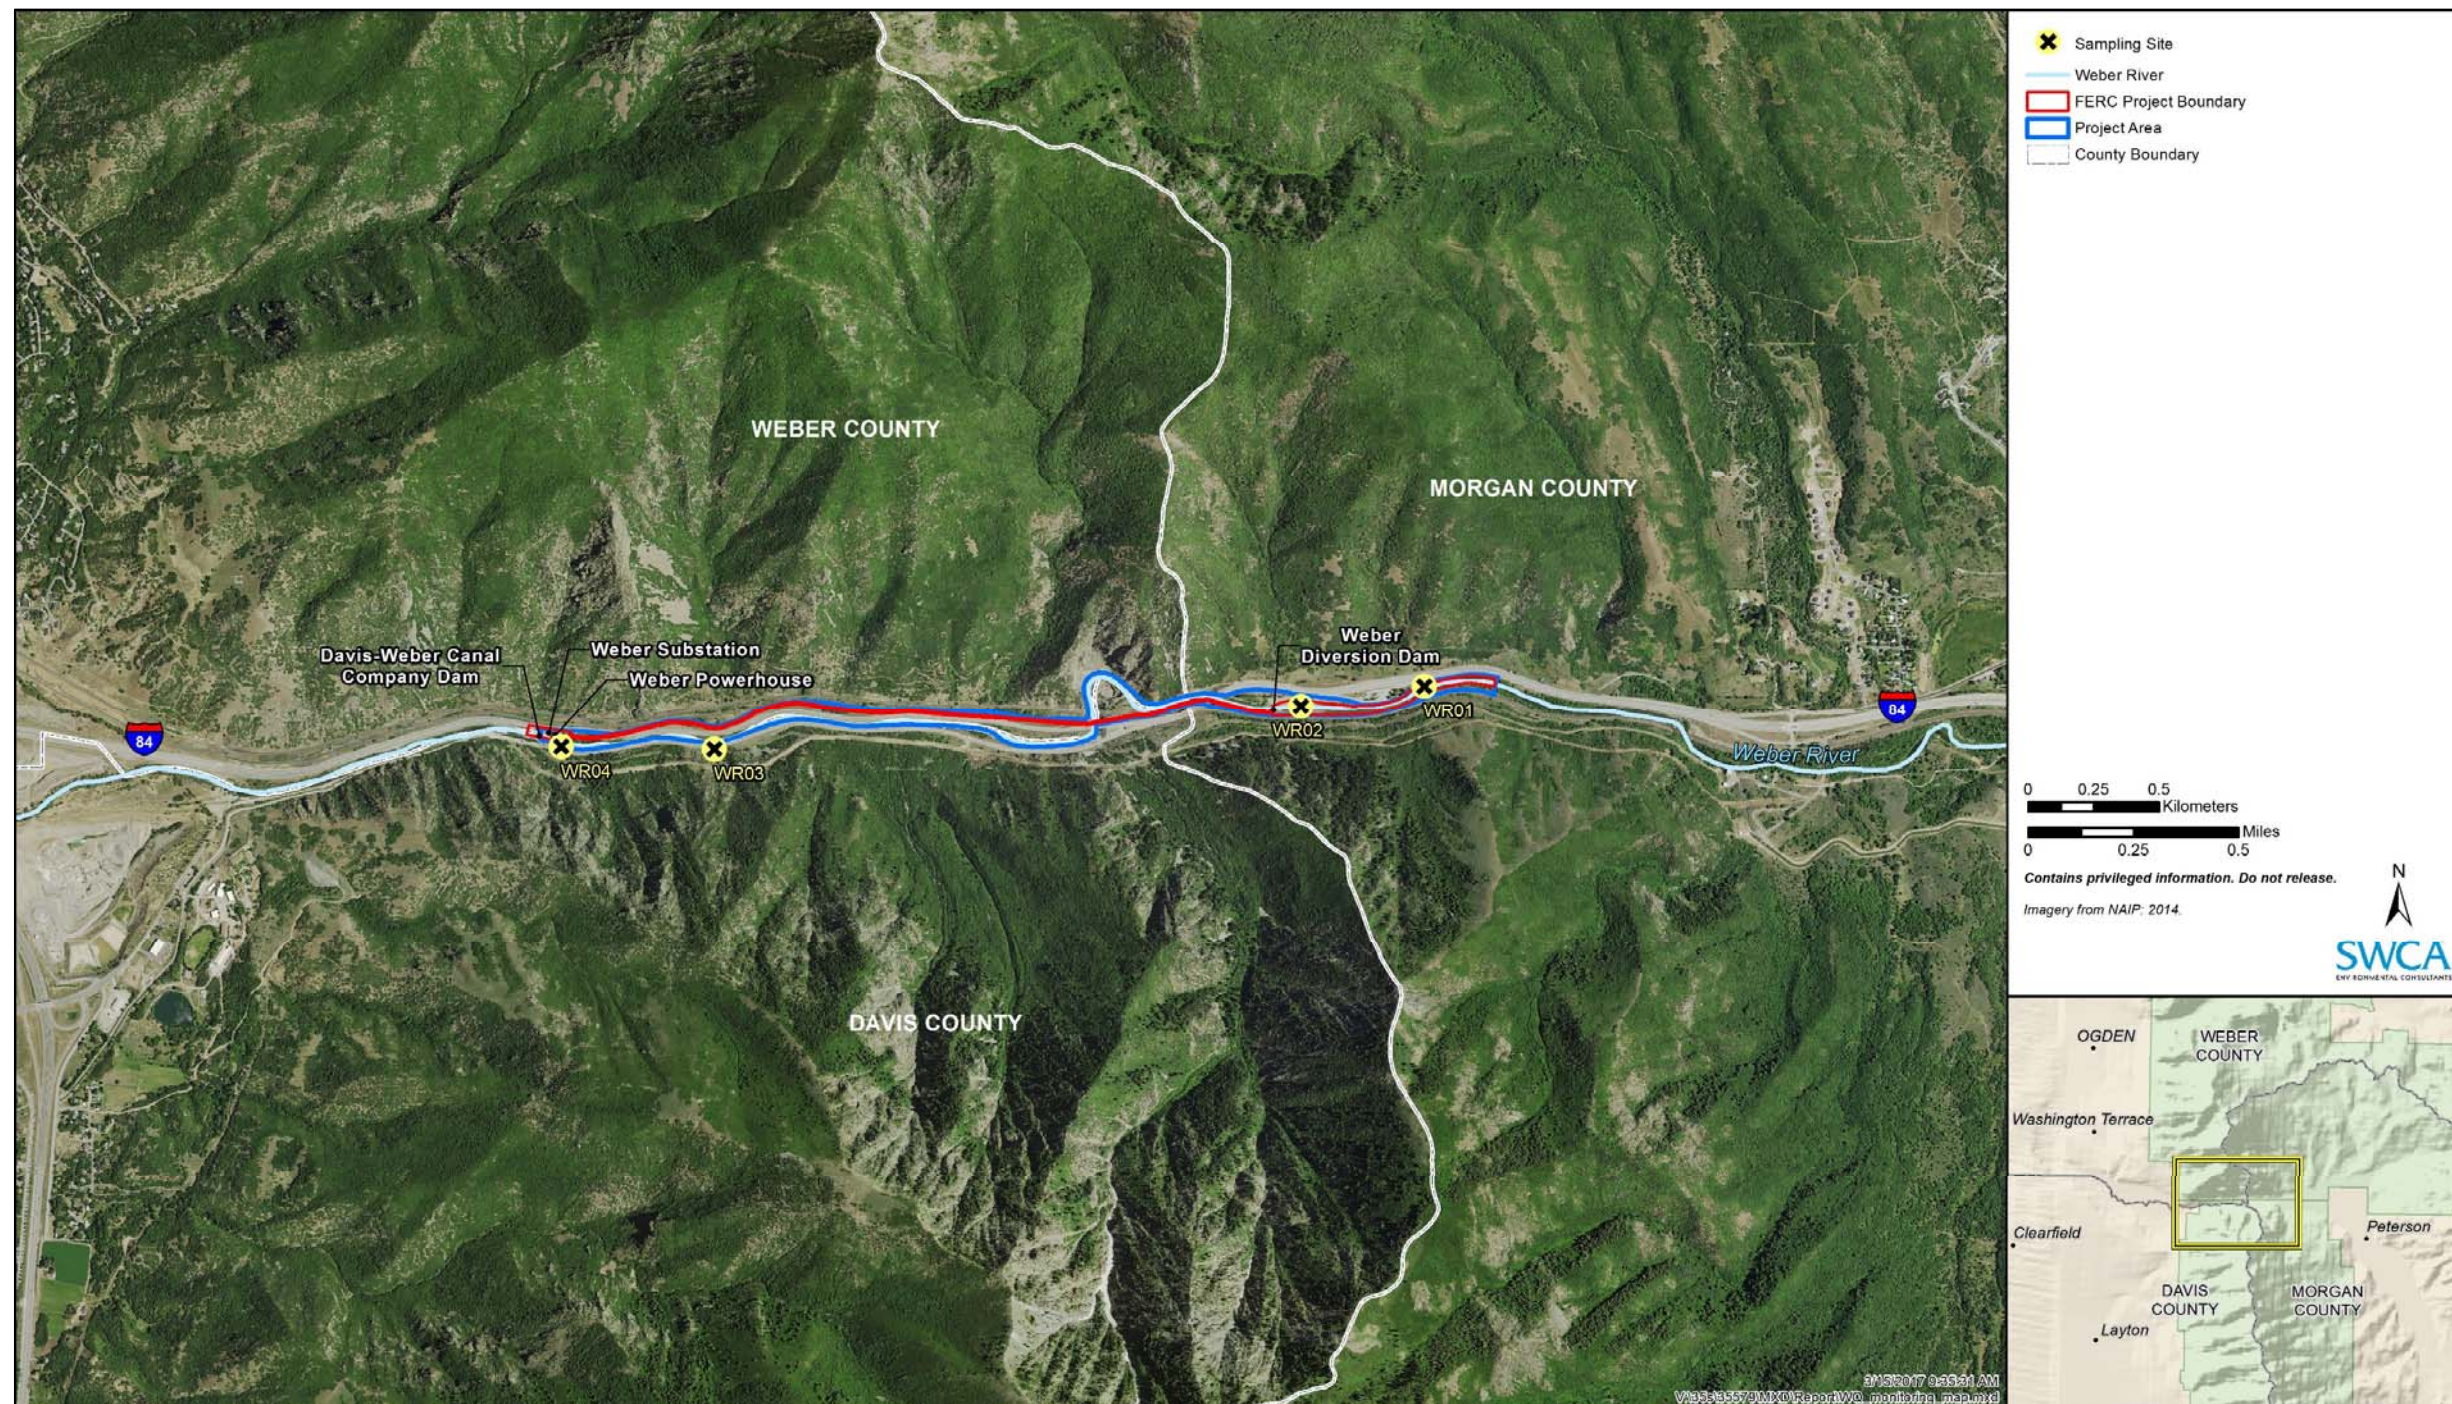
Figure 2. Water quality sampling site locations.

which the water is discharged back into the river. Additional information regarding the final selected sampling site locations are summarized and described in Table 1 and shown in Figure 2.

Sampling Site	Sampling Site Location Description
WR01	At U.S. Geological Survey station 10136500, Weber River, Gateway, Utah
WR02	Upstream of the Weber diversion dam
WR03	Below-Downstream of the Weber diversion dam, in the bypassed reach of the river, approximately 100 meters upstream of PacifiCorp's Weber powerhouse
WR04	Within PacifiCorp's Weber powerhouse outflow, upstream of the Davis-Weber Canal Company dam
