Lewis River Aquatic Fund Projects (SA 7.5.3.2)

Project Closeout Report

Project Title:	Lewis River Hydroelectric Project <i>Martin Access Riparian Forest and Off-channel Habitat Enhancement, the Two Forks Access Riparian Forest Enhancement, and the Plas Newydd Farm Riparian Forest Enhancement</i>
Project Approved By:	Aquatic Coordination Committee April 2007
Original Project Sponsor:	Cowlitz Indian Tribe
Project Funding	\$75,000
Project Description (work completed):	<ul style="list-style-type: none">• The Natural Resources Department of the Cowlitz Indian Tribe used ACC funding to plant a total of 1100 willow (Sitka willow <i>Salix sitchensis</i>, and Scouler's Willow <i>Salix scouleriana</i>), 950 Black Cottonwood (<i>Populus balsamifera ssp. trichocarpa</i>), 1020 Red-Osier Dogwood (<i>Cornus stolonifera</i>) and 124 Oregon Ash (<i>Fraxinus latifolia</i>) at four sites along the lower mainstem Lewis River of southwest Washington State. These numbers total, in all, 3270 plants.• Five species were selected for planting: Scouler's Willow, Sitka Willow, red-osier dogwood, black cottonwood and Oregon ash. These species were selected to accomplish multiple goals including: rapid growt

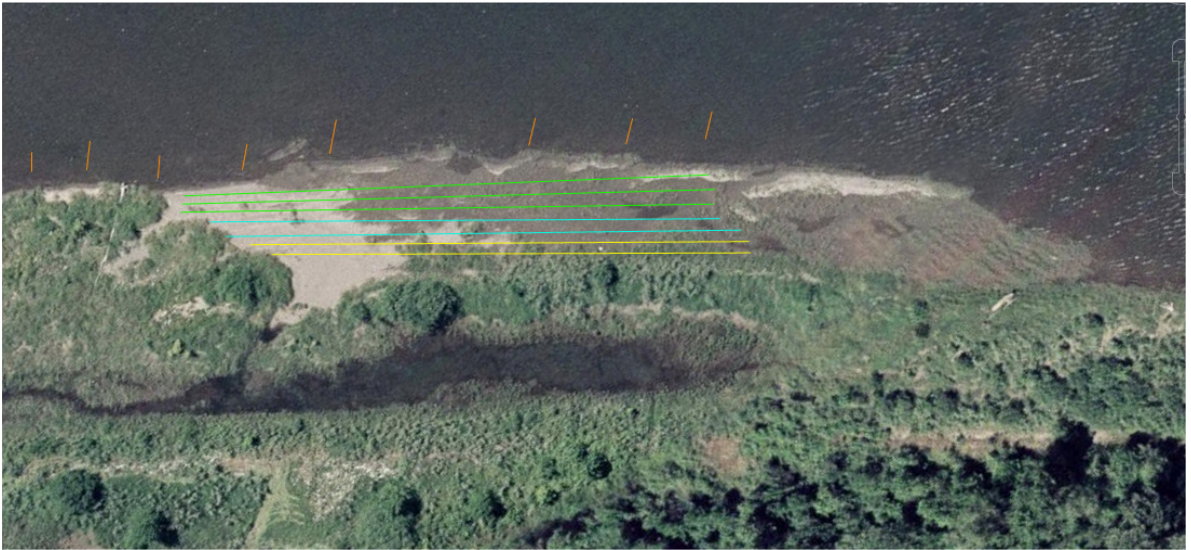
Plantings on Plas Newydd West. Green bars indicate where rows of willows planted, blue lines represent red-osier dogwood, and yellow bars represent black cottonwood plantings. Orange bars indicate where willow cuttings were placed.

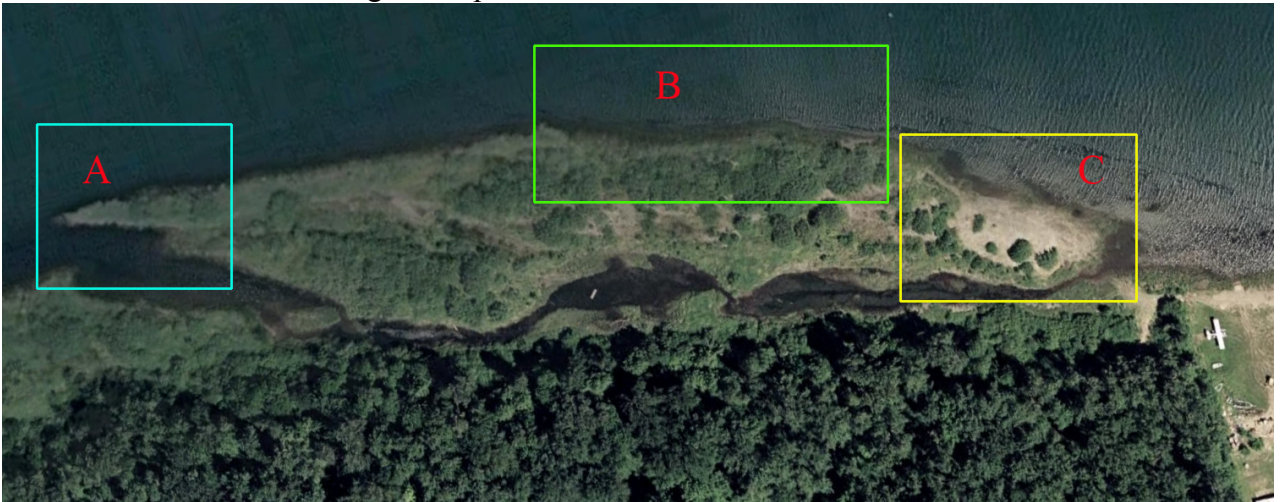
Overview of planting sites on Plas Newydd East. Plantings were done in three areas (Source: Google Earth) Site A had three rows of red-osier dogwood planted at the tip of the island.

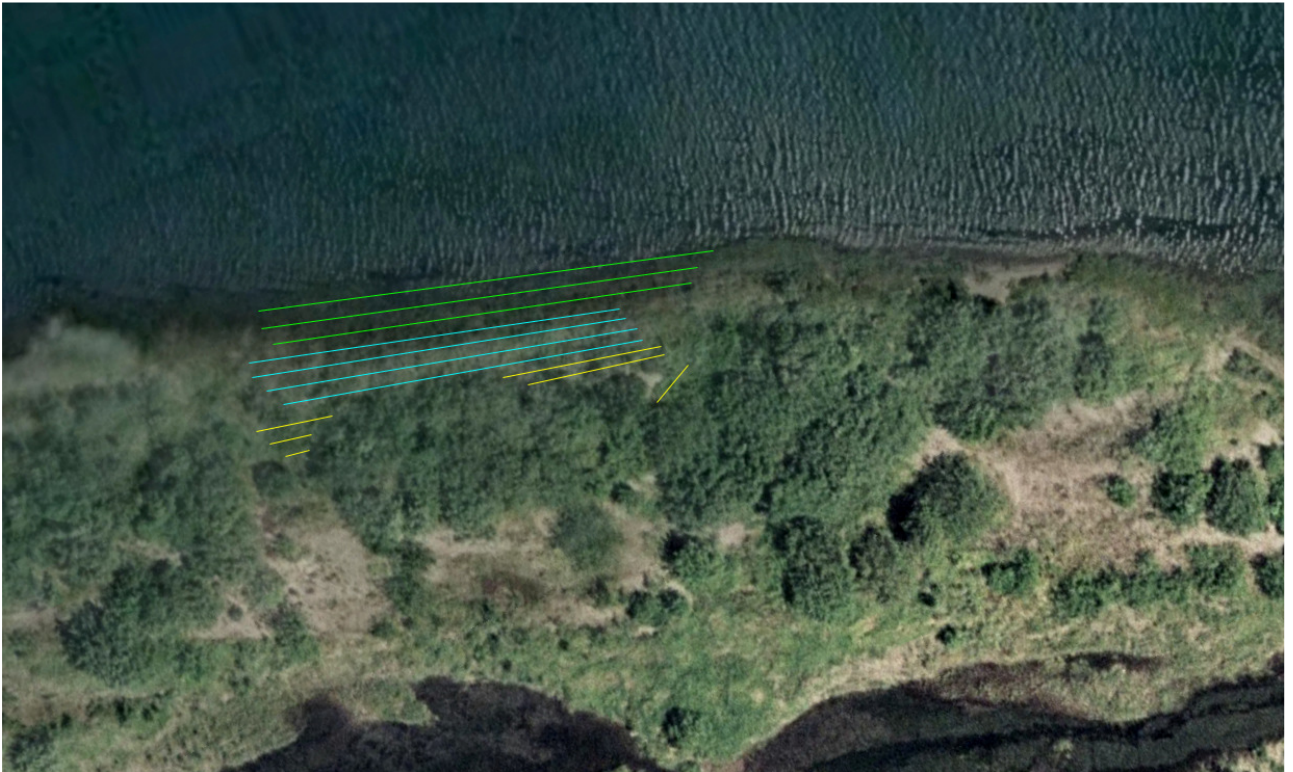
Plantings done on section “B” at Plas Newydd East. Green bars indicate where willows were planted. Blue bars show red-osier dogwood, and yellow bars indicate black cottonwood. (Source: Google Earth)

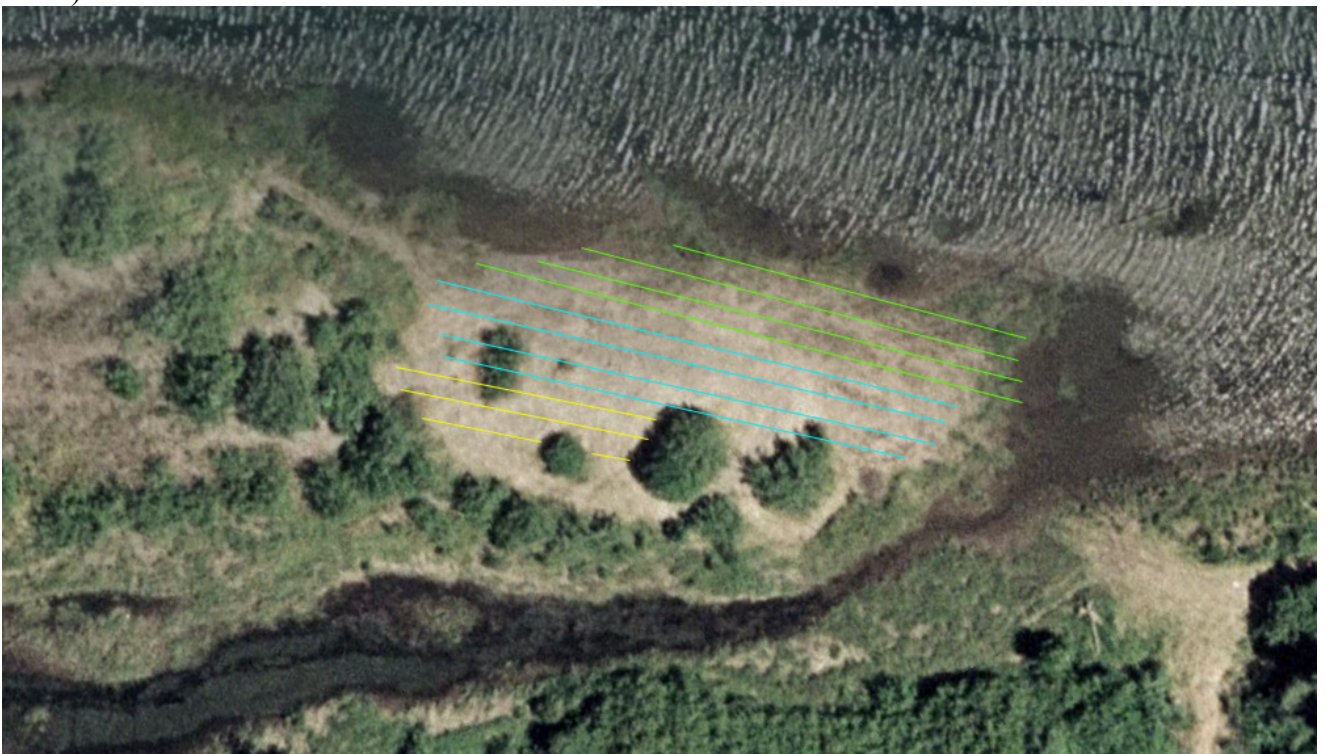
Plantings at Plas Newydd East, section “C”. Green bars indicate willow plantings, blue bars indicate red-osier dogwood, yellow bars indicate black cottonwood plantings. (Source: Google Earth)

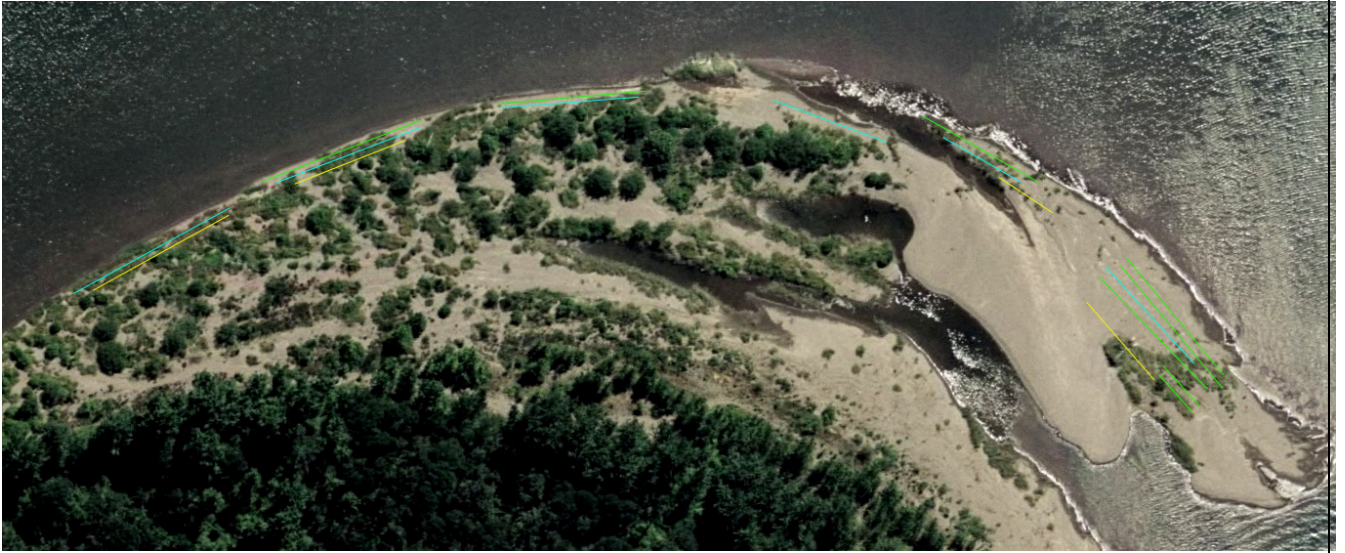
Plantings along Martin Access. Green bars indicate where willow were planted. Blue bars represent red-osier dogwood, yellow lines show black cottonwood. (Source: Google Earth)

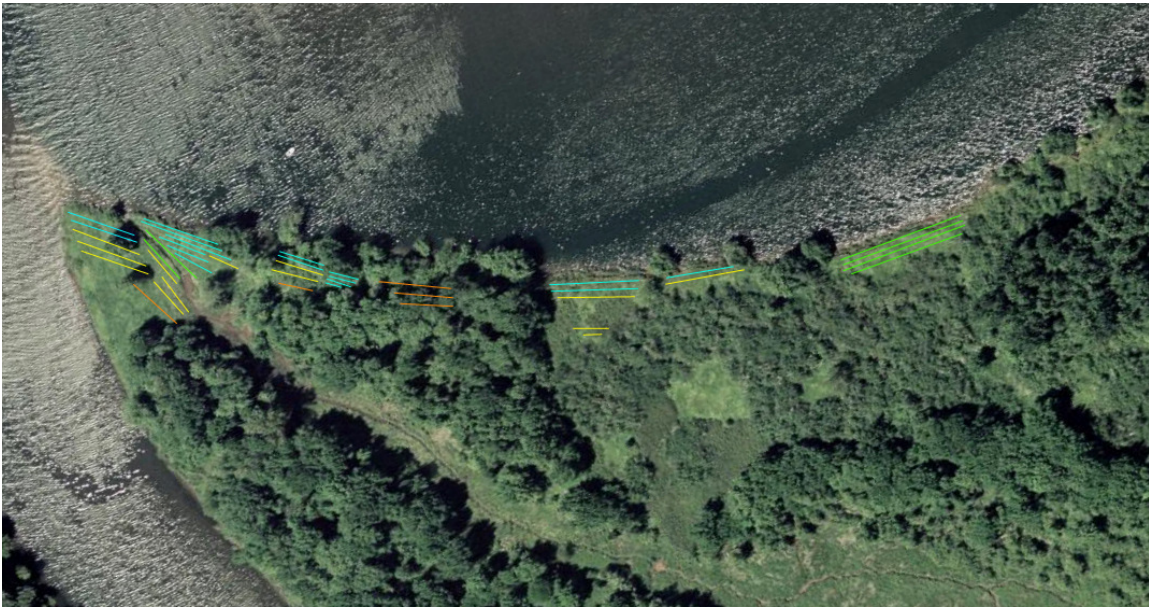
Plantings at Two Forks. Green bars indicate where willows were planted. Blue bars represent red-osier dogwood, yellow bars represent black cottonwood. Orange bars represent Oregon ash. (Source: Google Earth)

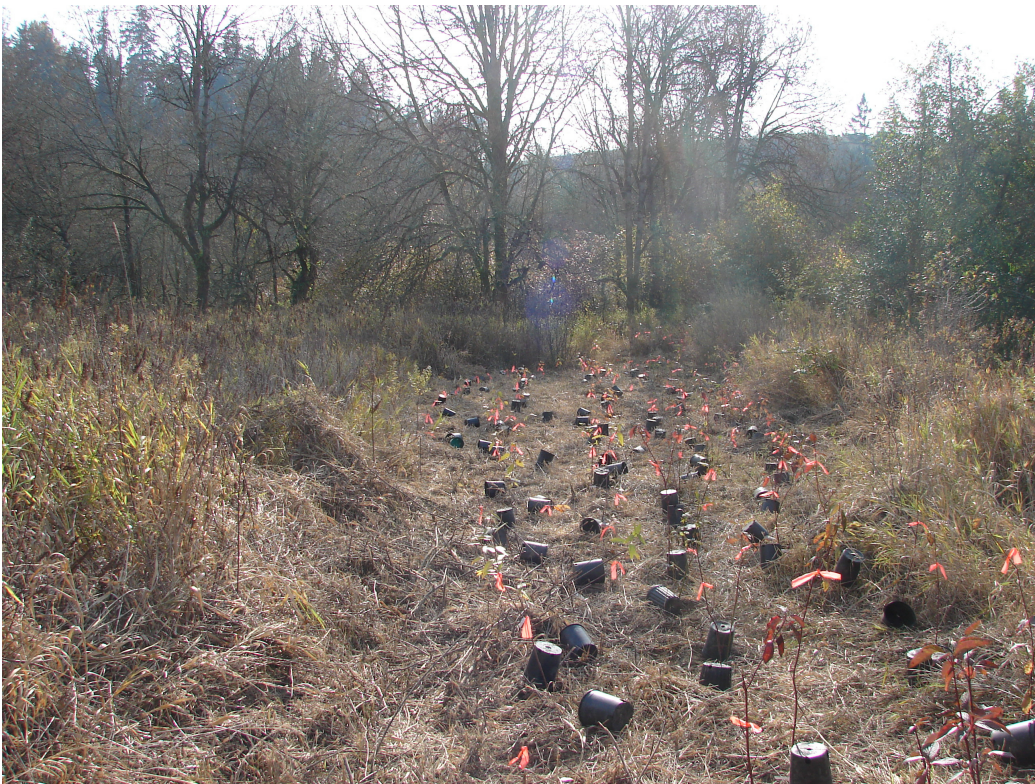
Plants being staged in an area at the Two Forks site. The site was prepared for planting by mowing reed-canary grass (Photo: Nathan Reynolds October 2007)

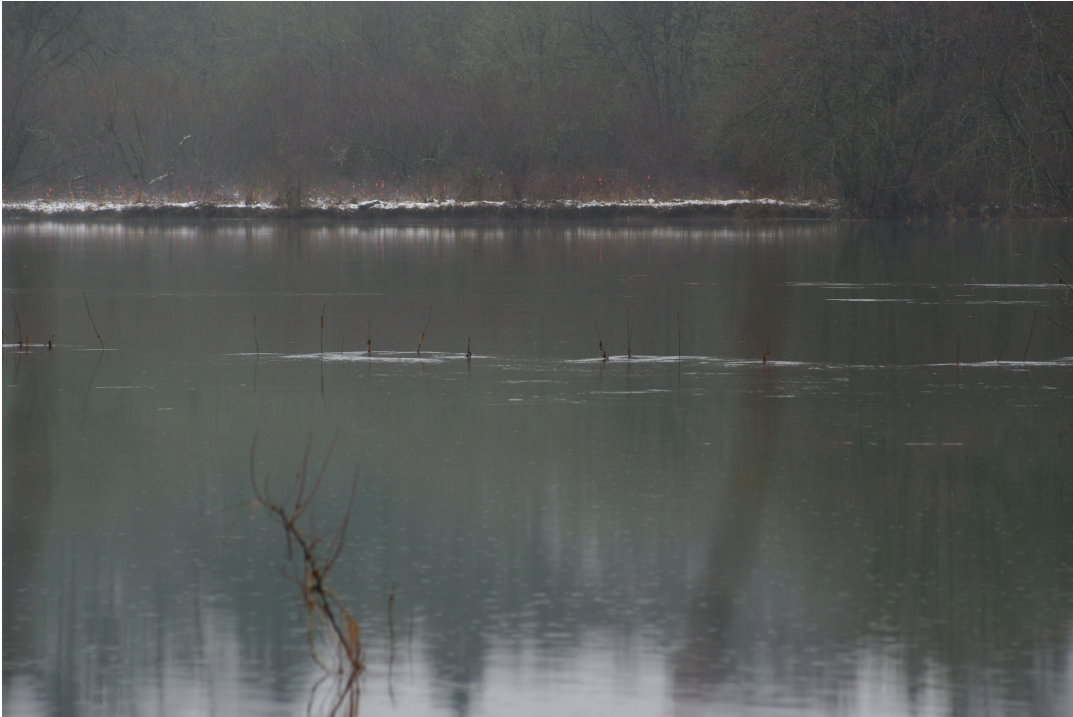
Plantings at Two forks with Martin Access plantings in the foreground. The plantings can be identified by the orange flagging. (Photo: Rudy Salakory December 2008)
