Lewis River Aquatic Fund Projects (SA 7.5.3.2) Project Closeout Report

Project Title: Lewis River Hydroelectric Project
8322 Fish Passage Culvert Replacement

Original Project Sponsor: USDA Forest Service

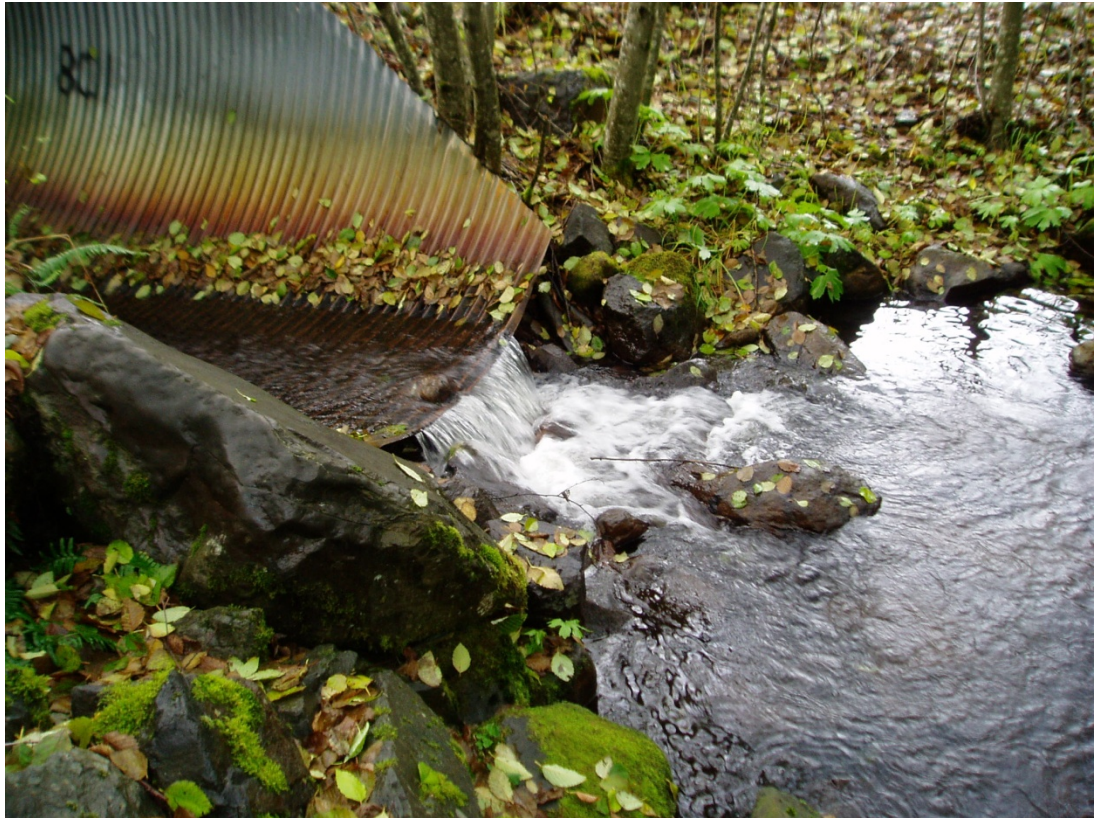
Picture 1. Outlet of Culvert to be replaced. Tracy 2005

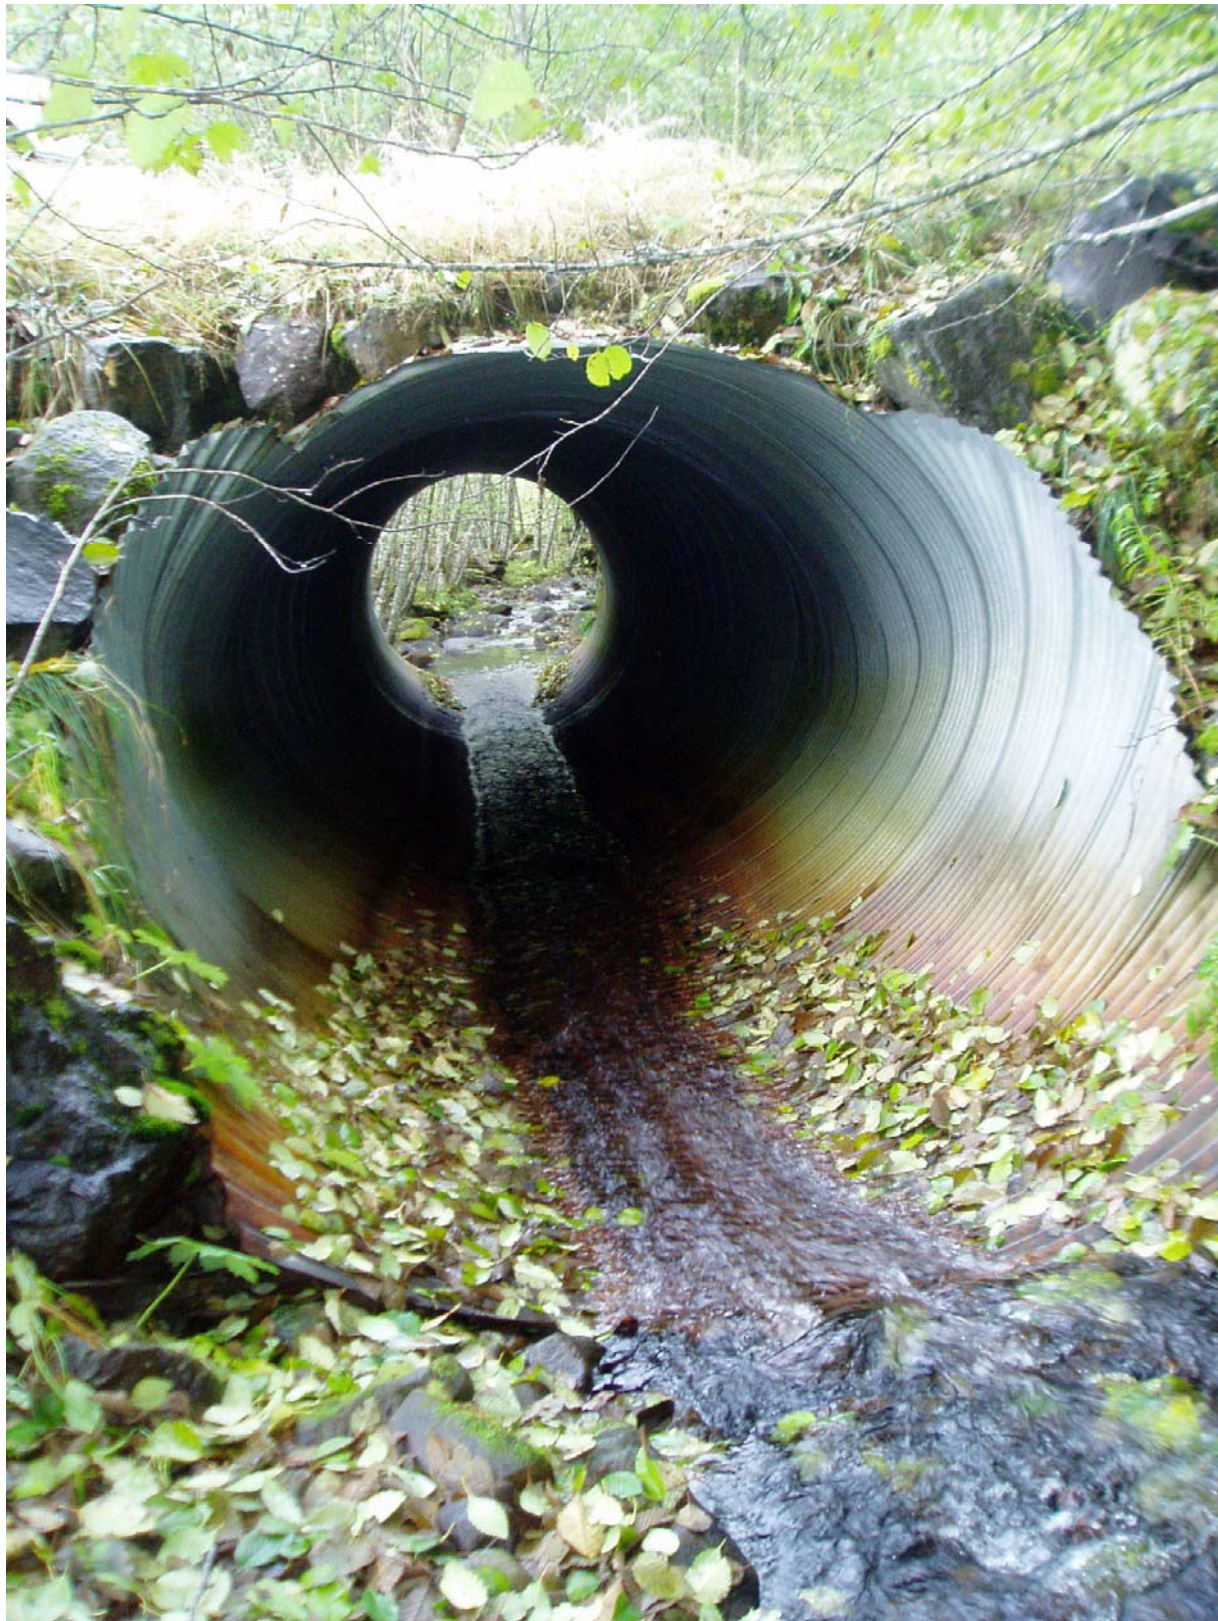
Picture 2. Inlet of culvert to be replaced. Tracy 2005

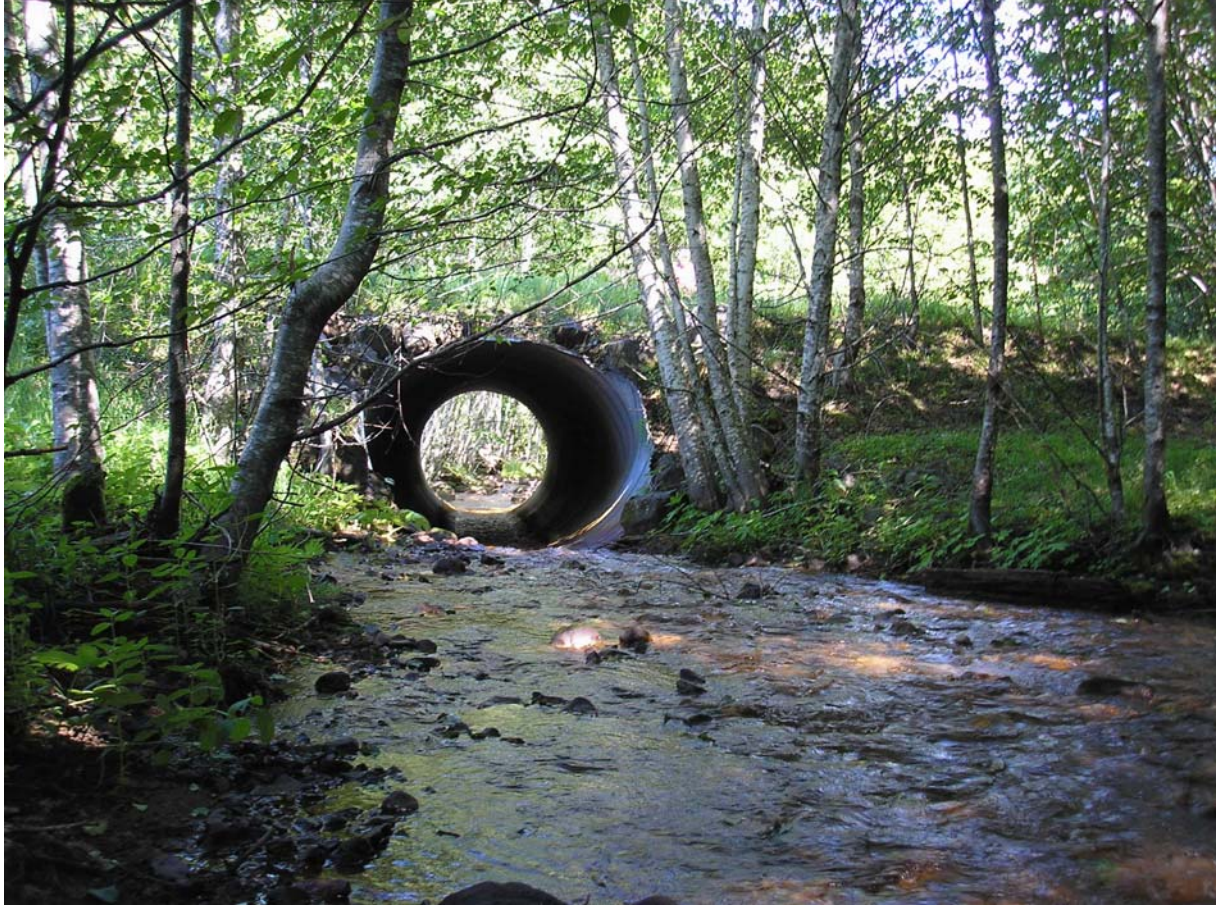
Picture 3. Culvert before replacement. Note kinked tree on left. Tracy 2005

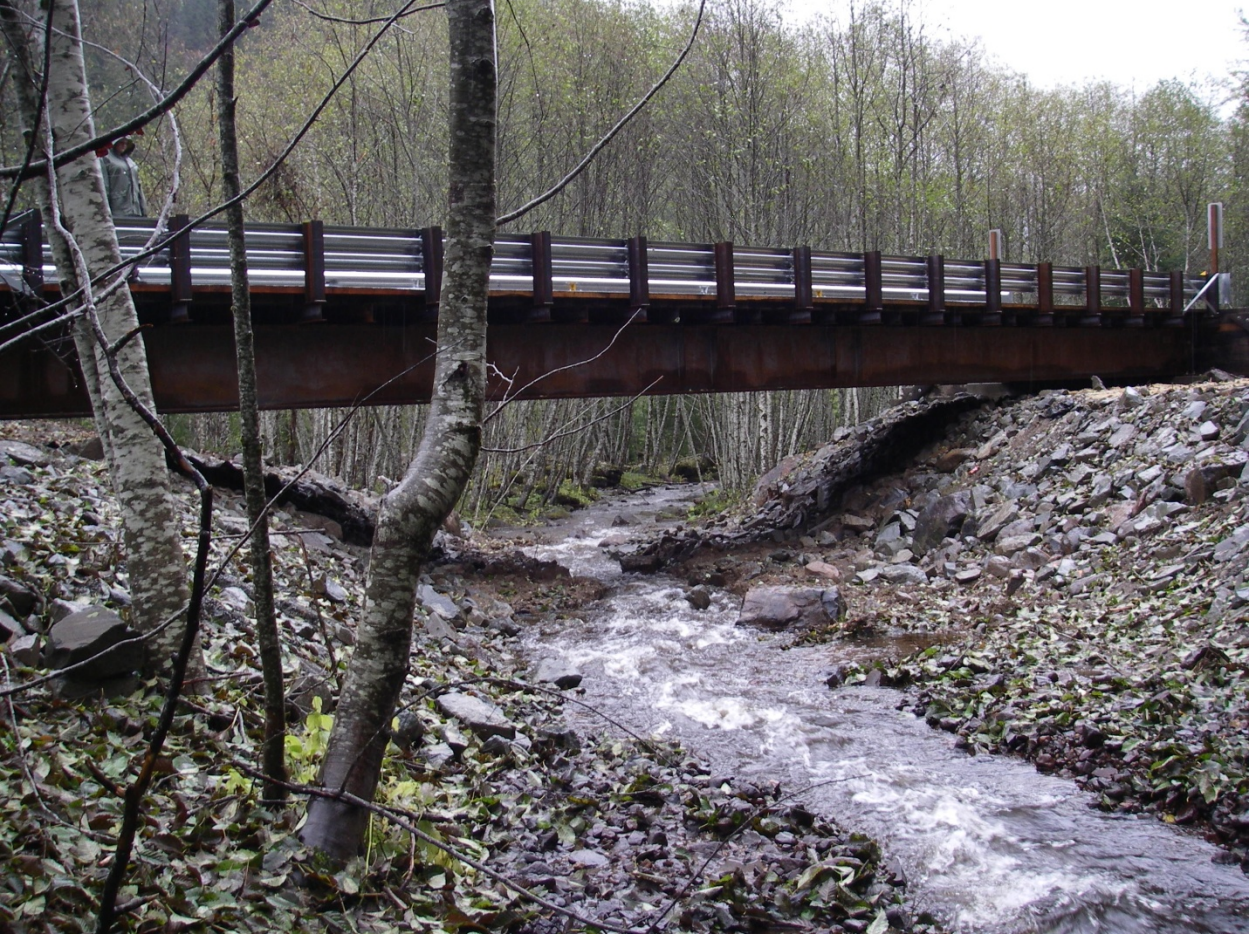
Picture 4. New bridge has replaced the culvert. Note Kinked tree on left. Becker
10/2009

- Removed a culvert that was creating passage problems for fish on a tributary of Muddy River with a bridge. We originally planned to use a bottomless arch, but were able to secure additional funding from Legacy Roads grants to ensure full channel connectivity with a bridge. One mile of stream was reconnected to the Muddy River consisting of both rearing and spawning habitat for anadromous and resident fish, and potentially bull trout. This stream provides refugia from high water events for juvenile salmonids and provides cold water during warm summer months.

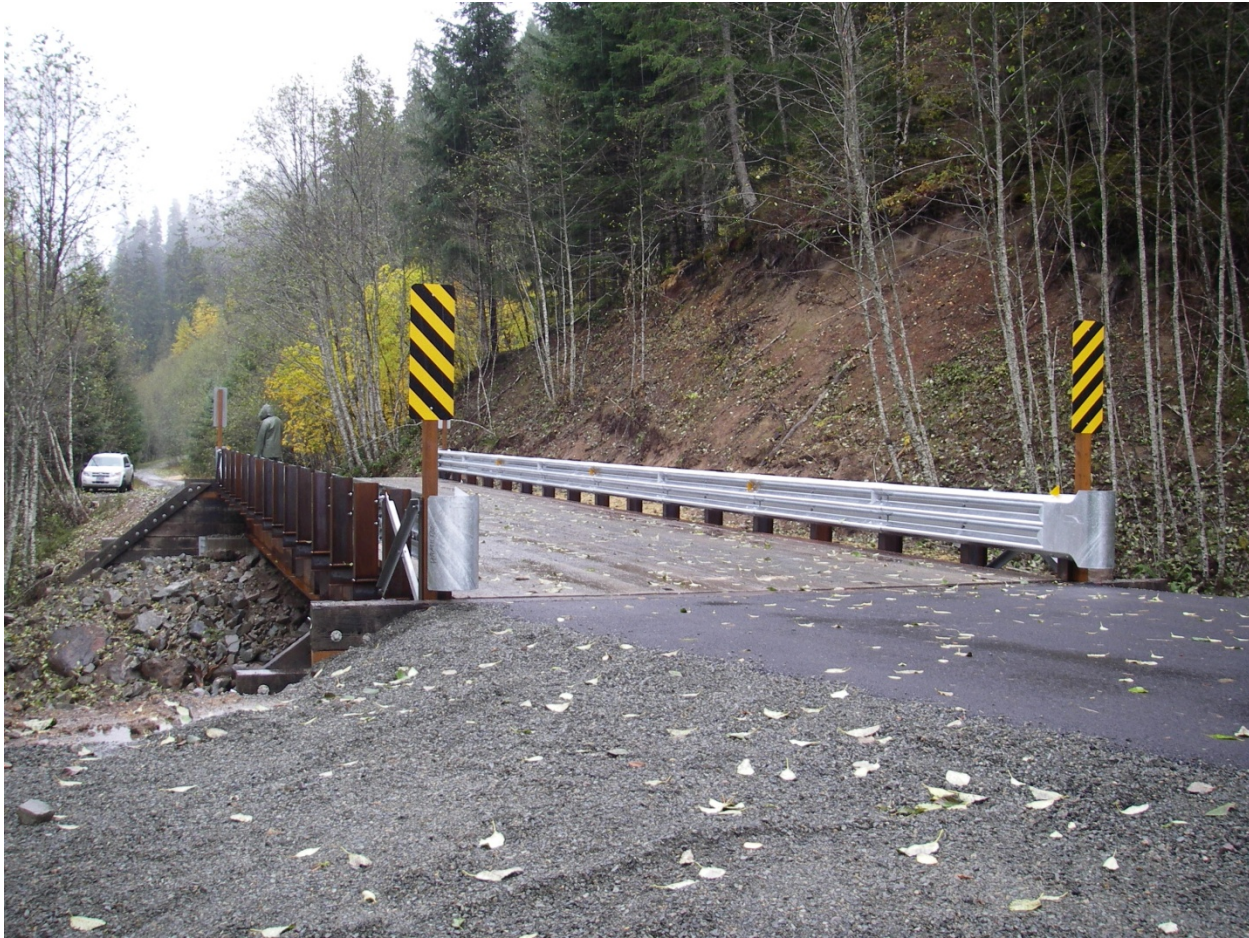
Picture 4. New bridge in place of old culvert. Becker 10/2009
