Lewis River Aquatic Fund Projects (SA 7.5.3.2)

Project Closeout Report

Project Title: Lewis River Hydroelectric Project
Mud Creek Enhancement

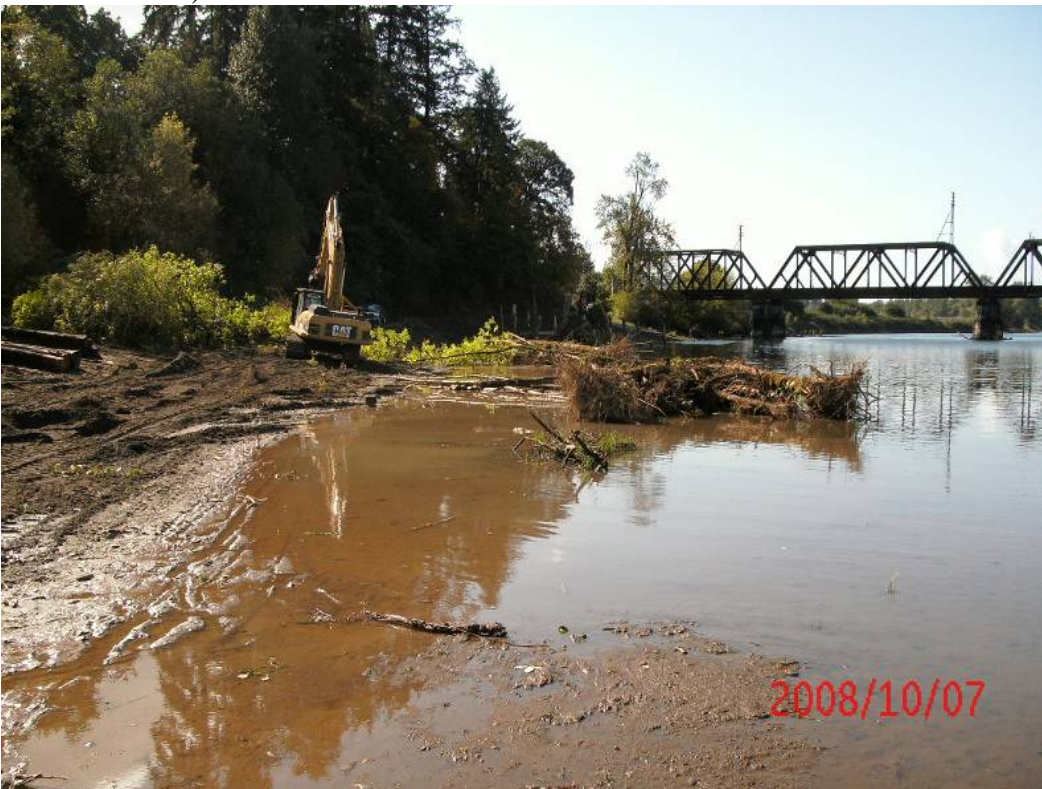
Wood debris being staged during low water times on site (Photo: Tony Meyer)

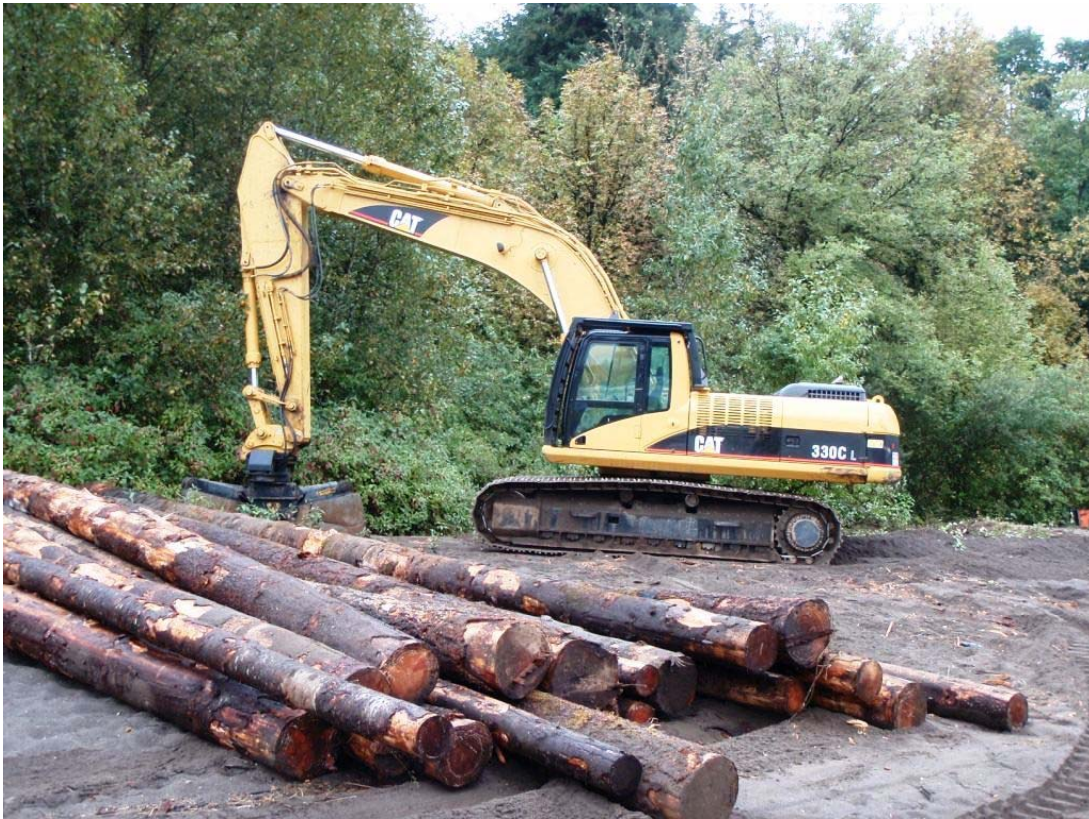
Pilings being staged (Photo: Shannon Wills)

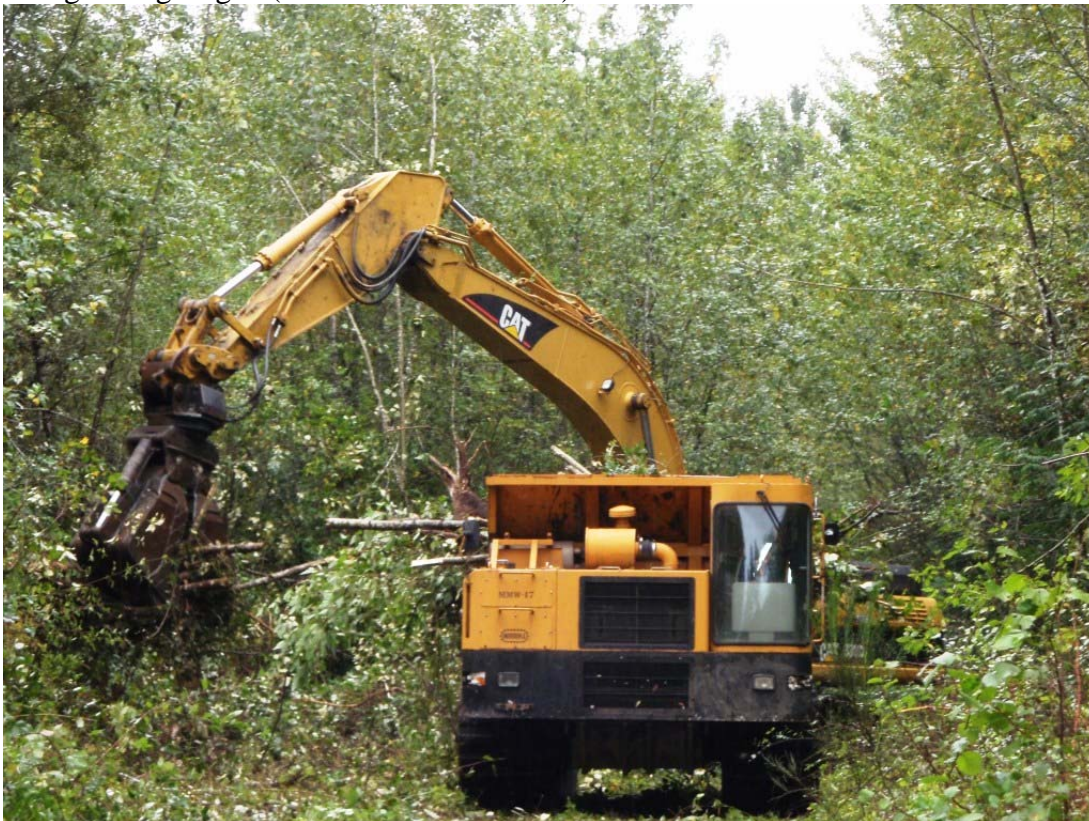
Brush and debris being collected on-site for use in the ELJ (Photo: Shannon Wills)

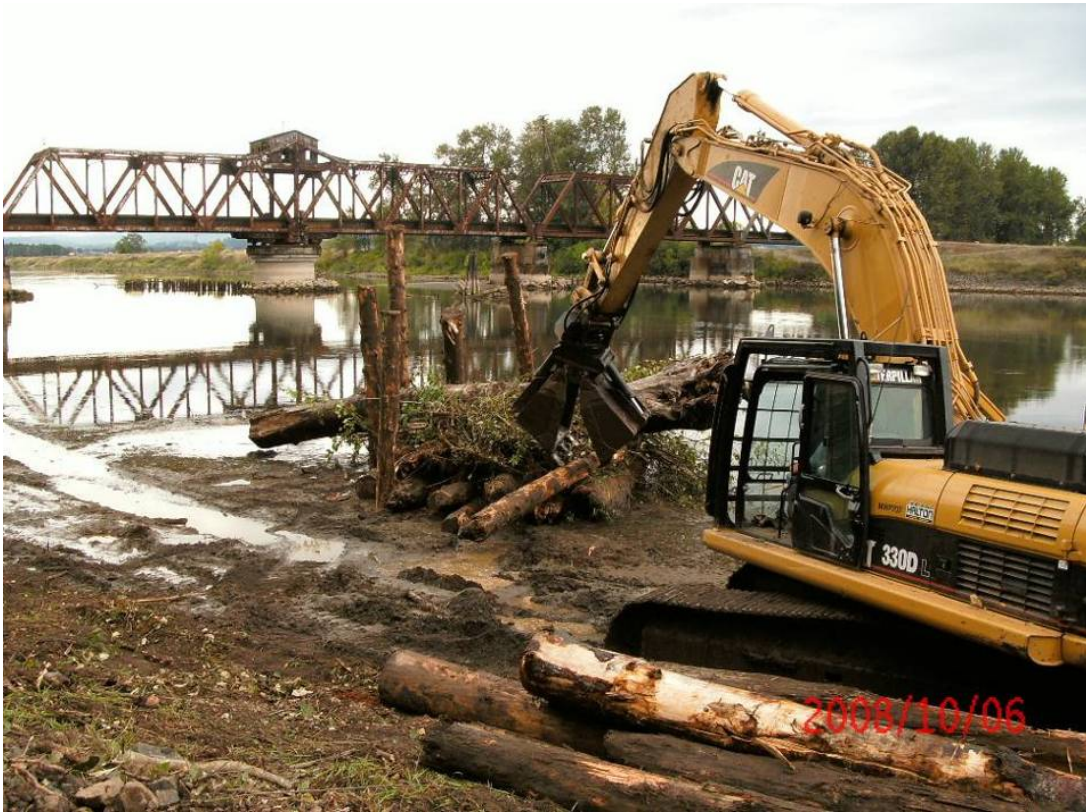
Pilings in place, and debris within the pilings, the boles are ready to be put into place. Land based equipment was used on this project because of the ease of access. (Photo: Tony Meyer)

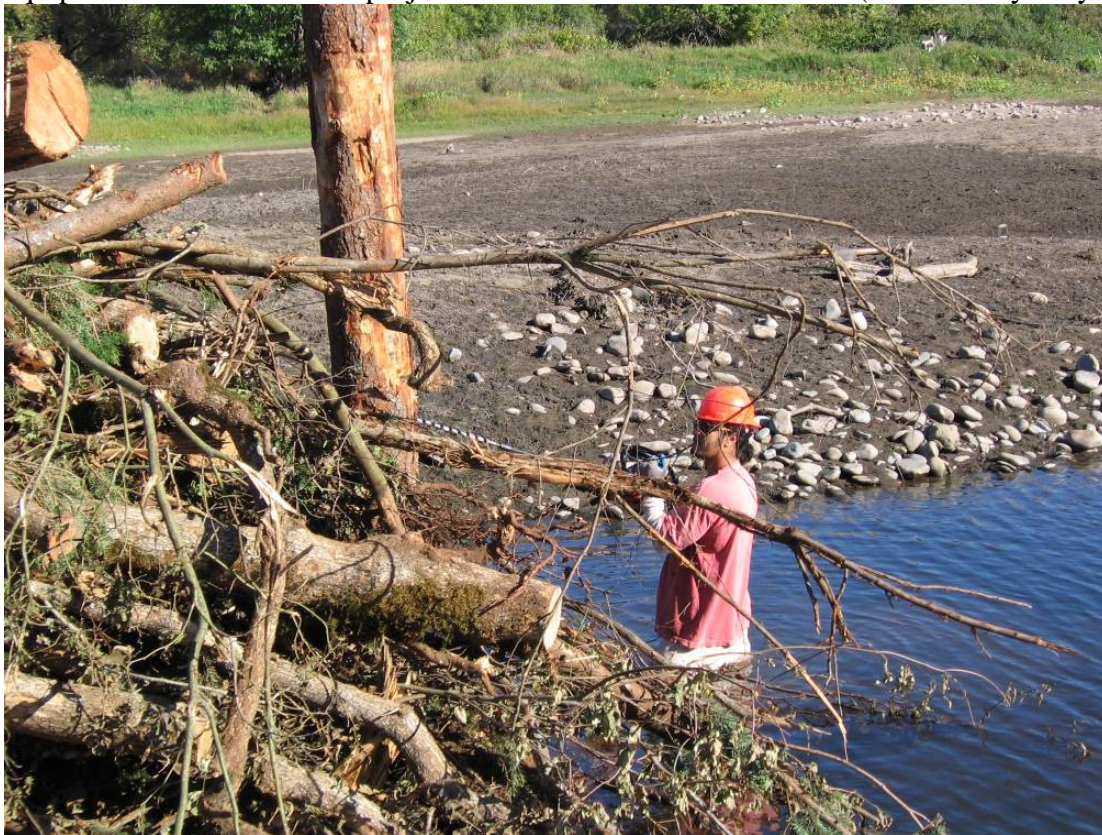
Holes were drilled into the pilings and structures to bolt and anchor each ELJ in place in order to prevent ELJ from floating out during high-water events. (Photo: Tony Meyer)

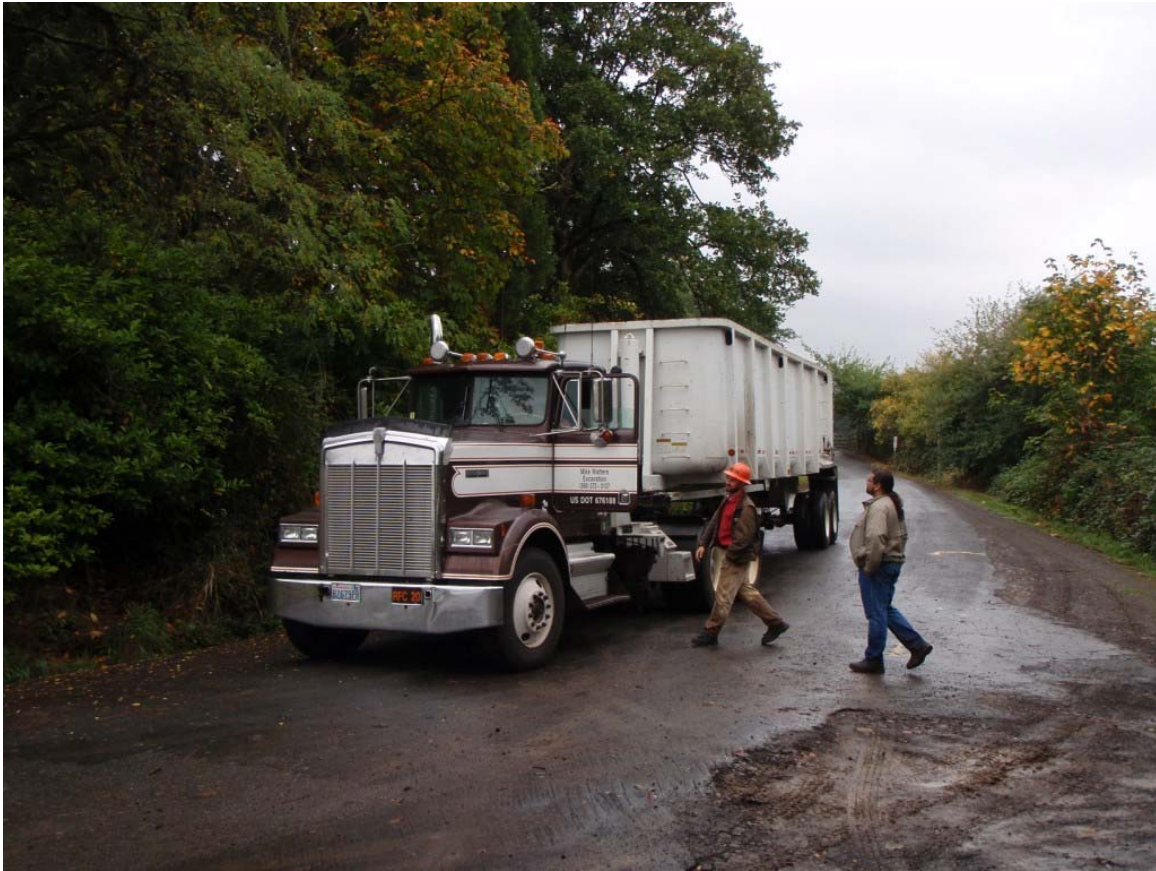
Pilings and boles were transported in from an upriver reservoir (Photo: Shannon Wills)

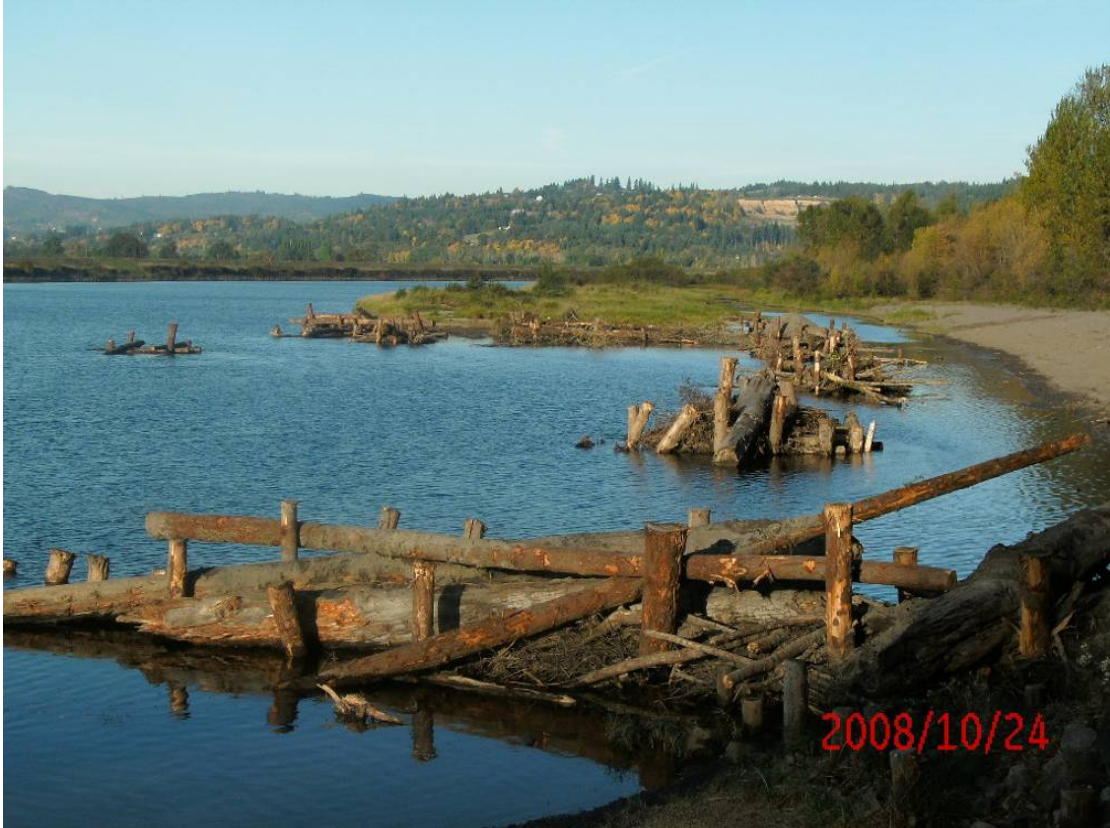
All seven completed ELJ at high tide during the end of the low-water season. (Photo: Tony Meyer [Oct 24 2008])

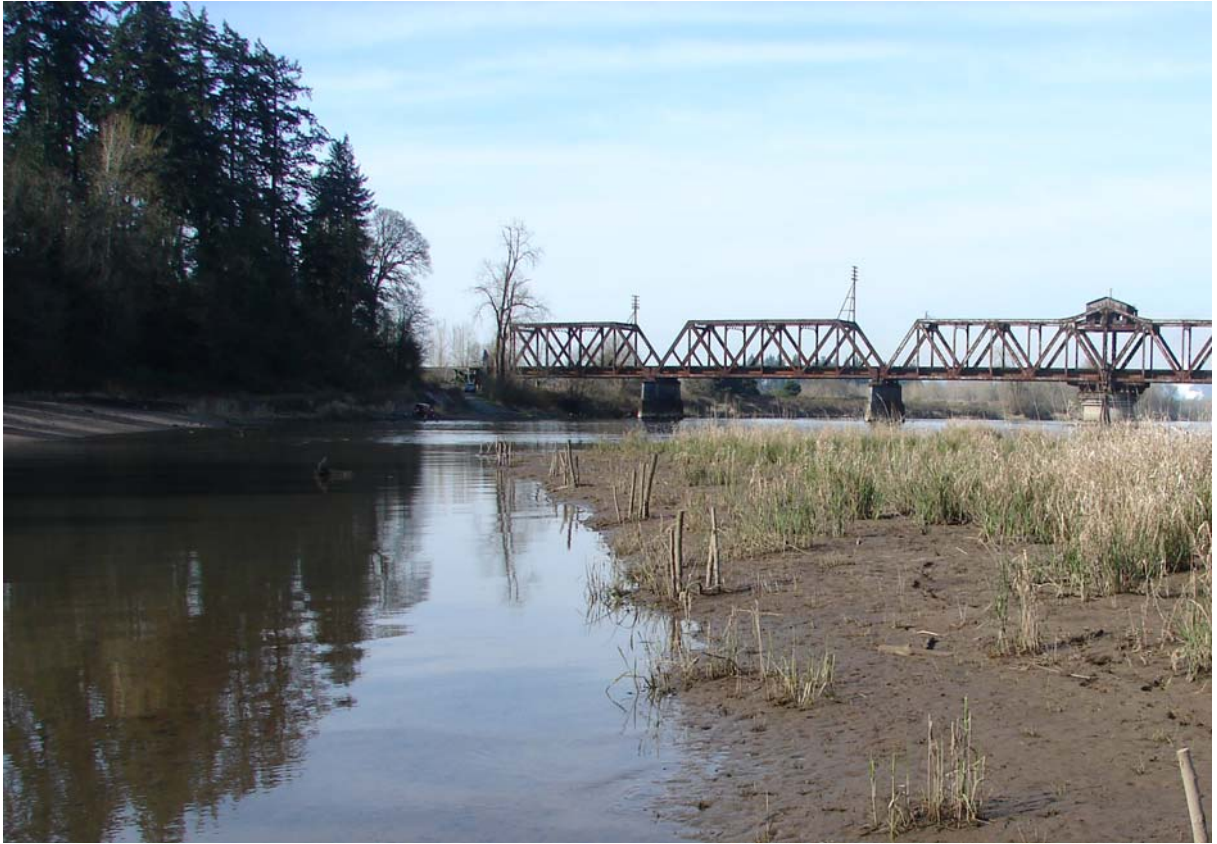
View from the east of the area before construction (Photo: Nathan Reynolds [April 2007])
