Clear Creek Instream Habitat Restoration Project Closeout Report

Project Title: Clear Creek In-stream Habitat Restoration

Agency: US Forest Service
Gifford Pinchot National Forest
Mount St. Helens Ranger District

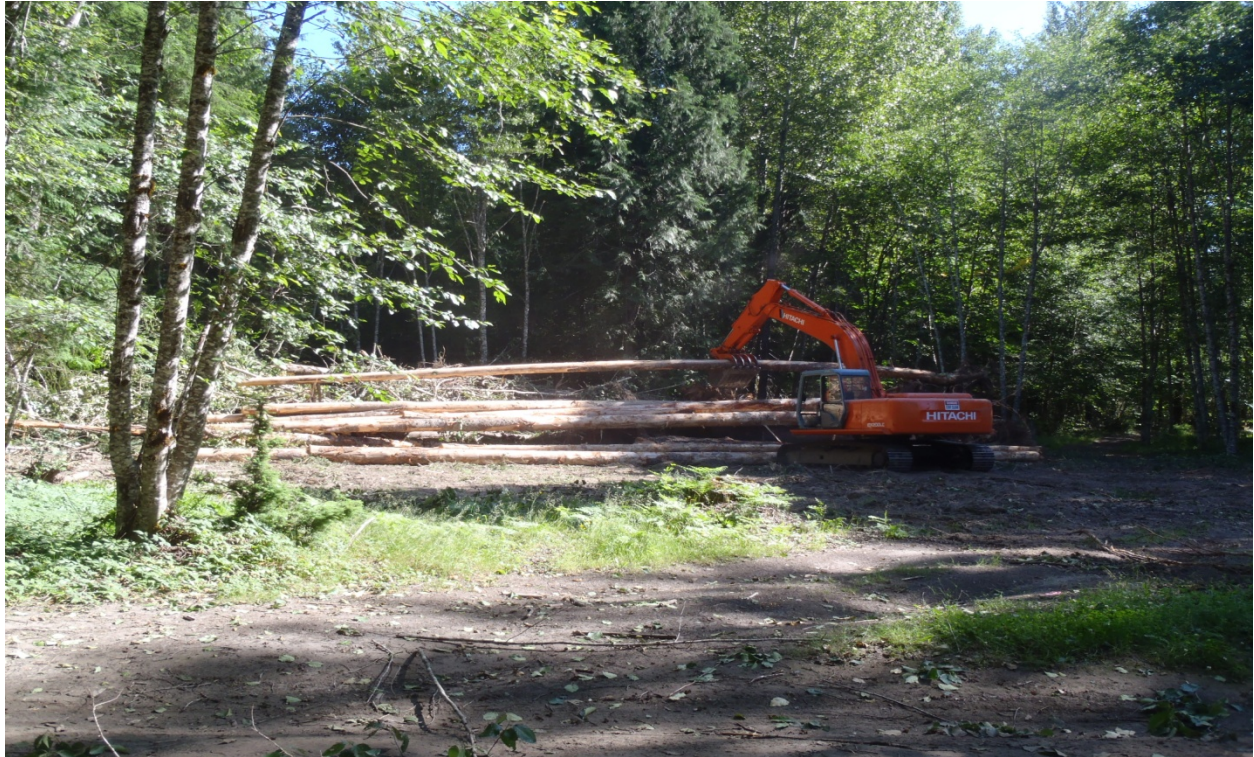
Stockpiling logs at the staging area

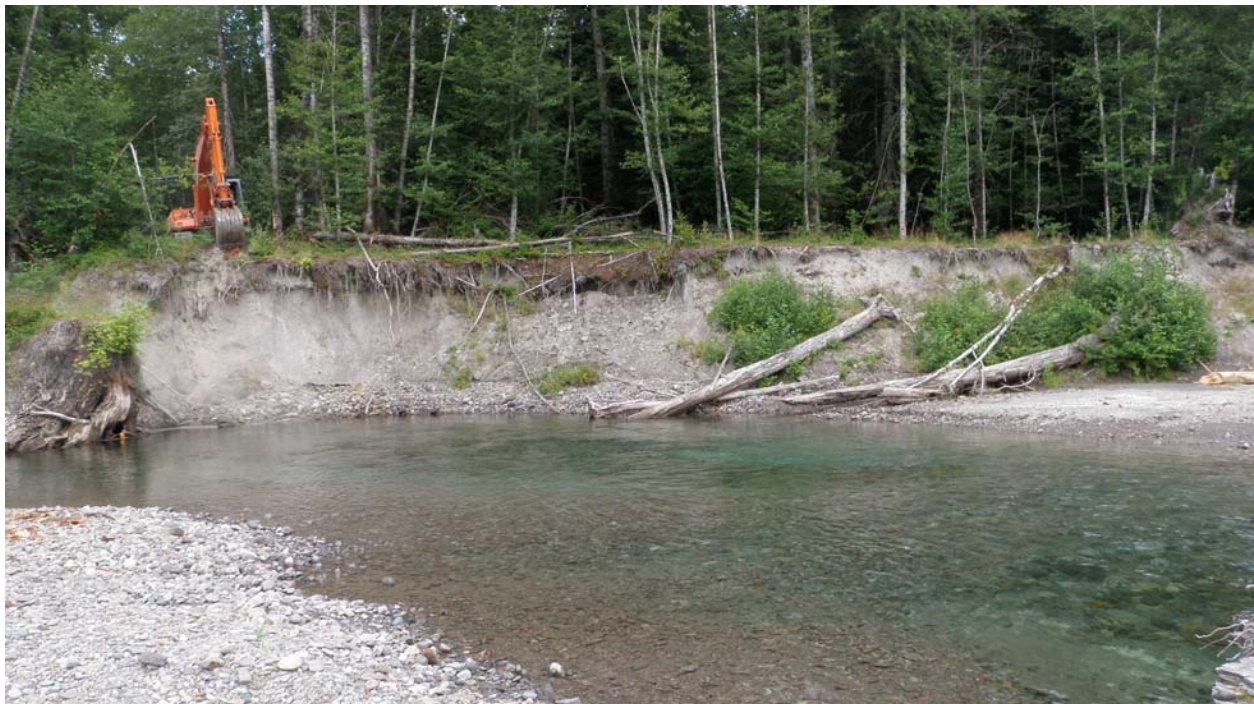
Looking down stream at eroding bank prior to bank stabilization structure ST#2

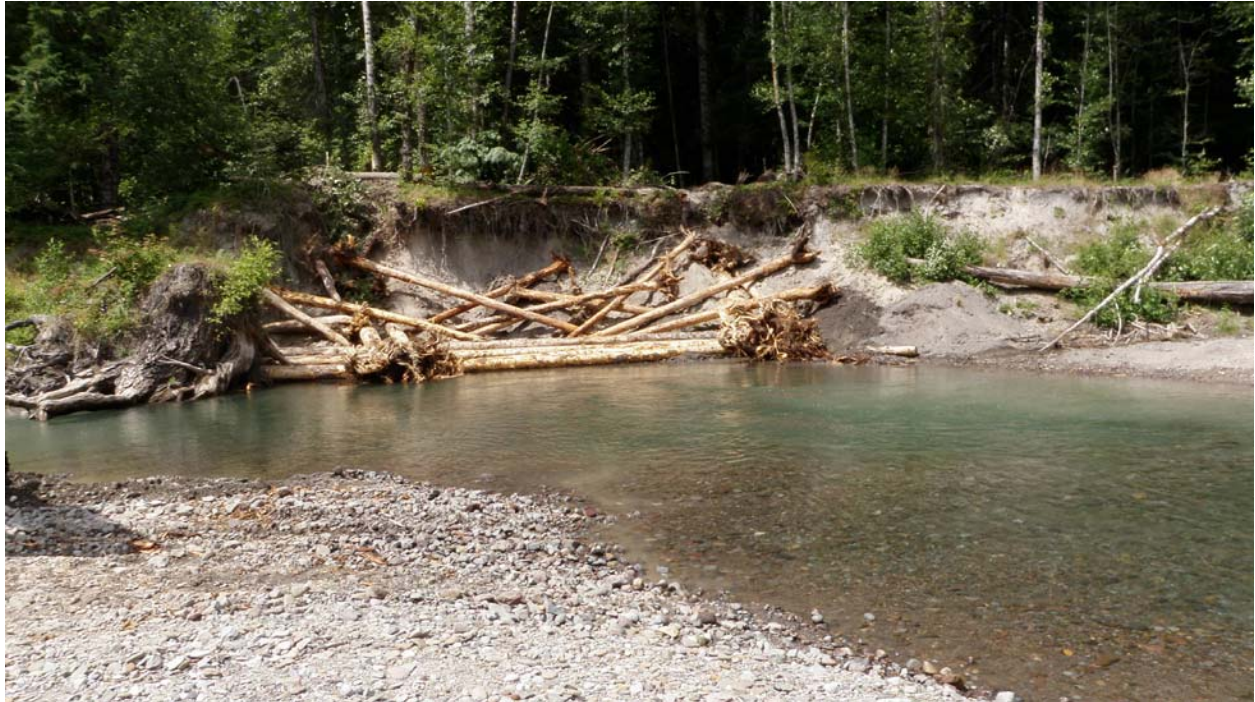
Looking down stream at bank stabilization structure 50 logs were placed in structure ST#2

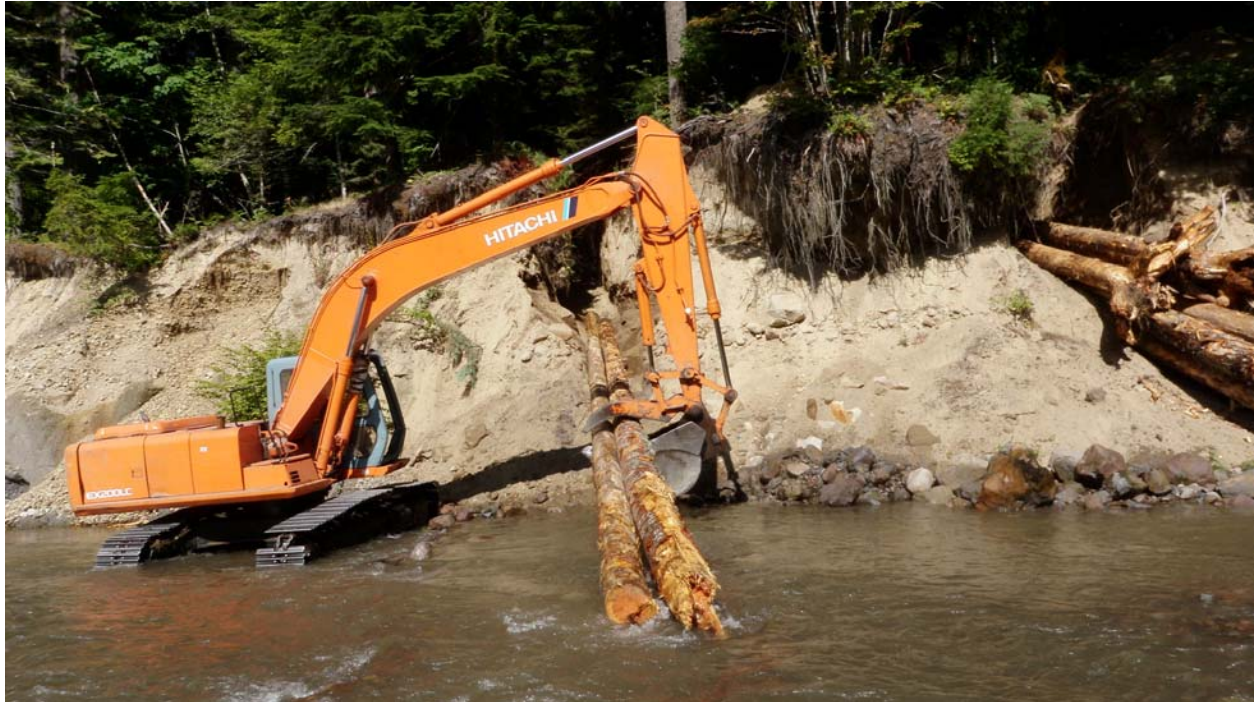
Excavator placing logs into banks ST#10

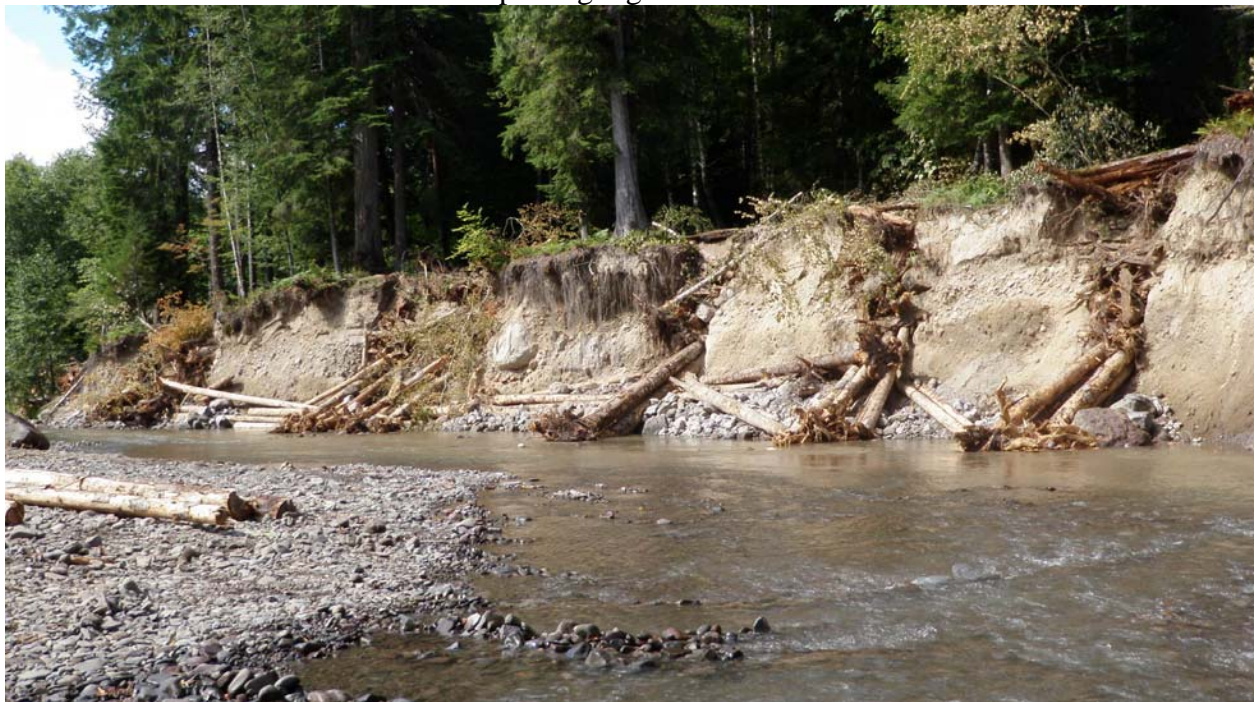
Completion of bank stabilization 87 logs was placed in eroding banks. Gravel bar on river left was shaved back 15-20 feet to help reduce flow on banks. ST#10

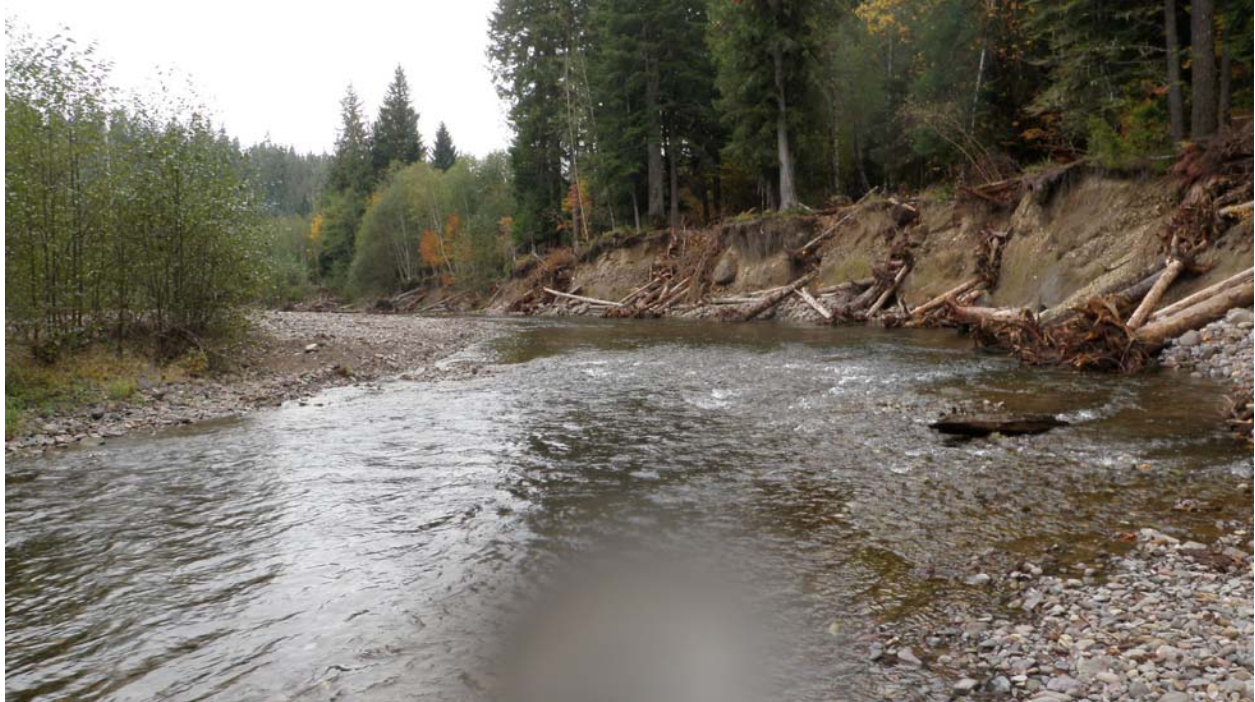
Looking down stream at ST#10, the gravel bar on river left has been shaved back 20 ft.

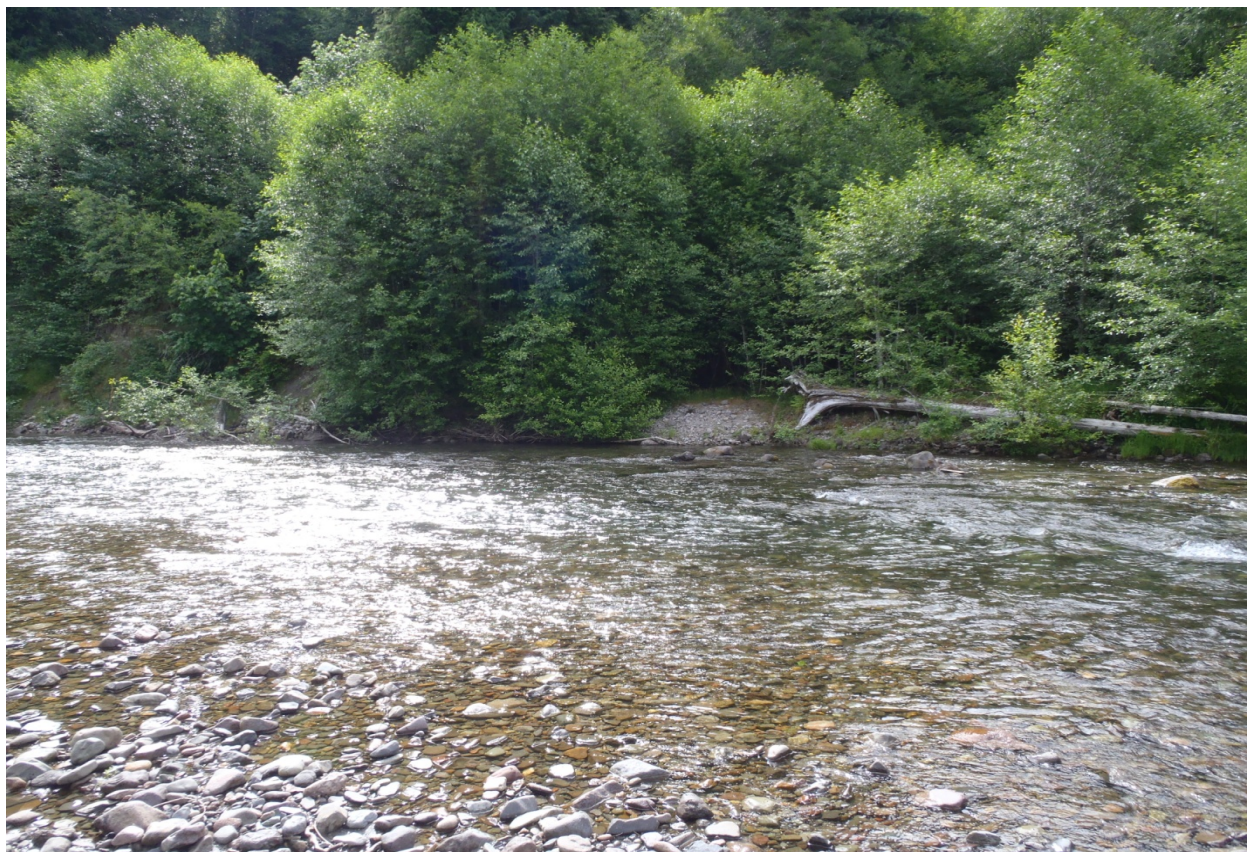
Looking across river prior to construction ST#5

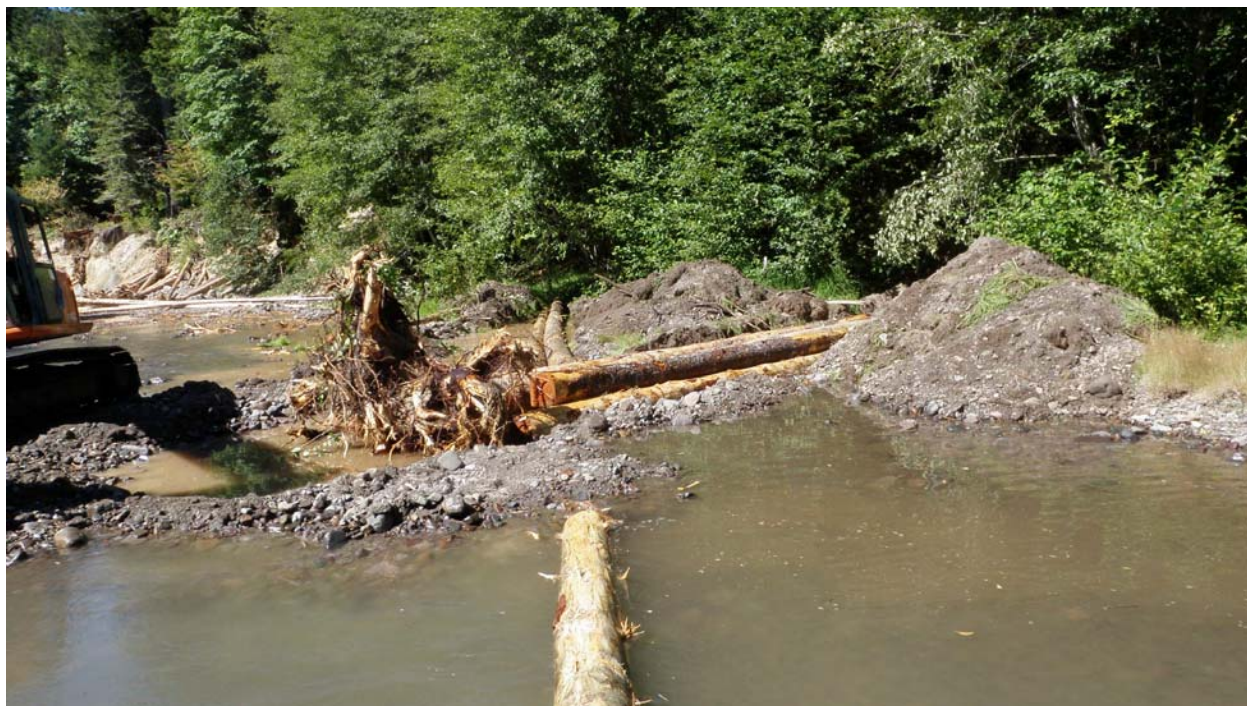
Start of the toe and anchor structure ST#12

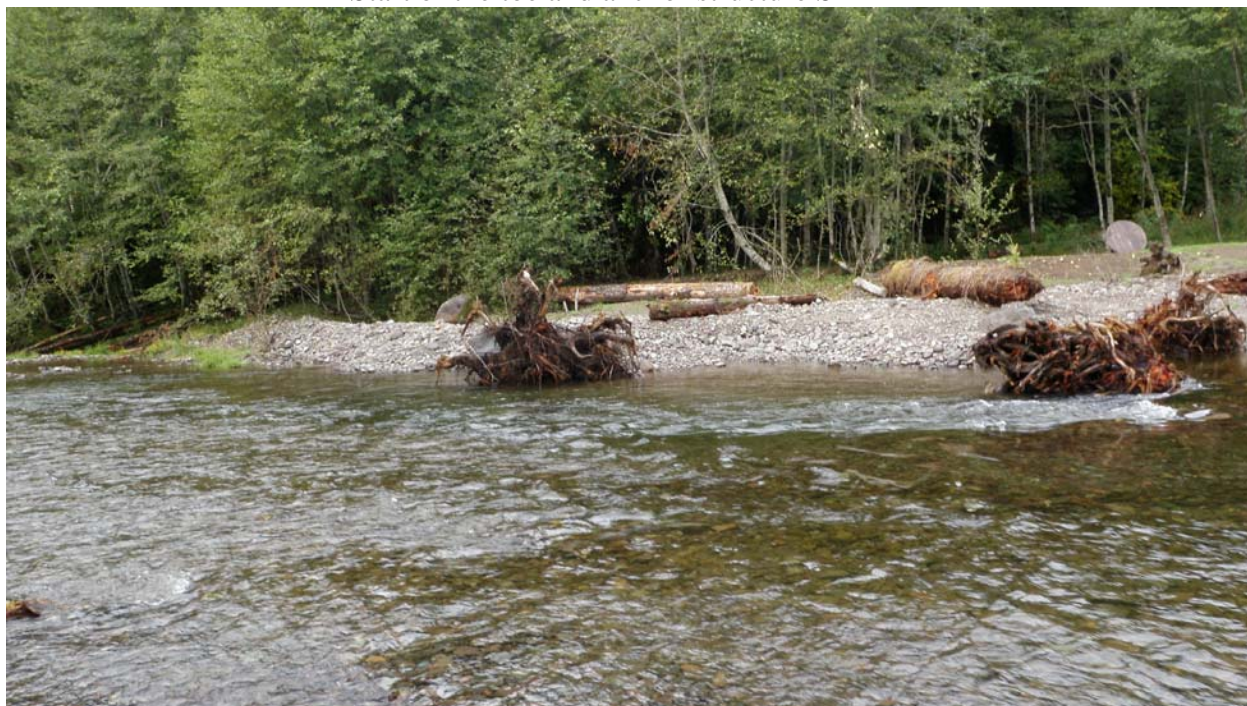
This is a complex toe and anchor structure. 23 logs were used in ST#12. Adult coho have been observed spawning above and below this structure after construction. Structures have created scour pools up to 4 deep.

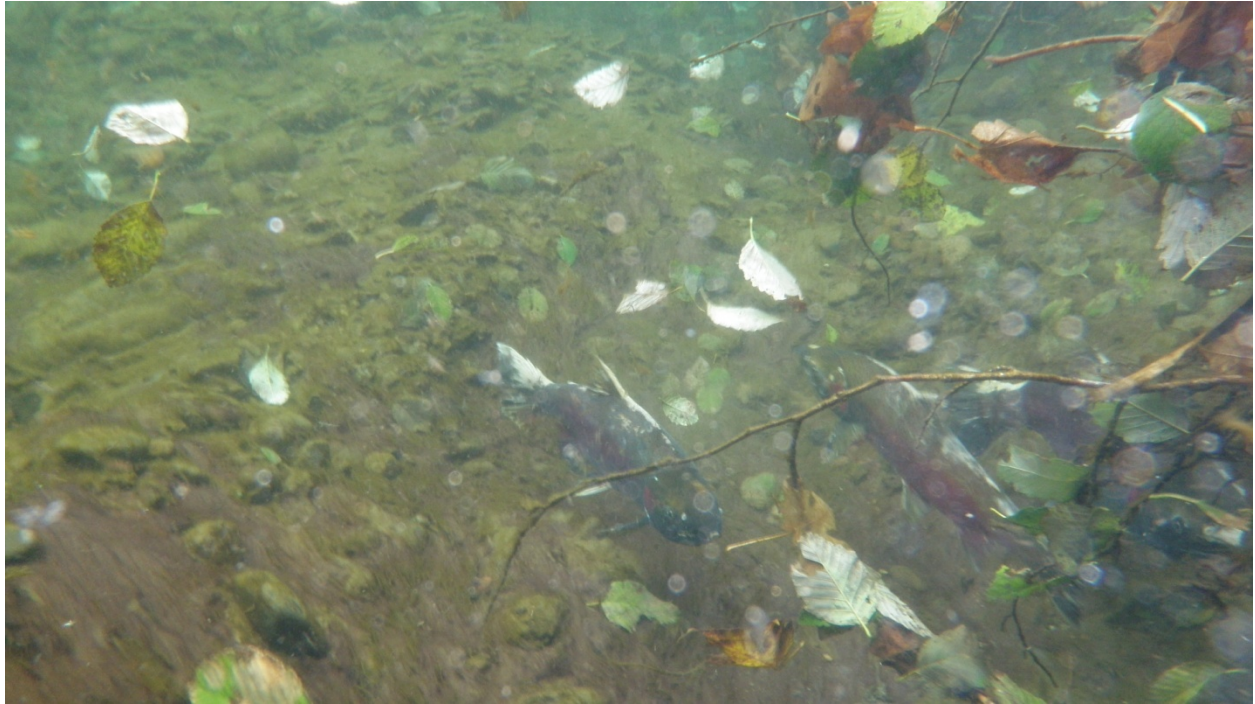
Four coho hiding in scour pool at ST#12

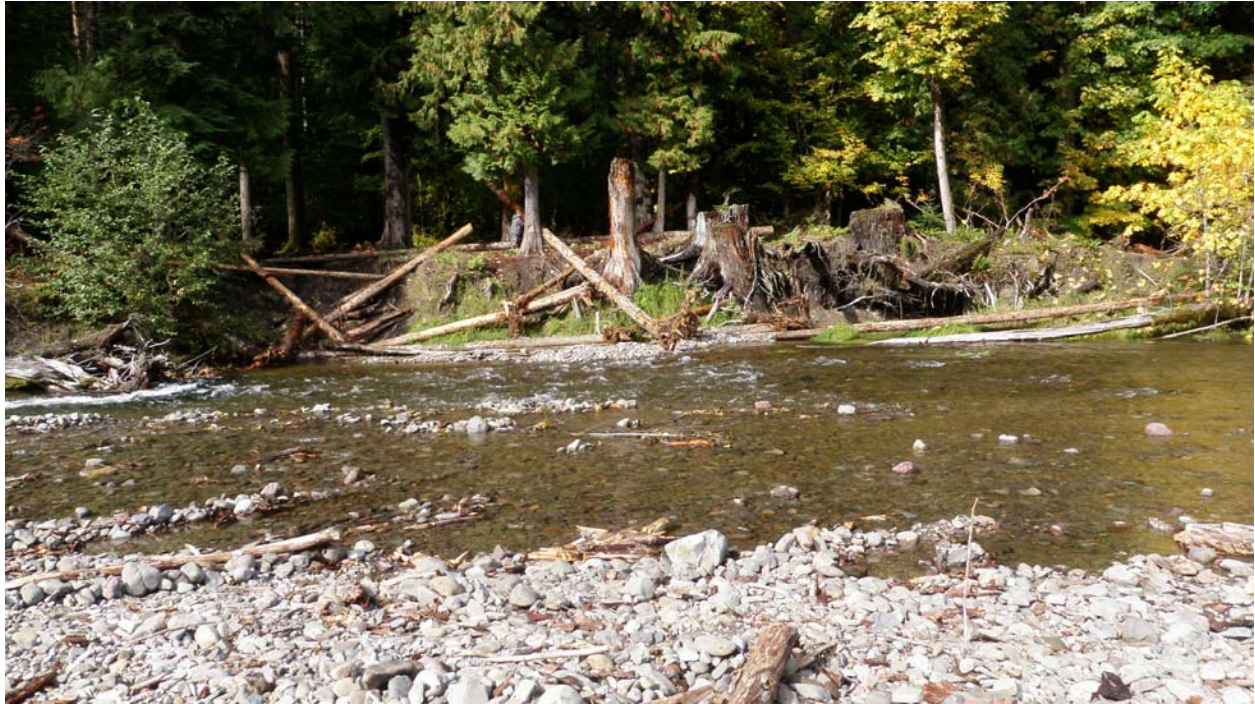
Looking across after construction of bank stabilization project 21 logs in ST#15

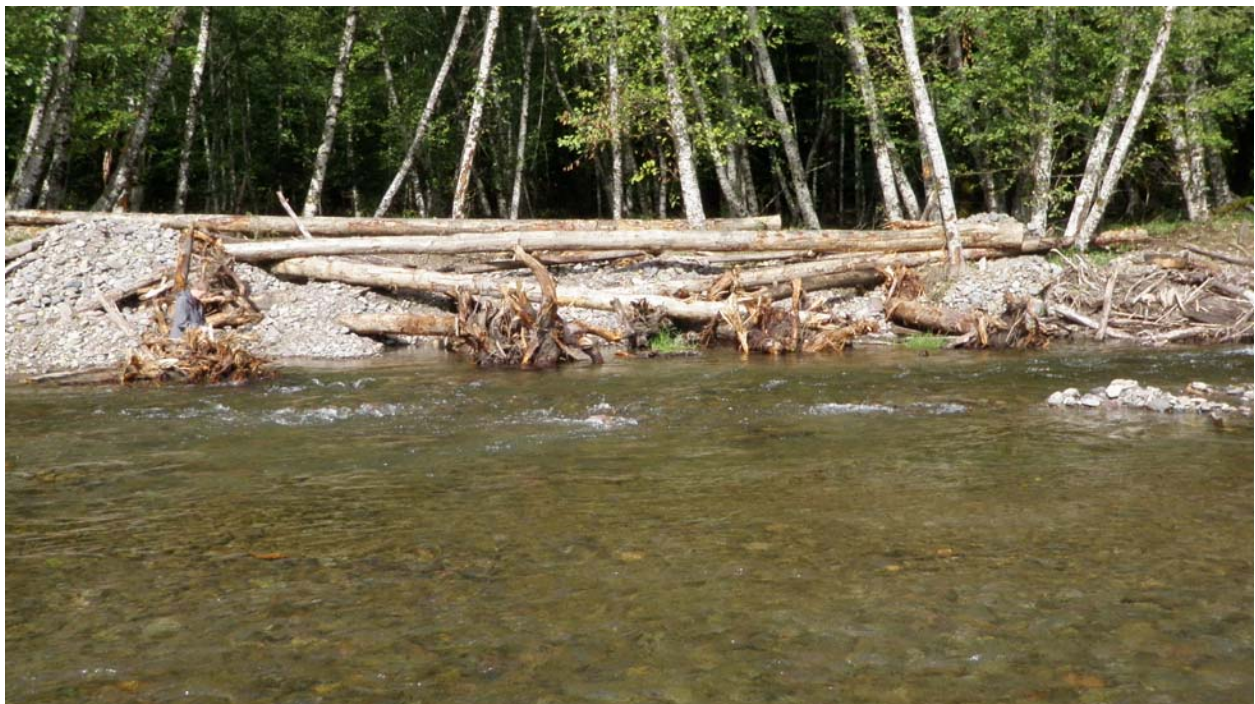
A series of 4 structures with 31 logs were placed at ST#16. Coho were observed spawning and rearing in and around the structure in fall 2011.

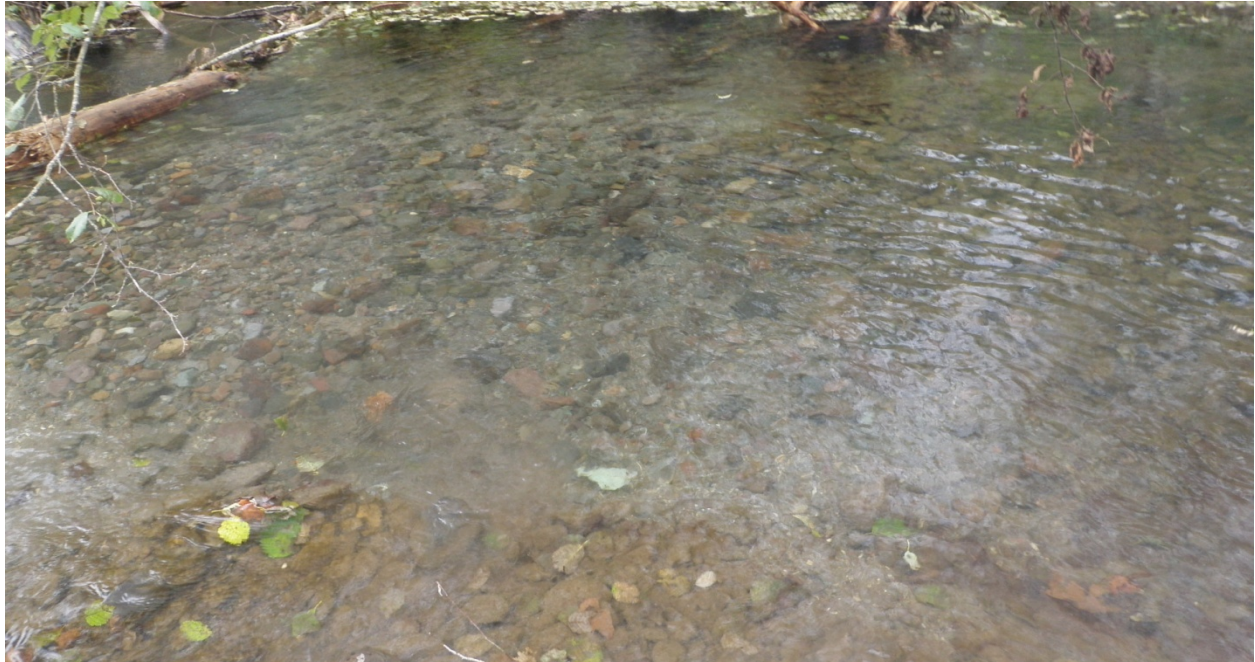
Coho redd directly above ST#16

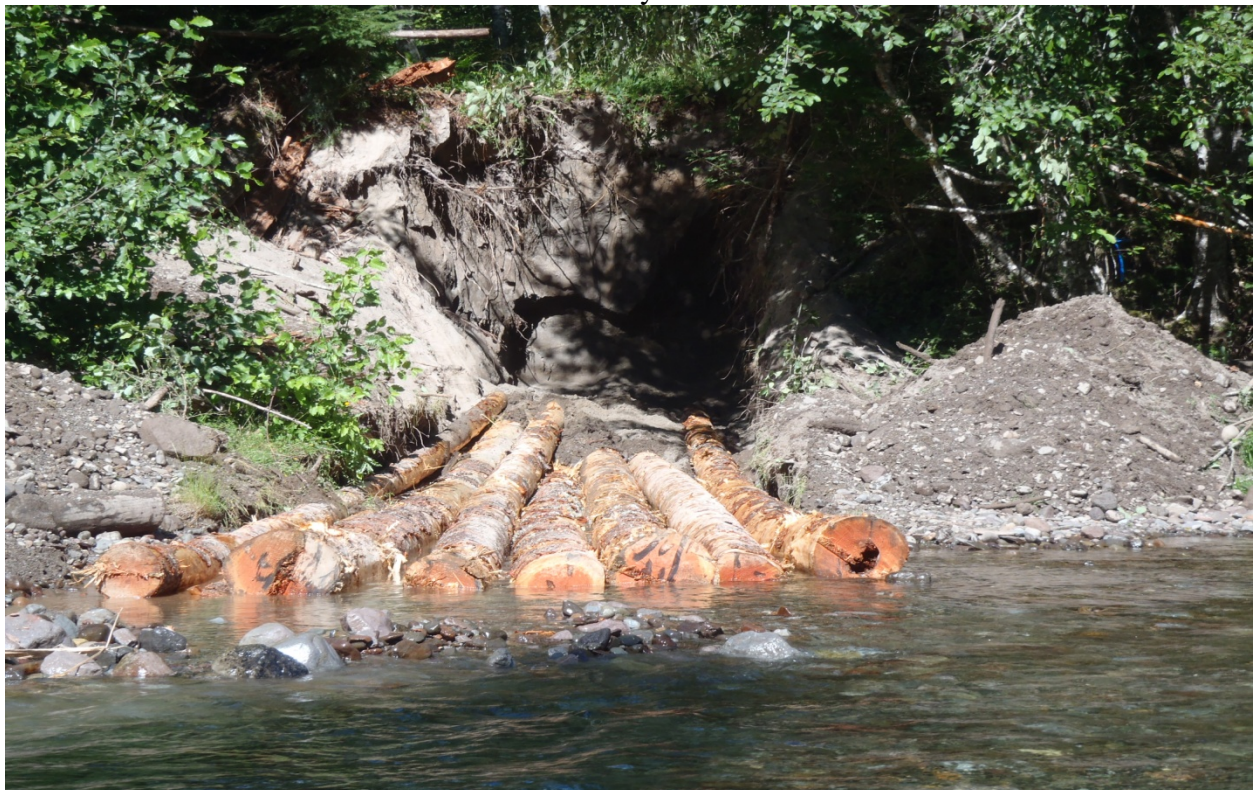
Logs buried 30-40 feet to increase stability, 7 logs in structure so far, a 5ft deep scour pool was created with this structure. Coho have were observed using this structure.

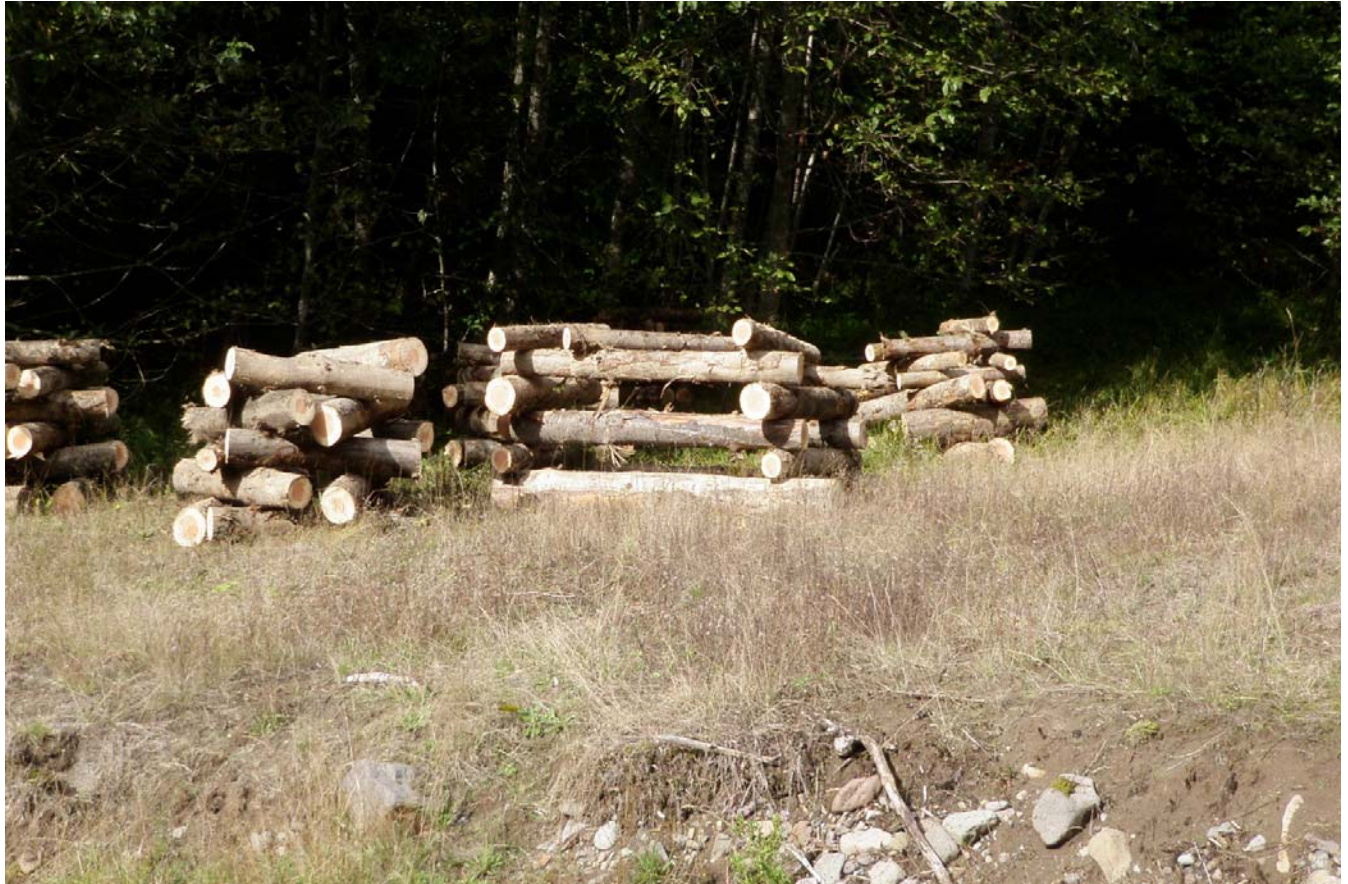
Seeding enclosure, a conifer seedling is planted in the middle of log cribbing to discourage elk and deer browsing.

Funding from Ecotrust was used to plant Several species of conifers and hardwoods over a two year period in the riparian zone to help stabilize streambanks and floodplains. Over 500 seedlings were planted covering an area of approximately 10 acres. Experimental seedling enclosures were built to help trees survive elk and deer browsing. Logs were cut into six and eight foot lengths and stacked to enclose seedlings.
