## USFS Region 6, Gifford Pinchot National Forest, Mount St. Helens National Volcanic Monument 2014

<b>Project Title</b>	Lewis River Side Channel Near Muddy River Instream Habitat Restoration.								
<b>Agency</b>	US Forest Service Gifford Pinchot National Forest Mount St. Helens Ranger District								
<b>Project Manager</b>	Adam Haspiel (360) 449-7833 <a href="mailto:ahaspiel@fs.fed.us">ahaspiel@fs.fed.us</a>								
<b>Project Approved By</b>	Aquatic Coordination Committee (March 29, 2011)								
<b>Project Funding</b>

# Post-implementation Status Report Lewis River Side Channel Near Muddy River

## Project Summary

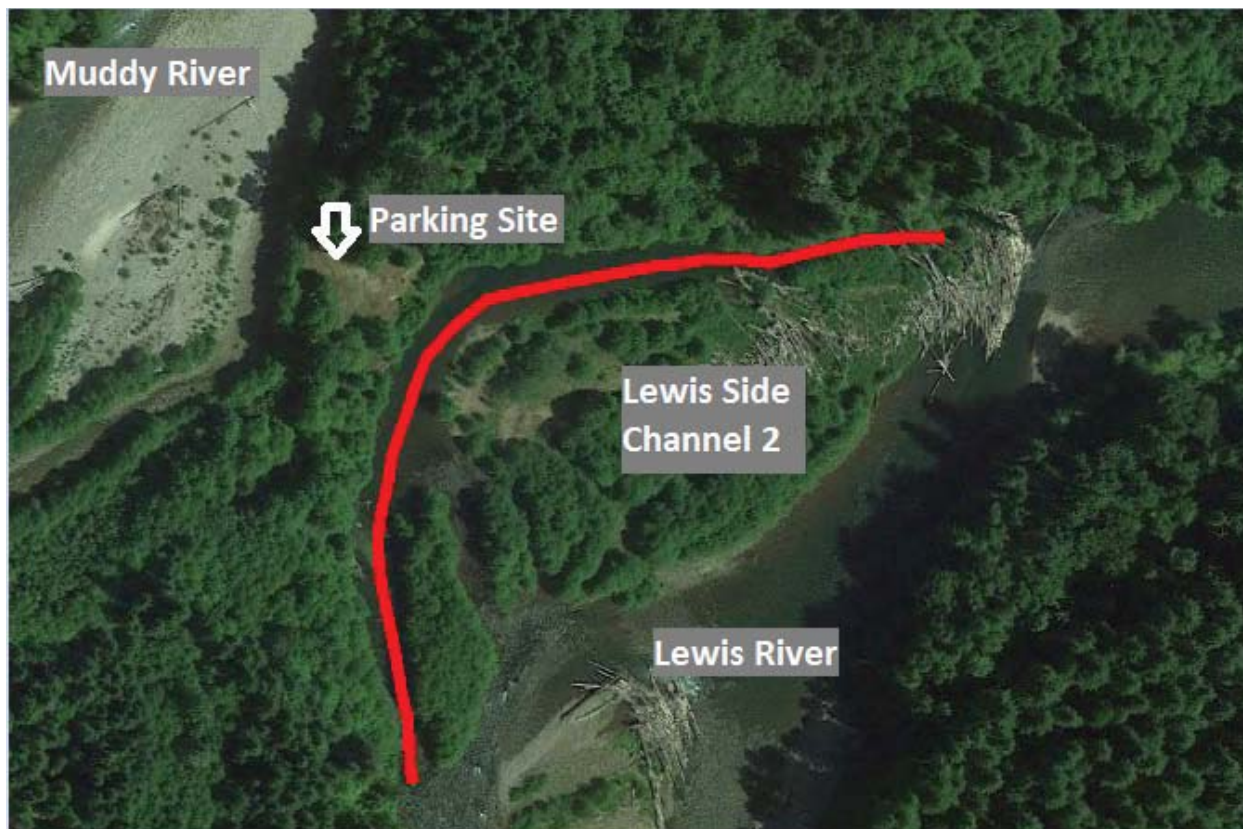
Figure 5: Map of project area

Lewis Side Channel near Muddy River Instream Habitat Restoration project located on private land, is a 1000 ft. long side channel around 2.0 miles upstream of the Swift Reservoir near the confluence of the Muddy River. Access to the site is by driving across the Curly Creek Bridge on FR 9039. After several miles there is a turn off on to private land. The road goes all the way down to the restoration site.

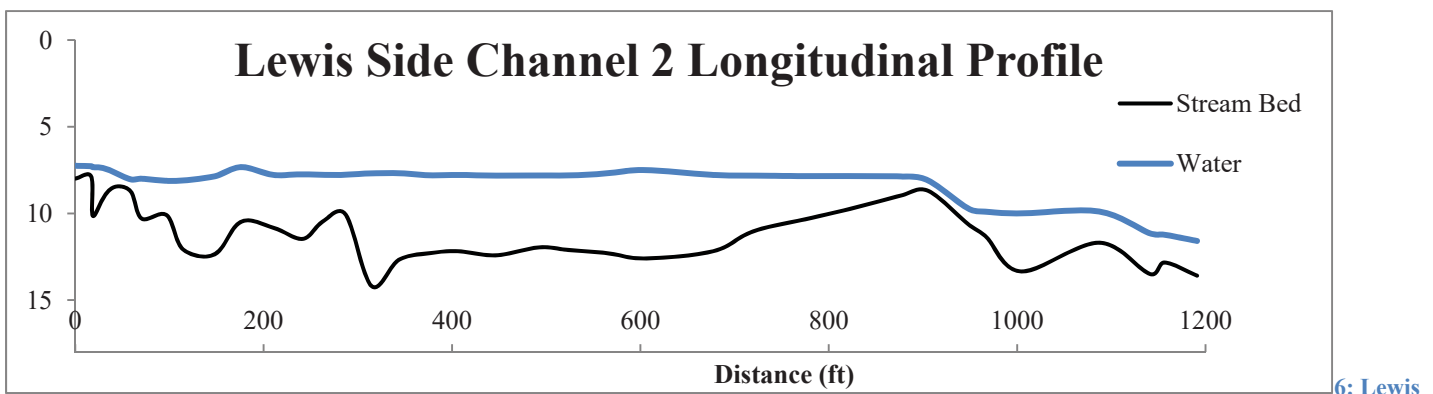
Side Channel 3 2014 Longitudinal Profile (0-2000 ft.)

The baseline longitudinal project is shown in Figure 2. Within the project reach there are 2 distinct pools with a base flow water depth of 3 feet or deeper, and a residual pool depth of at least 1.0 feet. The first pool covers the majority of the entire reach. The pool was too deep to measure a max depth which is over 5 ft. The pool: riffle ratio is 4.05:1, Slope is 0.47%.

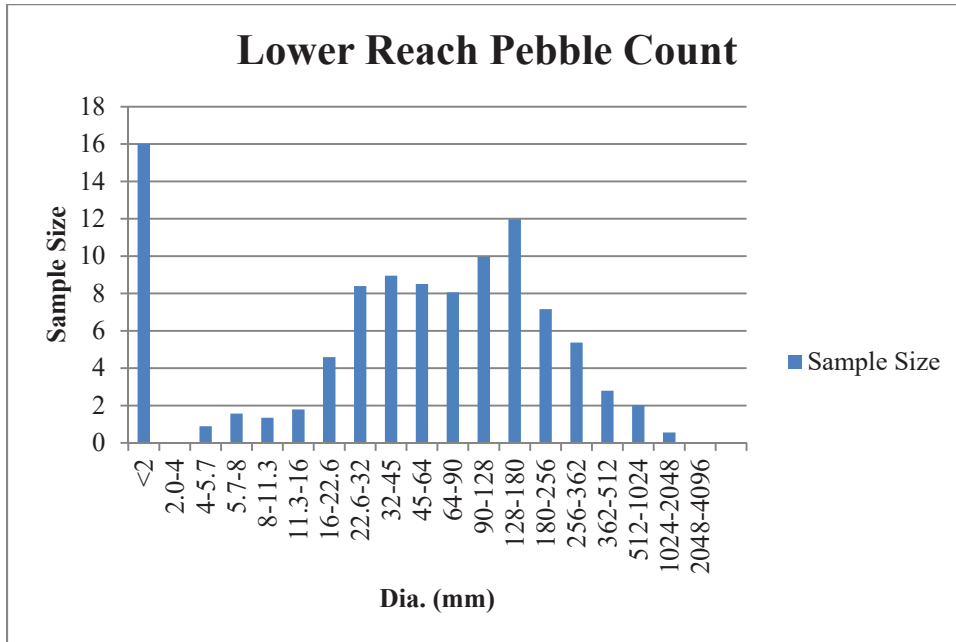
3: Lewis Side Channel 2 Lower Reach Substrate Size Distribution

Due to the depth of the two most upstream structures pebble counts were not performed there. All pebble counts were taken below the large pool tail out. Baseline post-installation survey of substrate size distribution confirms previous data

and reconnaissance reports. Throughout Lewis Side Channel near Muddy River Instream Habitat Restoration project restoration reach substrate size is moderate, with an average median substrate size of 51 mm and a D84 of 171 mm.

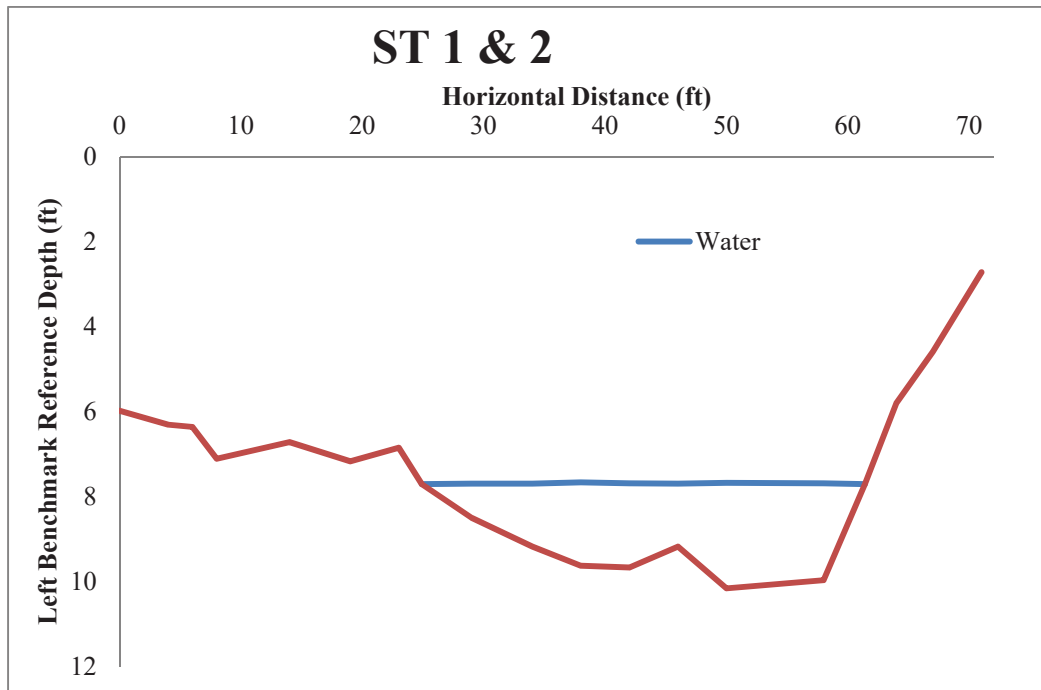
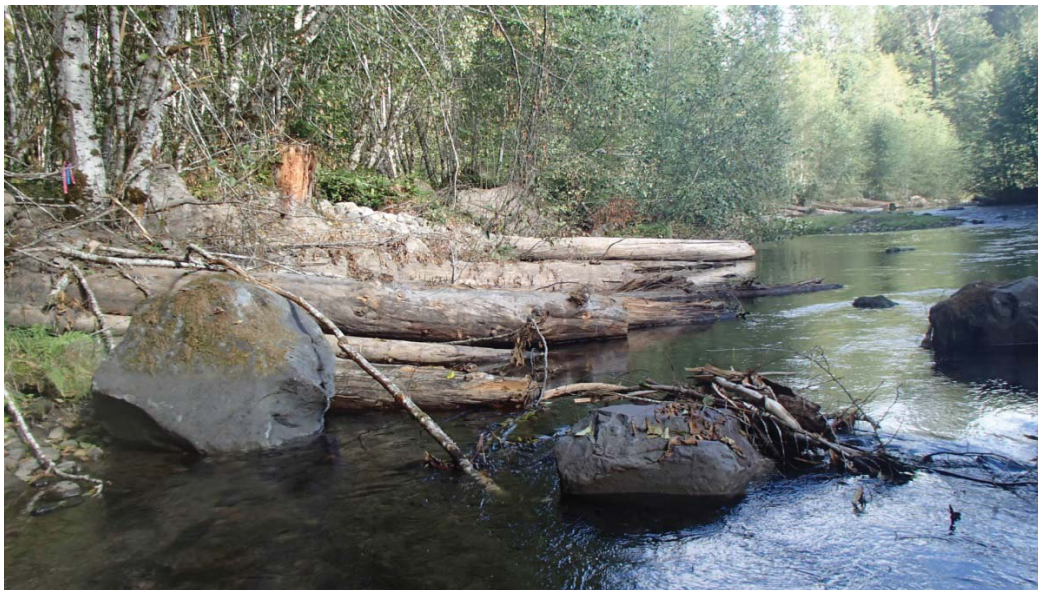
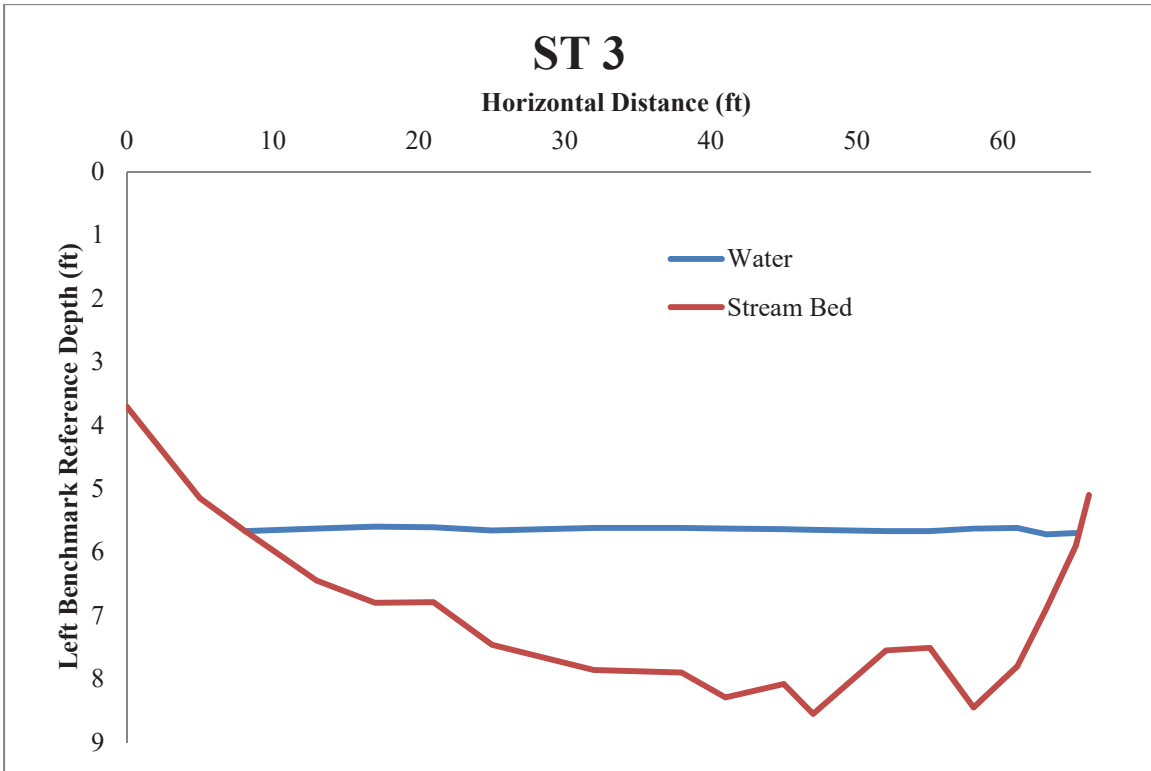
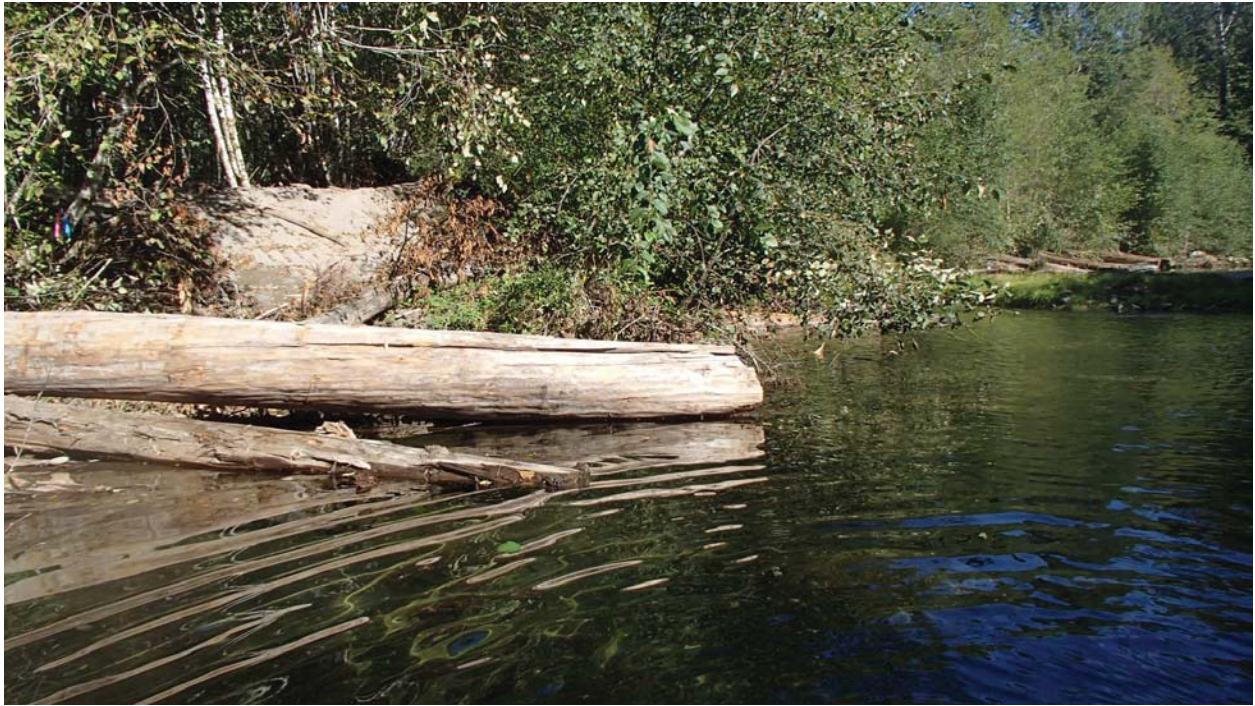
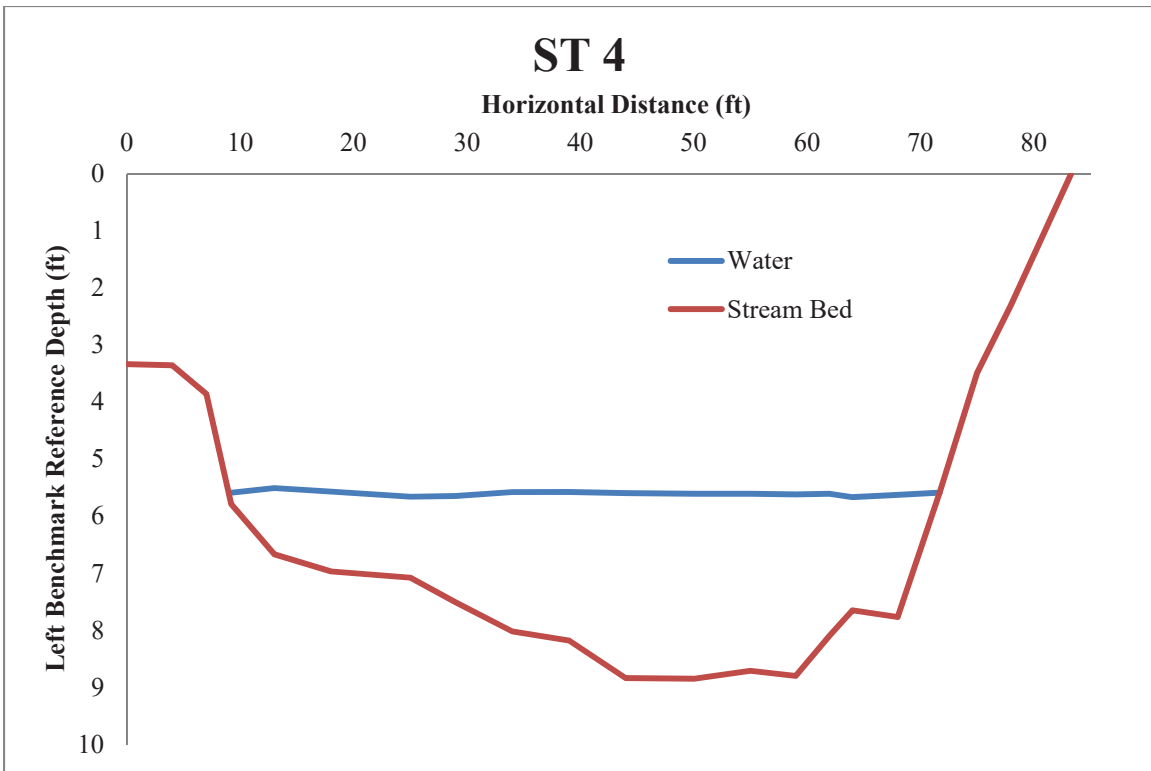
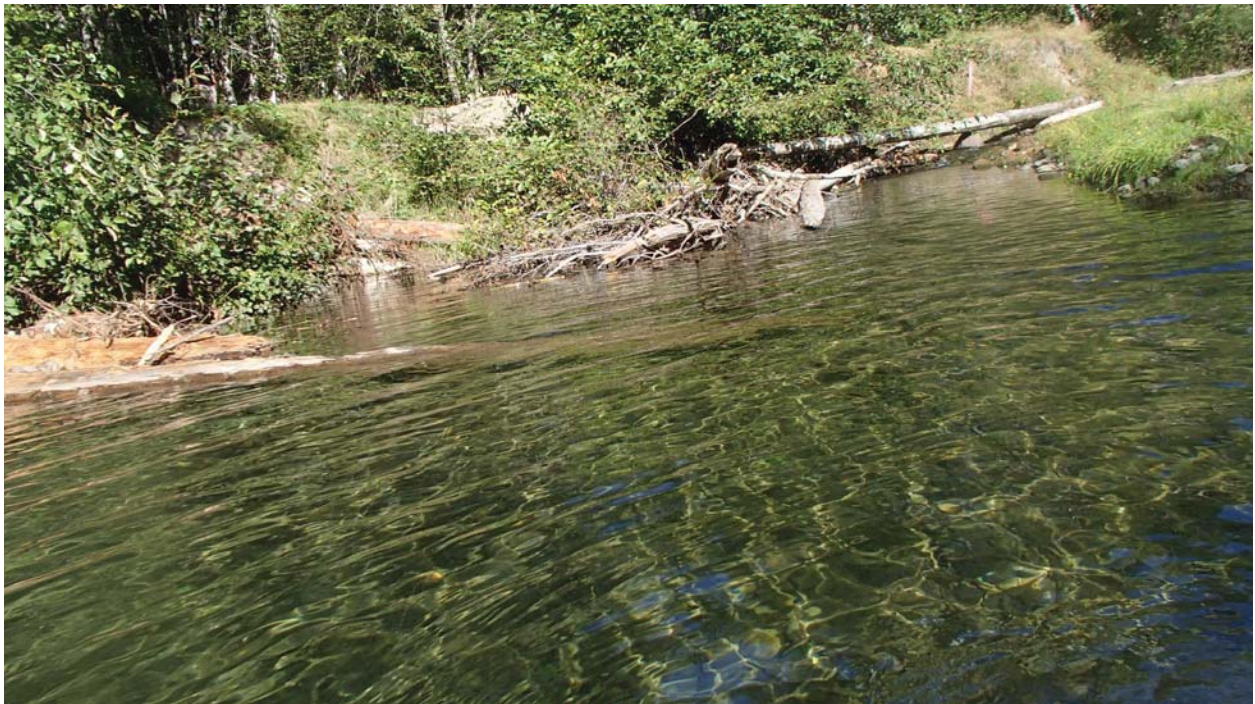
Included for each complex structure are baseline cross-sectional graphs and well as post-installation photographs. Substrate graphs and additional site photos are available upon request. Photos of bank stabilization structures are available on request.

To capture the effects of the complex structures a cross-section was established at a key point within the structure. Only structures that were designed to alter geomorphology (pools, gravel-beds) were surveyed. Two benchmarks for each cross-section were placed in live trees so they will last for many years. Throughout the reach there are several structures in close proximity, which warranted one benchmark on the non-structure side of the stream being used for two separate cross-sections. Each structure has an accompanying Wolman Pebble Count. A longitudinal profile was determined from an established benchmark at the upper extent of the project area. A longitudinal profile measures the elevation changes following the thalweg (the deepest continuing line in the stream channel). It is important to note that due to stream/thalweg meandering the longitudinal profile is not only a measure of distance and elevation, but also of sinuosity. From the longitudinal profile pool depths and pool:riffle counts can be assessed. Surveyors used *Stream Channel Reference Sites* (Harrelson et. al., 1994) as the standard surveying protocol. Photos were taken at all structures above the structure looking downstream, opposite the structure, and below the structure looking upstream. Results and Analysis
