Spencer Creek Alluvial Fan and Channel Rehabilitation Status Report 2018

**Partnership between Mount St. Helens Institute (MSHI) and
USFS Gifford Pinchot National Forest**

**Prepared by Katie Fielding, Kylie Sahota MSHI Fisheries Technicians and Abigail Groskopf,
MSHI Science Education Director**

August 2018

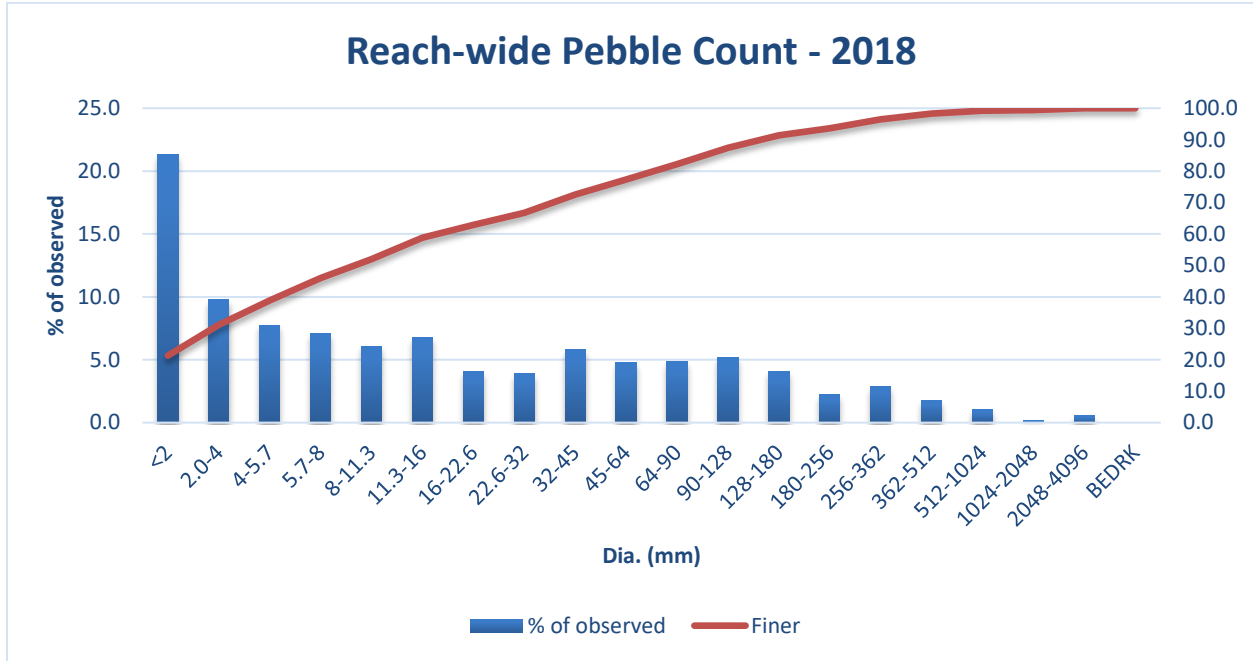
Figure 2: Reach-wide analysis for Spencer Creek Wolman Pebble Count data collected in 2018 prior to habitat restoration implementation indicating substantial fines mixed with some spawning gravel and cobble.

Substantial amounts of fines along with spawning gravel and cobble exist in Spencer Creek prior to implementation (Figure 2) and the D50 at the cross sections ranged from 6-14 (Table 2).

Reach-wide analysis of Wolman Pebble Counts shows that Spencer Creek surface substrate is roughly 40% fines (<6.4mm), 40% spawning gravel and 20% cobble. In addition to increasing habitat diversity, structures are also expected to increase spawning gravel retention. Pebble counts were not conducted in the Spencer Creek alluvial fan where a very large structure was constructed just upstream on the bank of the North Fork Lewis River with a roughened channel excavated to encourage high flow scours and increase sediment transport through the alluvial fan, large wood roughness was also added to both sides throughout the entire fan. The lower reaches of Spencer Creek are ephemeral which limits fall spawning opportunities for adult coho salmon. These actions will increase the sediment transport capability of the lower ephemeral reach by concentrating high flows and will provide fall spawning opportunities for coho salmon.

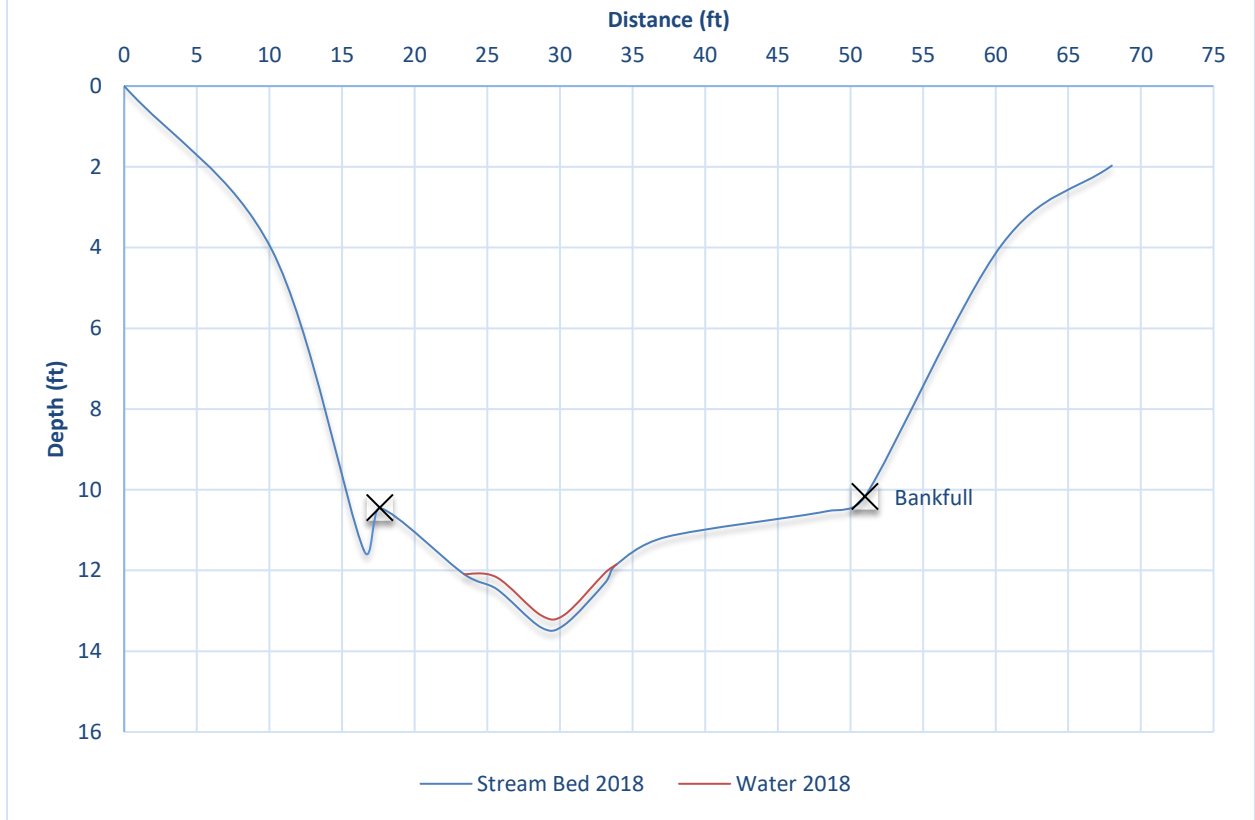
Spencer Creek XS 3- 2018 (pre-implementation)

Figure 7: Cross section channel profile at proposed location of Structure 3 in Spencer Creek from survey conducted prior to habitat restoration implementation in 2018 demonstrating a high terrace left bank and lower right bank with steep elevation increase to the floodplain.

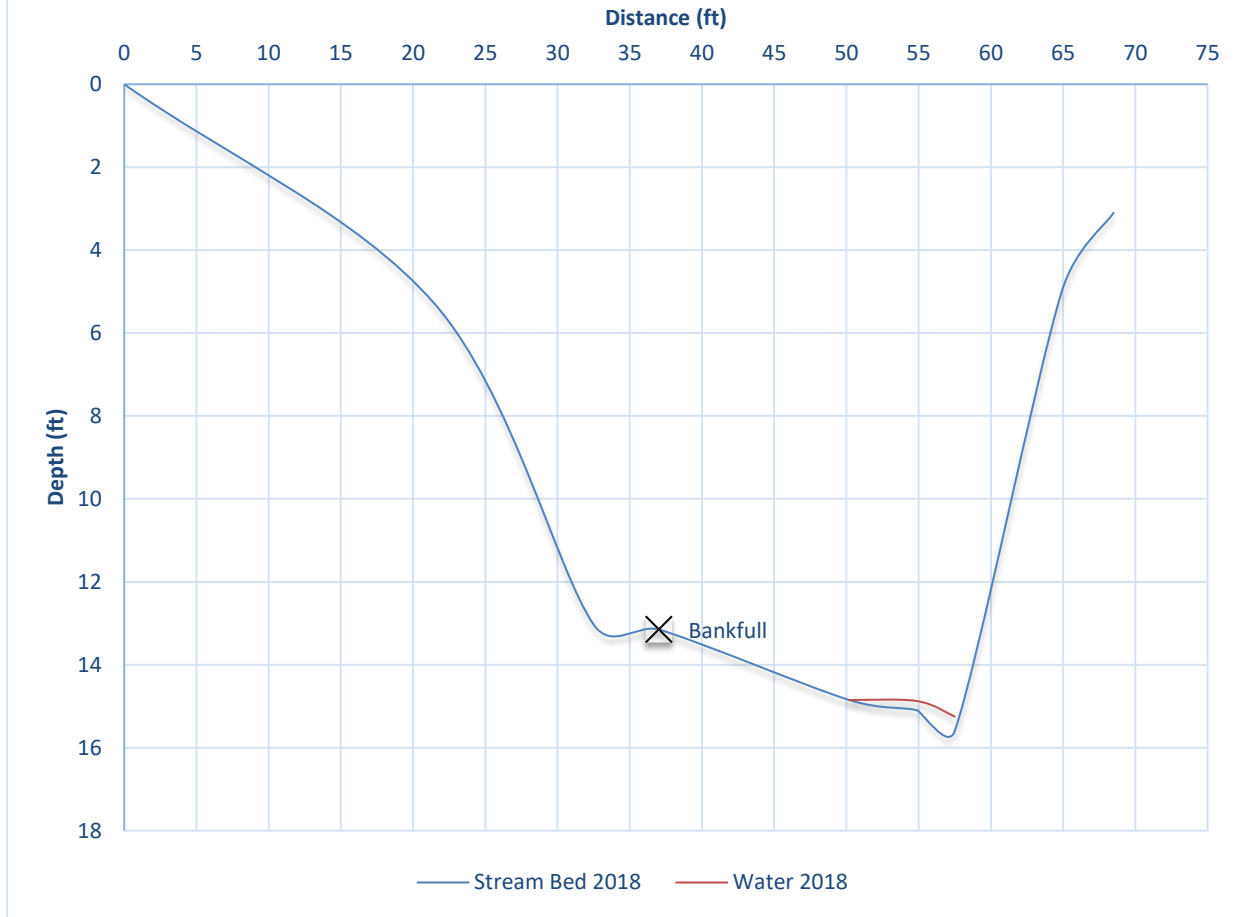
Spencer Creek XS 5- 2018 (pre-implementation)

Figure 11: Cross section channel profile at proposed location of Structure 5 in Spencer Creek from survey conducted prior to habitat restoration implementation in 2018 demonstrating a lower left bank increasing in elevation to the high terrace and a steep right bank increasing in elevation to the floodplain. Note right bank is undercut making REW and bankfull indeterminable.

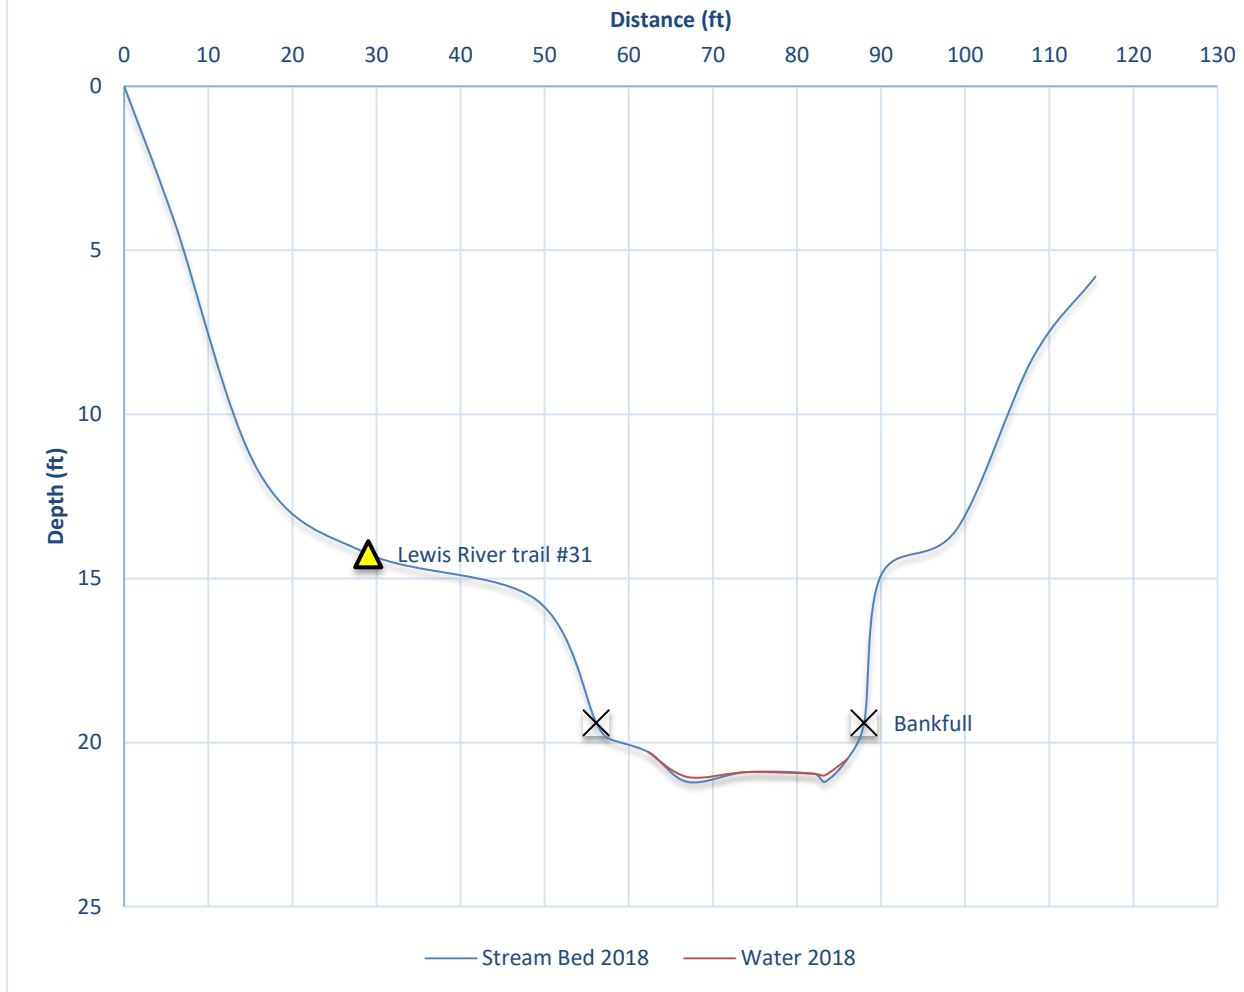
Spencer Creek XS 7- 2018 (pre-implementation)

Figure 15: Cross section channel profile at proposed location of Structure 7 in Spencer Creek from survey conducted prior to habitat restoration implementation in 2018 demonstrating a low left bank resulting from channel elevation meeting the elevation of the high terrace while the right bank has a steep elevation increase to the high terrace.
