REPORT OF INVESTIGATION <i>(Reference FSH 5309.11)</i>		Case/File Number 20-05-MBBK0WI																						
Controlling Office R5 - Law Enforcement and Investigations			Investigating Office LE&I – Klamath National Forest																							
Case Type Fire			Investigative Period From: 10/5/20 To 12/8/20																							
Case Status Pending Judicial Action			Report Type Supplemental/Final																							
Case Name Slater Fire			Investigated By Special Agent b6 & b7C																							
<p align="center"><u>SYNOPSIS</u></p> <p>On September 8, 2020, the "Slater Fire" ignited on U.S. Forest Service (USFS) land on Slater Butte, 5 miles north of Happy Camp within the Klamath National Forest (KNF).</p> <p>At the time of report the fire has been estimated at burning 157,229 acres with firefighting cost yet to be determined. Approximately 237 structures have been reported damaged with 197 of those being residential. Two fatalities are being investigated related to the Slater Fire.</p> <p>An origin and cause investigation was conducted 3 days after discovery of the fire. A general origin area of the Slater Fire was located just off Forest Road (FR) 17N48 below the Slater B

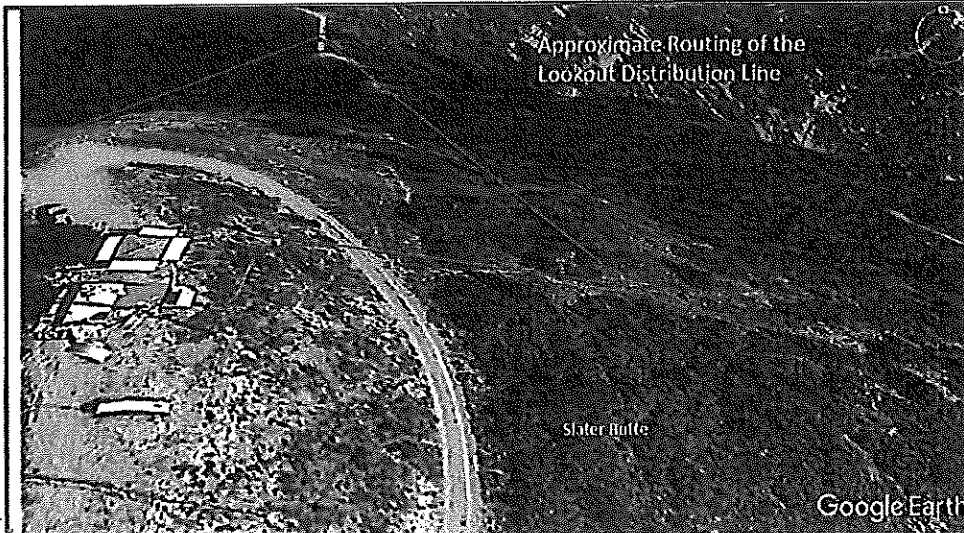
Photograph Number: NA
Date: NA
Time: NA
Photographer: NA
Subject: Approximate Route of Distribution Line

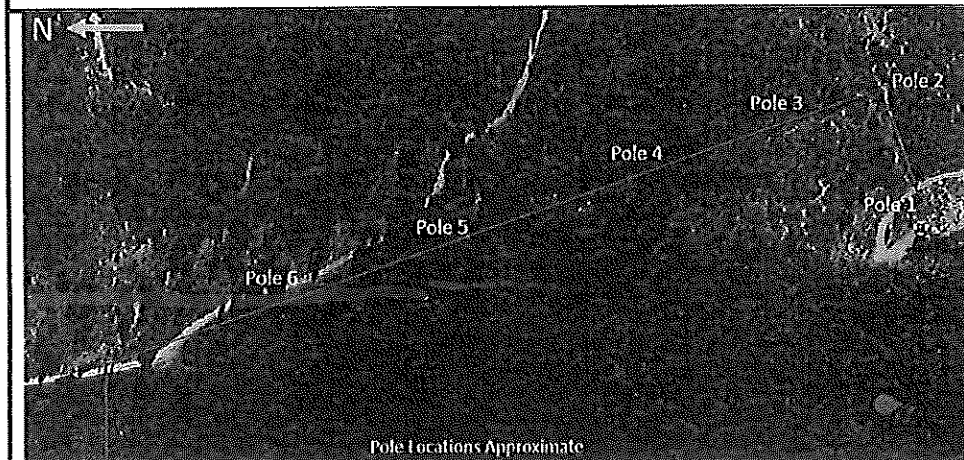
Photograph Number: NA
Date: NA
Time: NA
Photographer: NA
Subject: Power Pole Sequence In Distribution Line

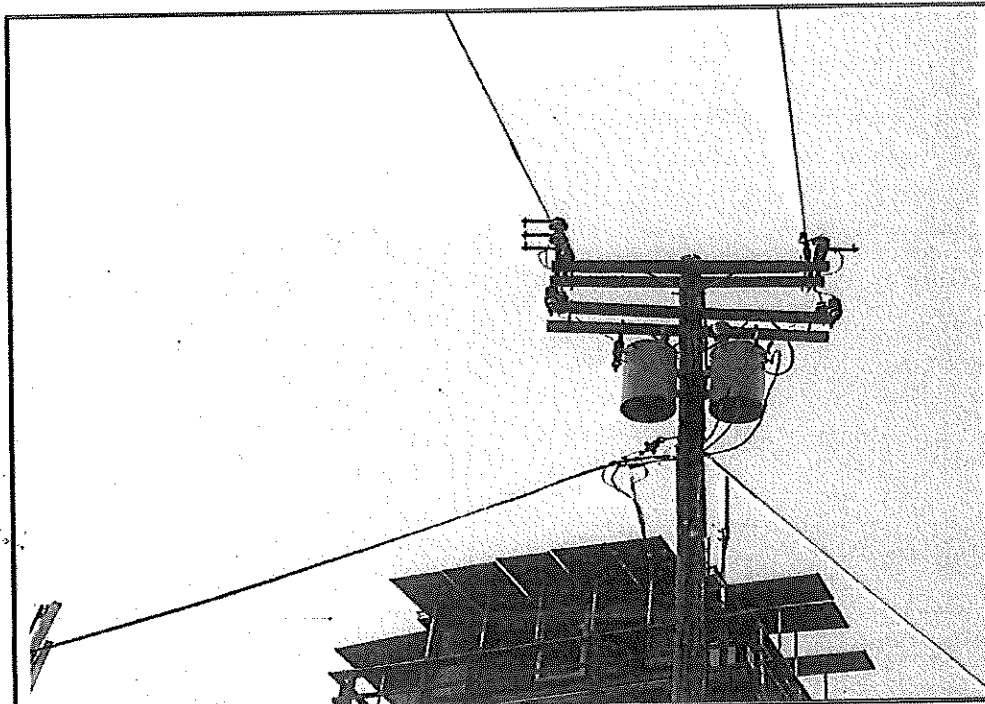
Photograph Number:
55 Electrical
Date:
9/13/20
Time:
1228
Photographer:
b6 & b7C
Subject:
East side of Pole 1

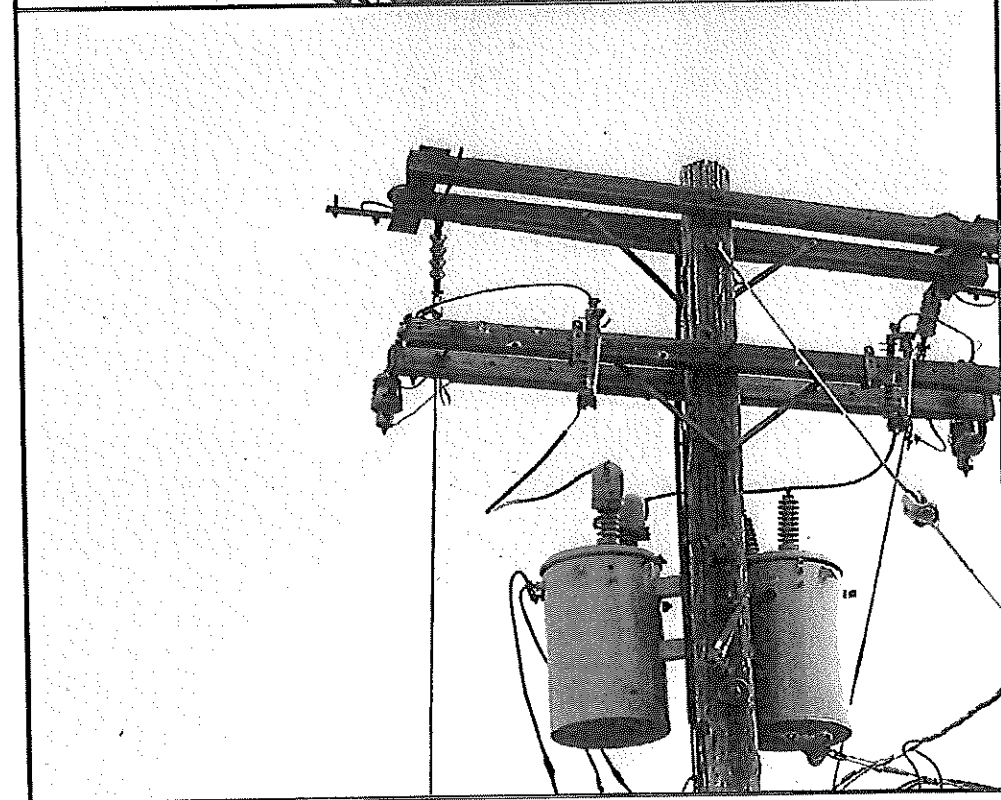
Photograph Number:
58 Electrical
Date:
9/13/20
Time:
1230
Photographer:
b6 & b7C
Subject:
West side of Pole 1

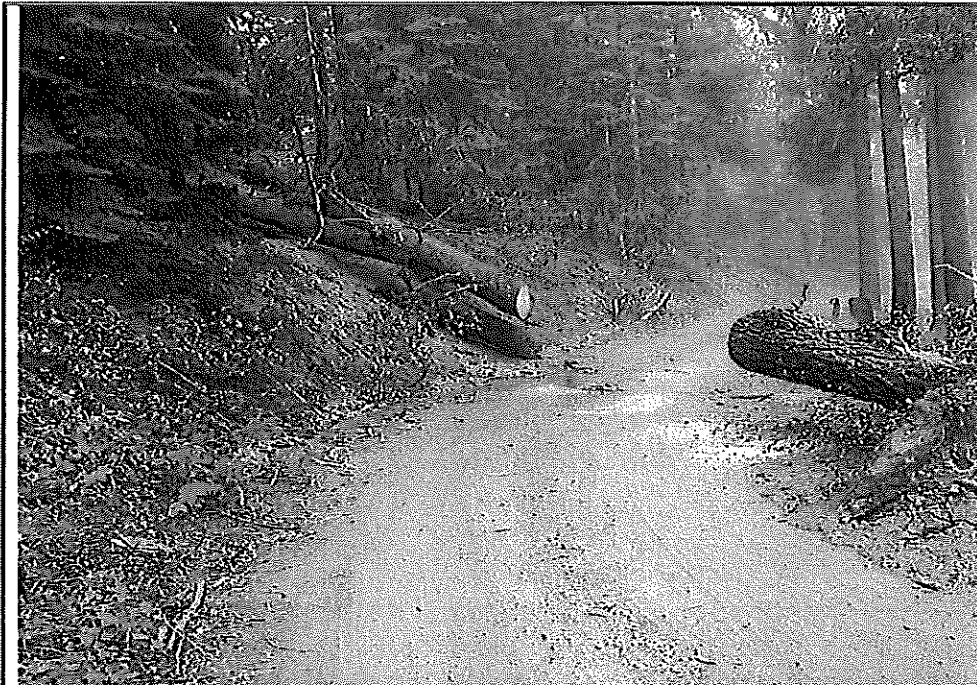
Photograph Number:
14 Tree
Date:
9/12/20
Time:
0951
Photographer:
b6 & b7C
Subject:
White Fir tree fallen across road
towards 12kv distribution line to the
west. Photo is looking to the north.

b6 & b7C located a tree across FR 17N48 when he left the lookout on the morning of September 8, 2020, just prior to the lookout gate across the road. Engine 327 was dispatched to remove the tree from the roadway in order to free **b6 & b7C**. Engine 327 cut five pieces out of the tree and rolled them off the downslope side of the road in order to open the road. The tree had partially uprooted as it fell. The trunk of the tree then cracked at about six feet above ground level on the windward (east) side. The tree then cracked open down to the ground level on the west side. The interior of the tree near the base was hollow with wet, rotten wood (**Exhibit 21- White Fire Tree Photos**). **b6 & b7C**, a Forest Pathologist with the USFS examined the tree and determined it to be a White Fire. **b6 & b7C** found heart-rot in the basal portion of the bole from below ground level extending upwards approximately six feet. **b6 & b7C** also discovered a white-rot and Rhizomorphs (melanized mycelial cords) present on the decaying wood (**Exhibit 22- b6 & b7C REPORT**). A cross section of the tree base was collected and stored by the USFS as evidence. The tree measured approximately 137 feet tall. The upper branches of the tree, though now burned, showed evidence of green healthy needles and was producing cones. **b6 & b7C**, an entomologist with the USFS described the tree as one that would not be identified or classified as a hazard given its outward appearance.

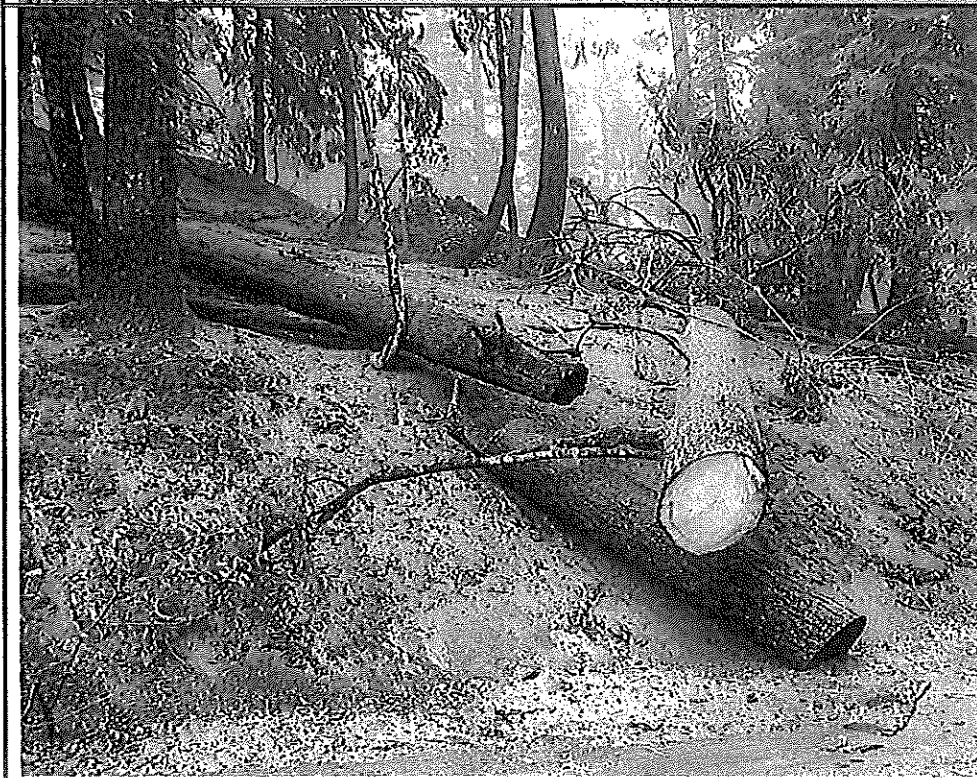
Photograph Number:
53 Tree
Date:
9/12/20
Time:
1044
Photographer:
b6 & b7C
Subject:
White Fir tree from cut out section
looking west uphill towards power
line right of way.

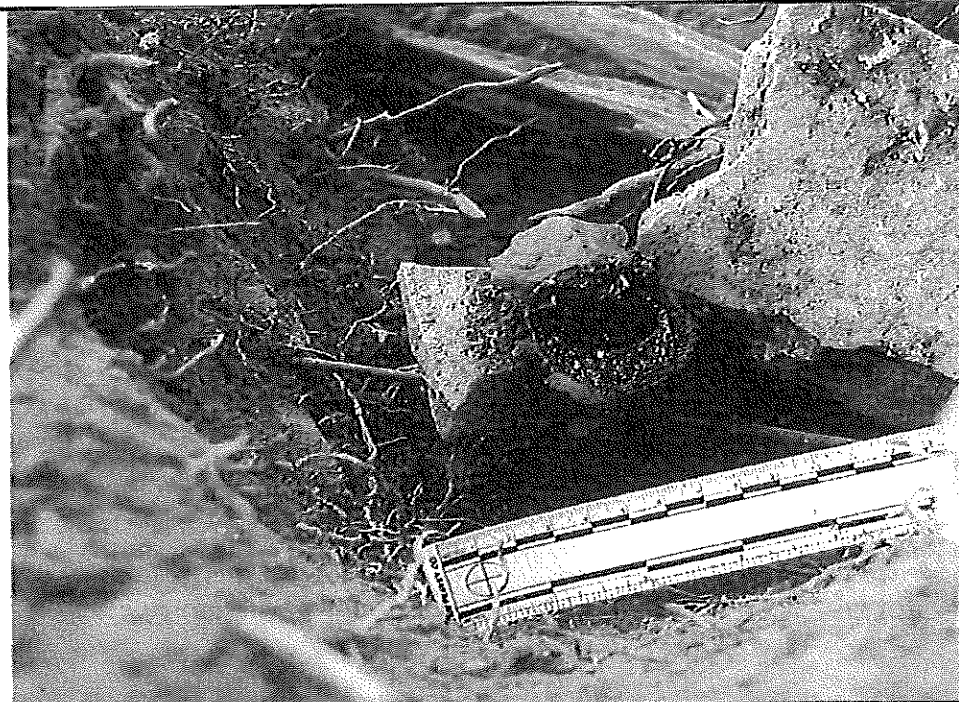
Photograph Number:
38 Indicators and fulgurite
Date:
9/13/20
Time:
1337
Photographer:
b6 & b7C
Subject:
Solid copper wire fused to fulgurite
below ground

Upon arrival on September 11, 2020 SA **b6 & b7C** and SA **b6 & b7C** located evidence of maintenance to the 12Kv power line. Two fuses were hanging from the center pole of the 69Kv transmission line. Several discarded pieces of power line and cooper wire were found within the power line right of way of the 12Kv distribution line. The power line pieces were determined to be discarded pieces from prior line maintenance due to the nature in the way it was located. The line was coiled and removed to the sides, or even outside the right of way. When digging out a fulgurite, solid copper wire was located buried below ground (**Exhibit 11- Discarded Conductor**).

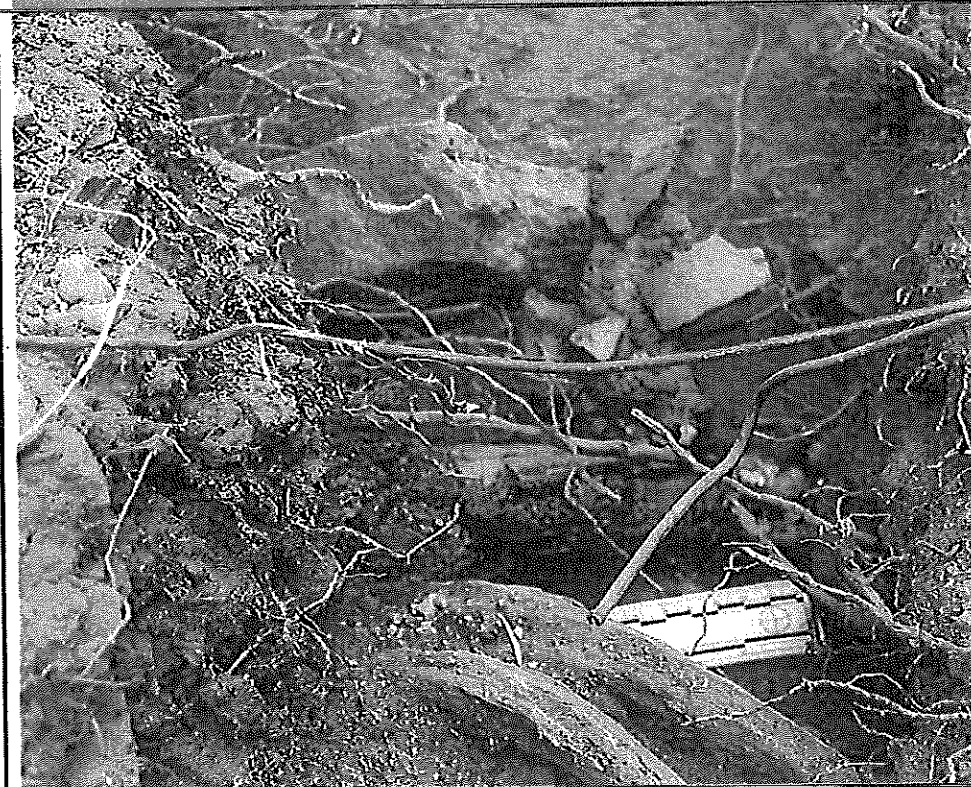
Photograph Number:
39 Indicators and fulgurite
Date:
9/13/20
Time:
1338
Photographer:
b6 & b7C
Subject:
Base of fulgurite with discarded
cooper wire from above.

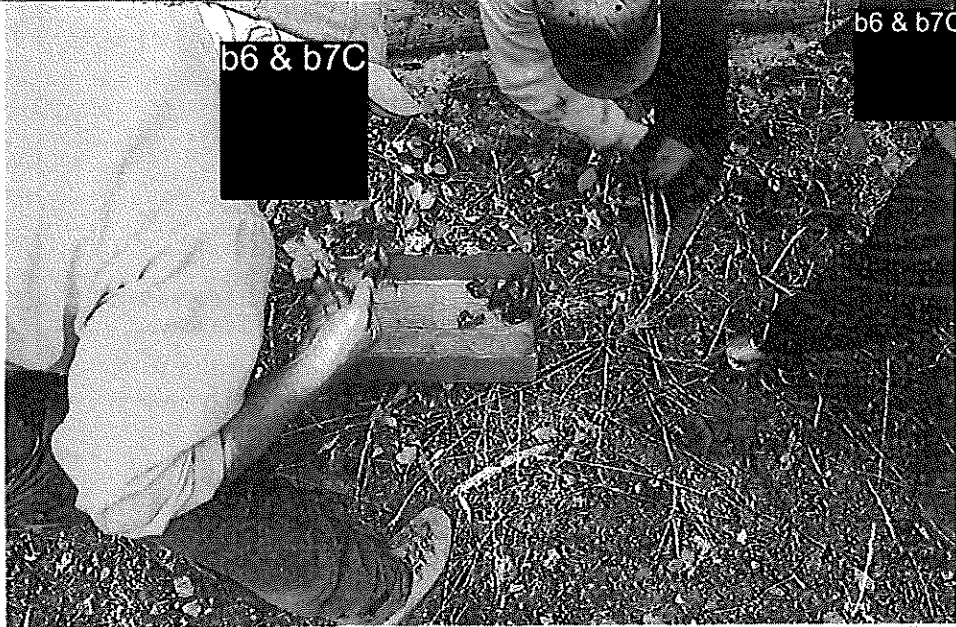
Subject:
Fulgurite collection, created prior to Slater Fire.

Outside of the general origin area, between Pole 5 and 6, SA **b6 & b7C** and SA **b6 & b7C** noticed numerous fulgurites. The fulgurites were generally small and weathered. Burn pattern indicators did not support any of these fulgurites being the origin of the Slater fire. A video was taken to document the locations of the fulgurites and at the conclusion of the investigation the fulgurites were removed and approximately 40 separate pieces of fulgurite were collected (**Exhibit 13- Prior Fulgurite Collection**). The presence of fulgurites indicates that at some point in the past live conductors had impacted the ground in this area.

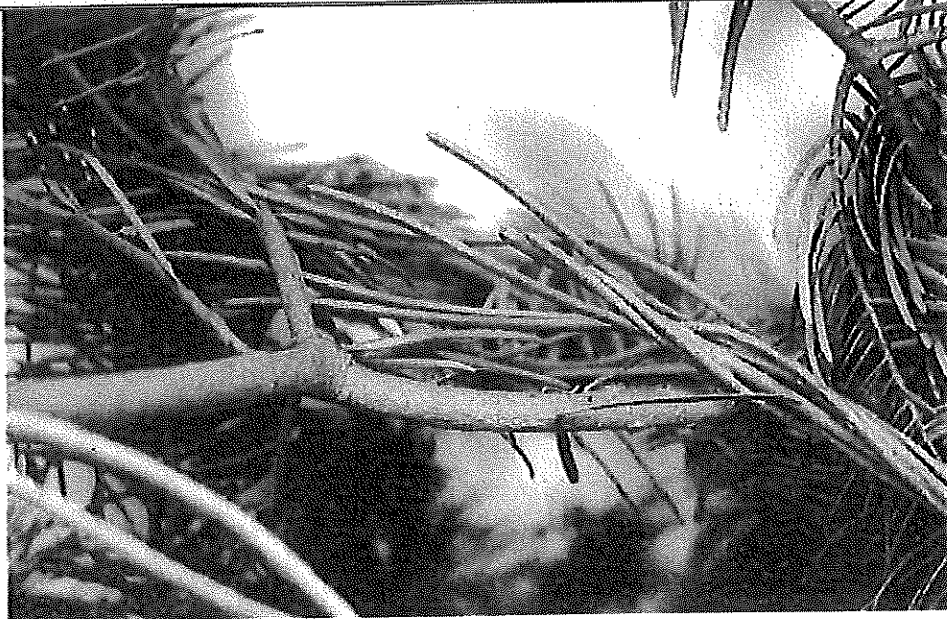
Subject:
Severed north end of west conductor

The west conductor severed at the approximate location the top of the large fallen tree had entered the power line right of way between Pole 5 and Pole 4. The north end of the severed west conductor was gathered into a short tree and had more or less appeared to come down in the same place as it had been suspended. The tree had burn marks around all the branches emanating from the tree trunk indicating the tree had become electrically charged. The frayed north end of the west conductor had strands that were necked down consistent with a tensile overload fracture (**Exhibit 14- Photo of North End of West Conductor End in Charred Tree**). Several other stems on trees and shrubs were located nearby with electrically burned and charred vegetation. Marks on the conductor corresponded to the charred vegetation (**Exhibit 15- Charred Vegetation & West Conductor**). In several places along the conductor the outer aluminum strands had been melted and stretched revealing the inner steel center strand. Where the west conductor had severed the center steel strand was not visible and it appeared this thinner section may be comprised of only aluminum strands. Further testing will be required to determine the conductor configuration.

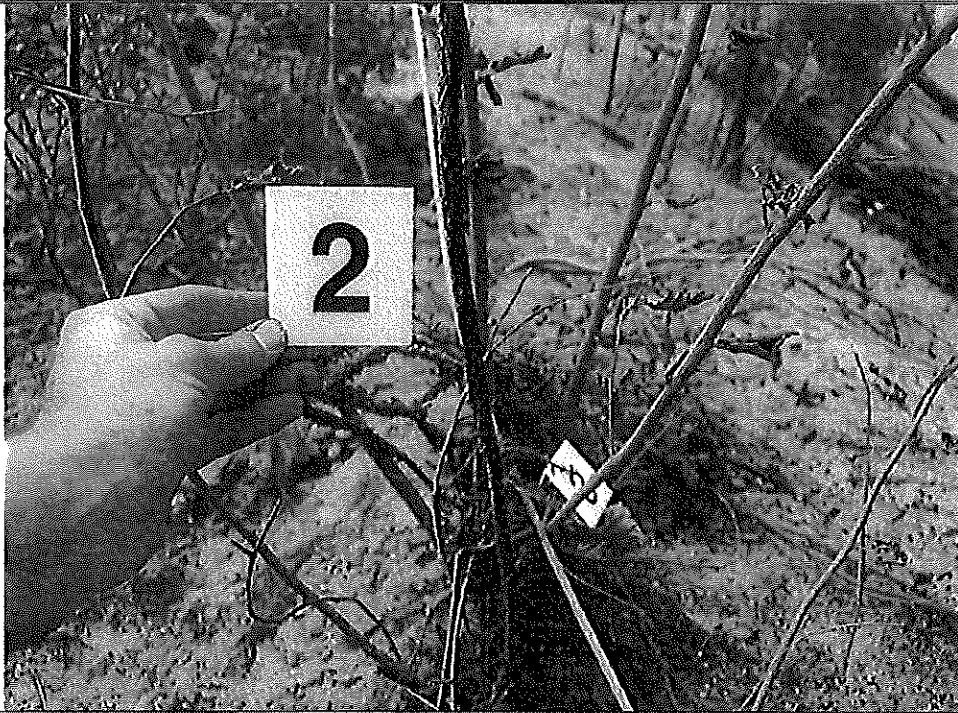
Photograph Number:
20 Electrical
Date:
9/12/20
Time:
1355
Photographer:
b6 & b7C
Subject:
Charred Conductor Struck
Vegetation

The west conductor to the south of the severe had recoiled and had come to rest in the vegetation between Poles 4 and 3 (**Exhibit 16- Photo of South End of West Conductor End**). Vegetation in the area had charred marks indicating that the conductor remained energized after it had severed. An insulator was still attached to the west conductor from where it broke free from the top of Pole 4. The south end severe also had necked down strands consistent with a tensile overload fracture. No center steel strand was identifiable in the conductor.

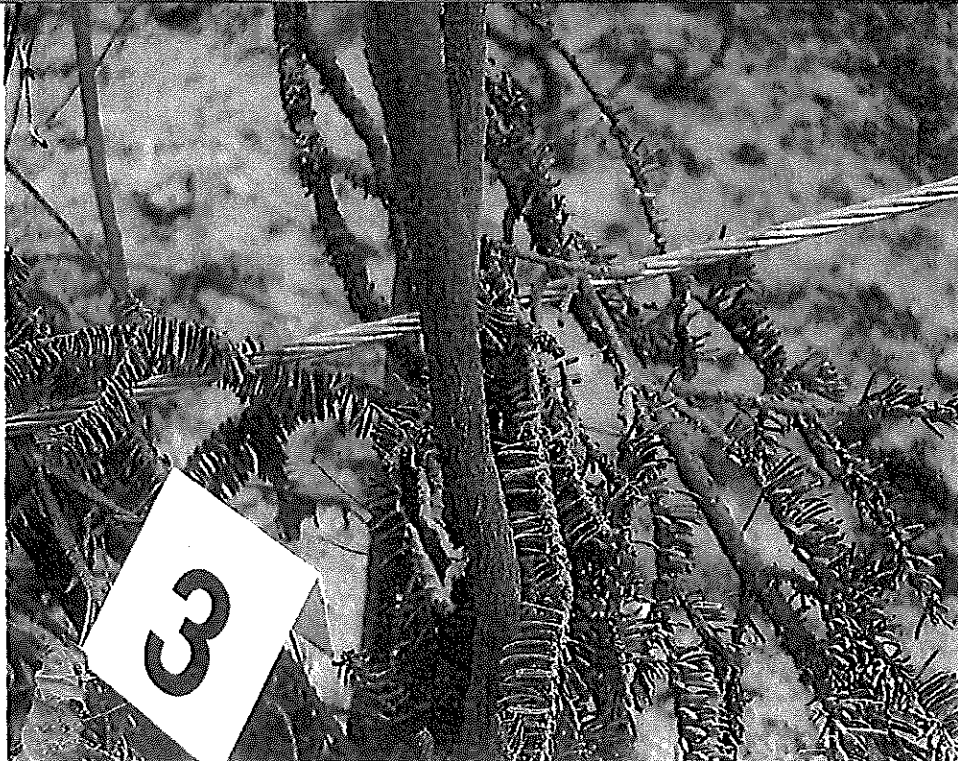
Photograph Number:
21 Electrical
Date:
9/12/20
Time:
1356
Photographer:
b6 & b7C
Subject:
Charred Conductor Struck
Vegetation

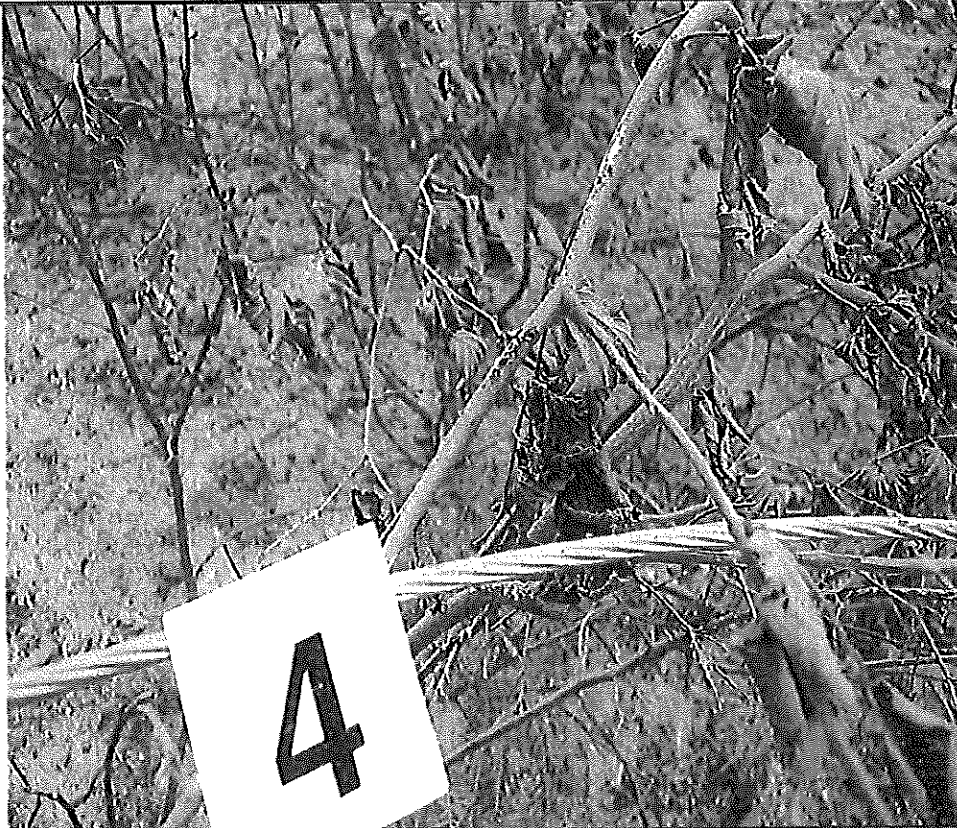
Photograph Number:
22 Electrical
Date:
9/12/20
Time:
1358
Photographer:
b6 & b7C
Subject:
Charred Conductor Struck
Vegetation

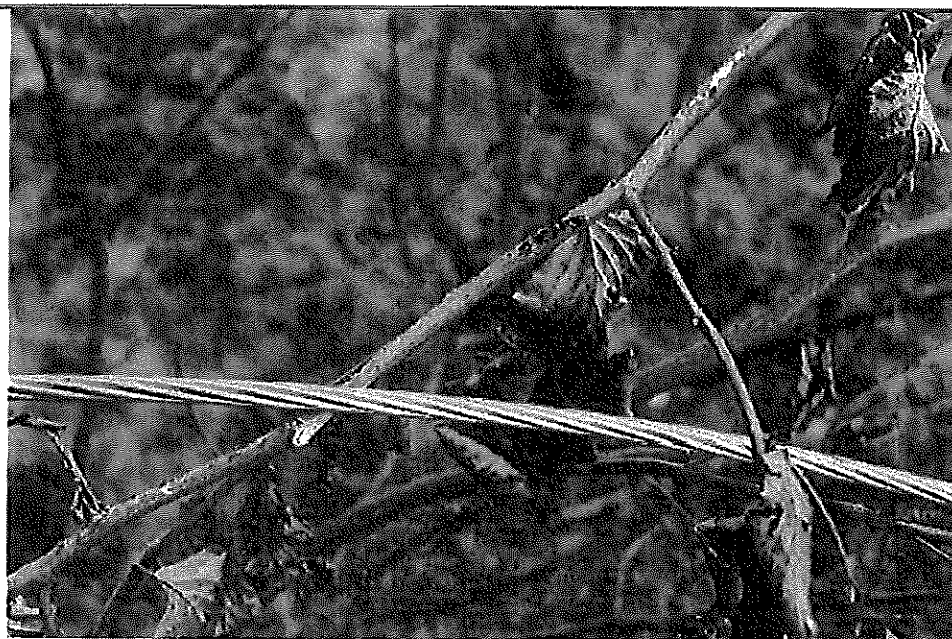
Subject:
Electrically Charred Conductor
Struck Vegetation

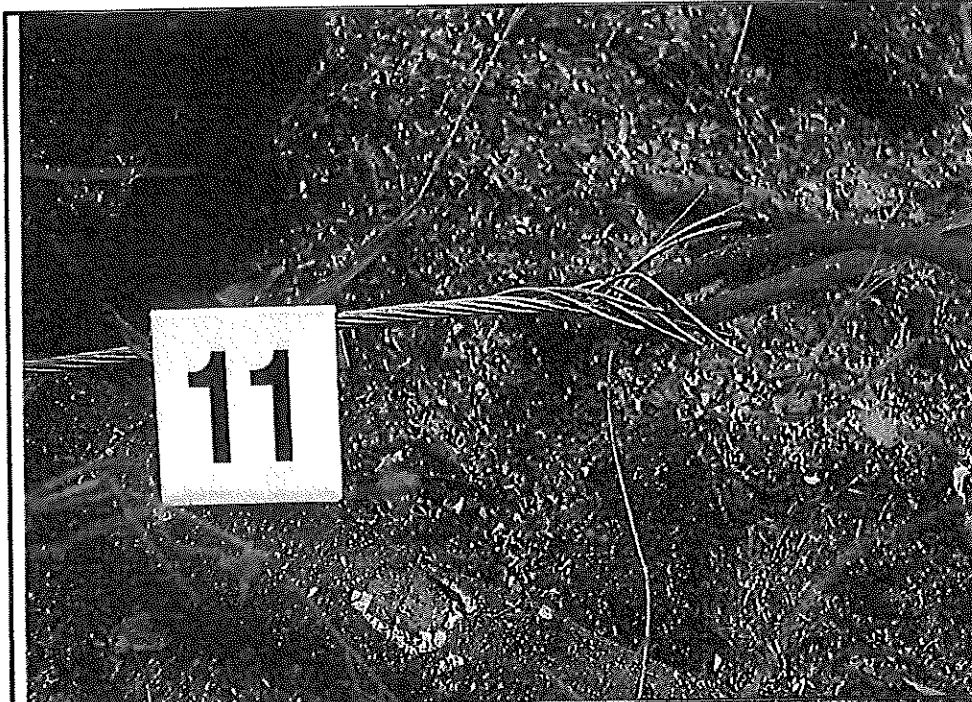
Photograph Number:
29 Electrical
Date:
9/12/20
Time:
1410
Photographer:
b6 & b7C
Subject:
South End of Severed West
Conductor

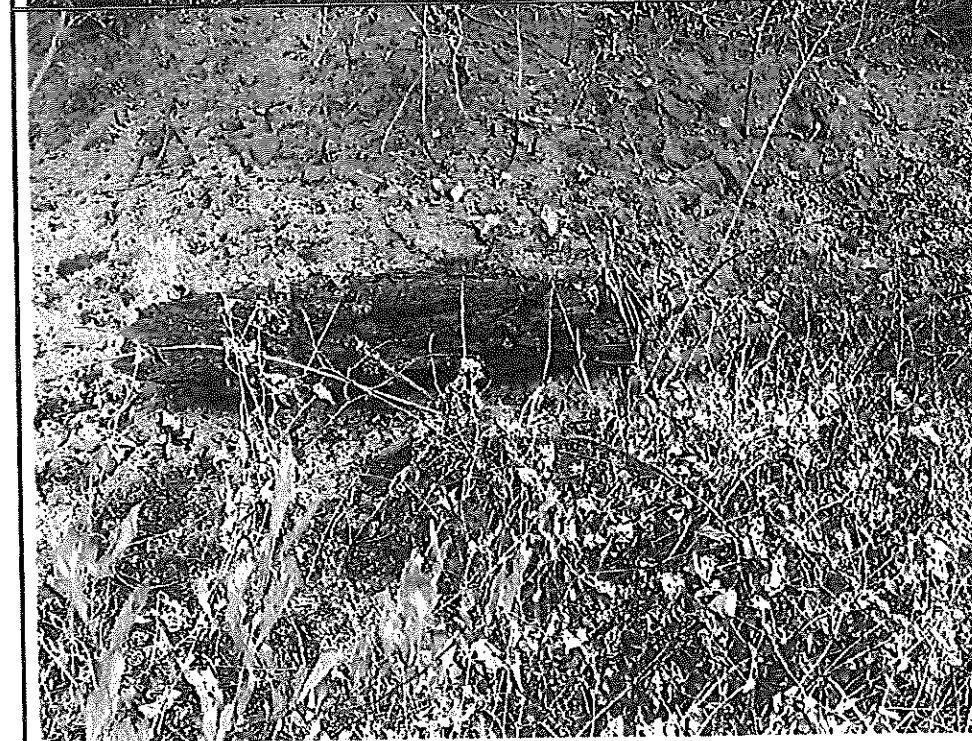
Photograph Number:
b6 & b7C 2020-09-18 13-18-08
Date:
9/18/20
Time:
1321
Photographer:
b6 & b7C
Subject:
South End of Severed West
Conductor

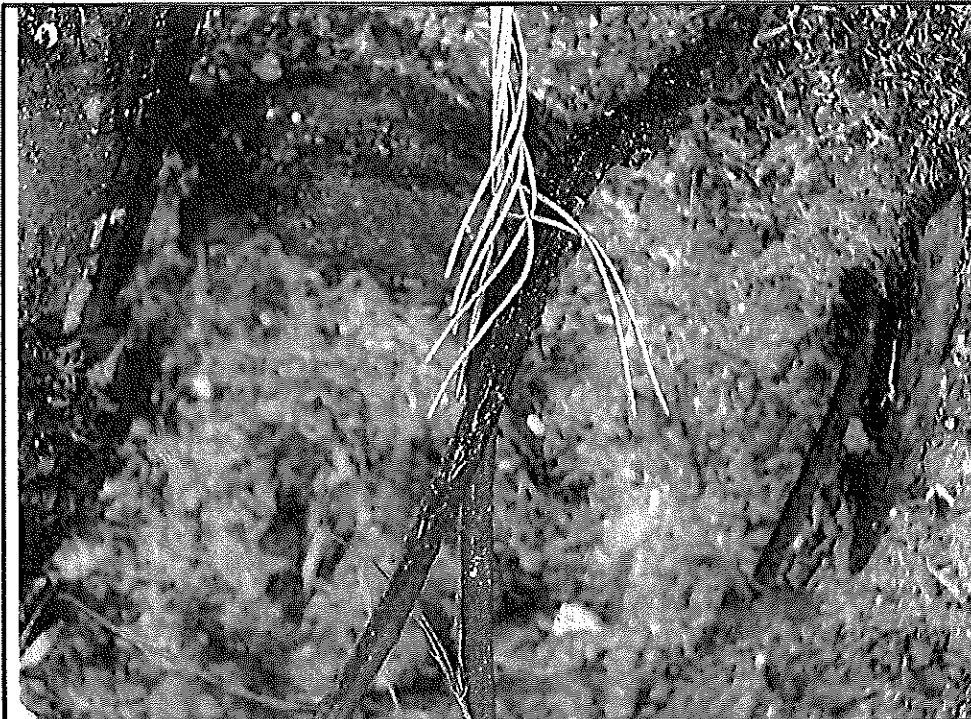
Photograph Number:
b6 & b7C 2020-09-18 13-19-25
Date:
9/19/20
Time:
1322
Photographer:
b6 & b7C
Subject:
South end of West Conductor from
above

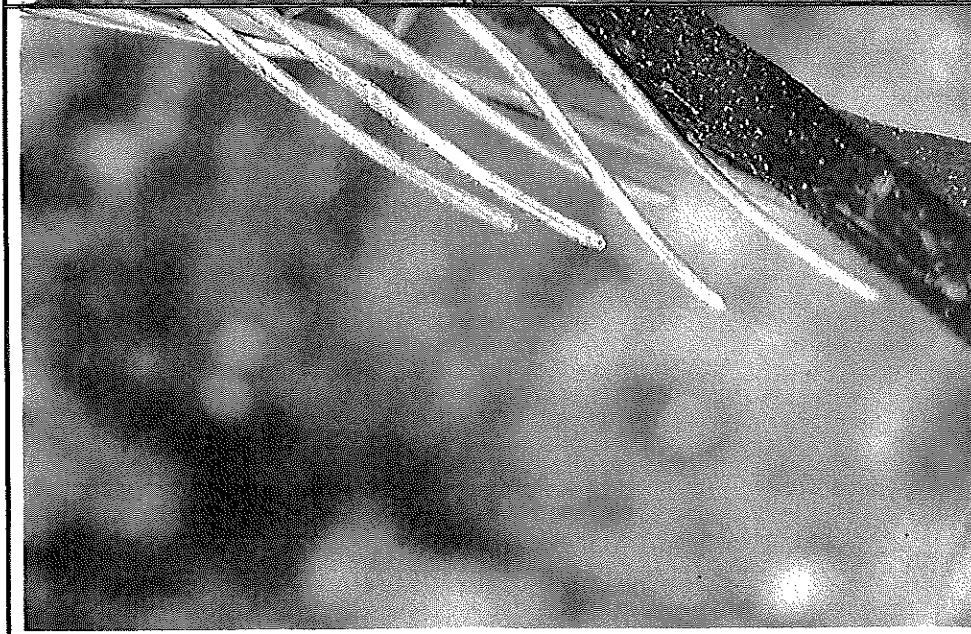
Photograph Number:
b6 & b7C 2020-09-18 13-18-36
Date:
9/18/20
Time:
1322
Photographer:
b6 & b7C
Subject:
Close Up South End of West
Conductor Ends

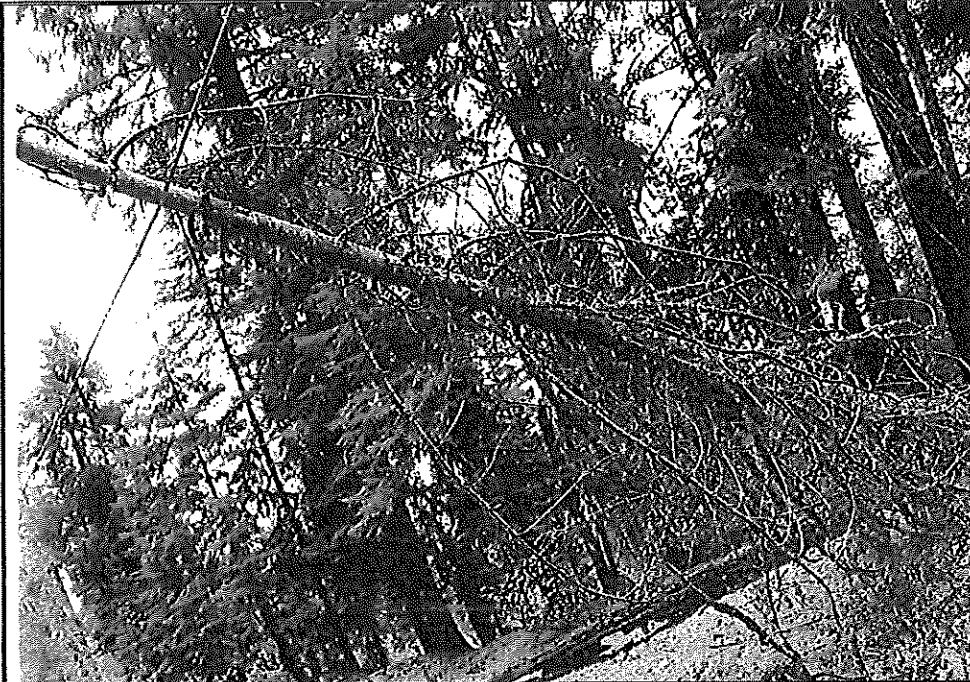
Photograph Number:
b6 & b7C 2020-09-18 13-25-35
Date:
9/18/20
Time:
1328
Photographer:
b6 & b7C
Subject:
Tree resting on East Conductor post
fire

The east conductor was pulled from the insulator at the top of Pole 4 and was touching the ground at the base of Pole 4. No fulgurites, arc erosion on the conductor, or burn pattern indicators to suggest an ignition point were found at this location.

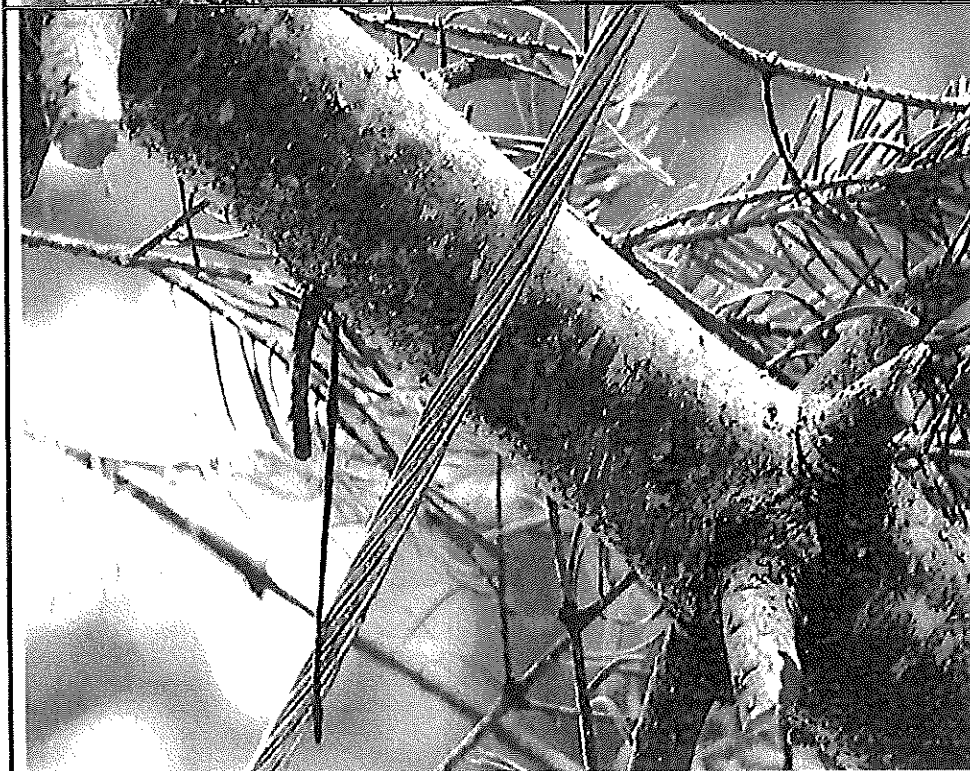
Photograph Number:
b6 & b7C 2020-09-18 13-25-59
Date:
9/18/20
Time:
1329
Photographer:
b6 & b7C
Subject:
Close up of Contact Point Tree
Resting on East Conductor

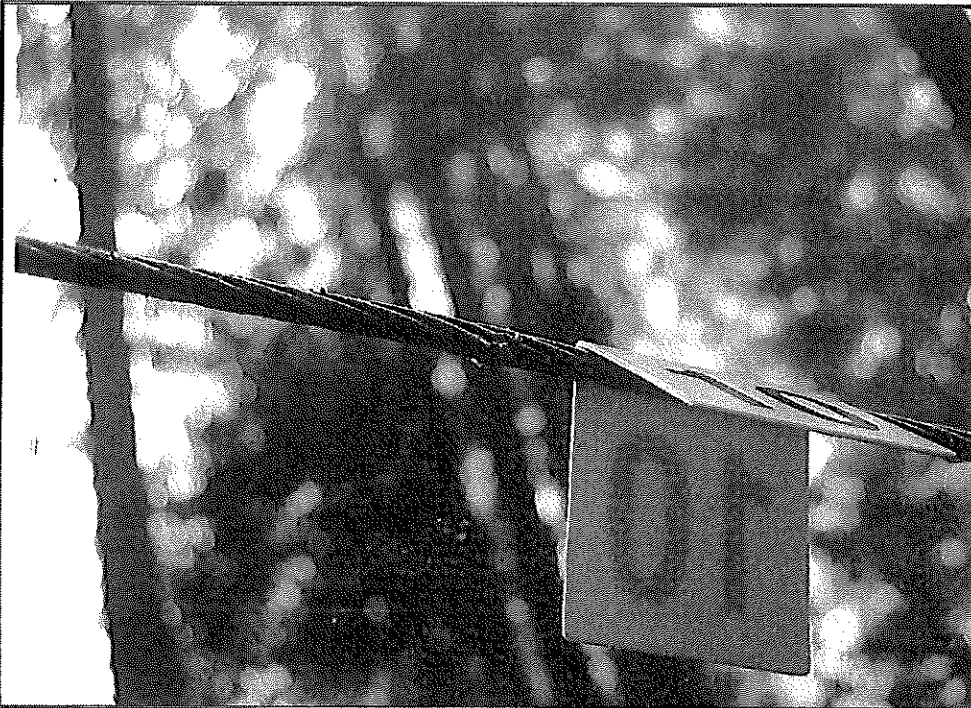
Photograph Number:
28 Indicators & Fulgurite
Date:
9/12/20
Time:
1405
Photographer:
b6 & b7C
Subject:
Sap Like Substance on East
Conductor above White Fir Tree

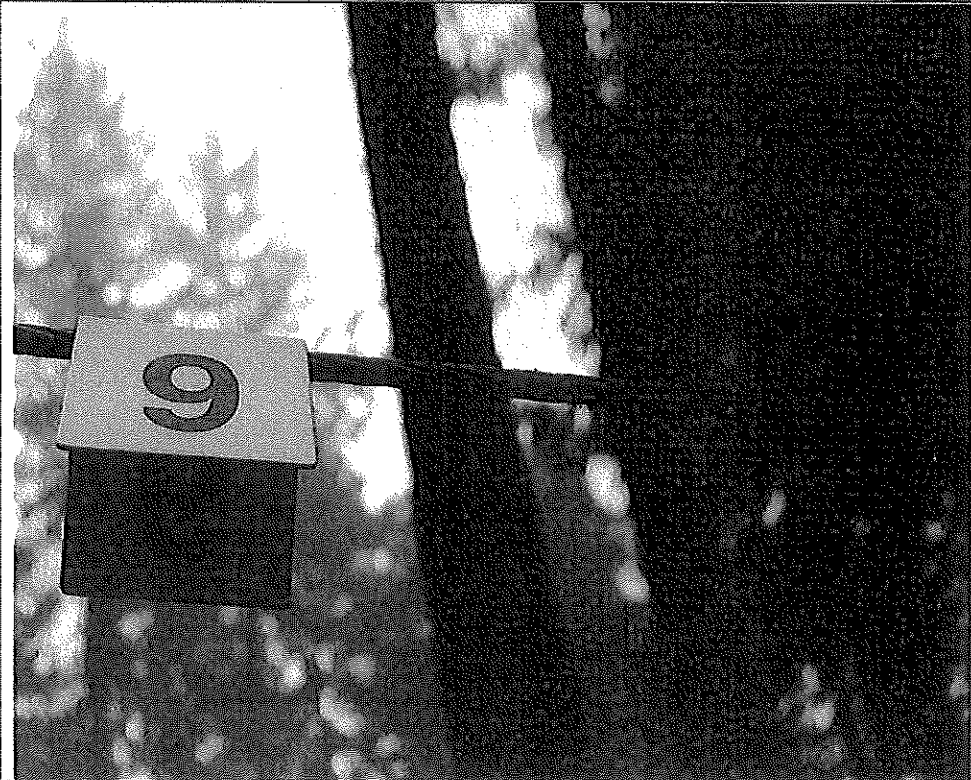
Photograph Number:
27 Indicators & Fulgurite
Date:
9/12/20
Time:
1405
Photographer:
b6 & b7C
Subject:
Debris on East Conductor Above
White Fir Tree

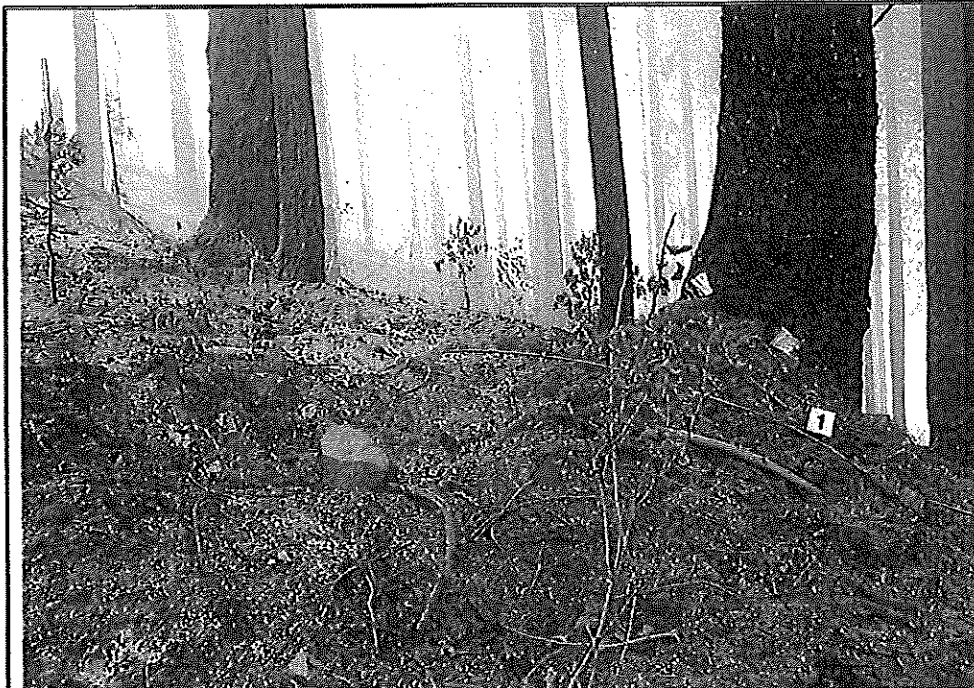
Photograph Number:
6 Indicators & Fulgurite
Date:
9/12/2020
Time:
1314
Photographer:
b6 & b7C
Subject:
West Conductor at Specific Origin

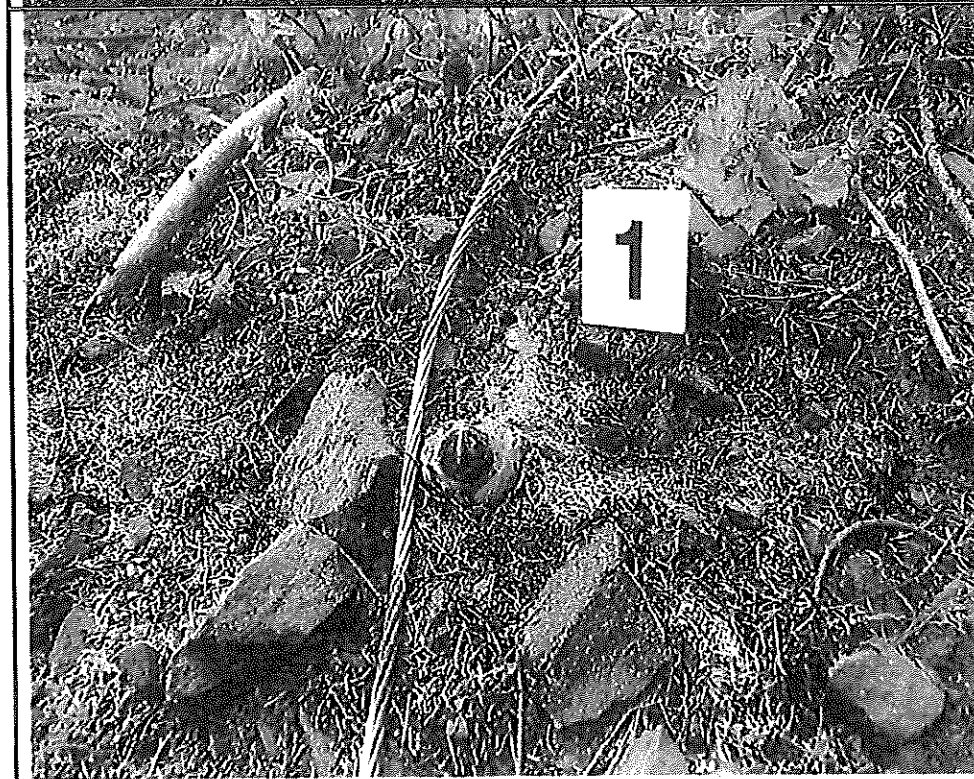
Photograph Number:
7 Indicators & Fulgurite
Date:
9/12/20
Time:
1315
Photographer:
b6 & b7C
Subject:
Fulgurite Located Within Specific
Origin

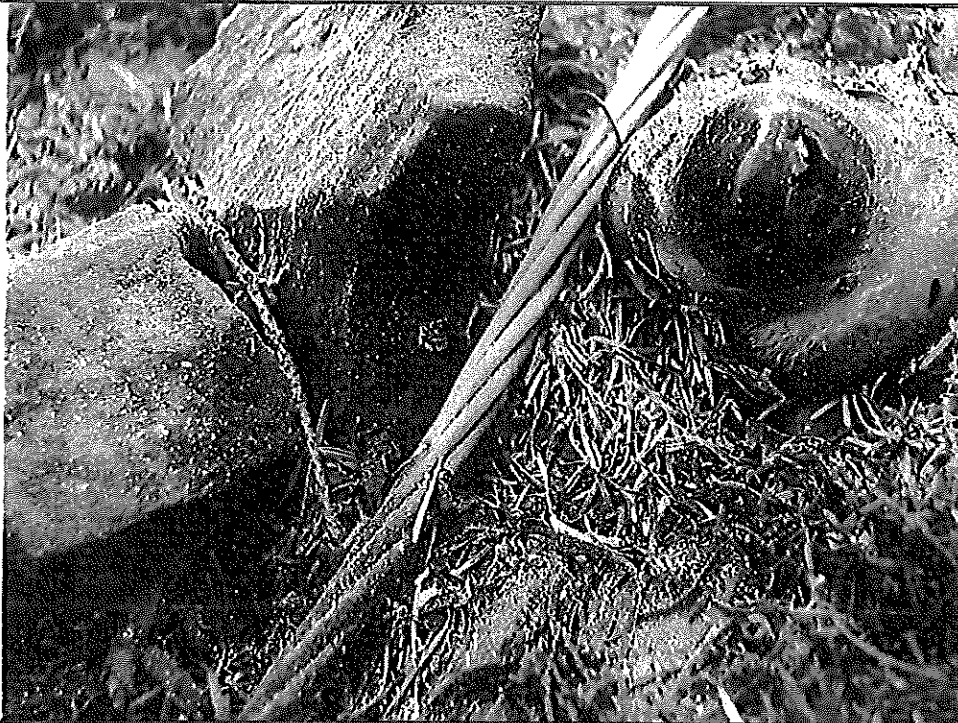
Photograph Number:
8 Indicators & Fulgurite
Date:
9/12/18
Time:
1316
Photographer:
b6 & b7C
Subject:
Arcing on West Conductor at
Fulgurite

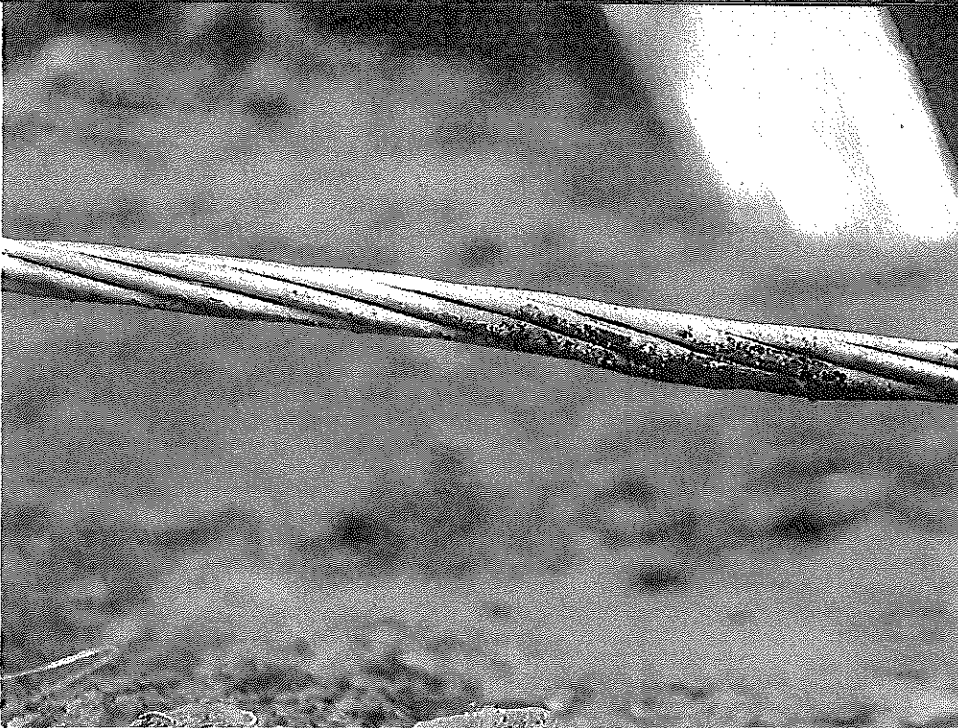
Photograph Number:
35 Indicators & Fulgurite
Date:
9/12/20
Time:
1556
Photographer:
b6 & b7C
Subject:
Arc Erosion on Underside of West
Conductor located after fulgurite
excavation.

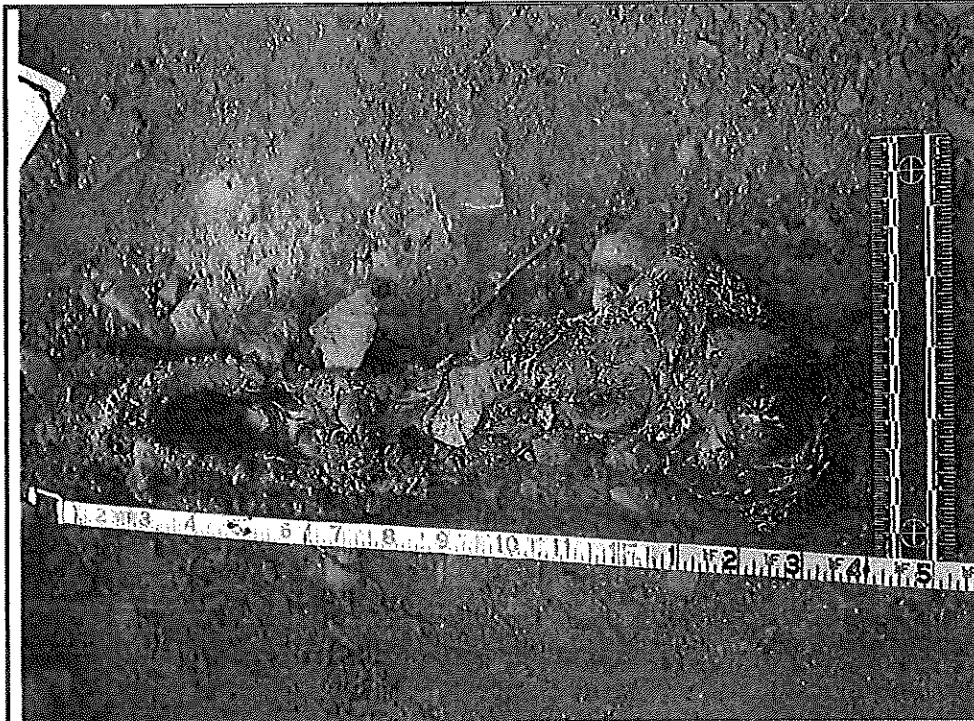
Photograph Number:
31 Indicators & Fulgurite
Date:
9/12/20
Time:
1446
Photographer:
b6 & b7C
Subject:
Partially Excavated Parallel Portion
of Fulgurite

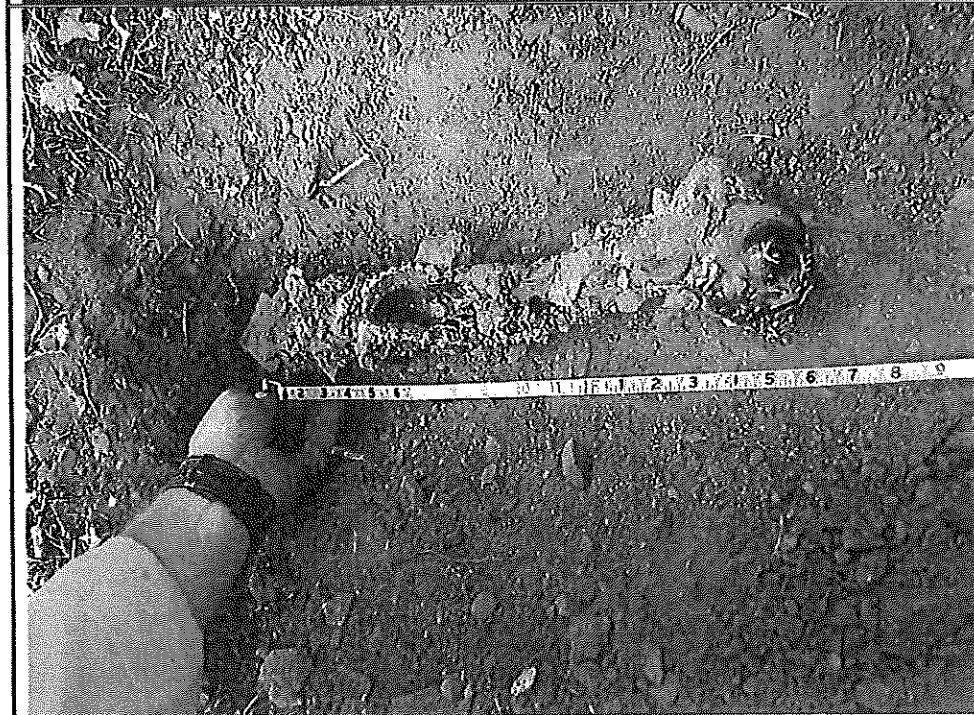
Photograph Number:
34
Date:
9/12/20
Time:
1517
Photographer:
b6 & b7C
Subject:
Further Excavation of Fulgurite to
point where Fulgurite Turns Vertical

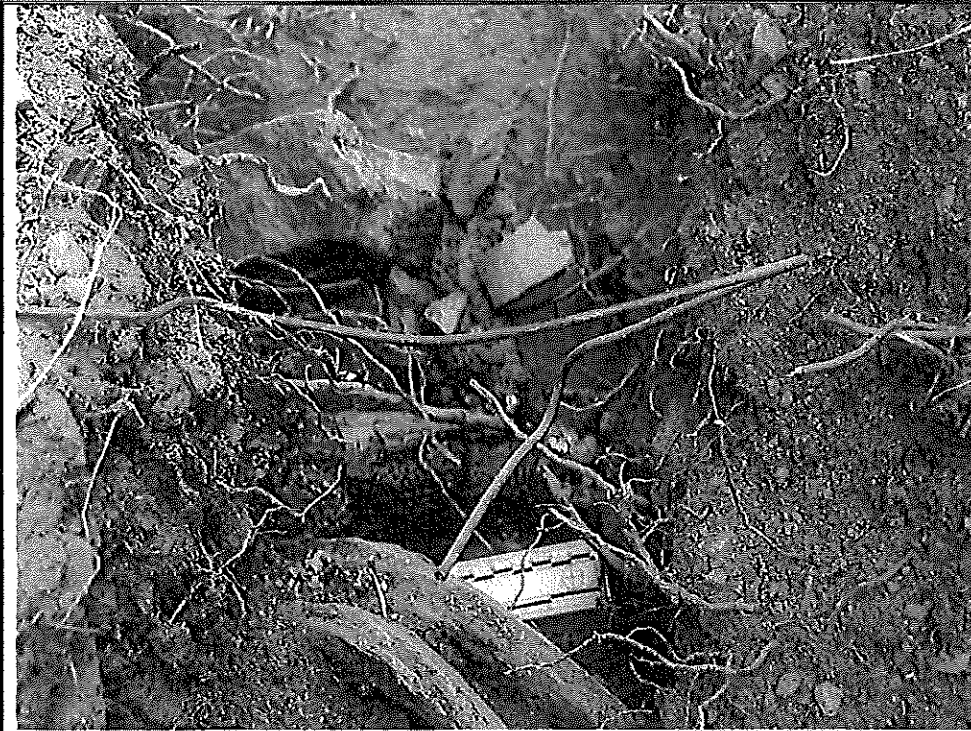
Photograph Number:
39 Indicators and Fulgurites
Date:
9/13/20
Time:
1330
Photographer:
b6 & b7C
Subject:
Vertical Portion of Fulgurite
Terminating on Charred Tree Root
with Buried Copper Conductor
