REPORT OF INVESTIGATION <i>(Reference FSH 5309.11)</i>		Case/File Number 20-05-MBBK0WI																						
Controlling Office R5 - Law Enforcement and Investigations			Investigating Office LE&I – Klamath National Forest																							
Case Type Fire			Investigative Period From: 10/5/20 To 12/8/20																							
Case Status Pending Judicial Action			Report Type Supplemental/Final																							
Case Name Slater Fire			Investigated By Special Agent b6 & b7C																							
<p align="center"><u>SYNOPSIS</u></p> <p>On September 8, 2020, the "Slater Fire" ignited on U.S. Forest Service (USFS) land on Slater Butte, 5 miles north of Happy Camp within the Klamath National Forest (KNF).</p> <p>At the time of report the fire has been estimated at burning 157,229 acres with firefighting cost yet to be determined. Approximately 237 structures have been reported damaged with 197 of those being residential. Two fatalities are being investigated related to the Slater Fire.</p> <p>An origin and cause investigation was conducted 3 days after discovery of the fire. A general origin area of the Slater Fire was located just off Forest Road (FR) 17N48 below the Slater B

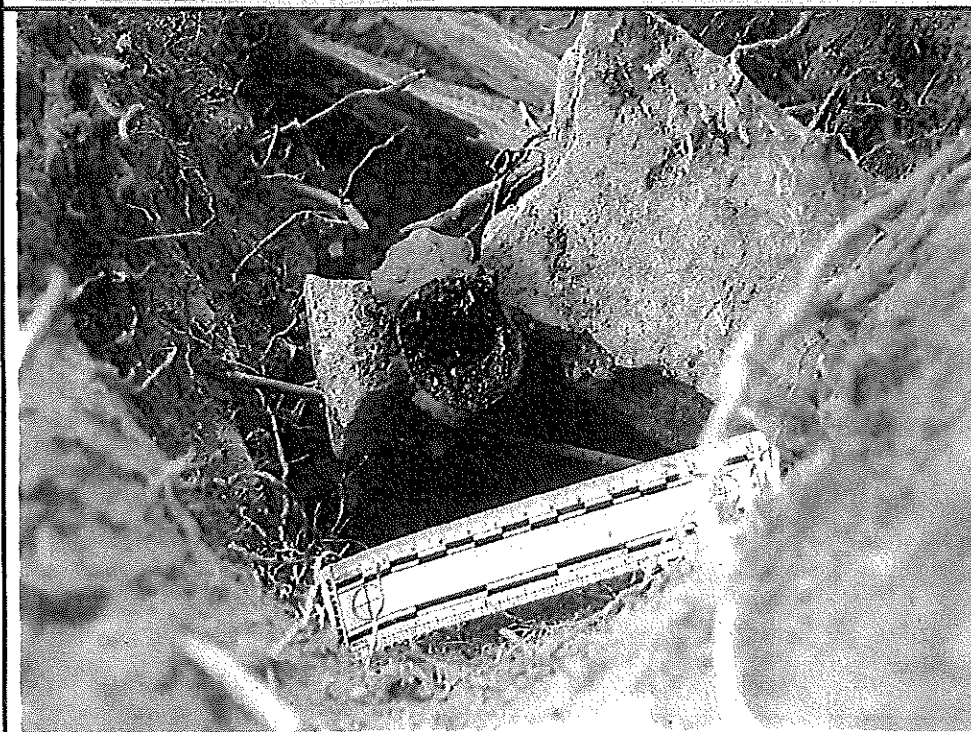
Photograph Number:
38 Indicators & Fulgurites
Date:
9/13/20
Time:
1337
Photographer:
b6 & b7C
Subject:
Hallow Center of Vertical Portion of
Fulgurite with Fused Copper
Conductor

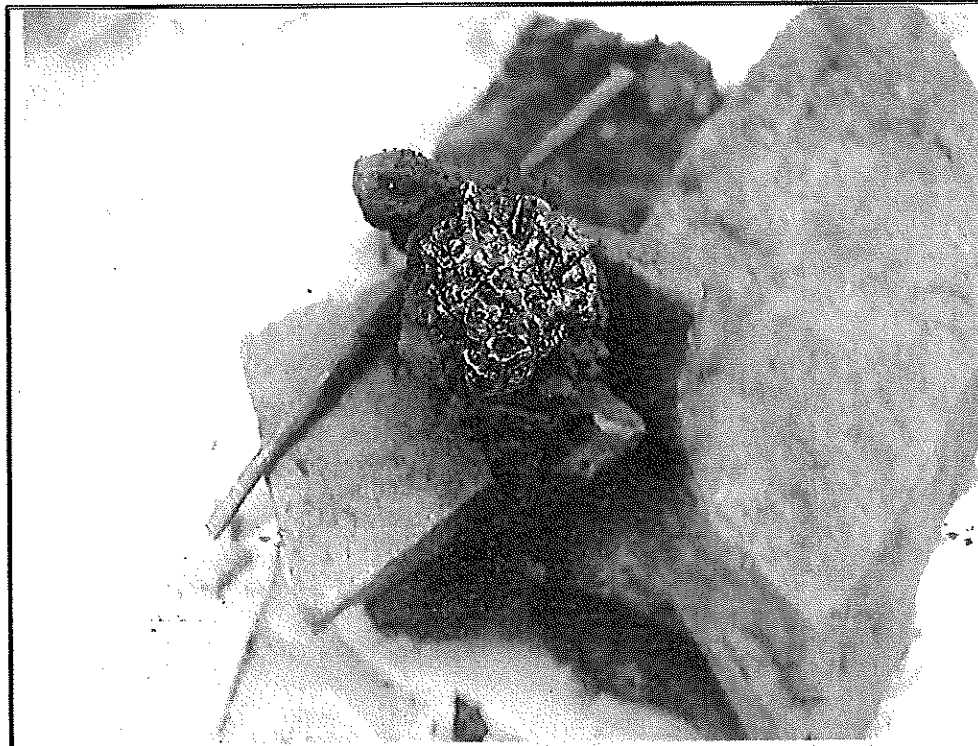
Photograph Number:
40 Indicators & Fulgurite
Date:
9/13/20
Time:
1344
Photographer:
b6 & b7C
Subject:
End of Vertical Portion of Fulgurite
that Contacted Charred Tree Root

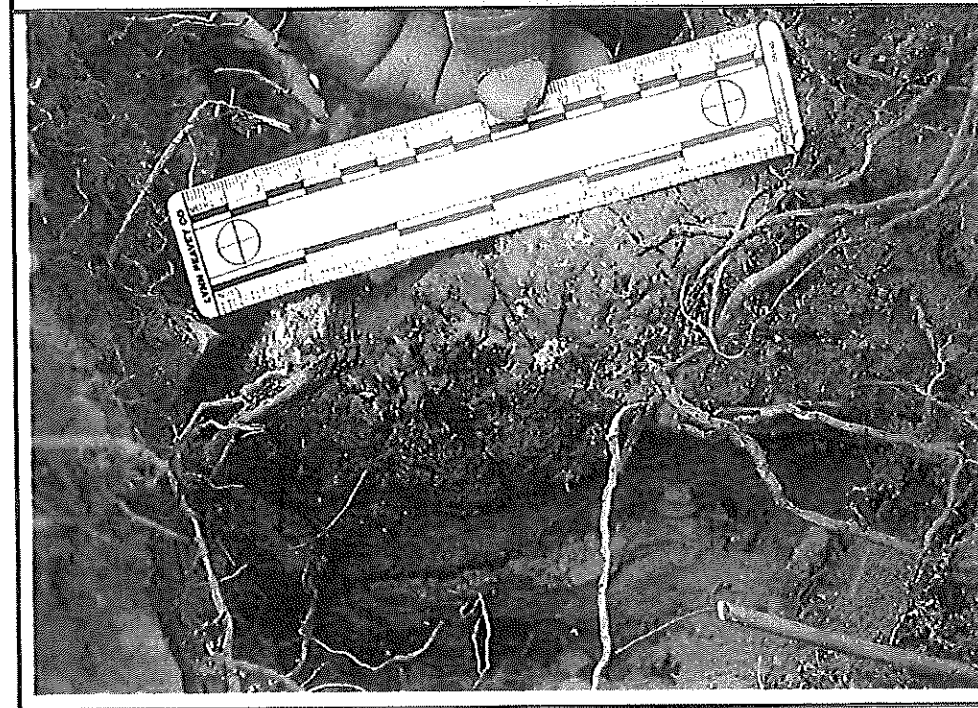
Photograph Number:
42 Indicators & Fulgurite
Date:
9/13/20
Time:
1347
Photographer:
b6 & b7C
Subject:
Point Where Fulgurite Contacted
Tree Root

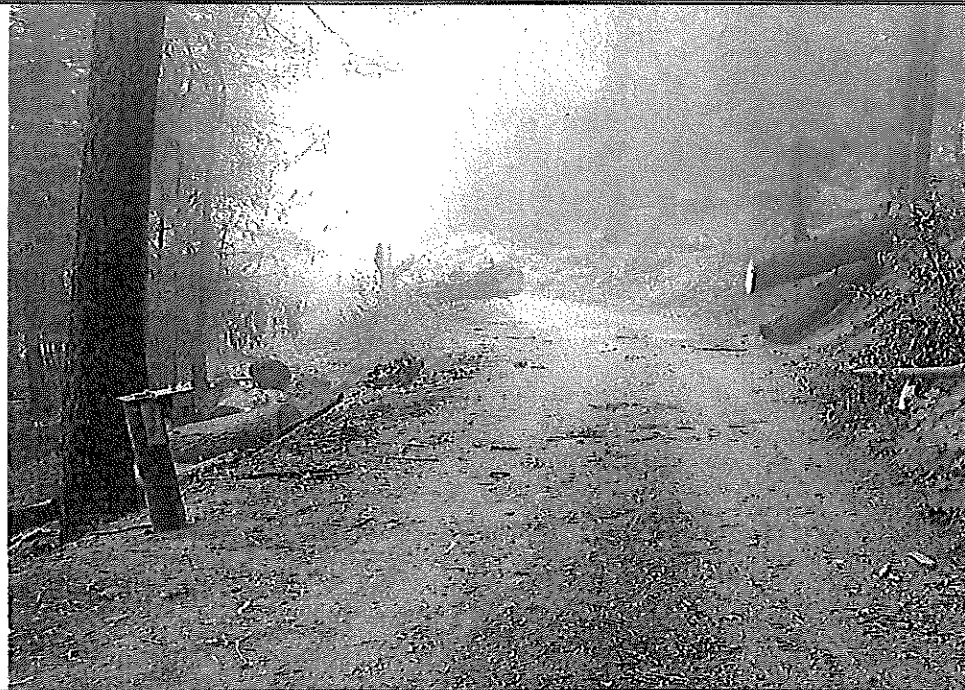
Photograph Number:
52 Tree
Date:
9/12/20
Time:
1043
Photographer:
b6 & b7C
Subject:
Lookout Gate and White Fir Tree
Looking South

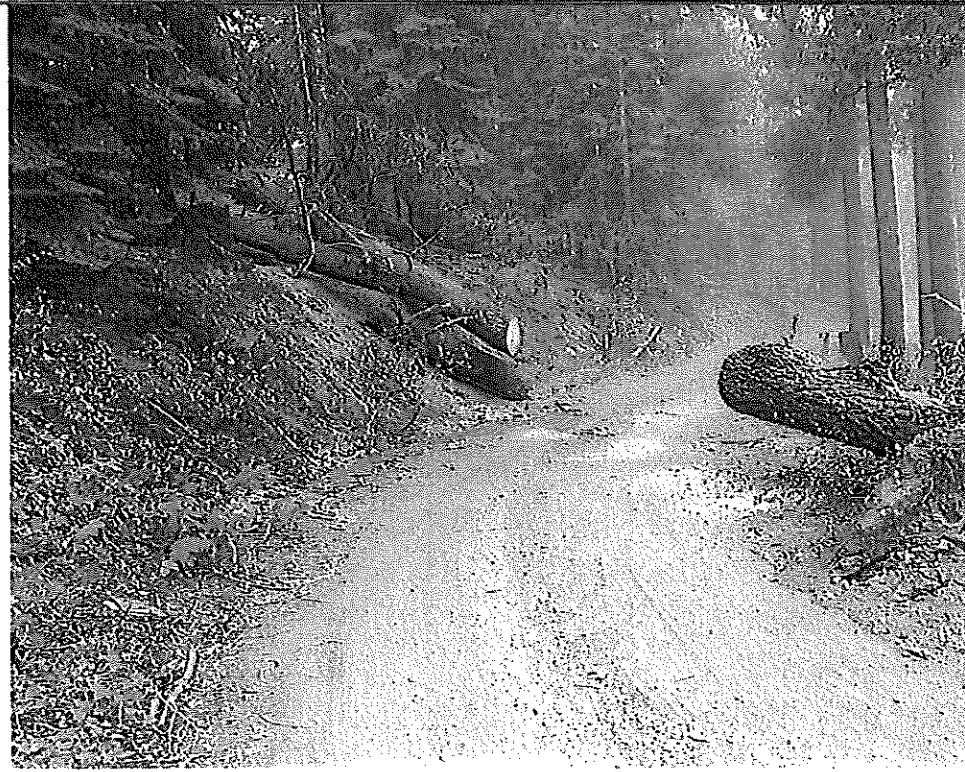
Photograph Number:
14 Tree
Date:
9/12/20
Time:
0951
Photographer:
b6 & b7C
Subject:
White Fir Tree Looking North

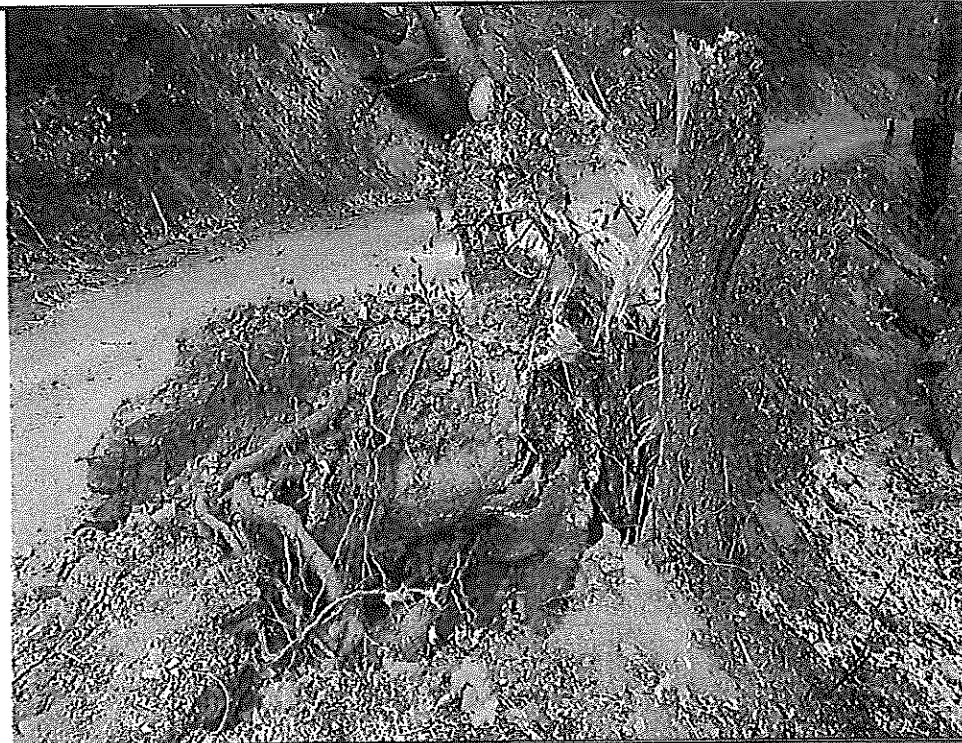
Photograph Number:
15 Tree
Date:
9/12/20
Time:
0952
Photographer:
b6 & b7C
Subject:
Base of White Fir Tree from South
Side

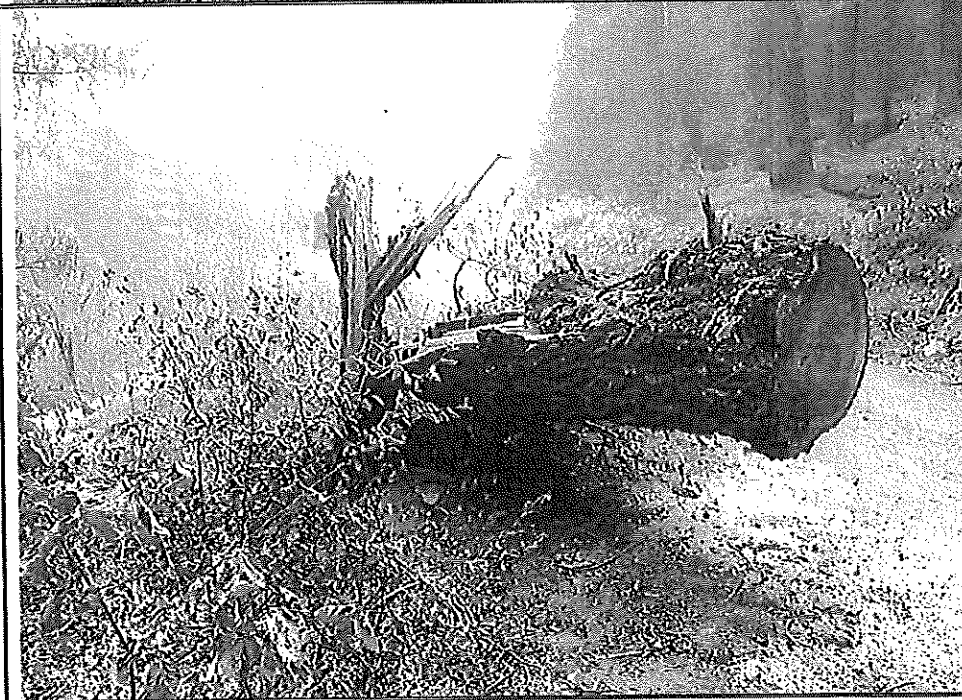
Photograph Number:
36 Tree
Date:
9/12/20
Time:
1026
Photographer:
b6 & b7C
Subject:
Base of White Fire Tree from North
Side

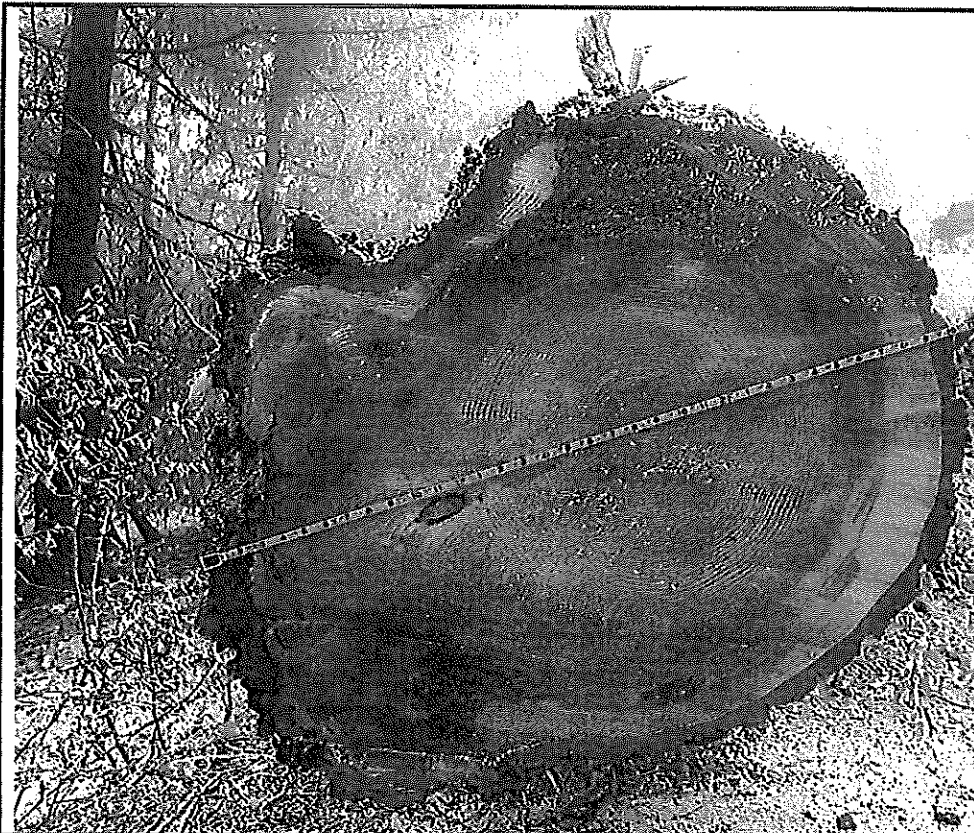
Photograph Number:
25 Tree
Date:
9/12/20
Time:
1017
Photographer:
b6 & b7C
Subject:
Diameter of White Fir Tree

The tree that failed was a white fir (*Abies concolor*) with a diameter of approximately 30.5 inches at 7.8 feet from the ground. It was not possible to take a diameter at breast height measurement because that portion of the bole had failed and was split into two sections, one suspended over the road, one remaining anchored in the ground (see image below).

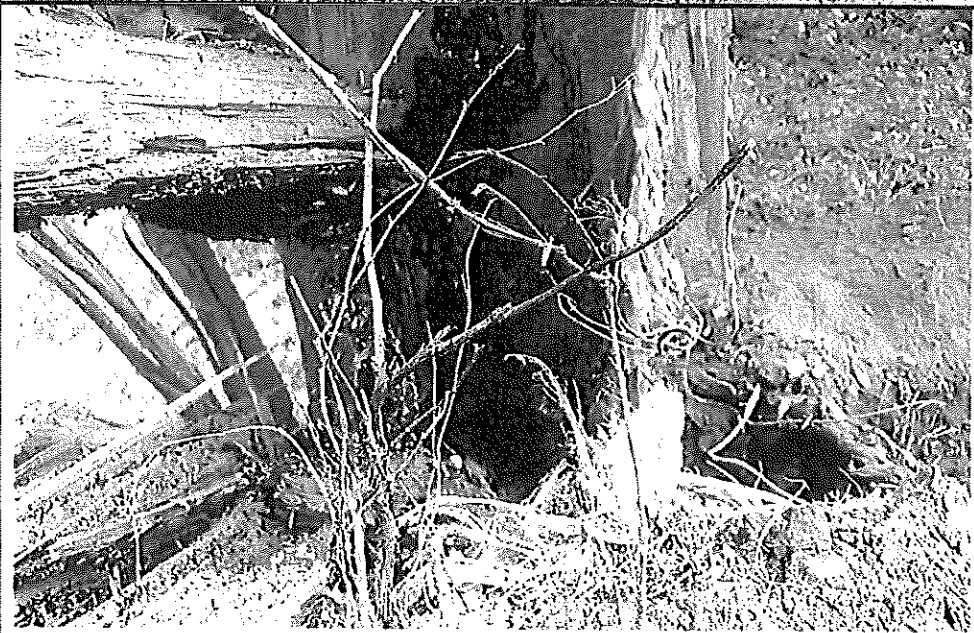
Photograph Number:
23 Tree
Date:
9/12/20
Time:
1014
Photographer:
b6 & b7C
Subject:
Fracture at Ground Level of White
Fir Tree
