2016 Coal Combustion Residuals Annual Inspection

Dave Johnston Power Plant *Industrial Landfill*

Prepared for
PacifiCorp
North Temple Office
1407 West North Temple
Salt Lake City, Utah 84116

November 23, 2016

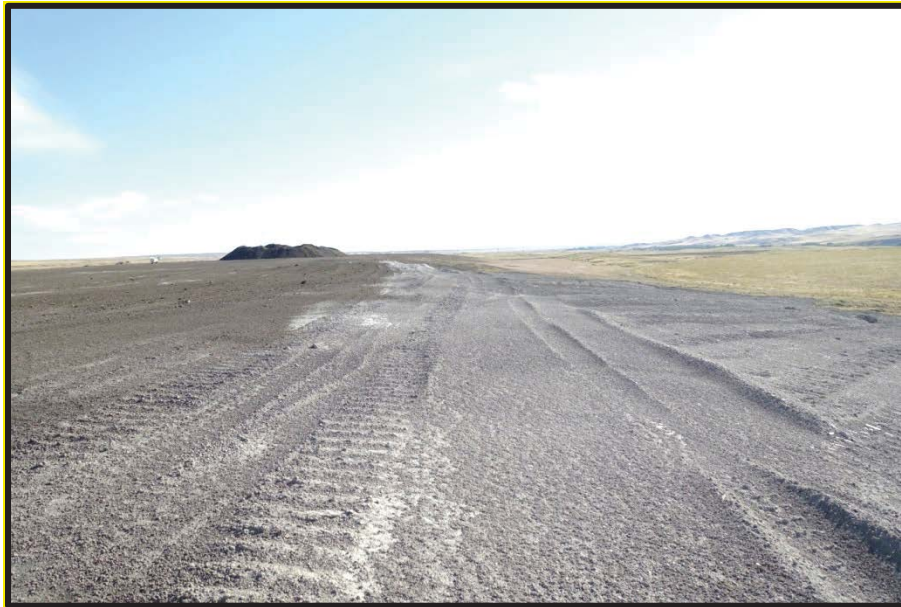
URS found no observations that would indicate imminent failure of the embankment for the Dave Johnston Power Plant Expansion Landfill. There is no indication of movement of the embankment. Figure 1-1 on the following page is an aerial photograph of the landfill.

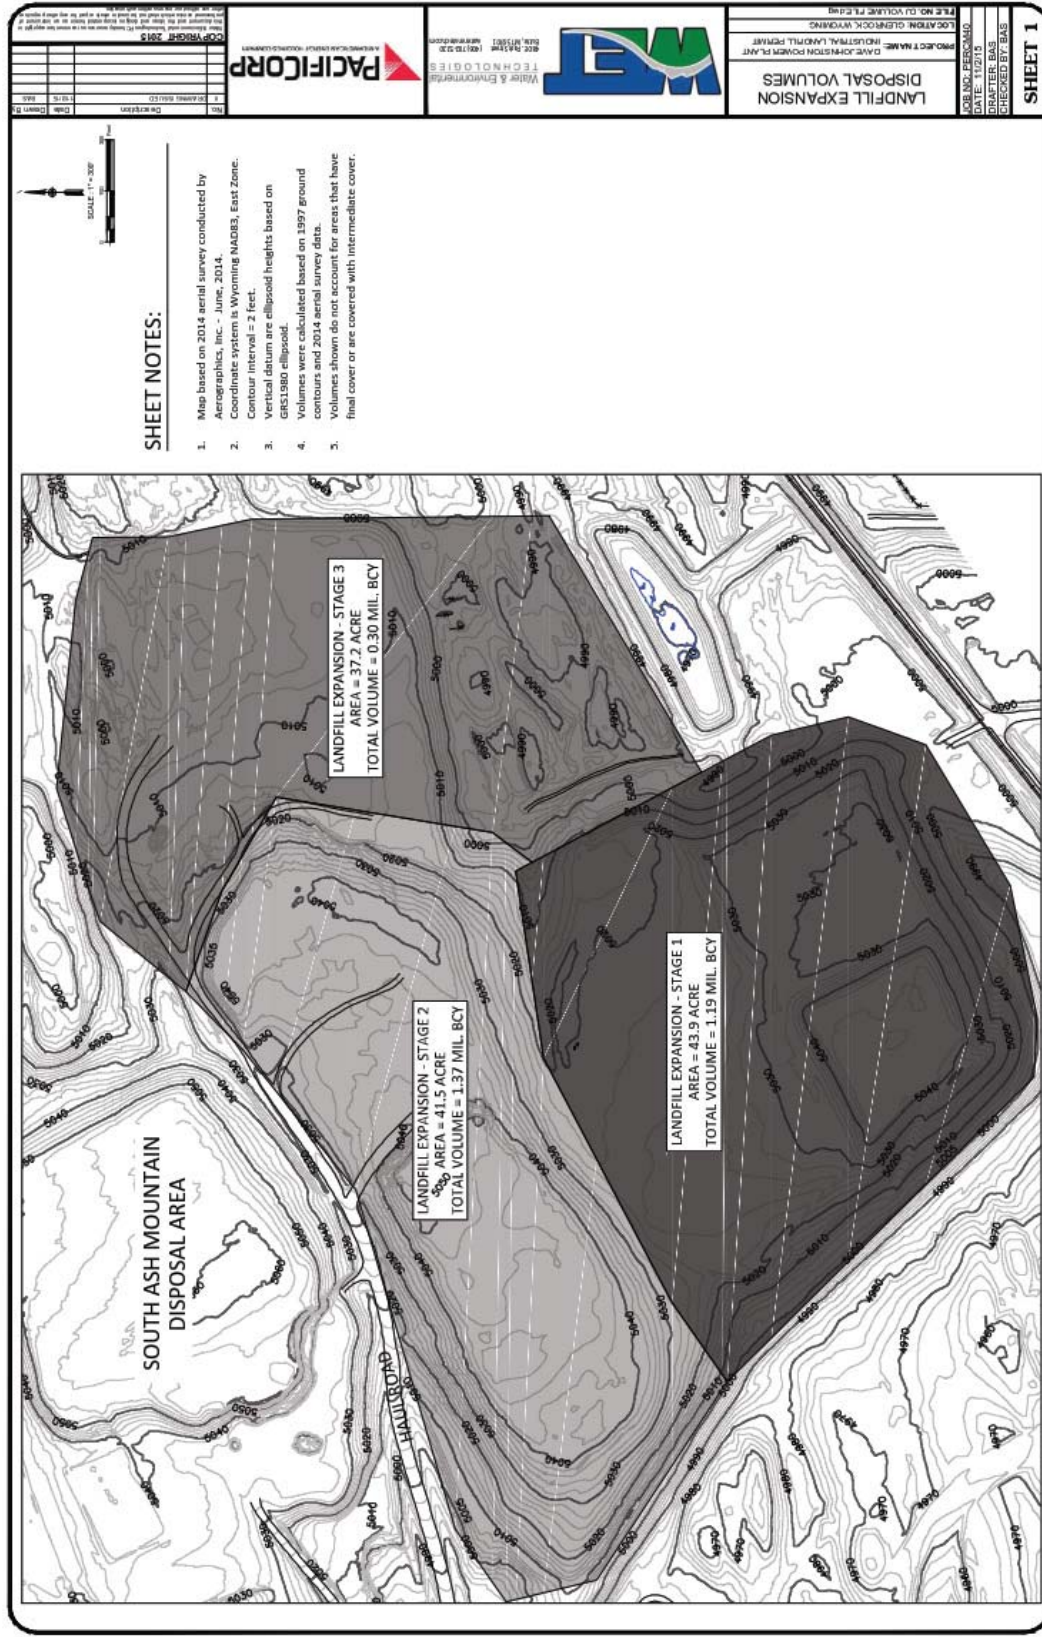
Figure 2-1. Site Plan and Disposal Volumes for Expansion Landfill [4]

The Dave Johnston Power Plant Expansion Landfill accepts only CCR material; consequently, there is no industrial waste disposed of in the landfill. The Expansion Landfill consists of three stages, each with a planned design life of 5 years [2]. Figure 2-1 shows the design layout for the three stages.

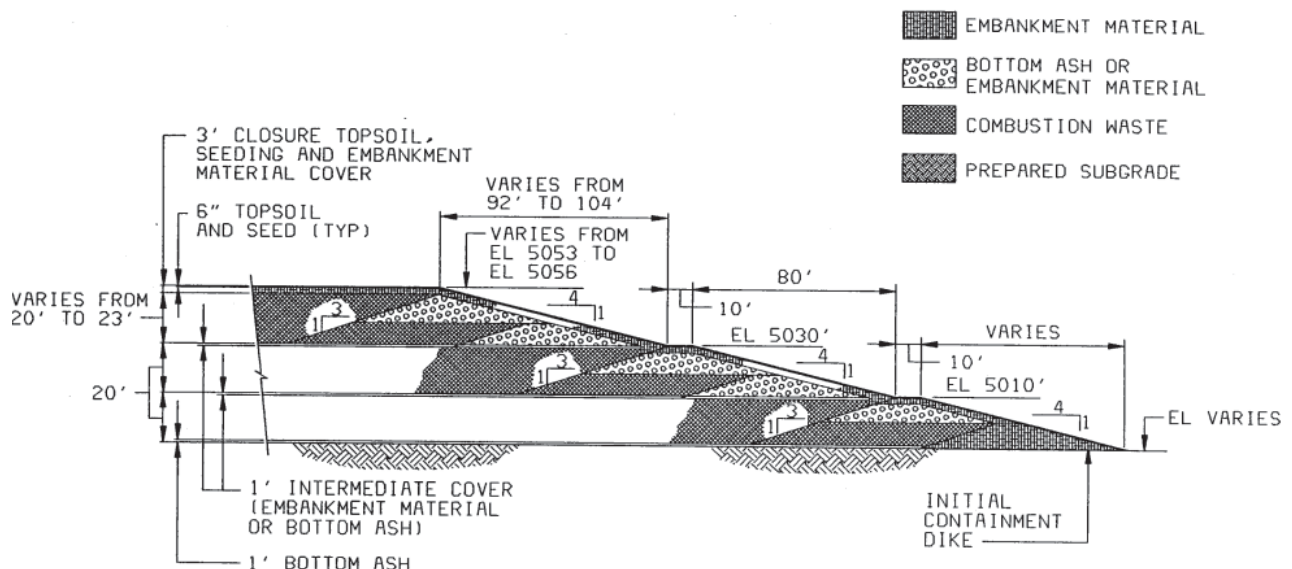
Figure 3-1. Cross Section of Final Landfill Configuration [2]

The Operations Manual [2] reports that the landfill was constructed initially with containment dikes of excavated material. It also states that material is placed in the landfill in lifts of 6 to 24 inches to a maximum height of 20 to 23 feet on a 4 horizontal to 1 vertical slope. Figure 3-1 is a cross section of the final configuration.

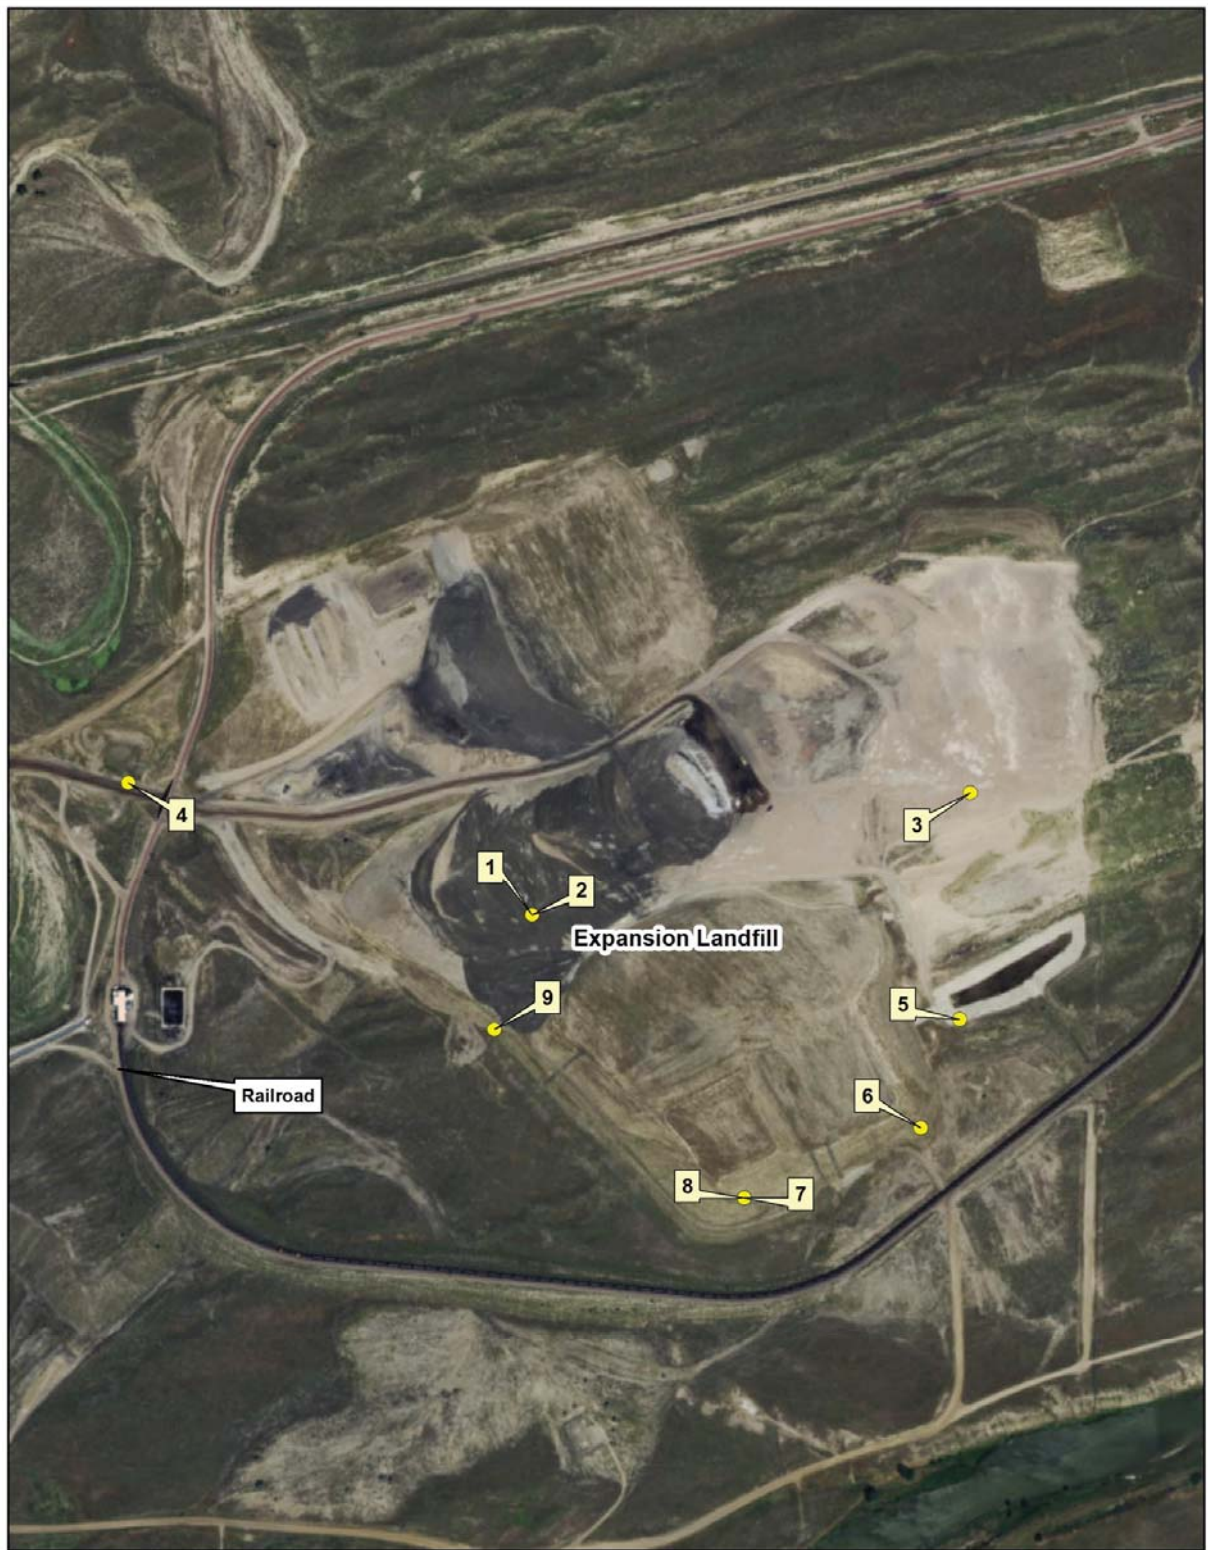
There were no observable changes that would indicate any safety concerns. Photographs were taken of embankment faces of the landfill to compared with photographs from 2015. There were no observed changes. These locations are marked on the Appendix A overview map and should be observed in future inspections for change.
