# 2017 Coal Combustion Residuals Annual Inspection

## Hunter Power Plant

### *Hunter CCR Landfill*

November 30, 2017

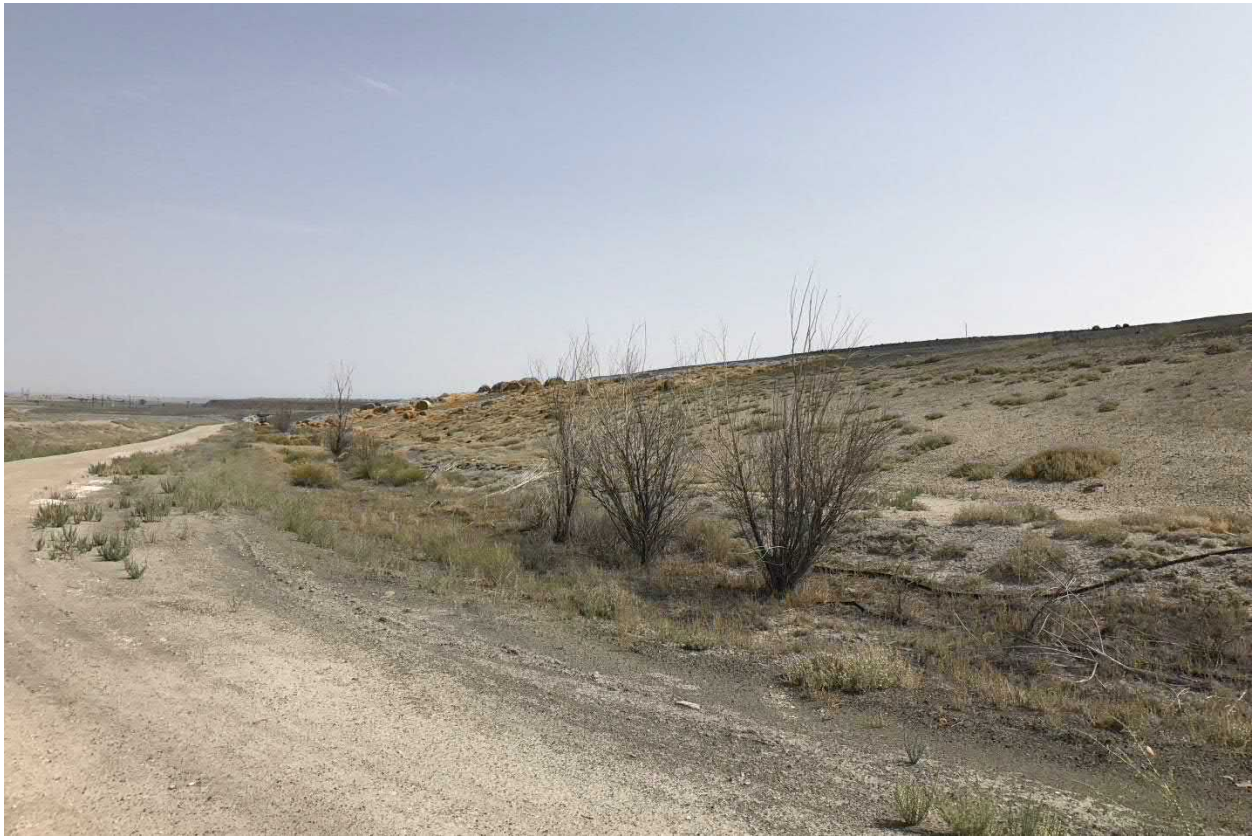
**Photograph No. 8** View of west ash slope and onsite runoff collection ditch running along the toe of the slope, looking northeast.

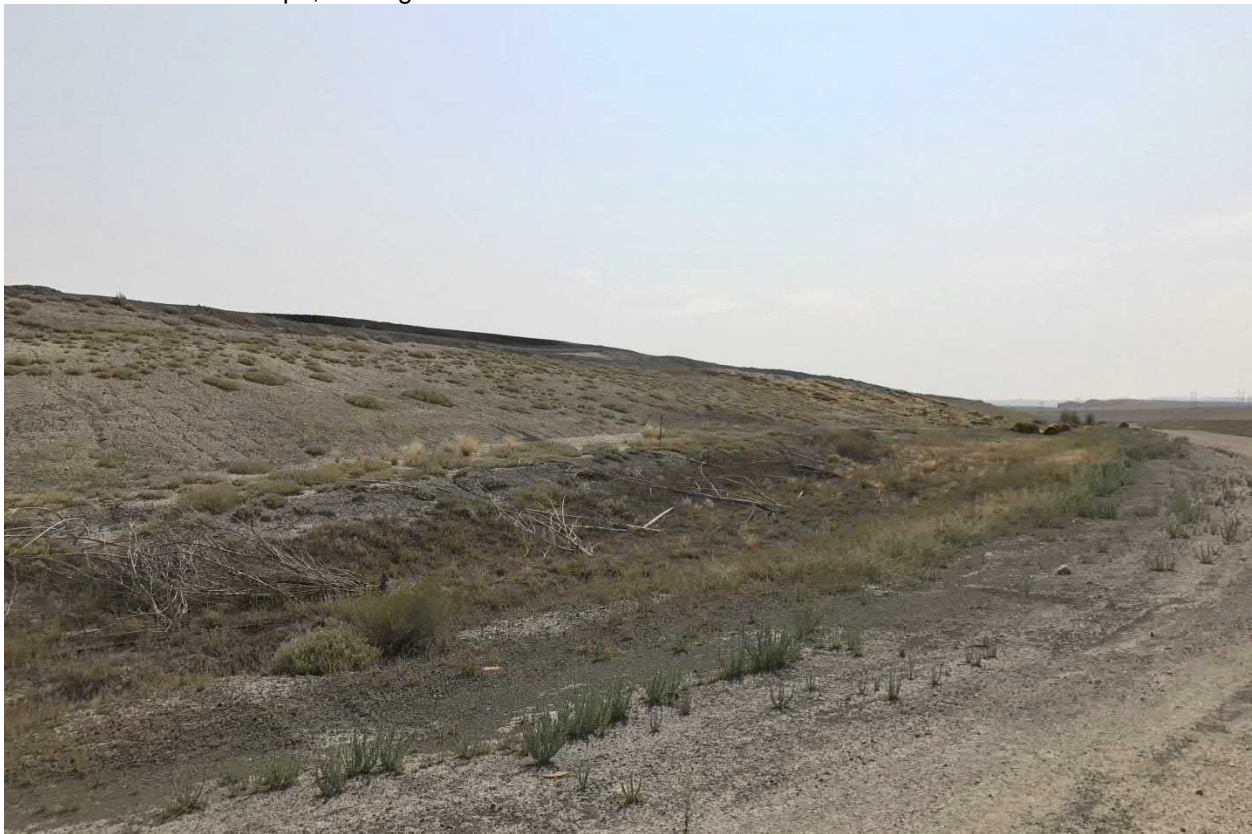
**Photograph No. 9** View of southwest ash slope and onsite runoff collection ditch running along the toe of the slope, looking southeast.

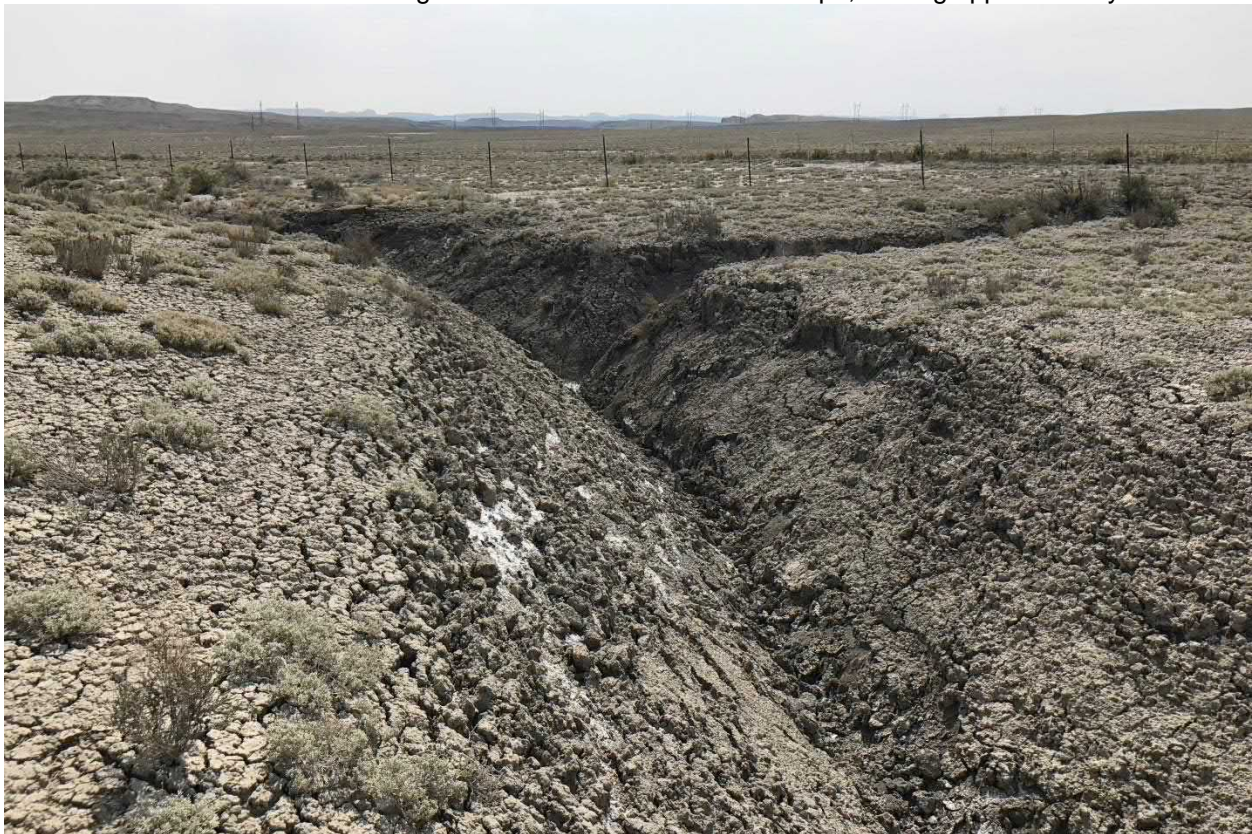
**Photograph No. 11** View of drainage ditch diverting offsite runoff around permitted CCR Landfill, looking south-southeast.

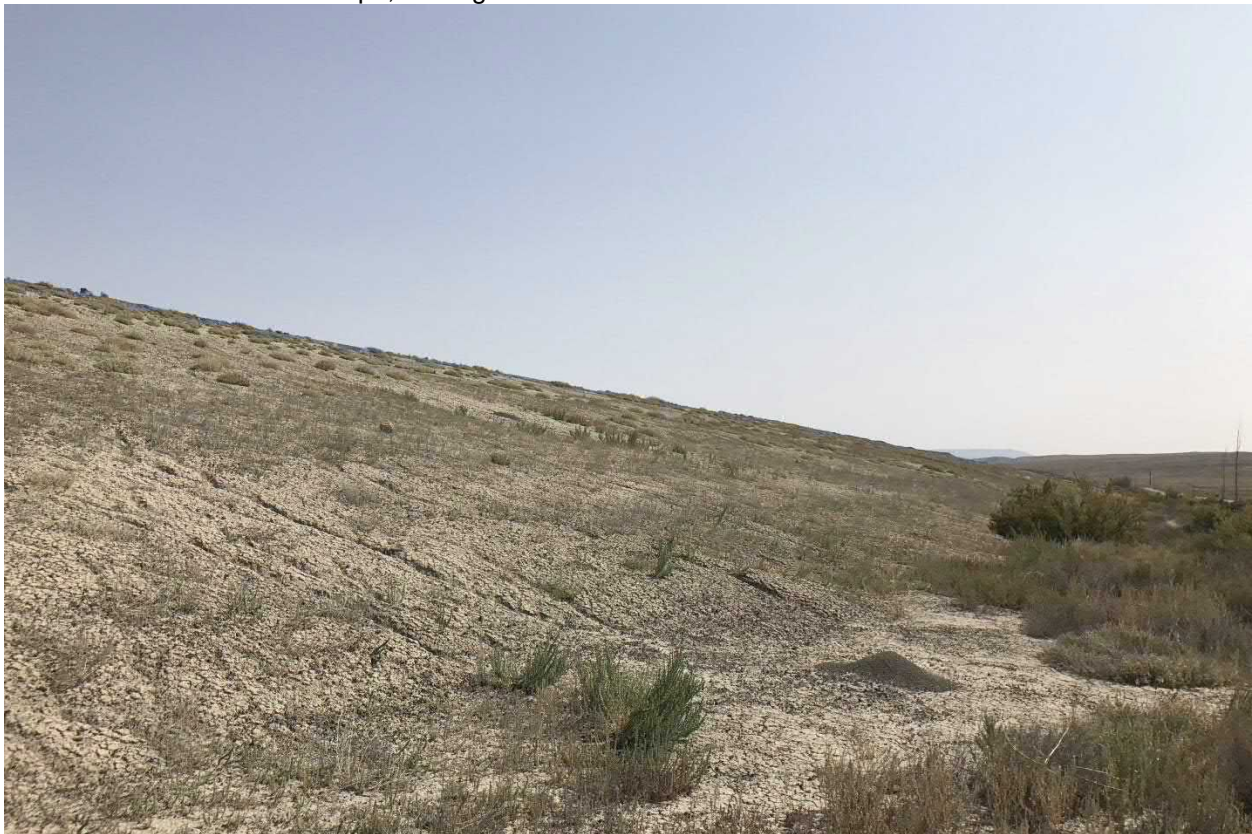
**Photograph No. 14** View of south ash slope and onsite runoff collection ditch running along the toe of the slope, looking east.

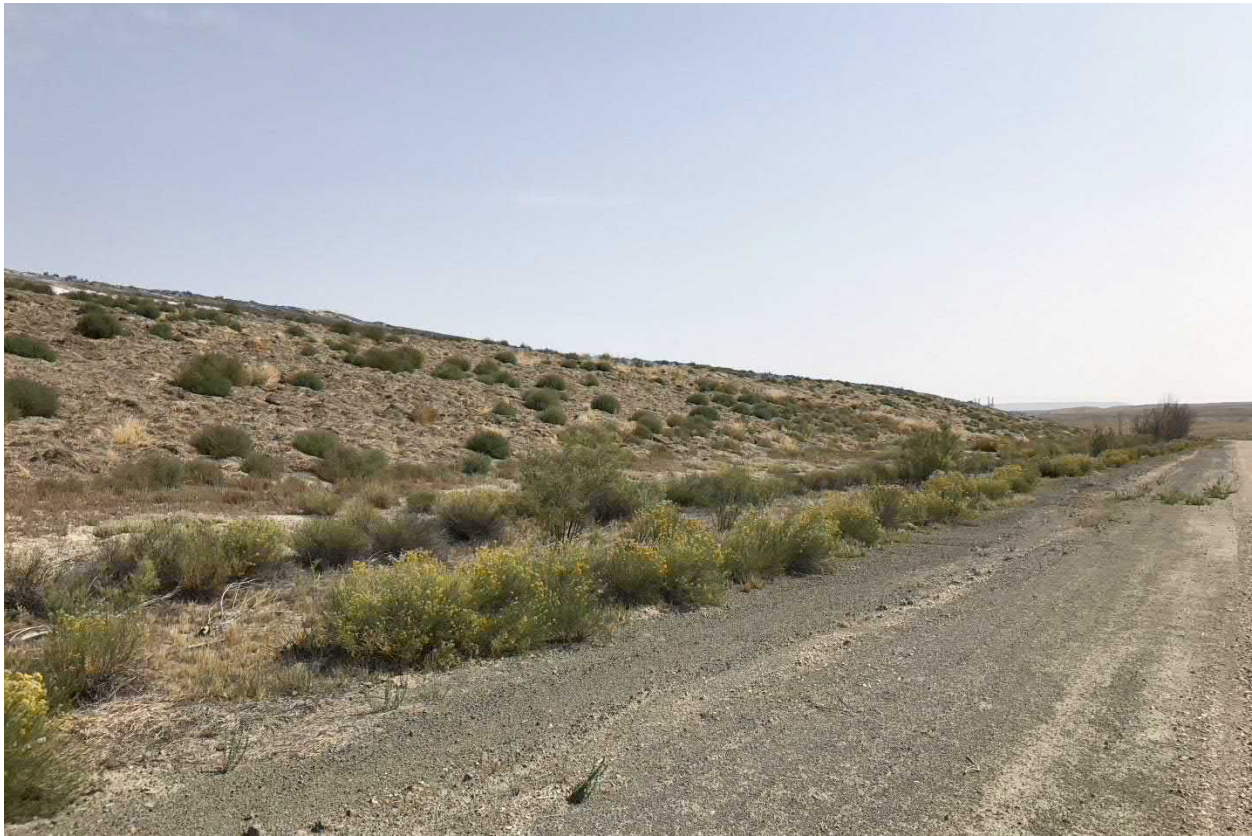
**Photograph No. 17** View of straw-treated south ash slope with some vegetation and more moderate vegetation beneath the toe, looking east-northeast.

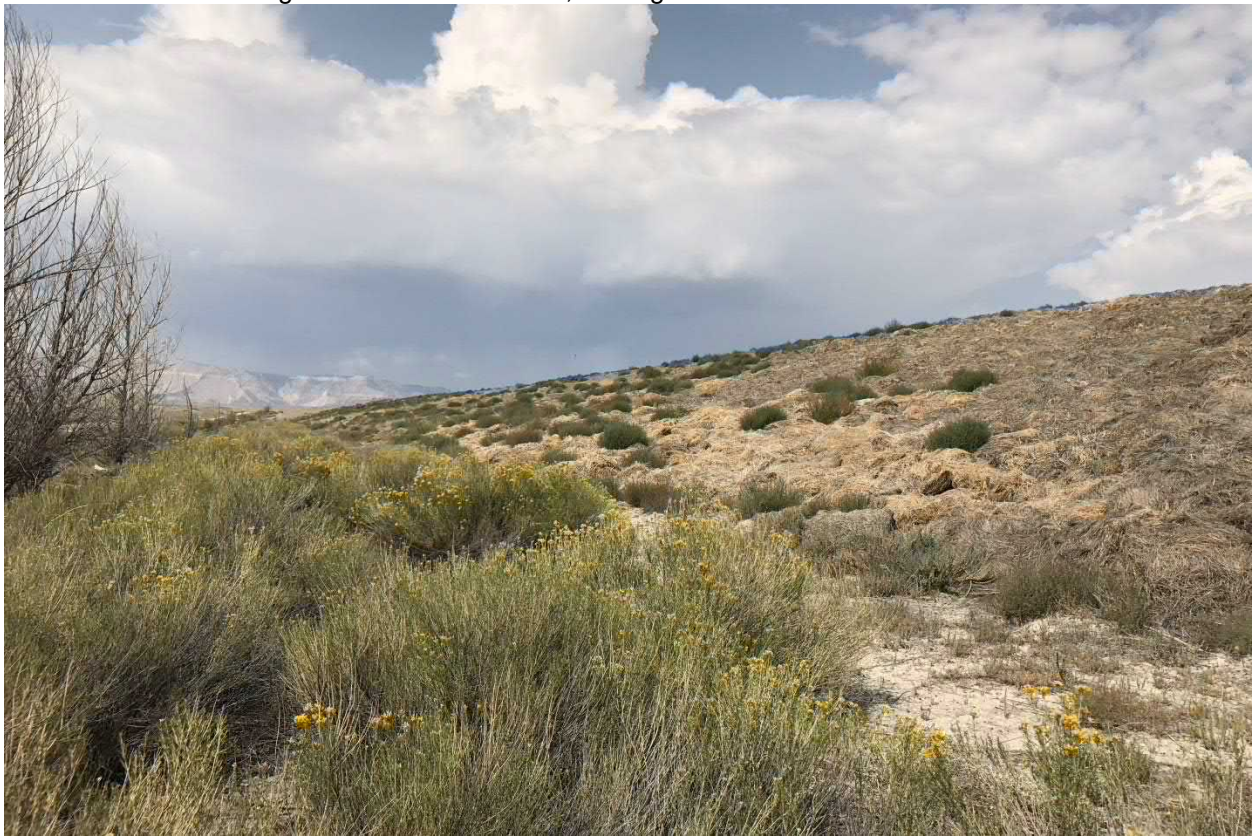
**Photograph No. 18** View of south ash slope, looking west-northwest.

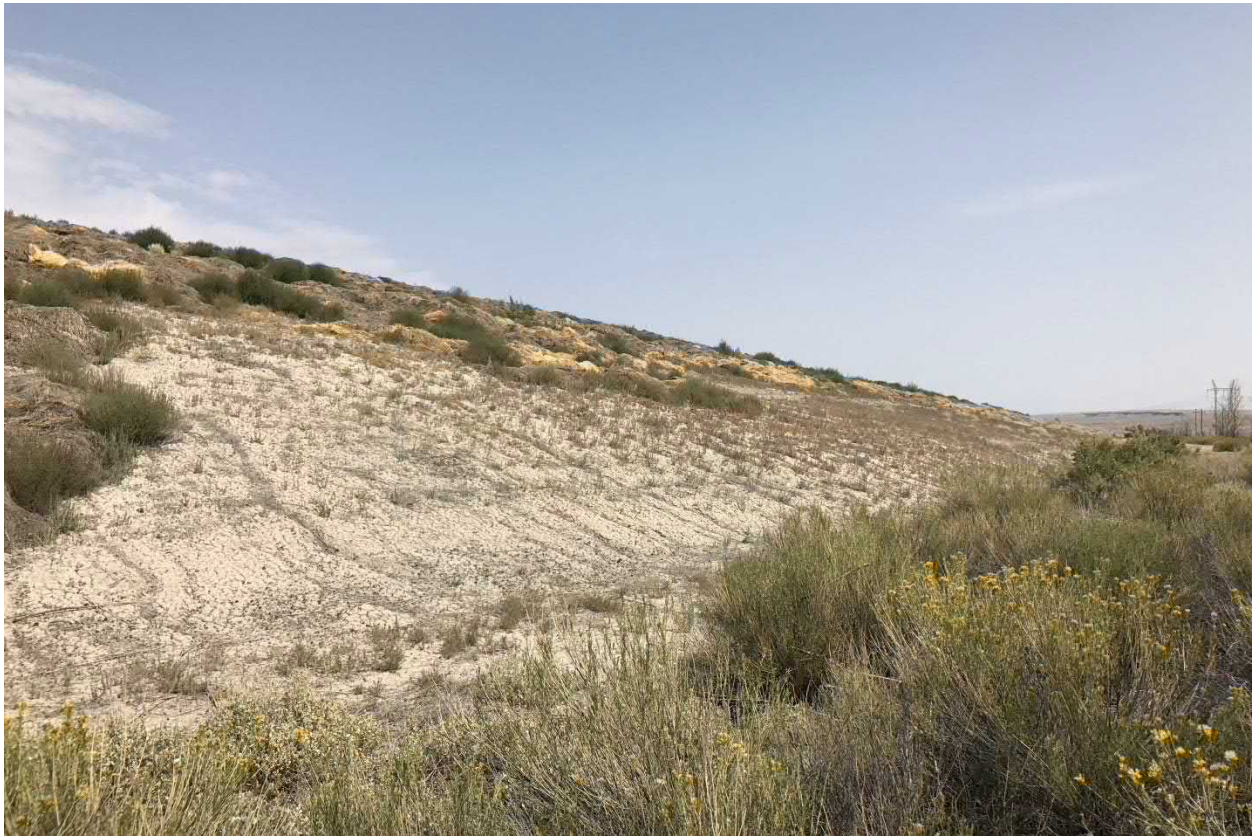
**Photograph No. 20** View of southeast ash slope, looking northeast.

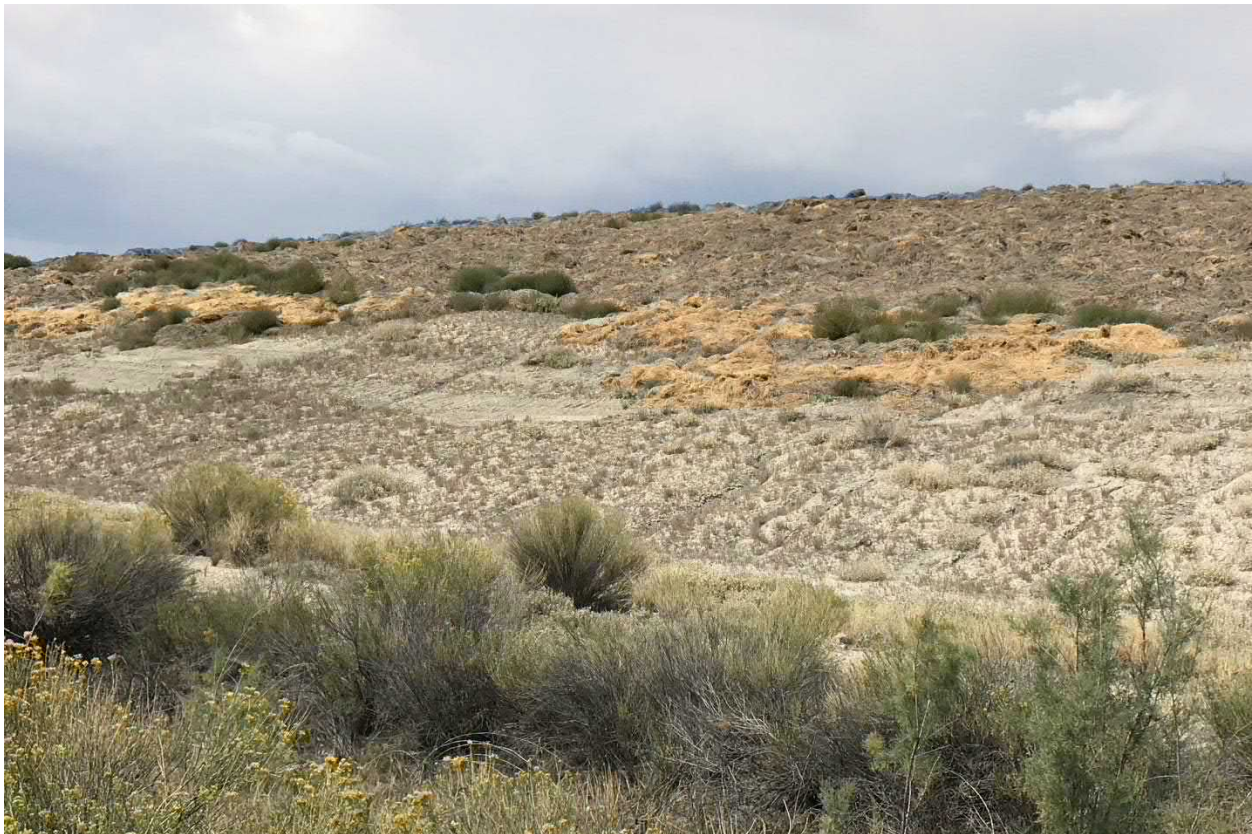
**Photograph No. 21** View of southeast ash slope, looking west. Slope has been treated with straw for erosion protection on the top portion of the slope.

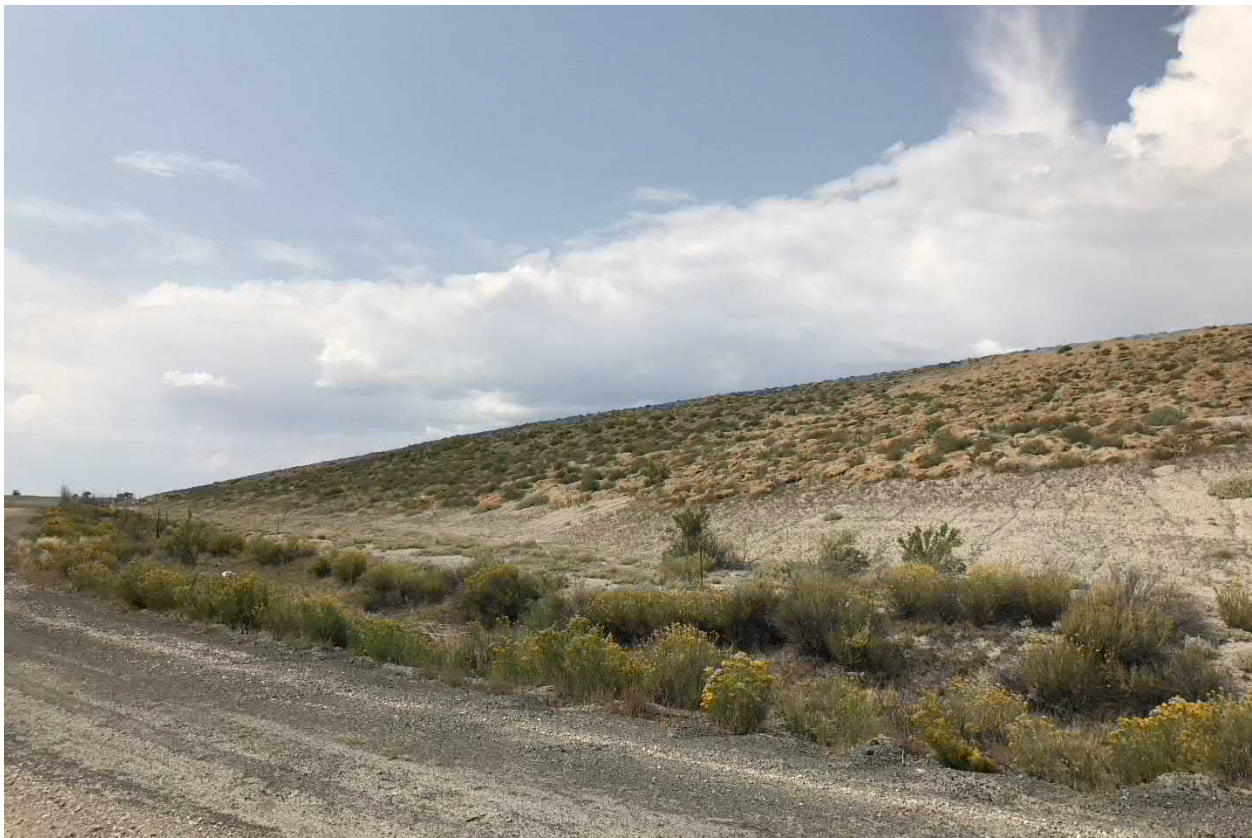
**Photograph No. 22** View of southeast ash slope of landfill, looking southwest.

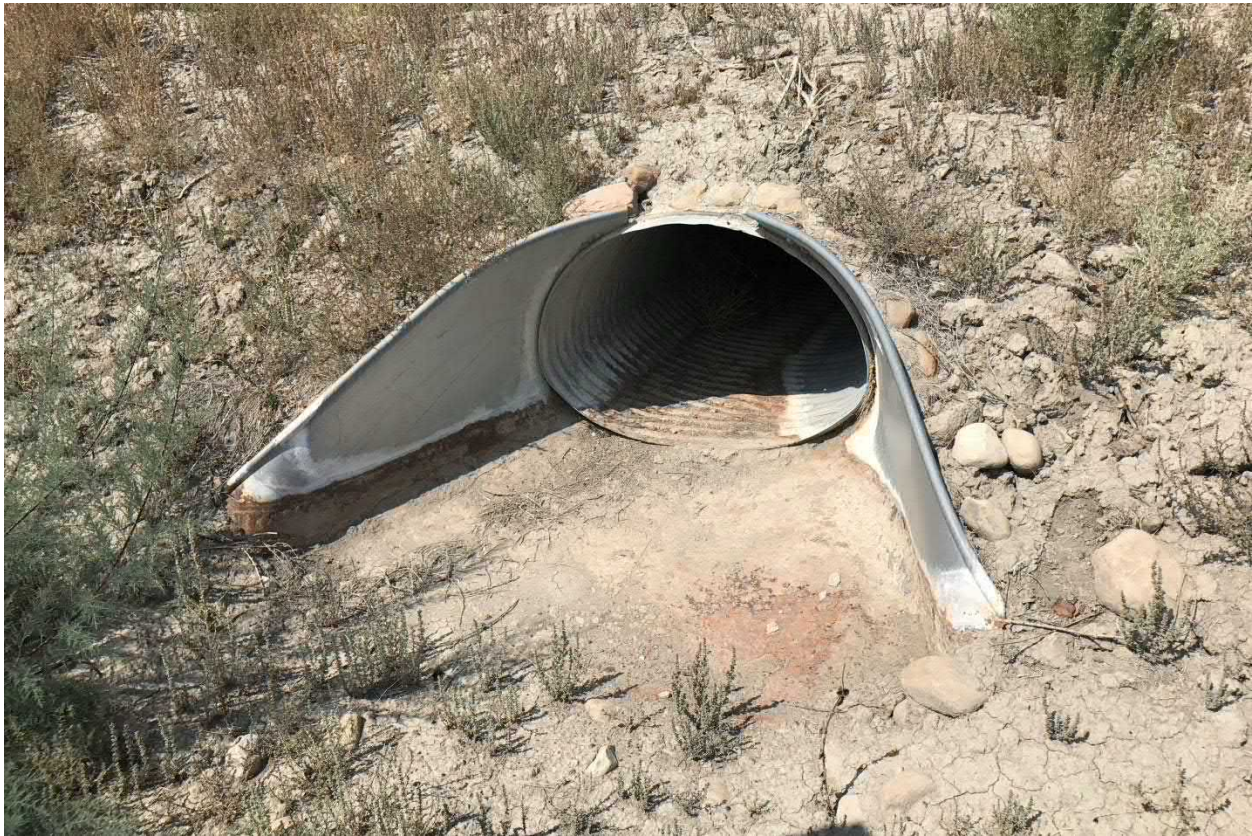
**Photograph No. 24** View of south retention basin inlet pipe (upstream end). Pipe culvert was unobstructed and free of debris, looking northwest.

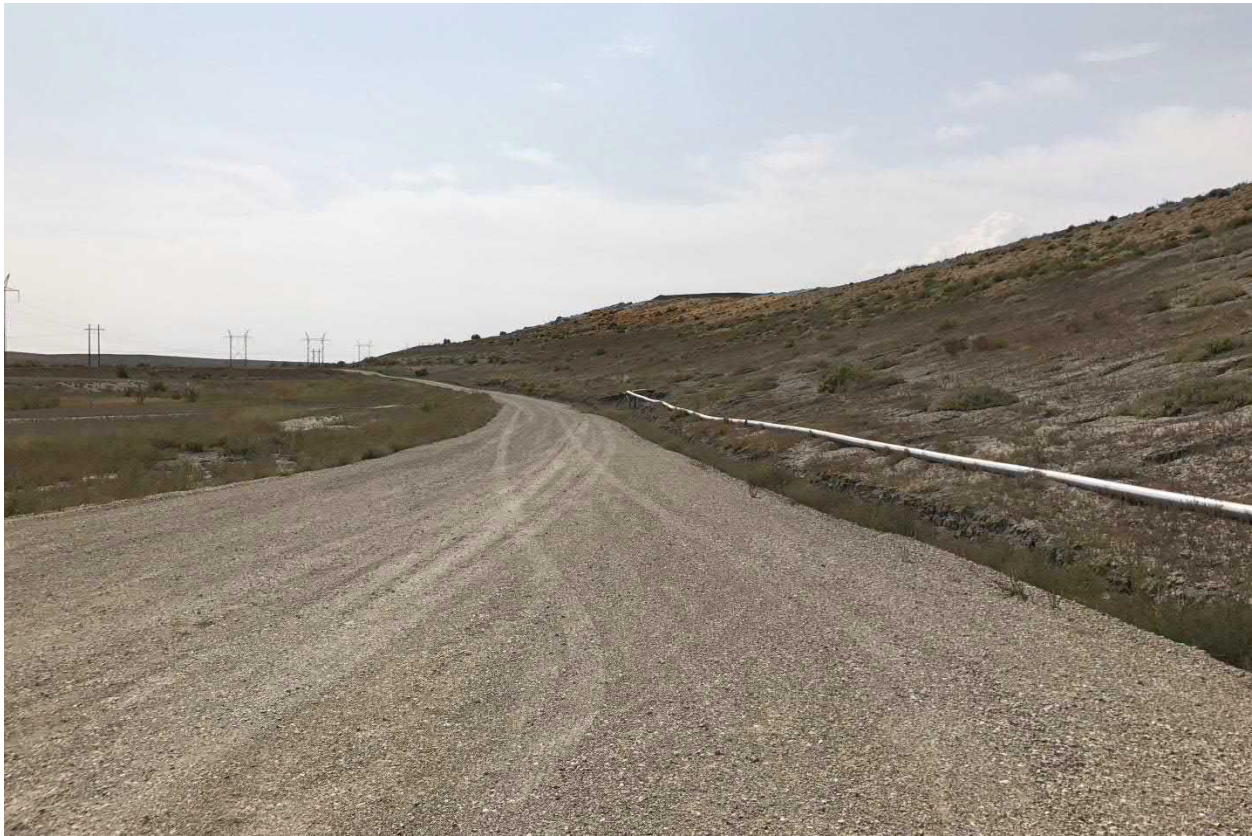
**Photograph No. 26** View of drain line from underdrains to Frac tank (see Photograph No. 27), looking south-southwest.

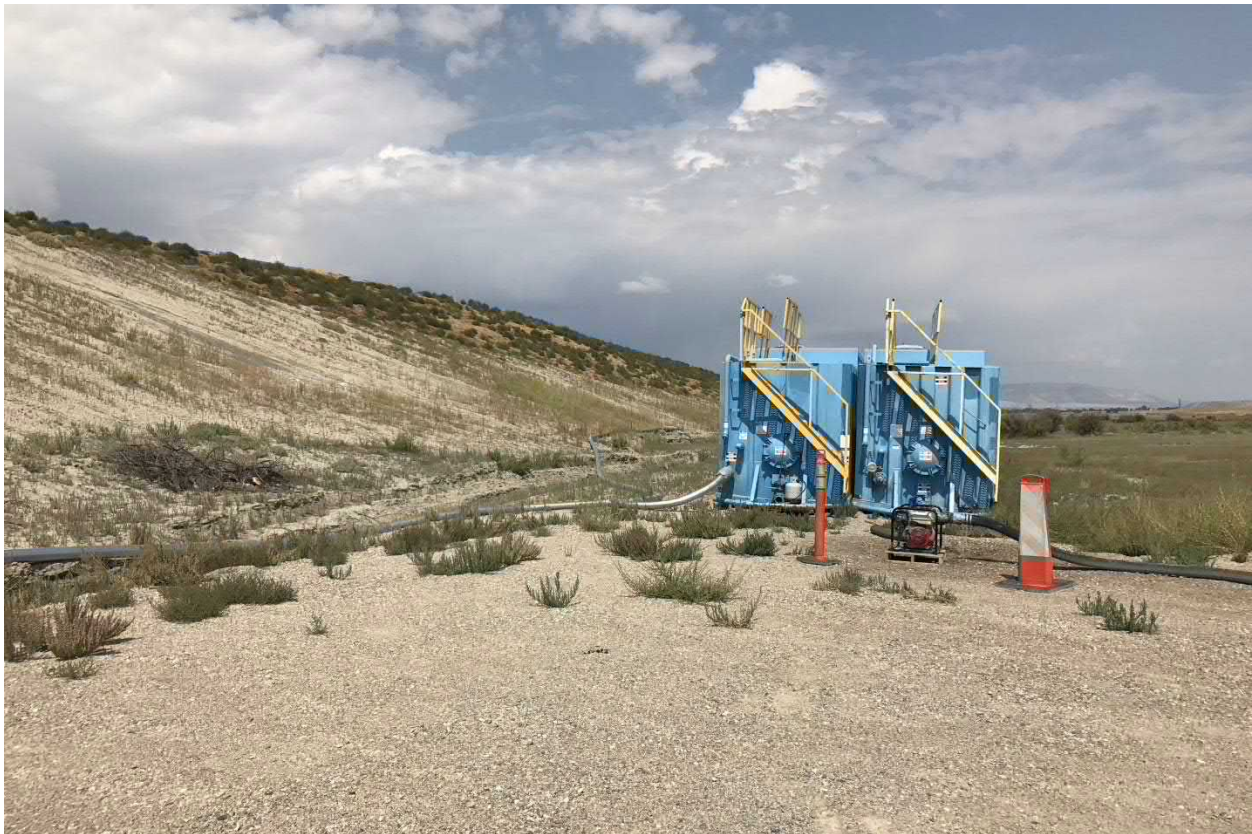
**Photograph No. 27** View of Frac tank used for underdrain water storage, looking north-northwest.

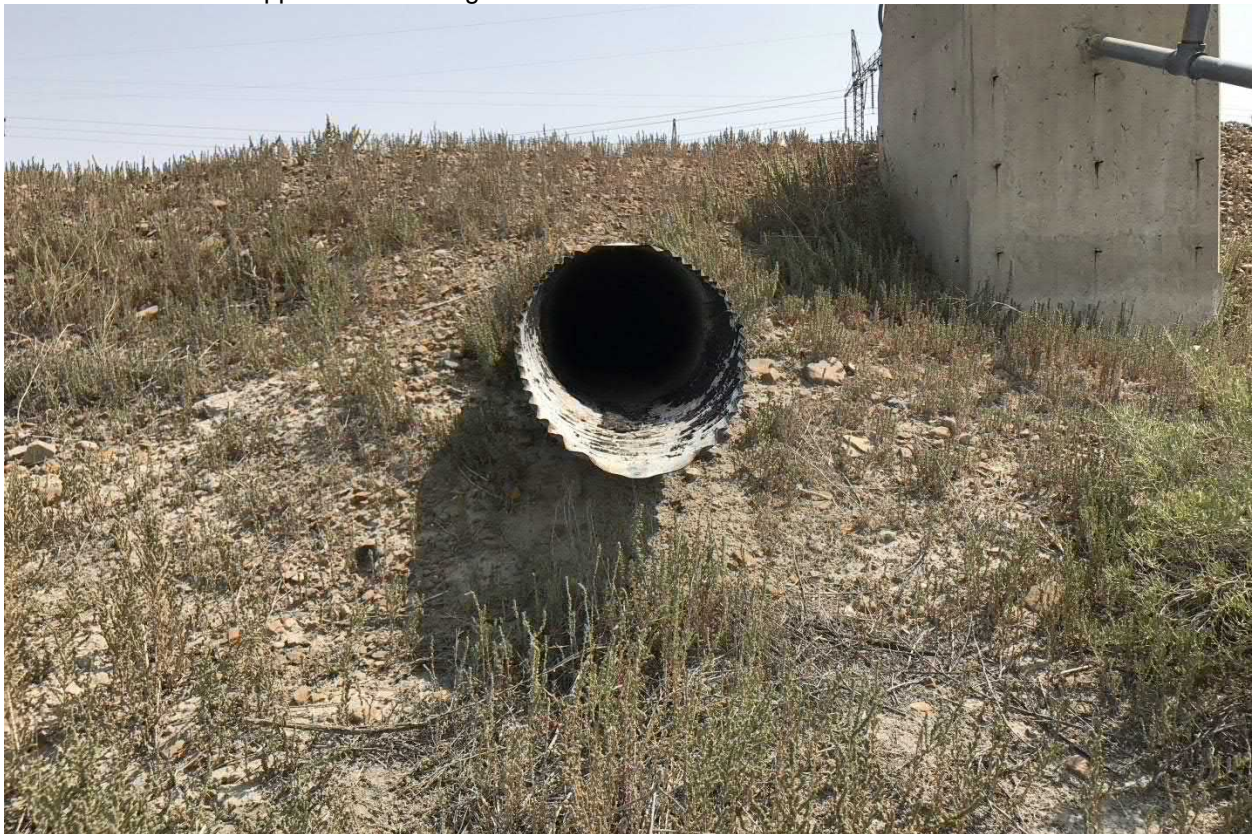
**Photograph No. 31** View of auxiliary spillway (upstream end) adjacent to the slide gate control structure, looking approximately east. The pipe is unobstructed at this end.

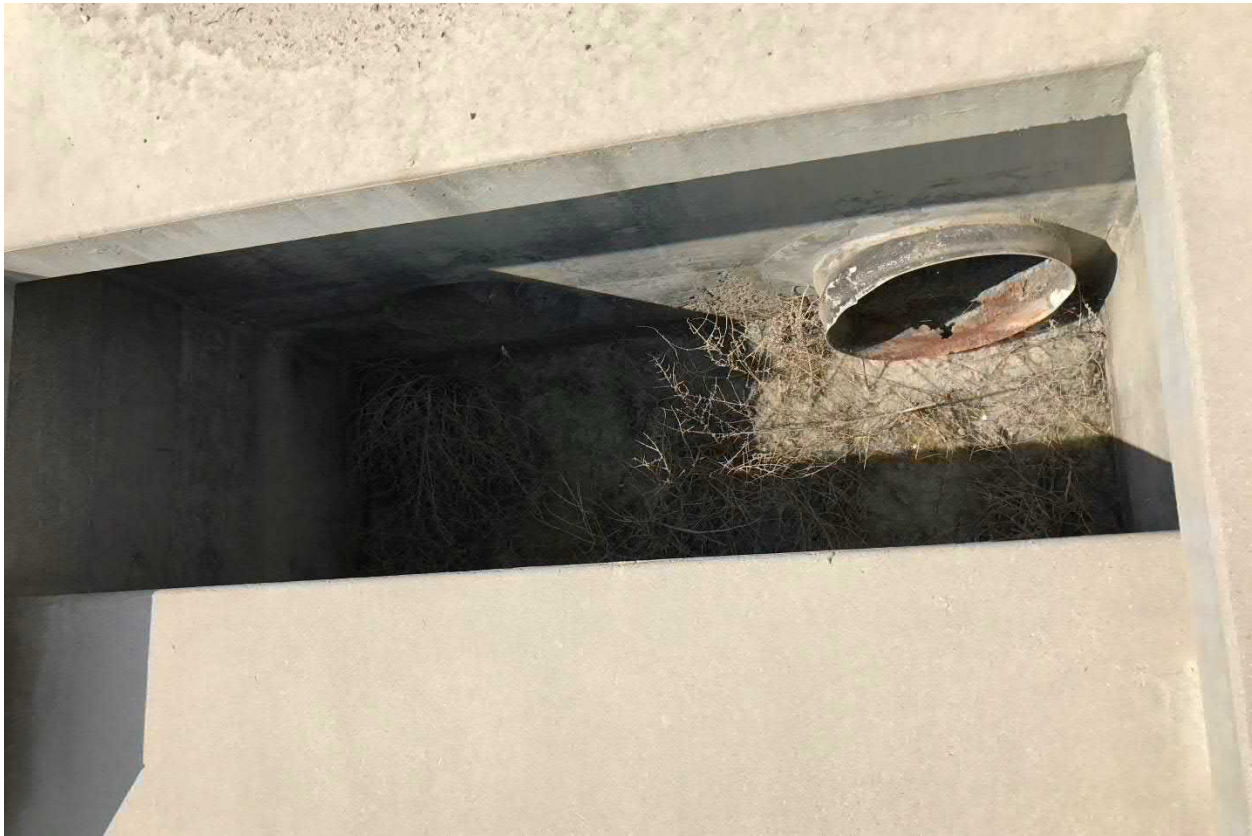
**Photograph No. 32** View of auxiliary and primary spillway (downstream end), looking down into energy dissipation structure. Inspection team did not inspect downstream end of pipes.

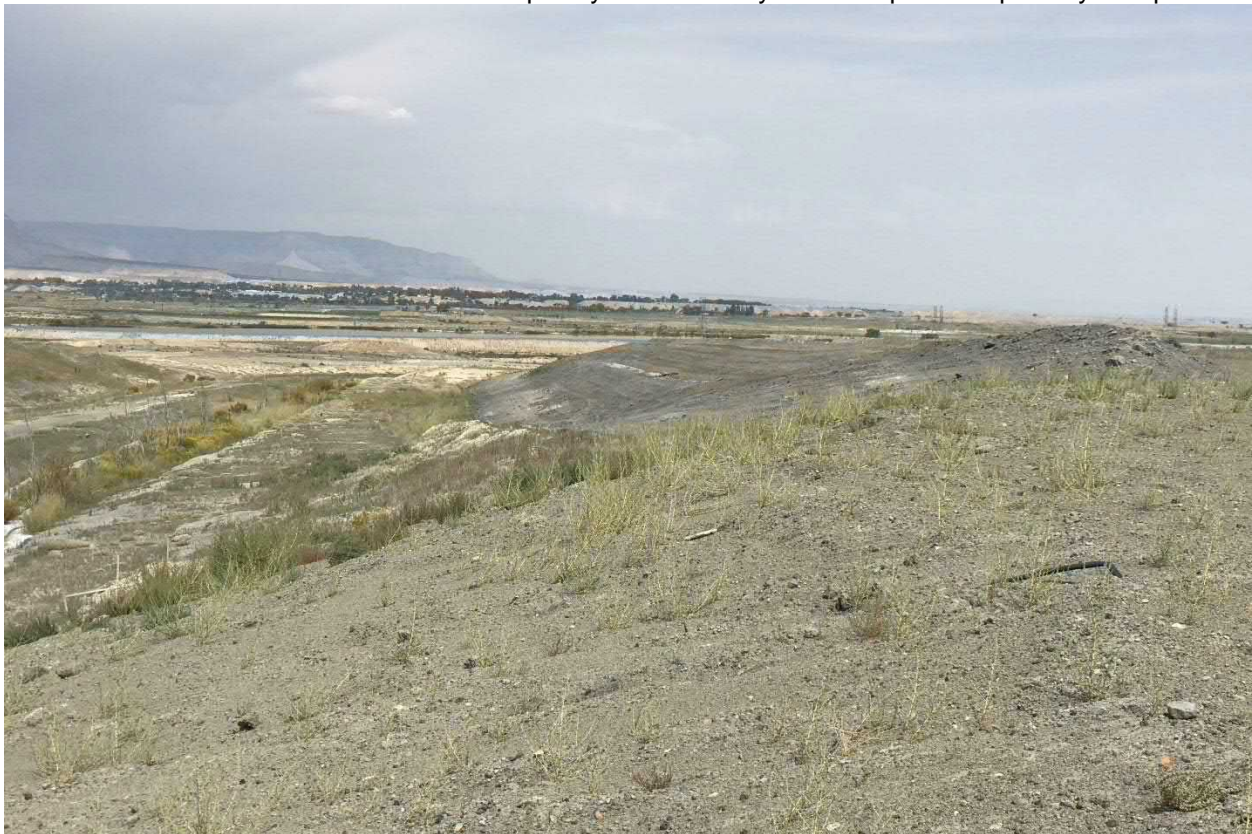
**Photograph No. 36** View of west ash slope north of south access/haul road, looking approximately north. Onsite runoff collection ditch is visible beneath the toe of the slope.

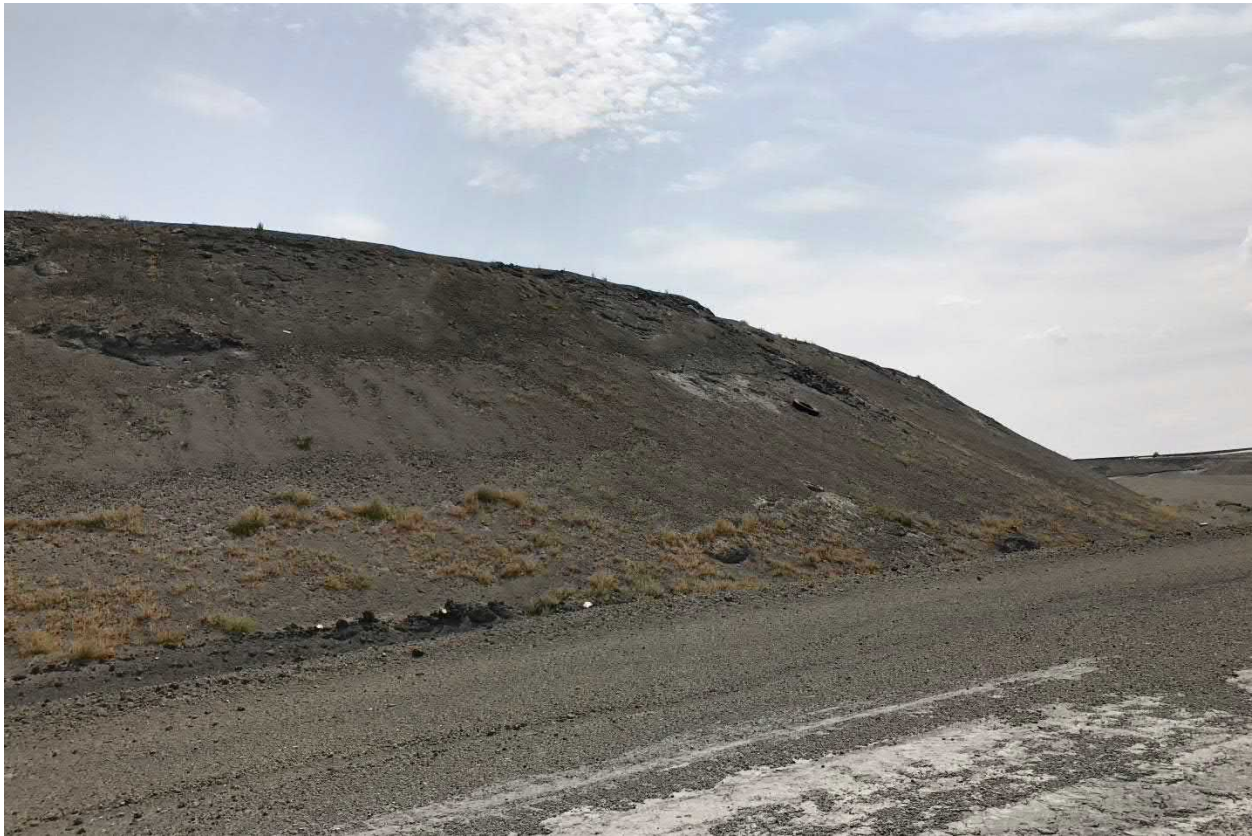
**Photograph No. 37** View of northwest temporary ash slopes, looking south-southwest.

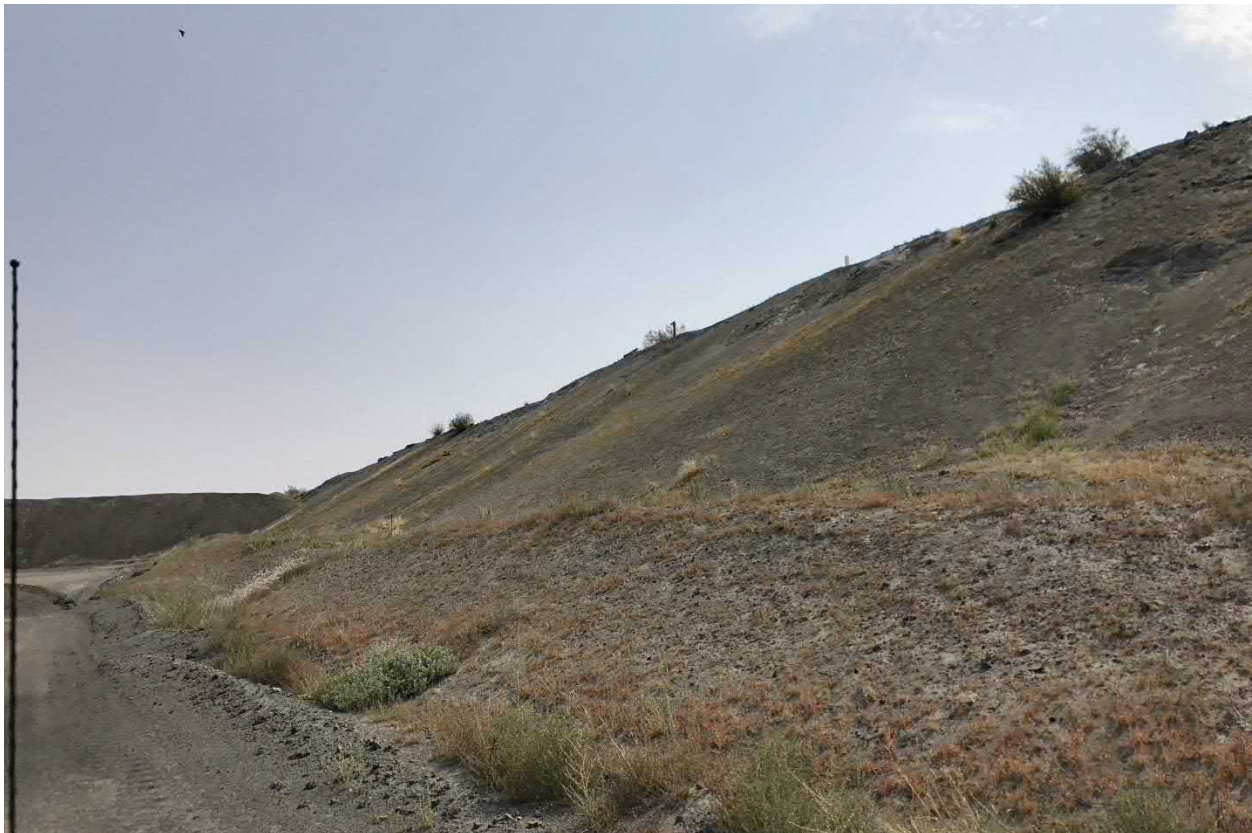
**Photograph No. 38** View of northwest temporary ash slopes, looking approximately east.

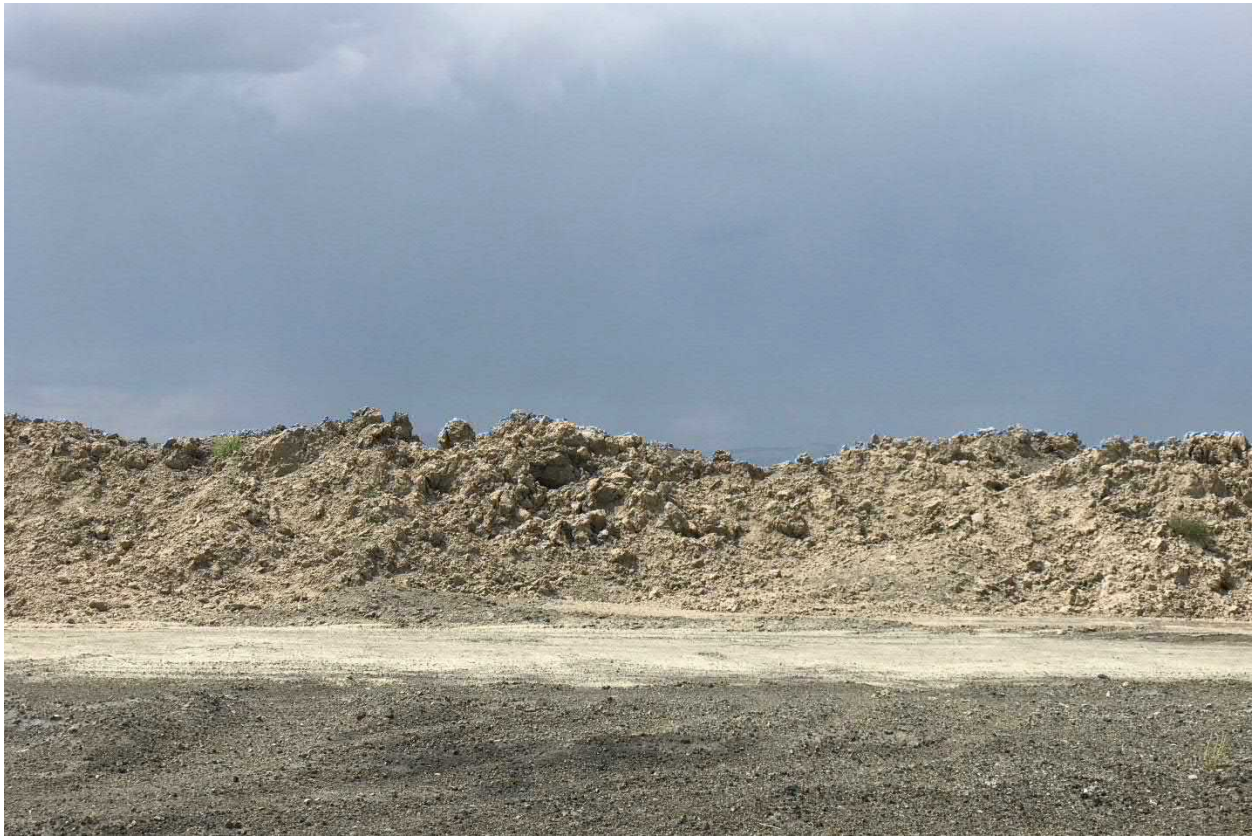
**Photograph No. 39** View of native soils stockpiled at top of landfill, looking approximately west. Soil was visible in several locations along the east edge on top of the landfill.

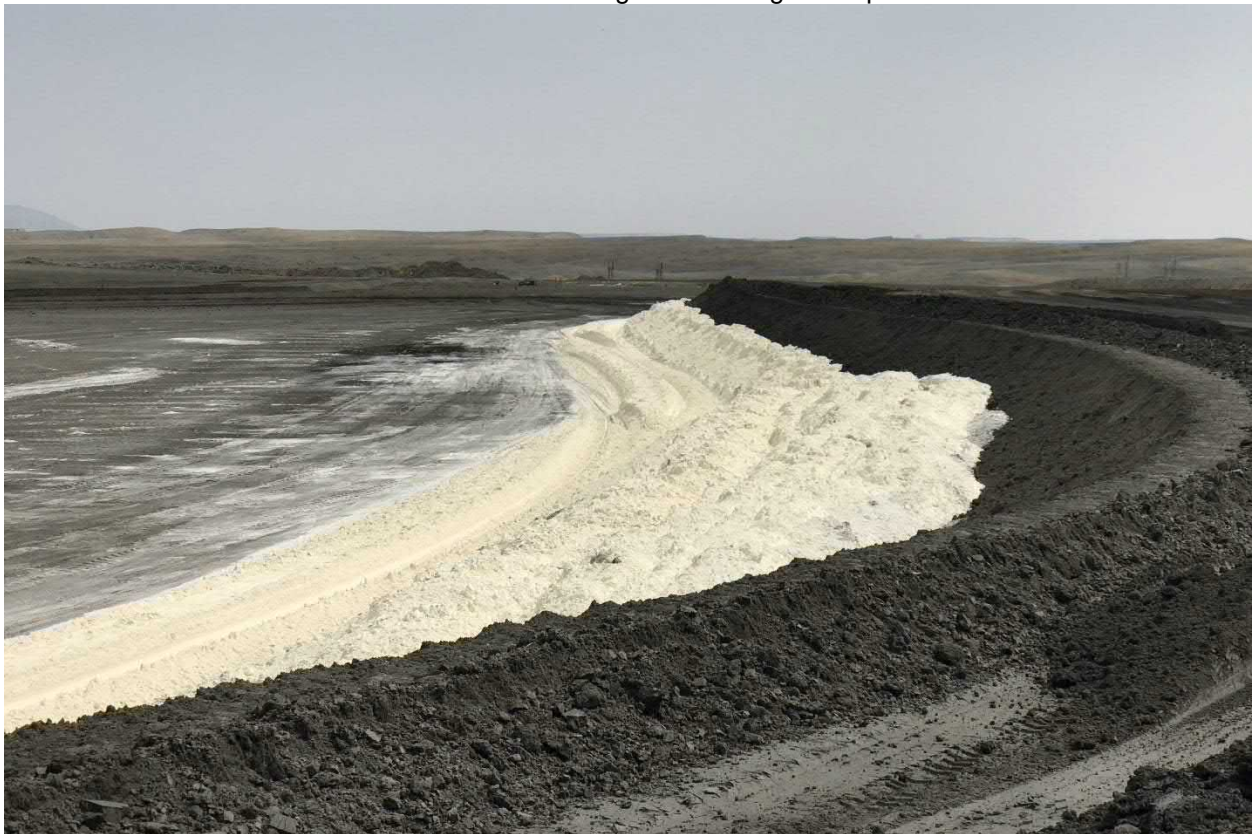
**Photograph No. 40** View of FGD gypsum disposed of in the active area of the CCR Landfill, looking approximately southeast.
