# 2018 Coal Combustion Residuals Annual Inspection

## Hunter Power Plant

### *Hunter CCR Landfill*

FINAL December 11, 2018

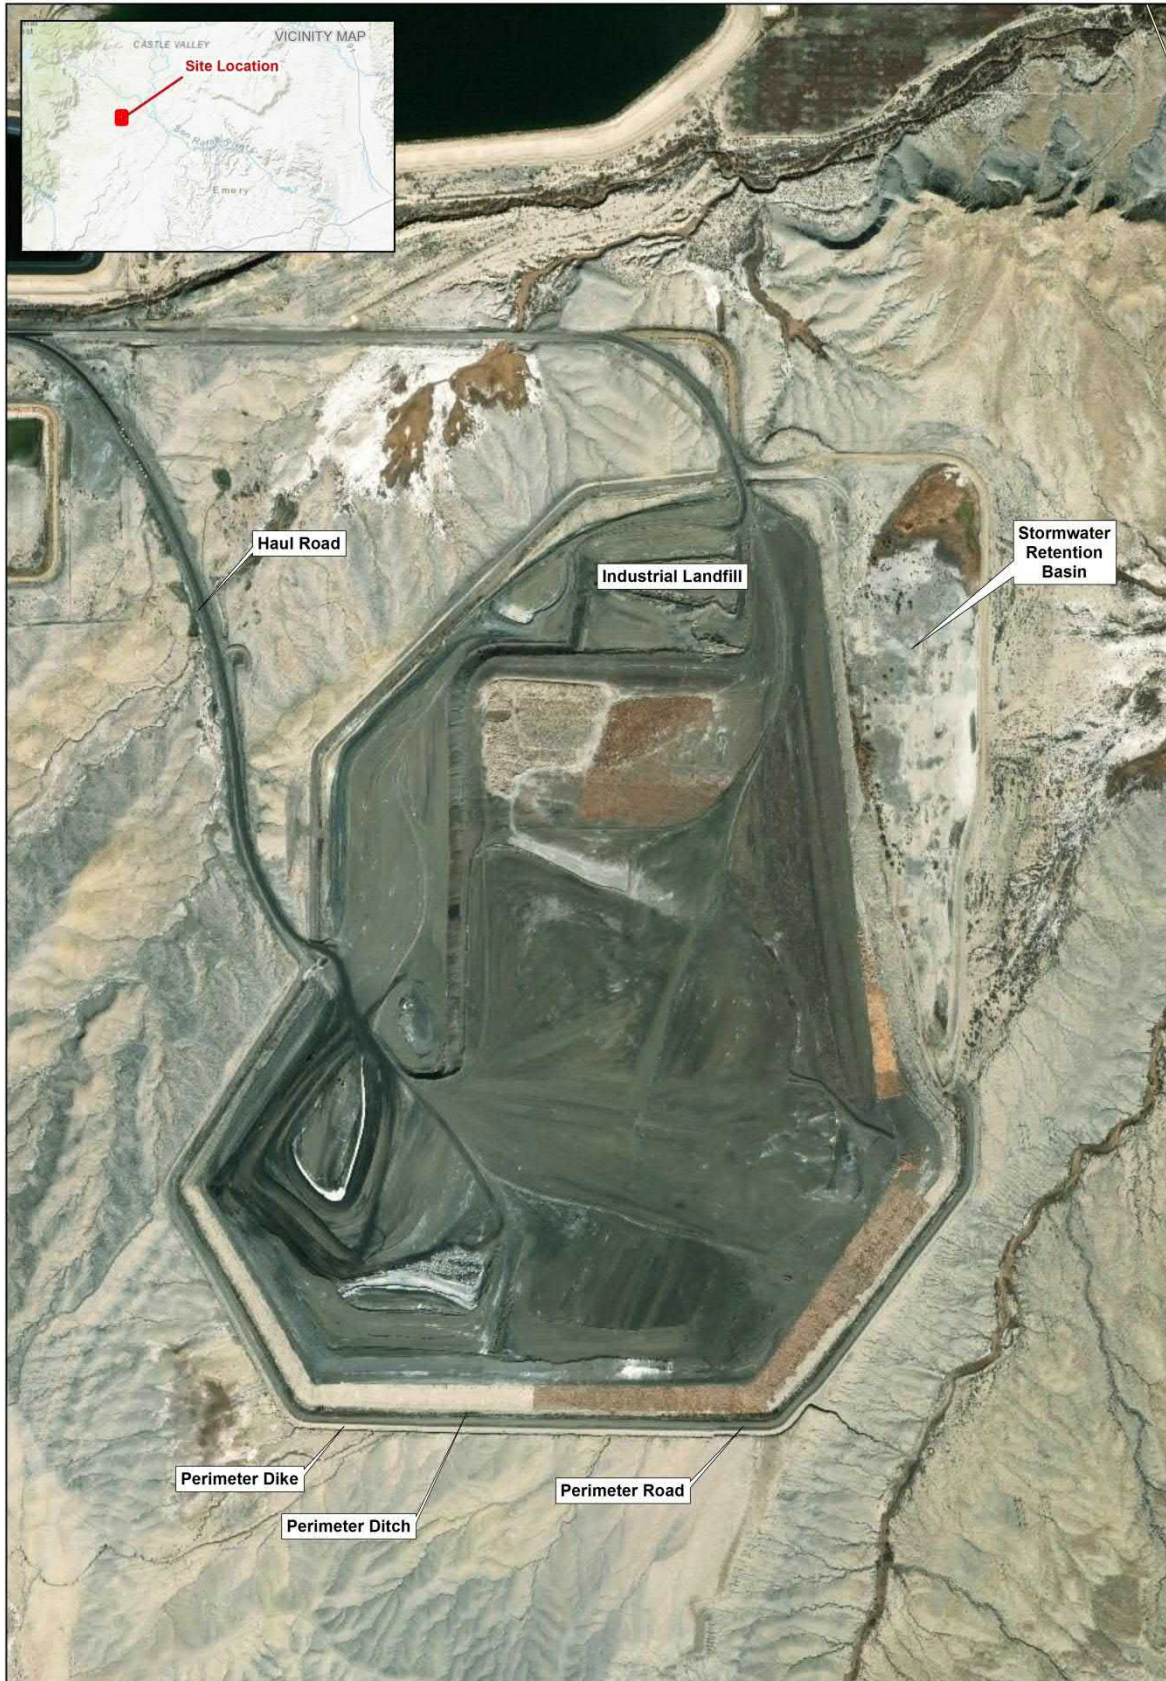
Figure 1-1. Hunter Power Plant CCR Landfill (ESRI and Digital Globe; November 2016)

AECOM observed no signs, such as slumps, tension cracks or other movements that would indicate imminent failure of the embankment for the Hunter Power Plant CCR Landfill. Figure 1-1 on the following page is an aerial photograph of the landfill.

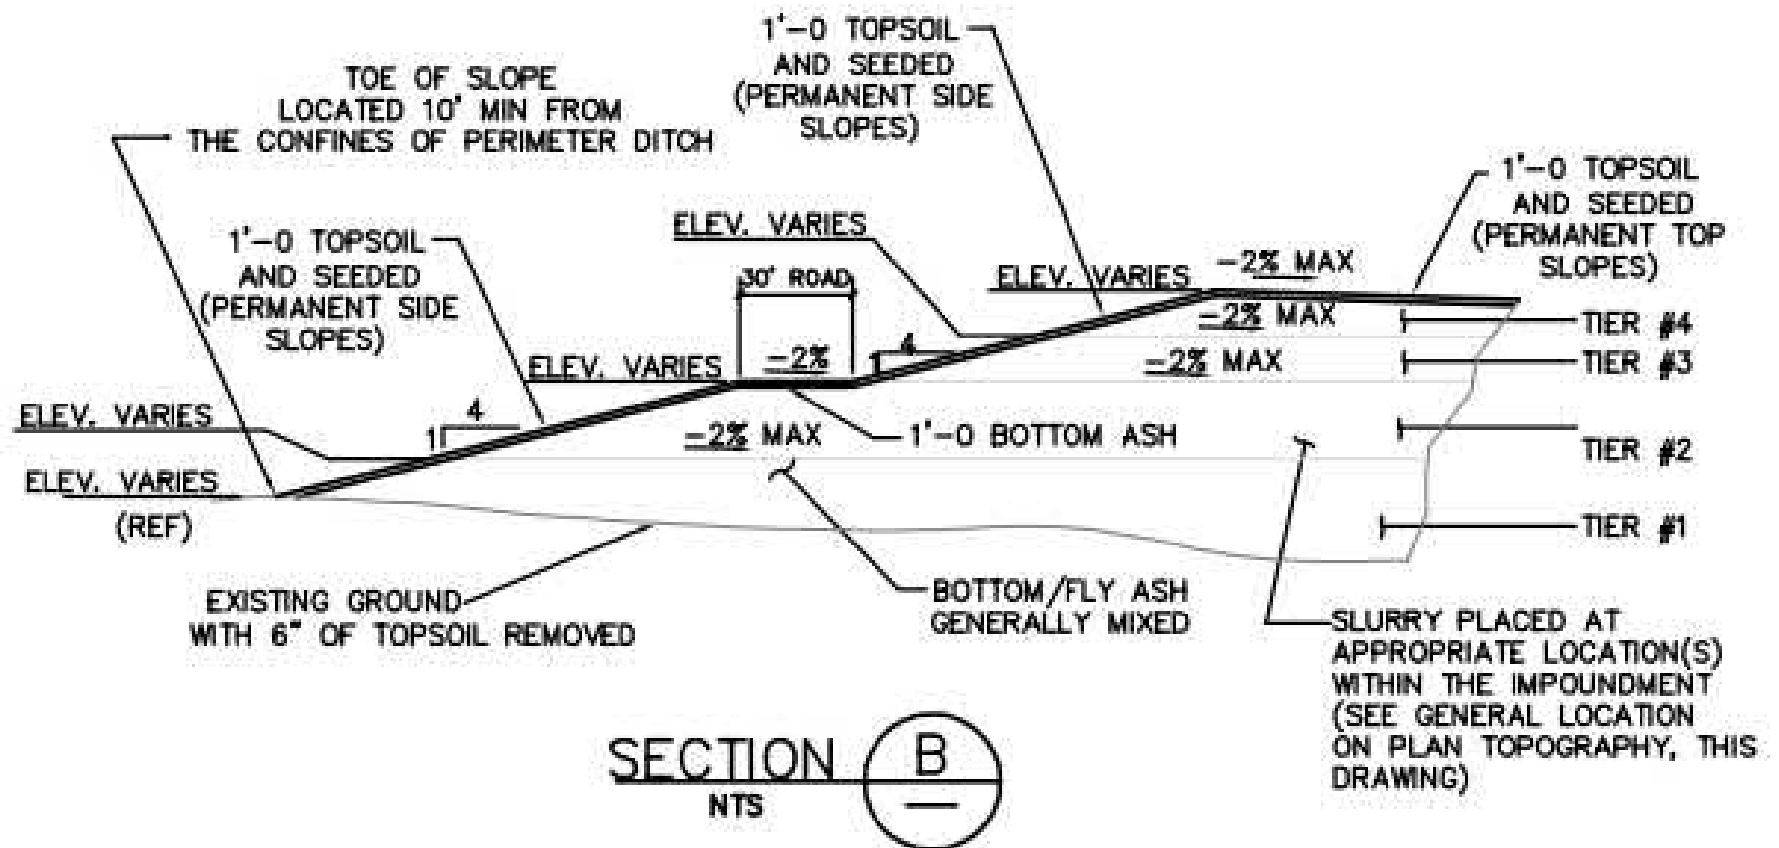
Figure 3-1. Section of South Face of Hunter Landfill [5]

Figure 3-1 shows a cross section of the embankment slope on the south face of the landfill. This section is found in the Industrial Landfill Renewal Application, June 27, 2006, Plan Sheet 3 [5] and is typical of the other landfill faces. The slopes are a maximum of 4 horizontal to 1 vertical.

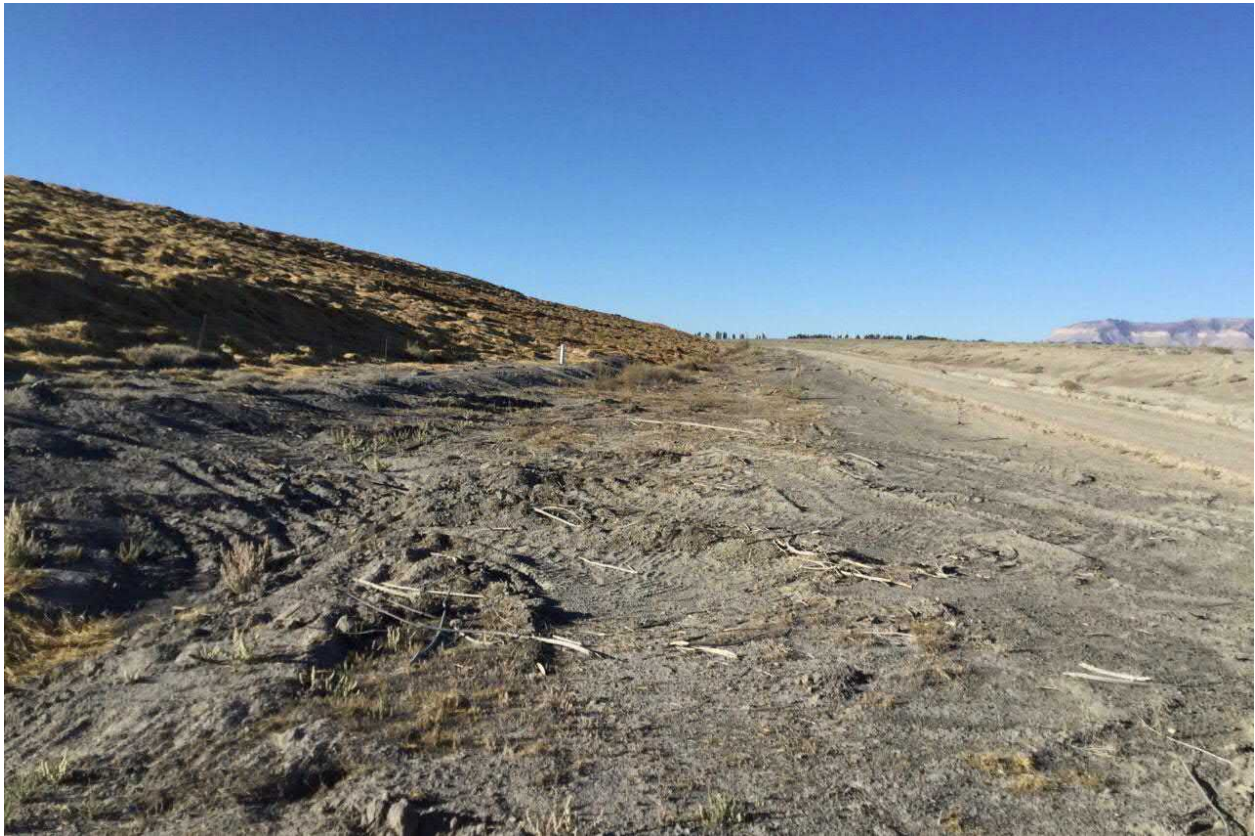
**Photograph No. 2** View of west slope of CCR Landfill south of main haul road entrance into landfill, looking south-southwest.

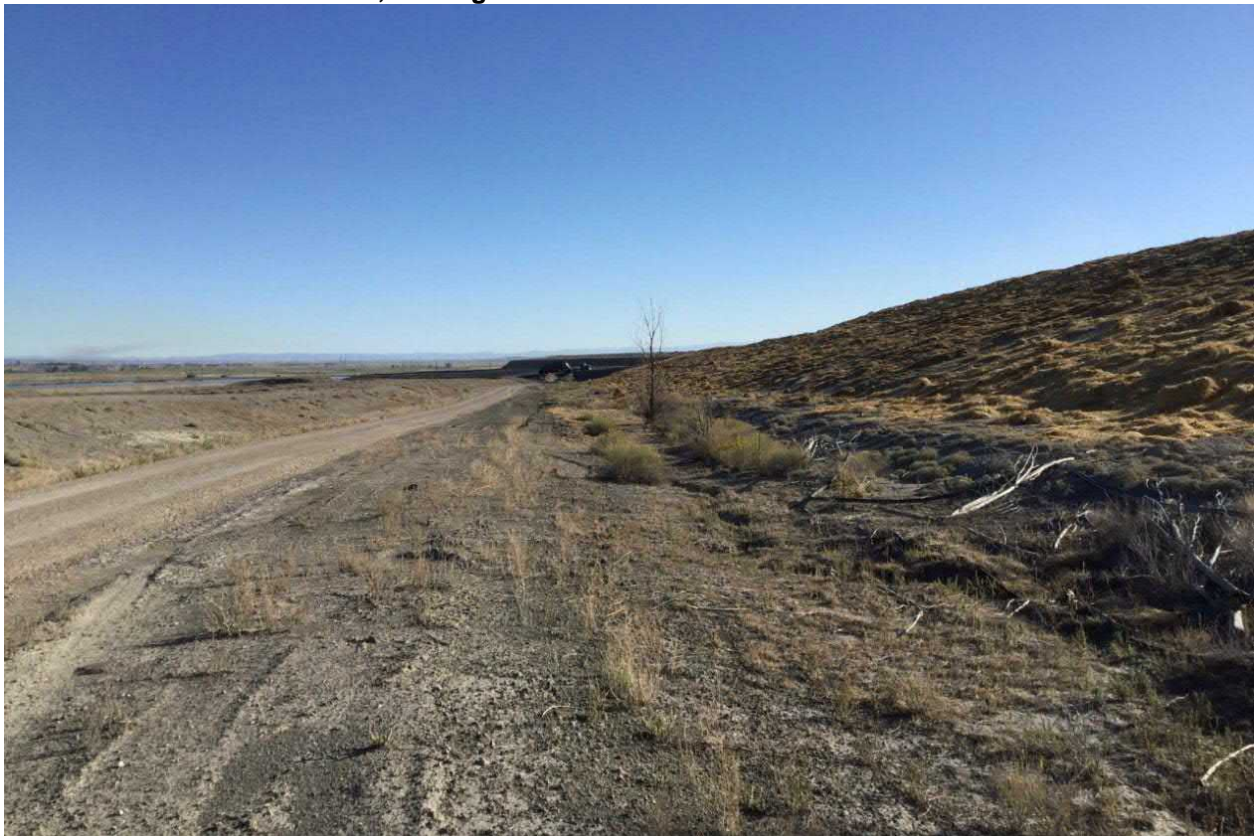
**Photograph No. 3** View of west slope of CCR Landfill and onsite runoff collection ditch running along the toe of the slope, looking north-northeast.

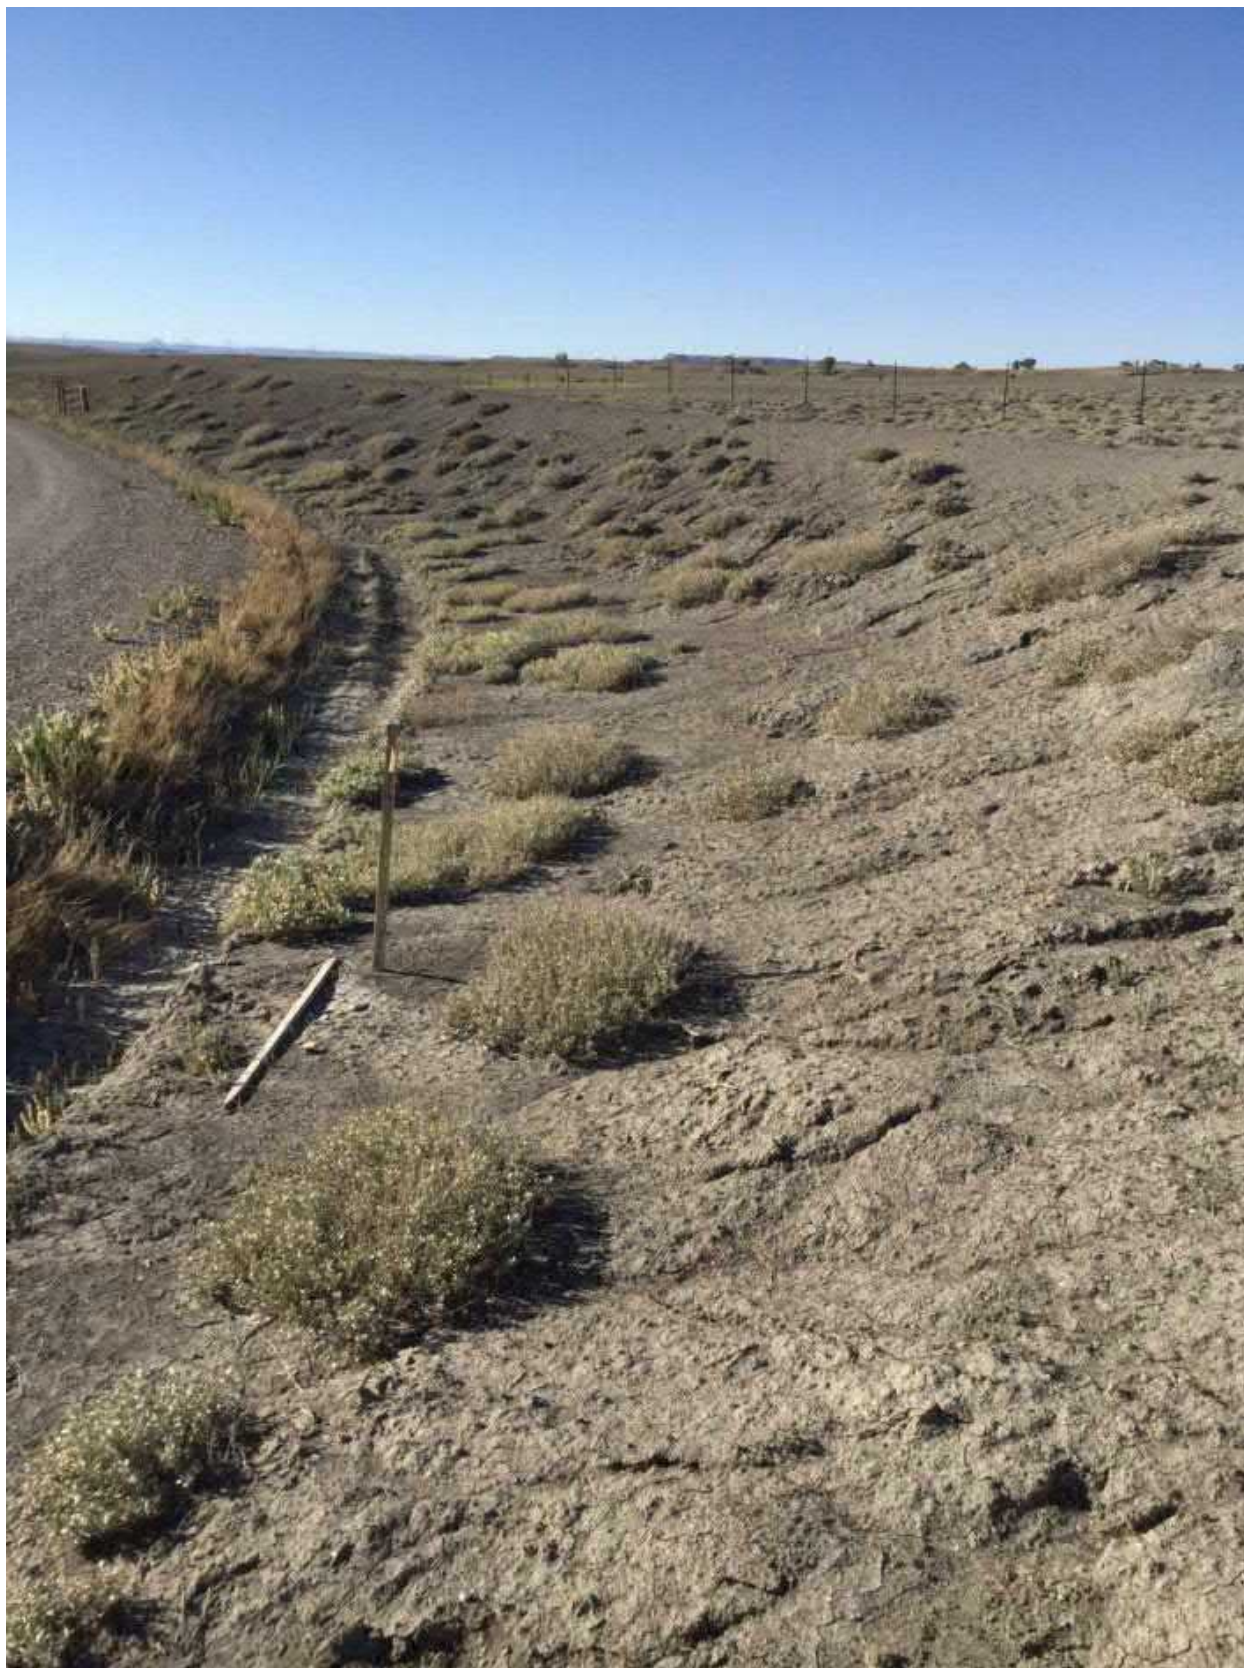
Photograph No. 4 View of interior slope of perimeter berm, looking south.

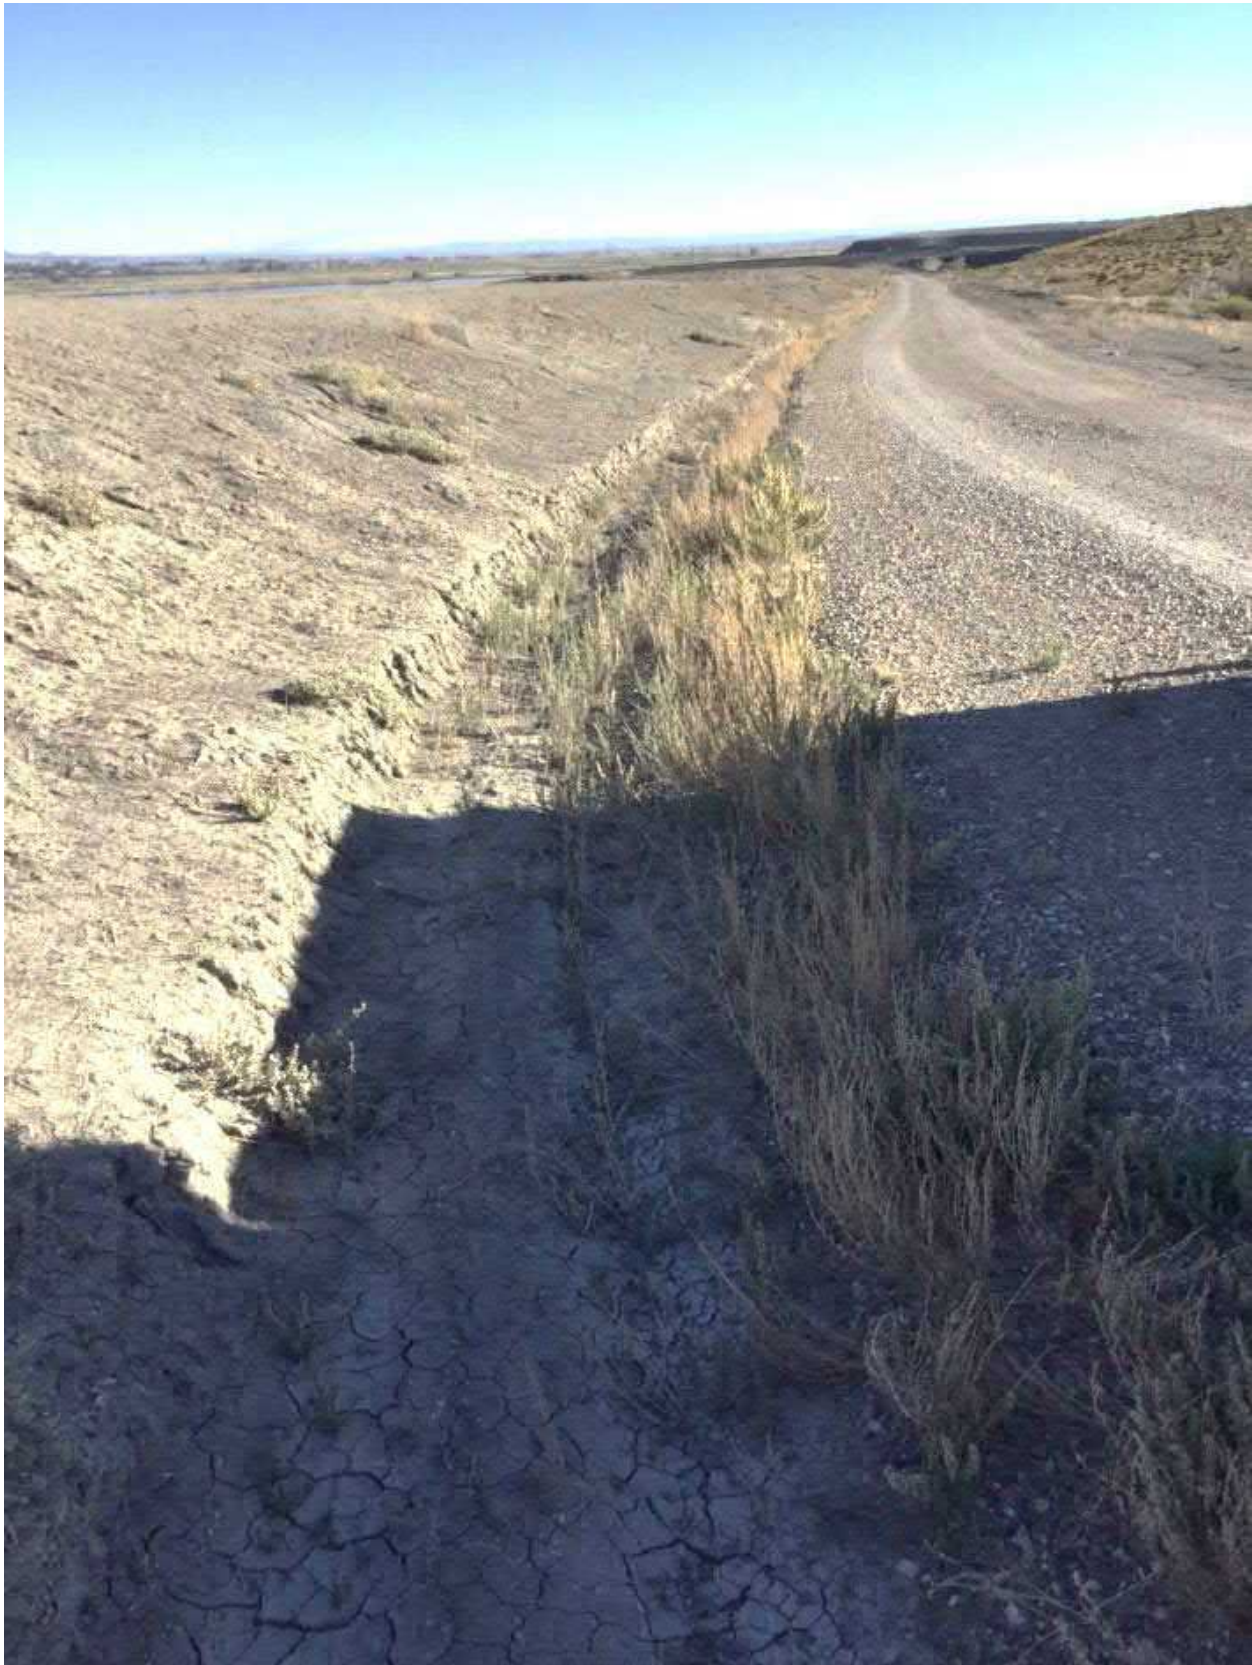
**Photograph No. 5**      **View of interior slope of perimeter berm, looking north-northeast.**

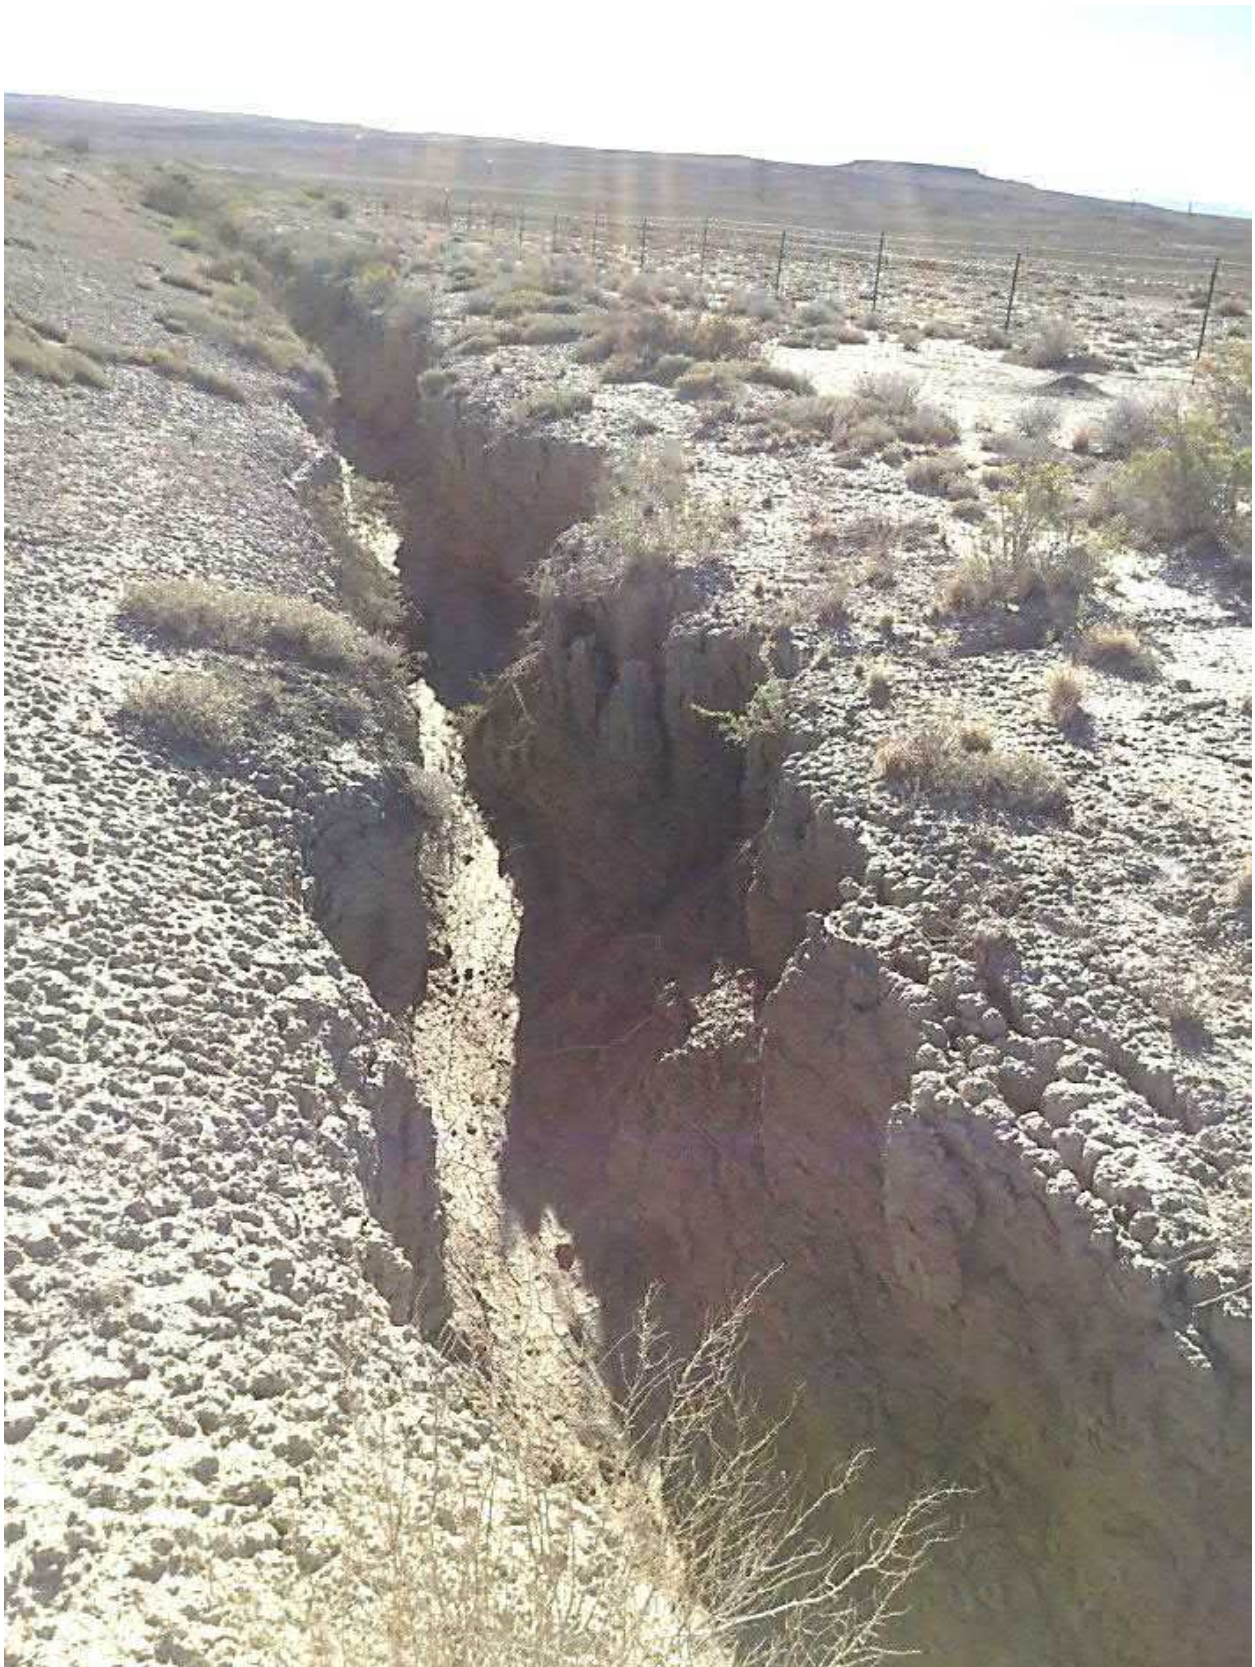
**Photograph No. 7**      **View of offsite diversion channel diverting offsite runoff around permitted CCR Landfill, looking east.**

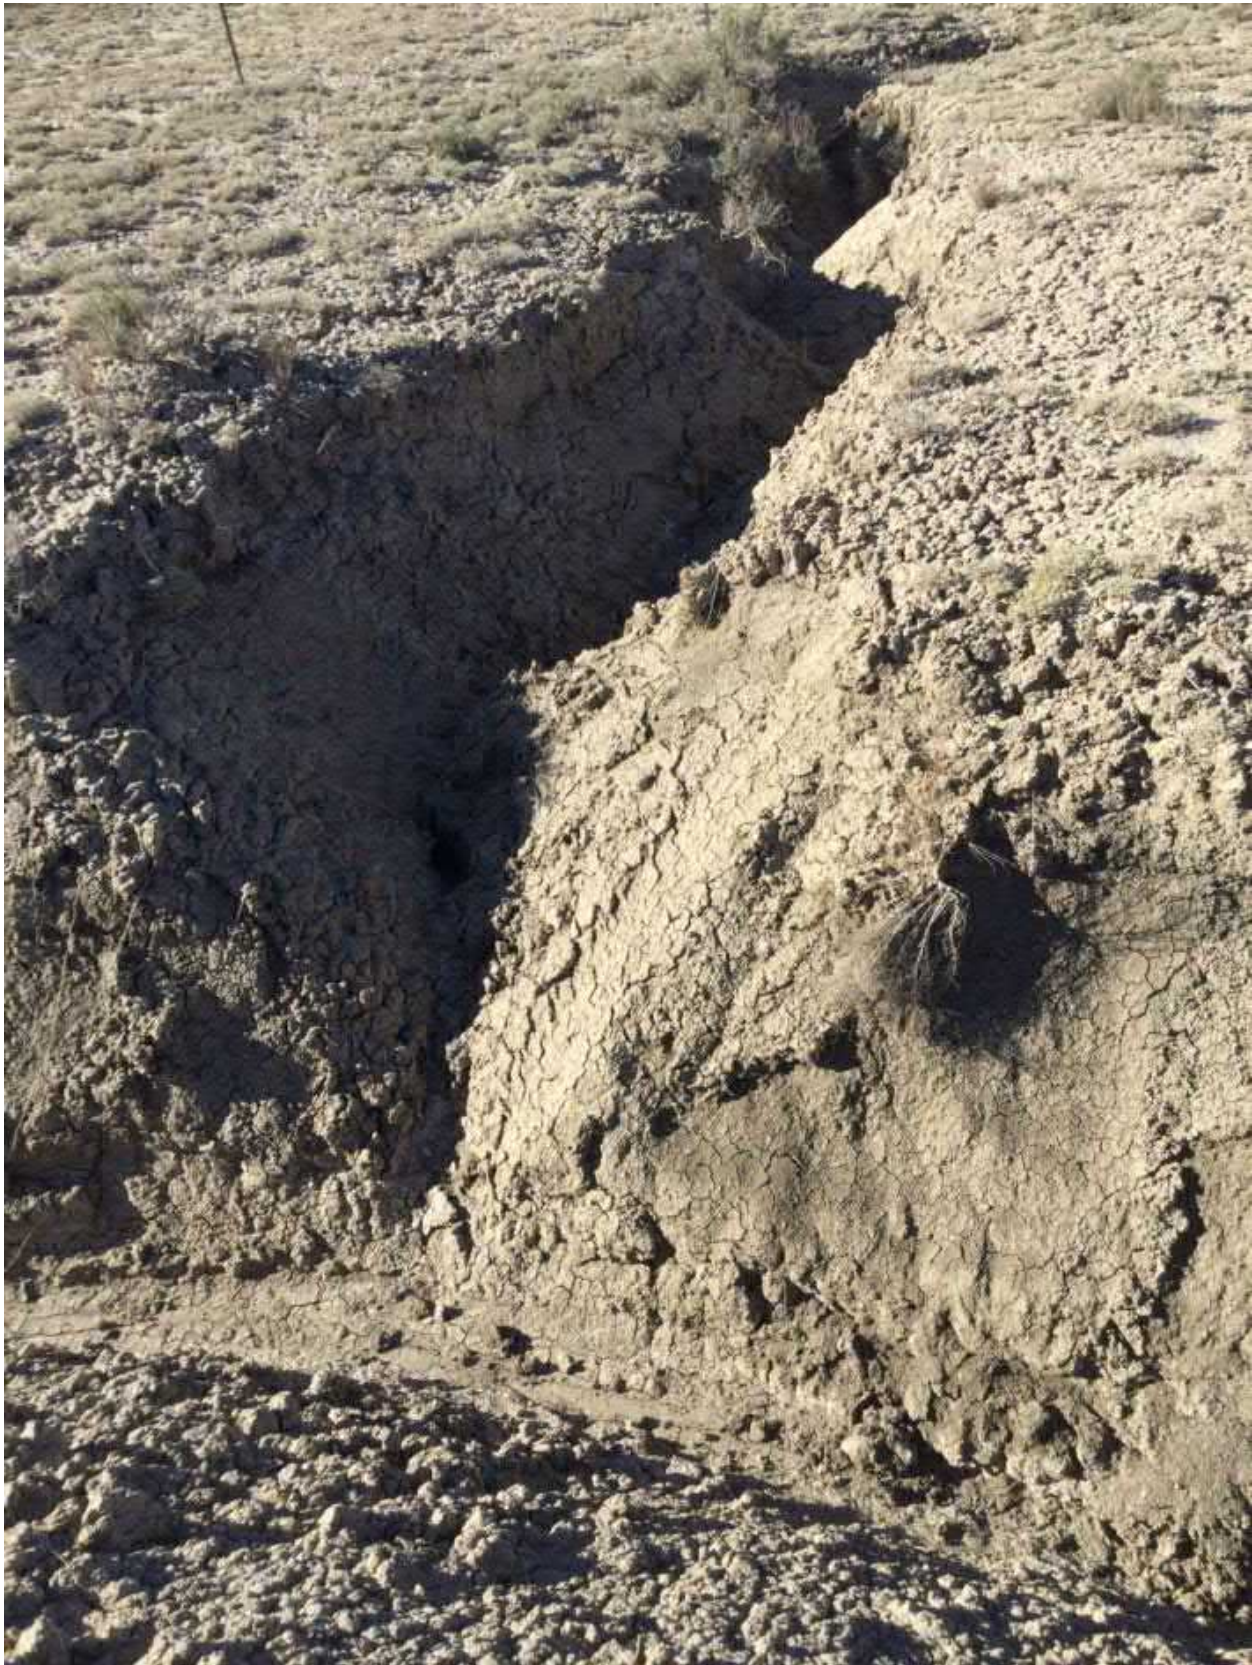
**Photograph No. 8**

**View of offsite drainage channel discharging into offsite diversion channel and diverted around permitted CCR Landfill, looking south.**

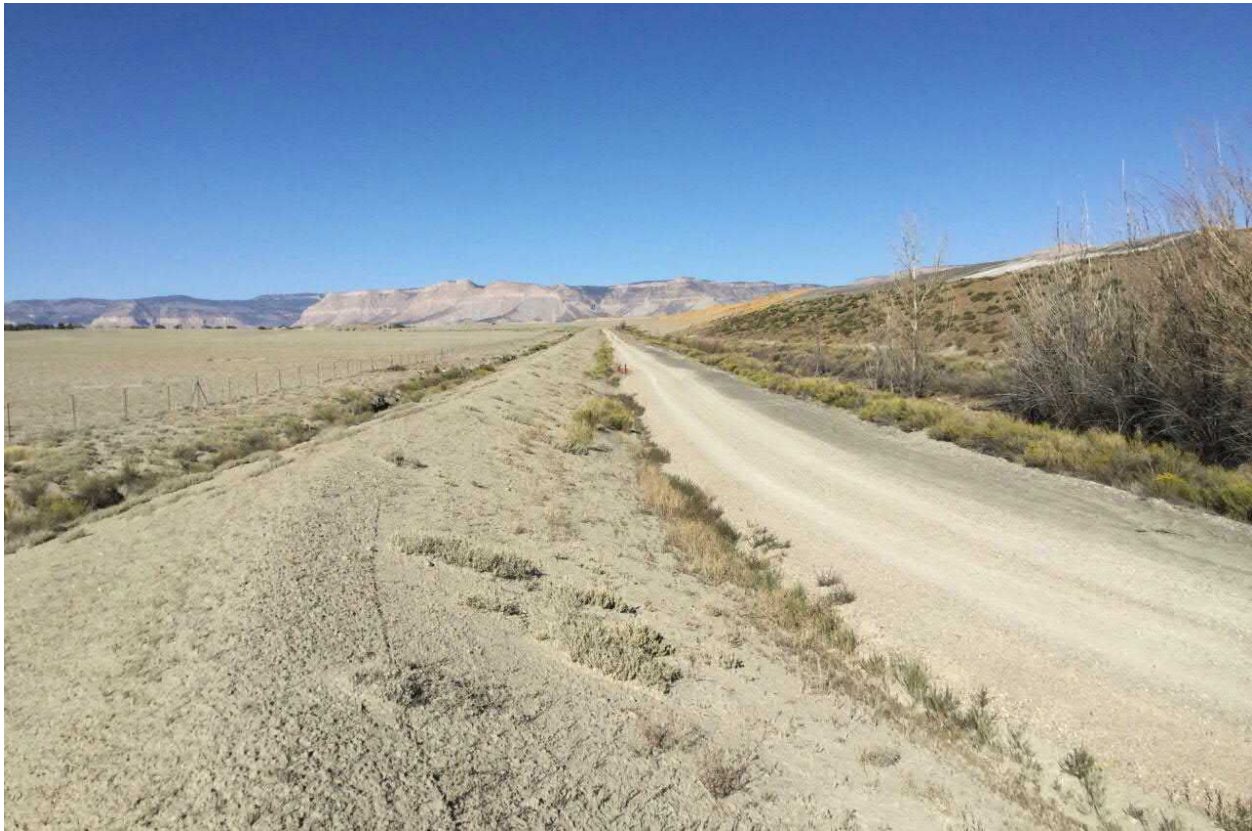
**Photograph No. 11** View of interior slope of perimeter berm and perimeter road, looking west.

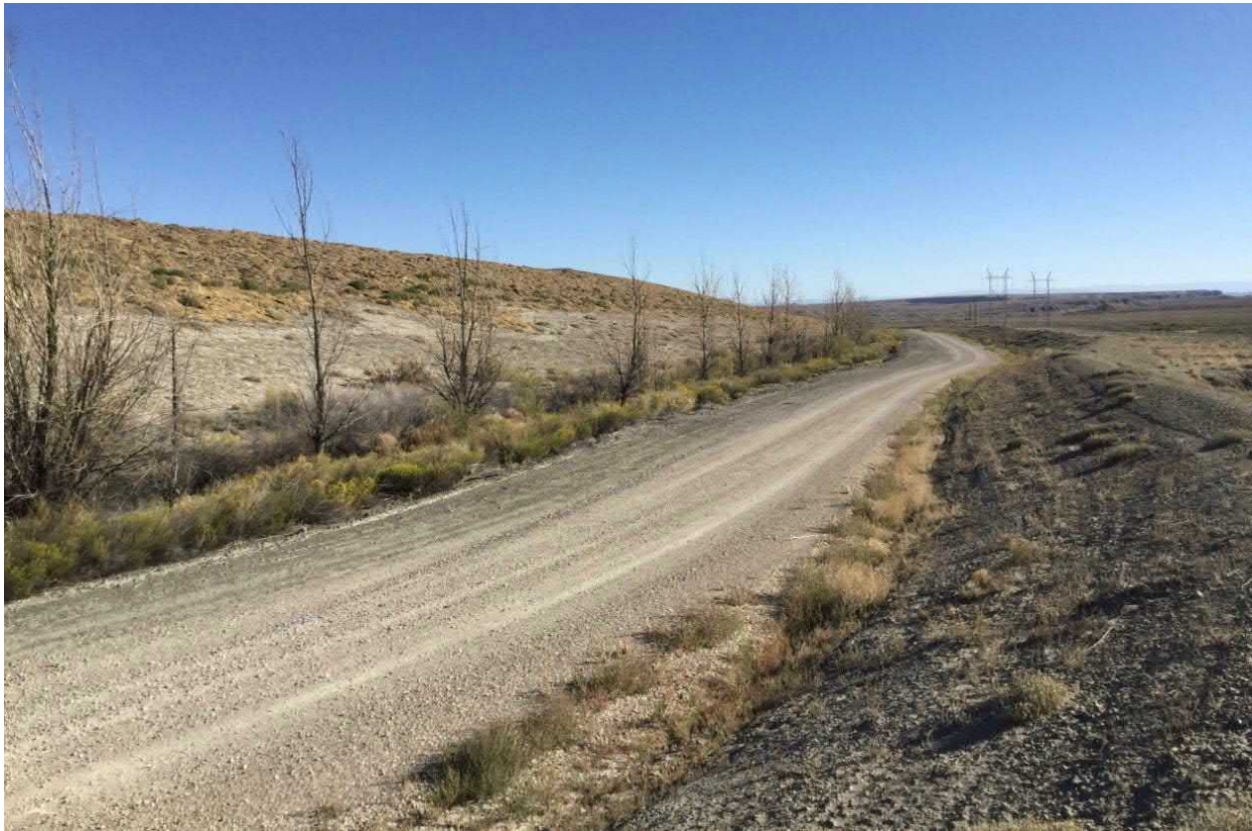
**Photograph No. 13** View of southeast slope of CCR Landfill, perimeter road, and interior slope of perimeter berm, looking northeast.

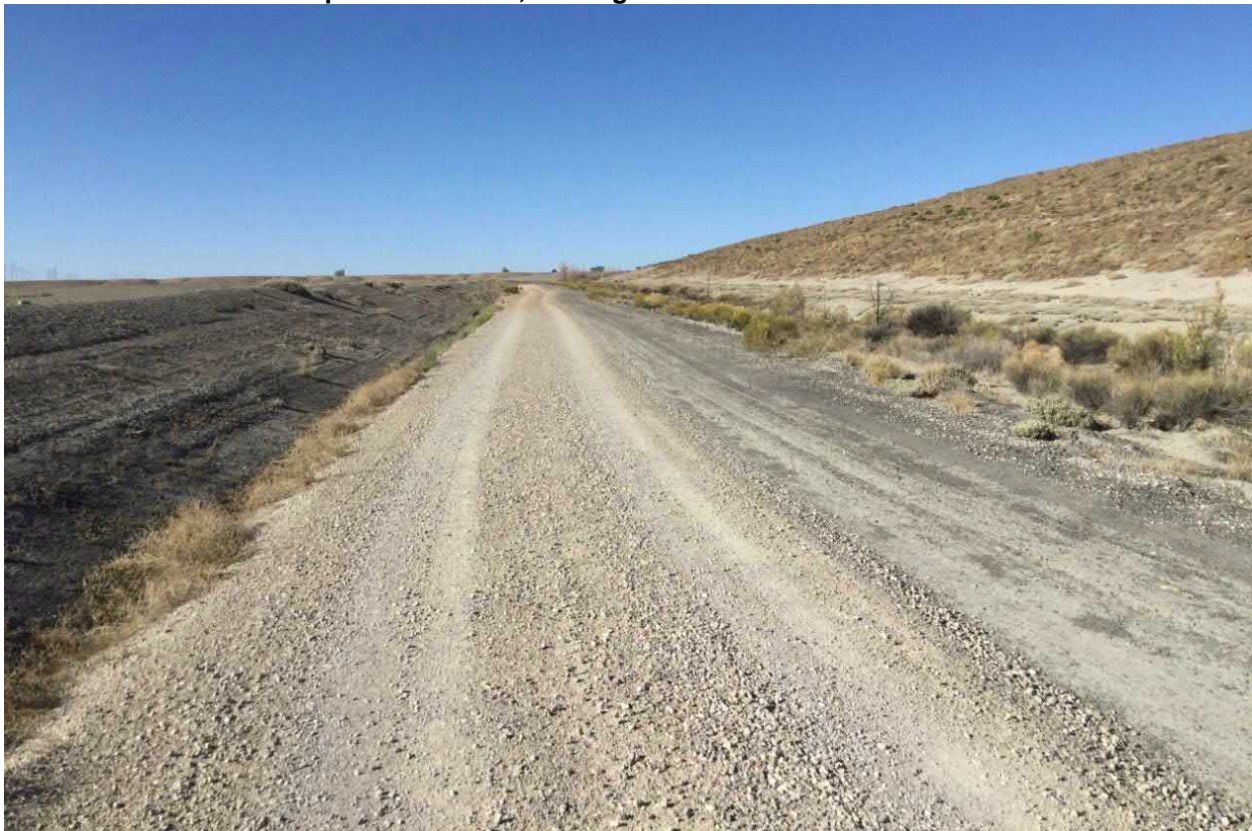
**Photograph No. 14** View of southeast slope of CCR Landfill, perimeter road, and perimeter berm, looking southwest.

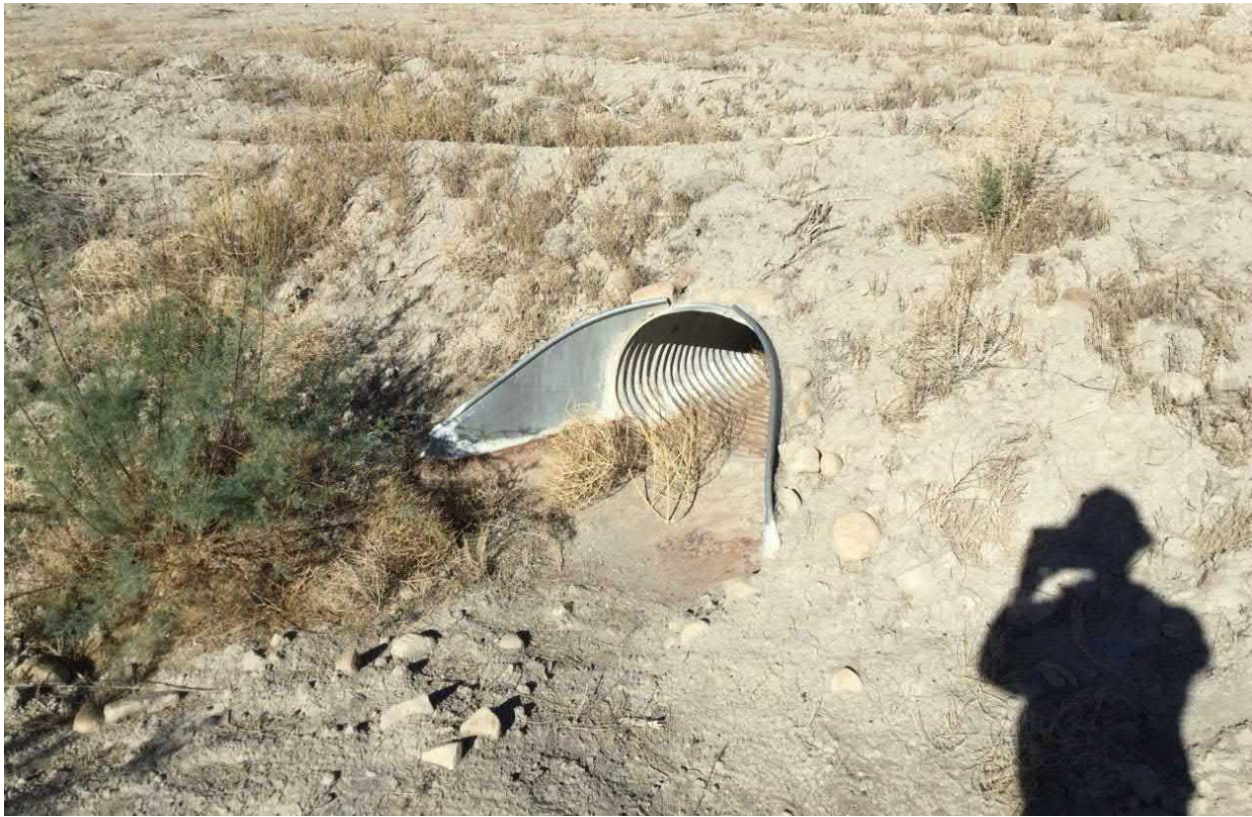
**Photograph No. 15** View of south retention basin inlet pipe (upstream end). Pipe culvert was unobstructed and free of debris, looking west-northwest.

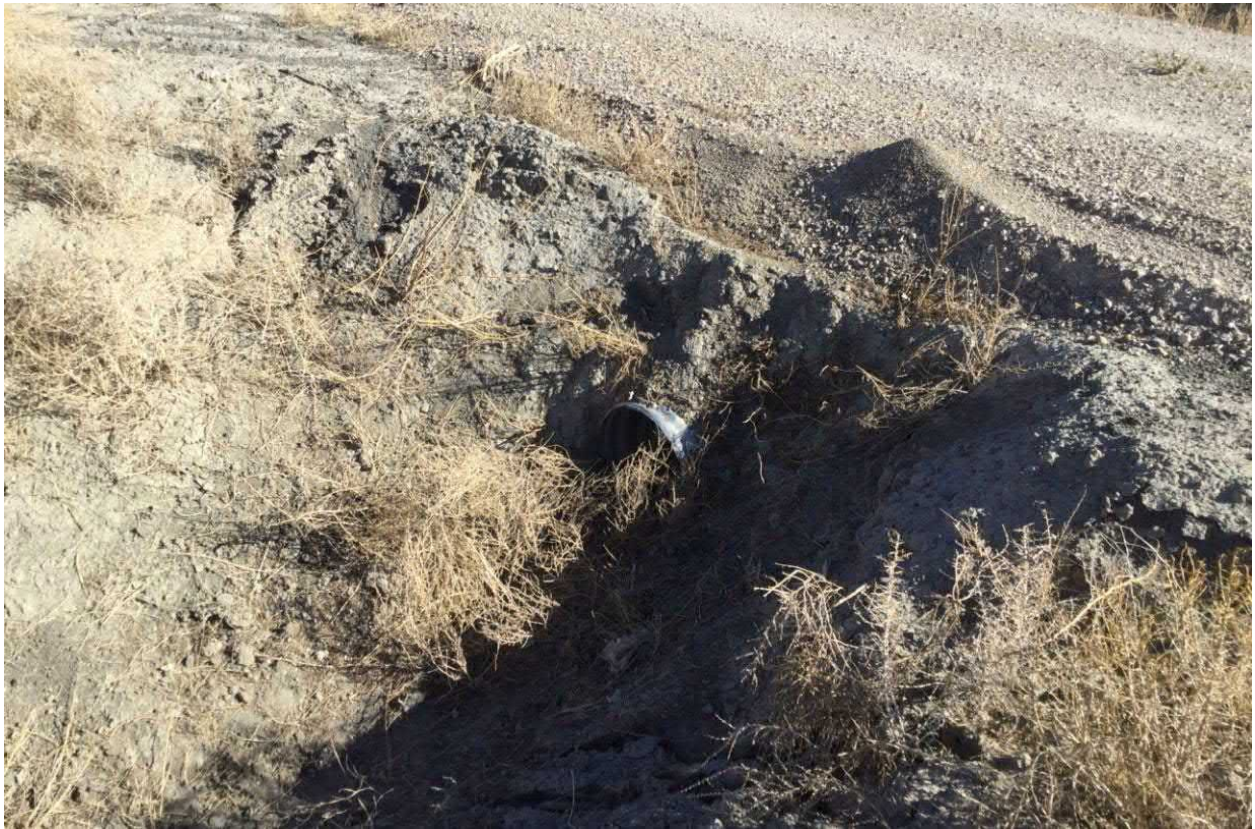
**Photograph No. 17** View of pipe culvert passing under perimeter road (downstream end), looking southeast.

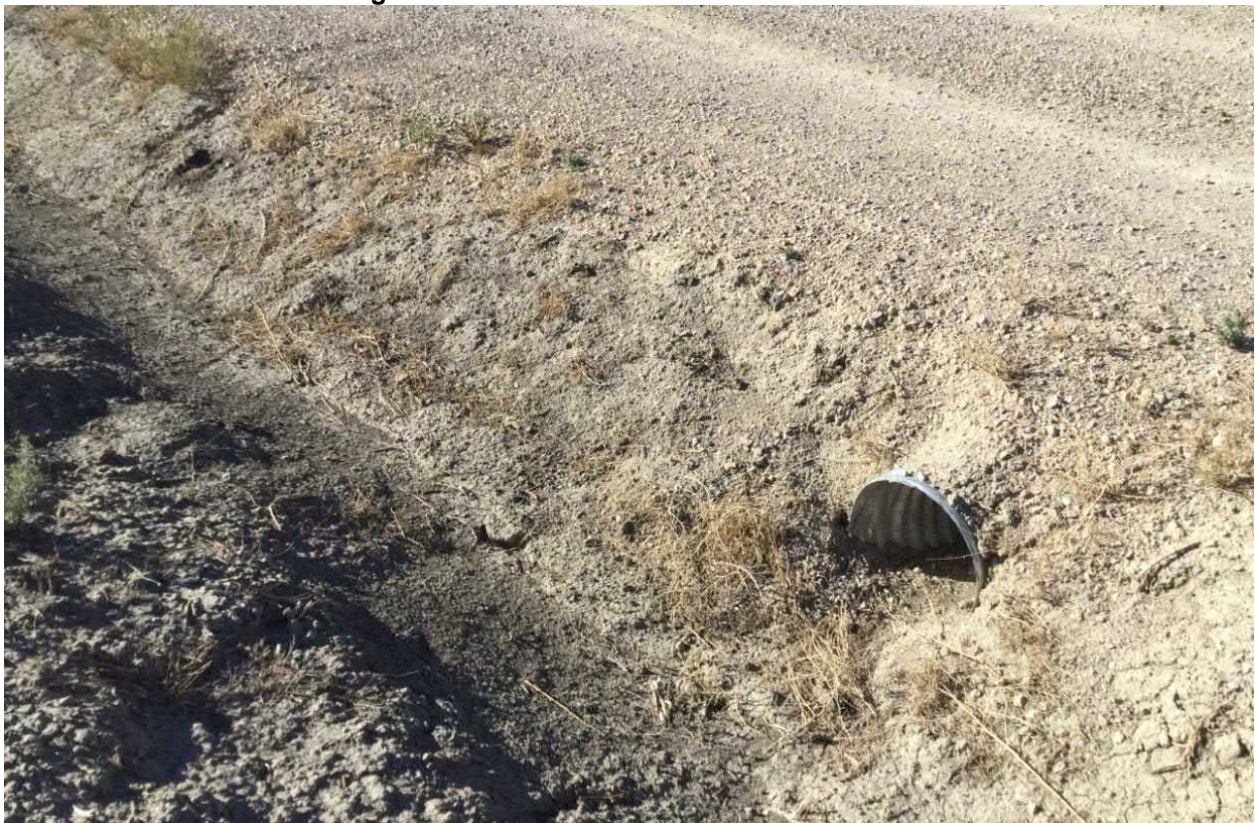
**Photograph No. 18** View of pipe culvert passing under perimeter road (upstream end), looking southwest.

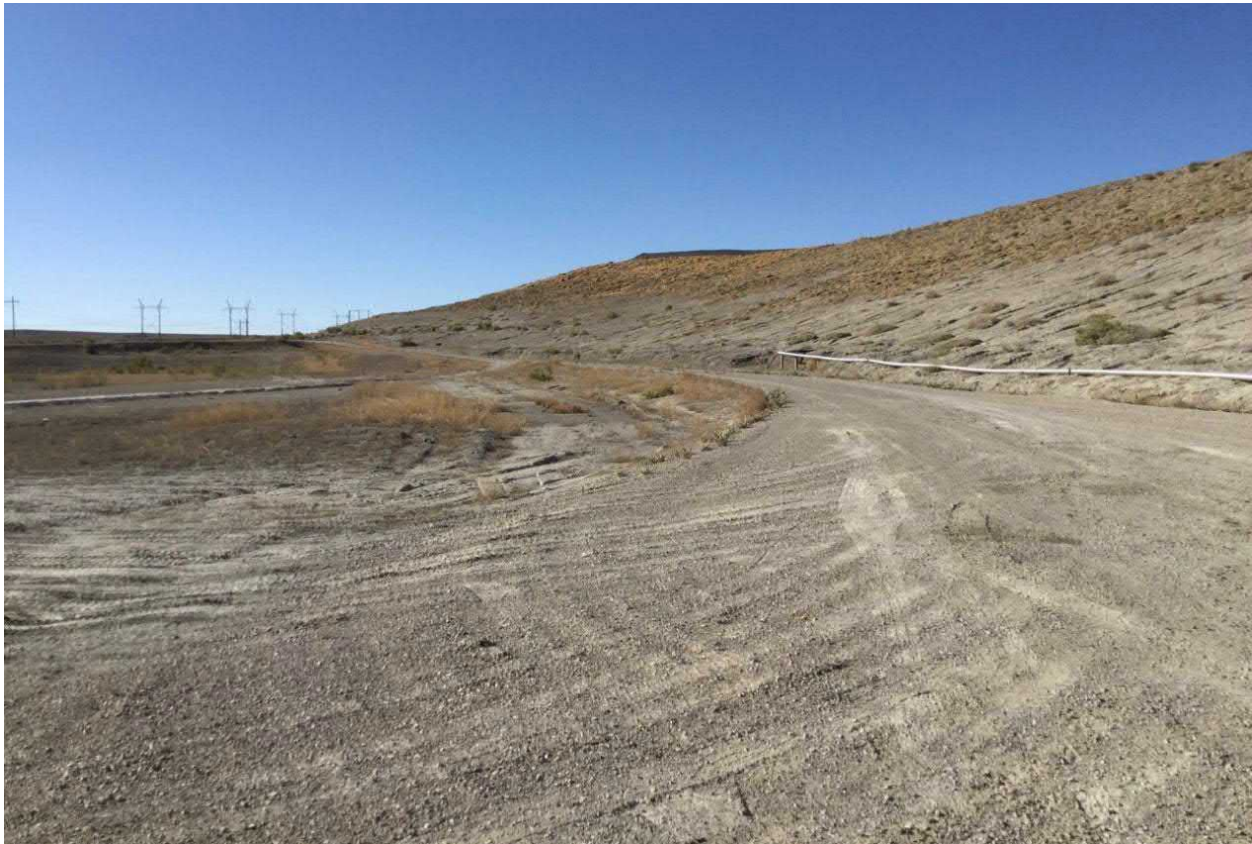
In 2015, URS completed a geotechnical study to evaluate the feasibility of expanding the landfill vertically [8]. The study includes geotechnical analyses assessing the stability of the landfill under the additional loading. This study concluded that it is feasible and that the landfill is stable for this expansion, provided that monitoring of internal pore pressures is performed. It also included a recommendation to relieve pore pressure in the landfill using horizontal drains. Photographs 19 and 20 of in Appendix A show some of the features associated with the underdrain system.

**Photograph No. 19** View of east slope of CCR Landfill and drain line from underdrains to Frac tank (see Photograph No. 20), looking south.

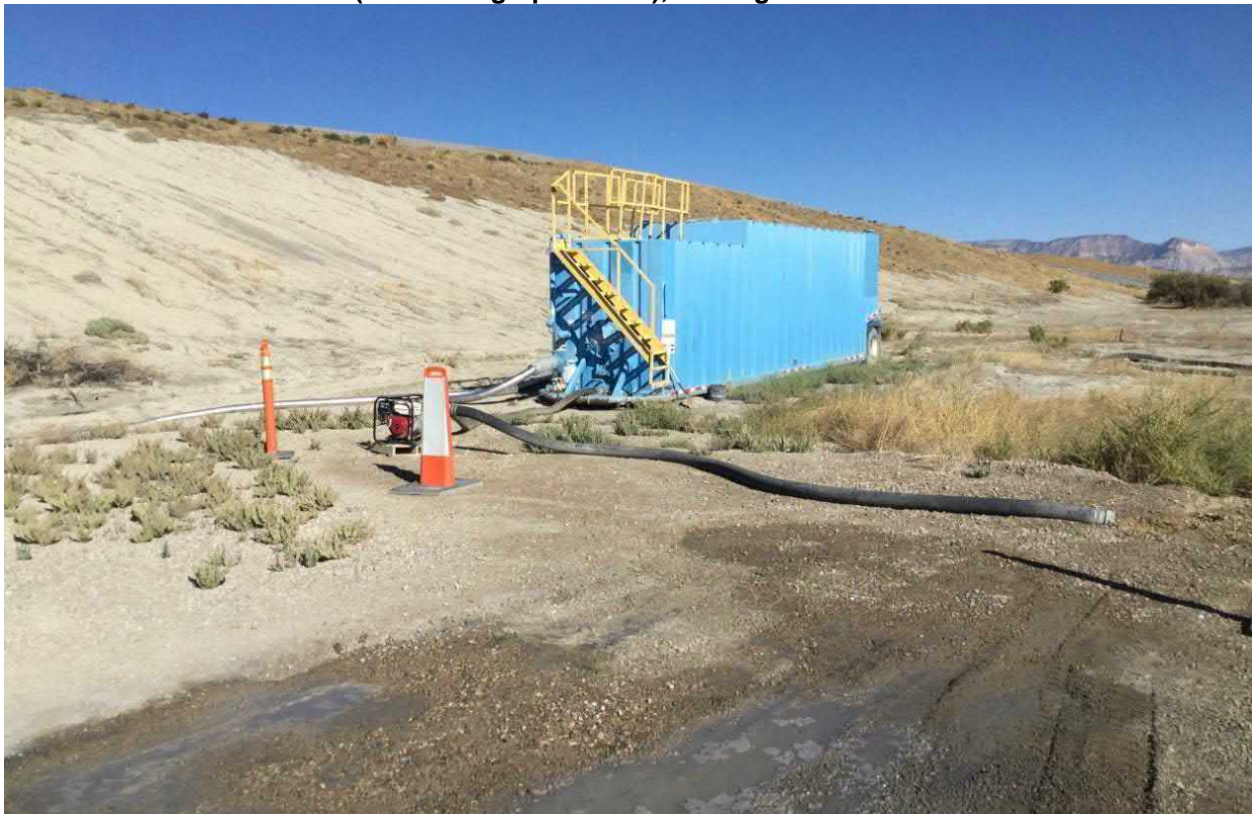
**Photograph No. 20** View of Frac tank used for underdrain water storage, looking north-northwest.
