# 2018 Coal Combustion Residuals Annual Inspection

## Hunter Power Plant

### *Hunter CCR Landfill*

FINAL December 11, 2018

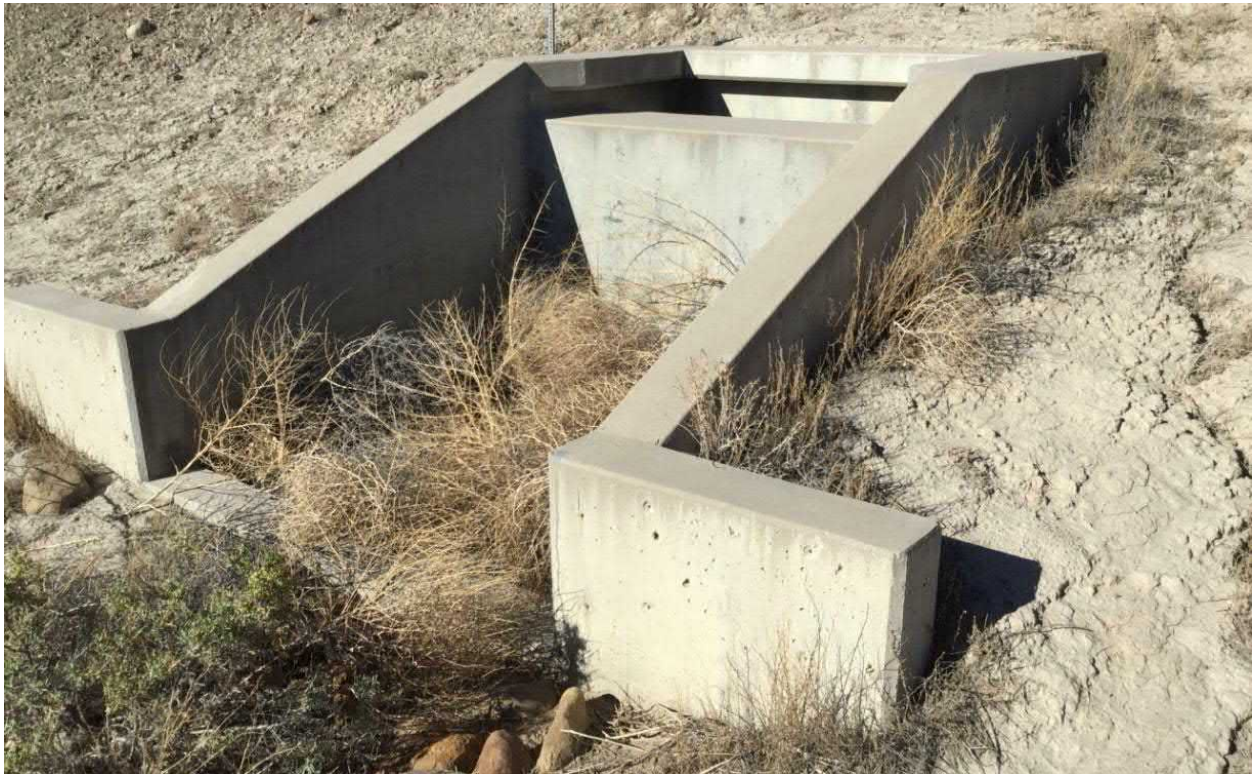
**Photograph No. 23** View of energy dissipation structure at downstream end of retention pond outlet conduit, looking southwest. This facility is a zero-discharge facility and gate remains closed.

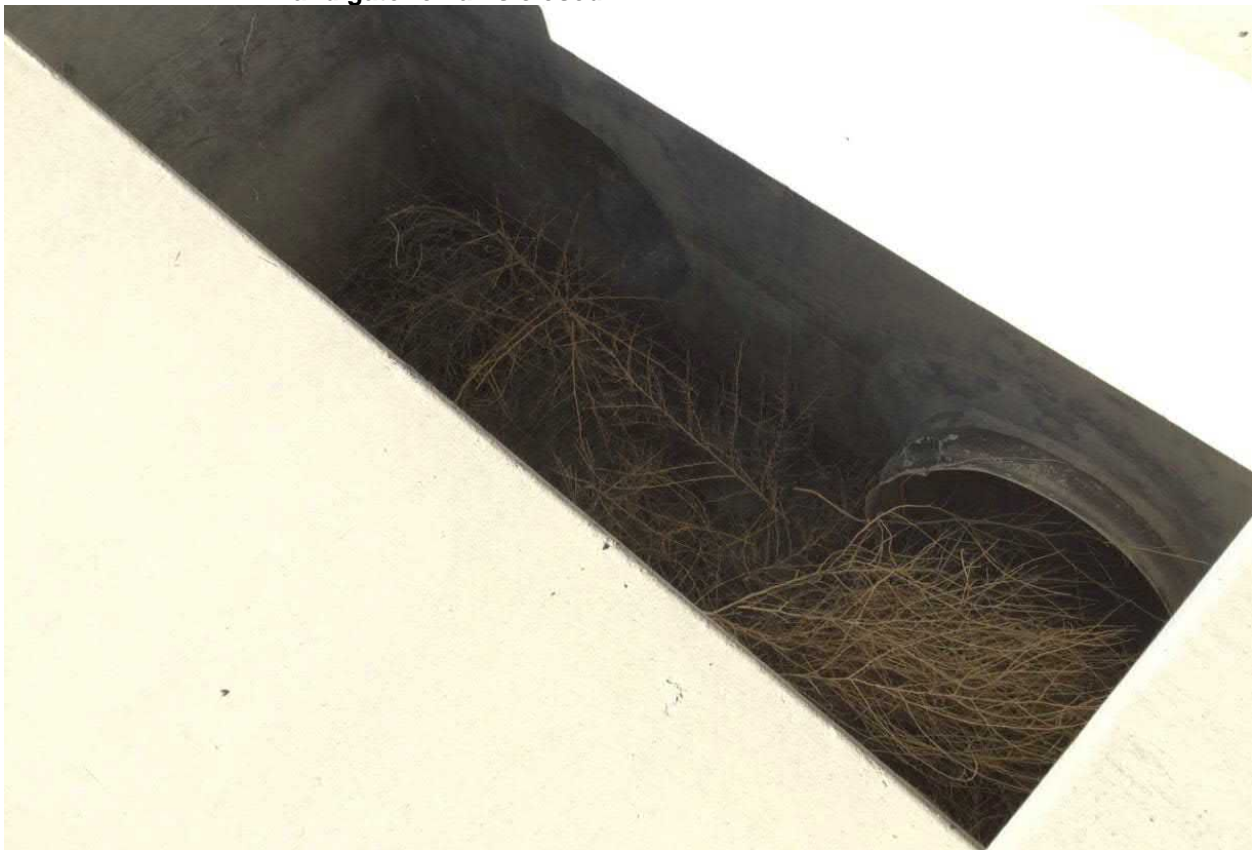
**Photograph No. 24** View of energy dissipation structure at downstream end of retention pond outlet conduit and upstream of baffle. Note discharge conduit from auxiliary spillway.

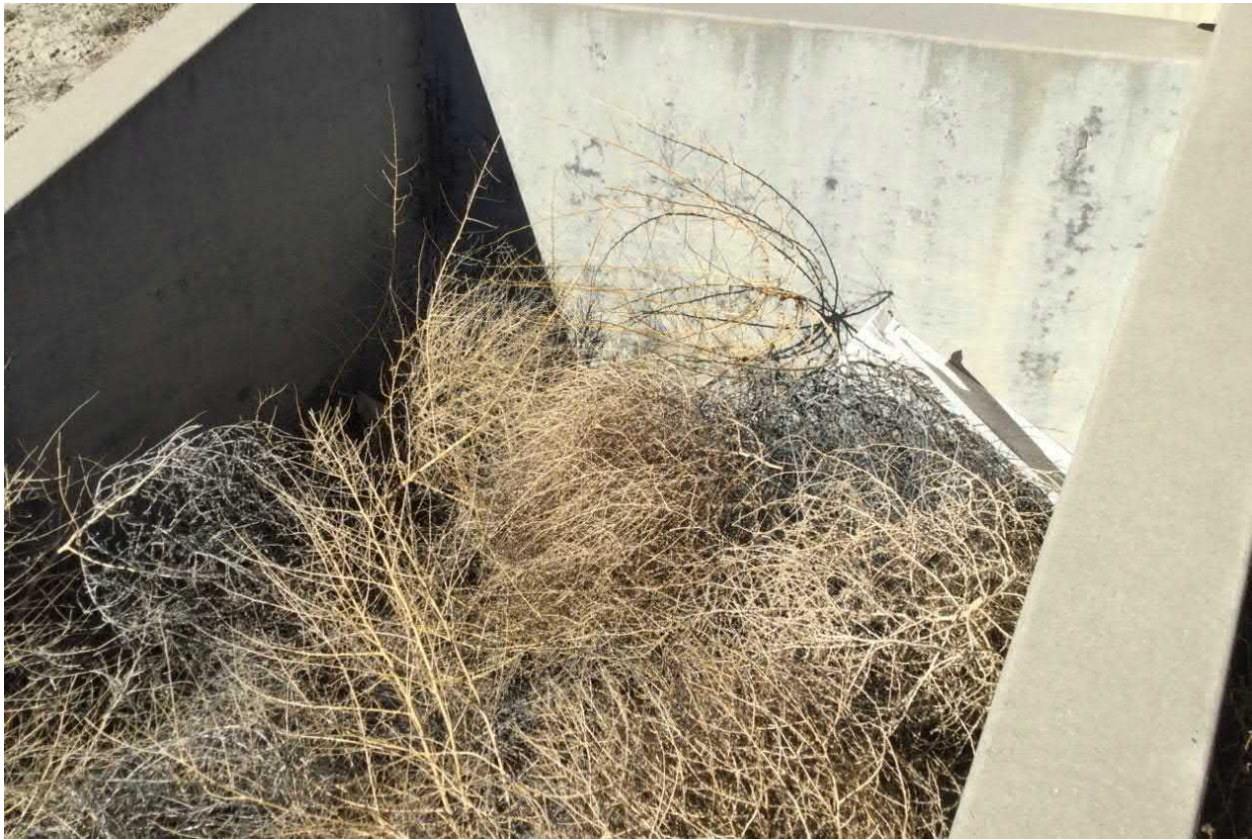
**Photograph No. 25** View of energy dissipation structure at downstream end of retention pond outlet conduit and downstream of baffle.

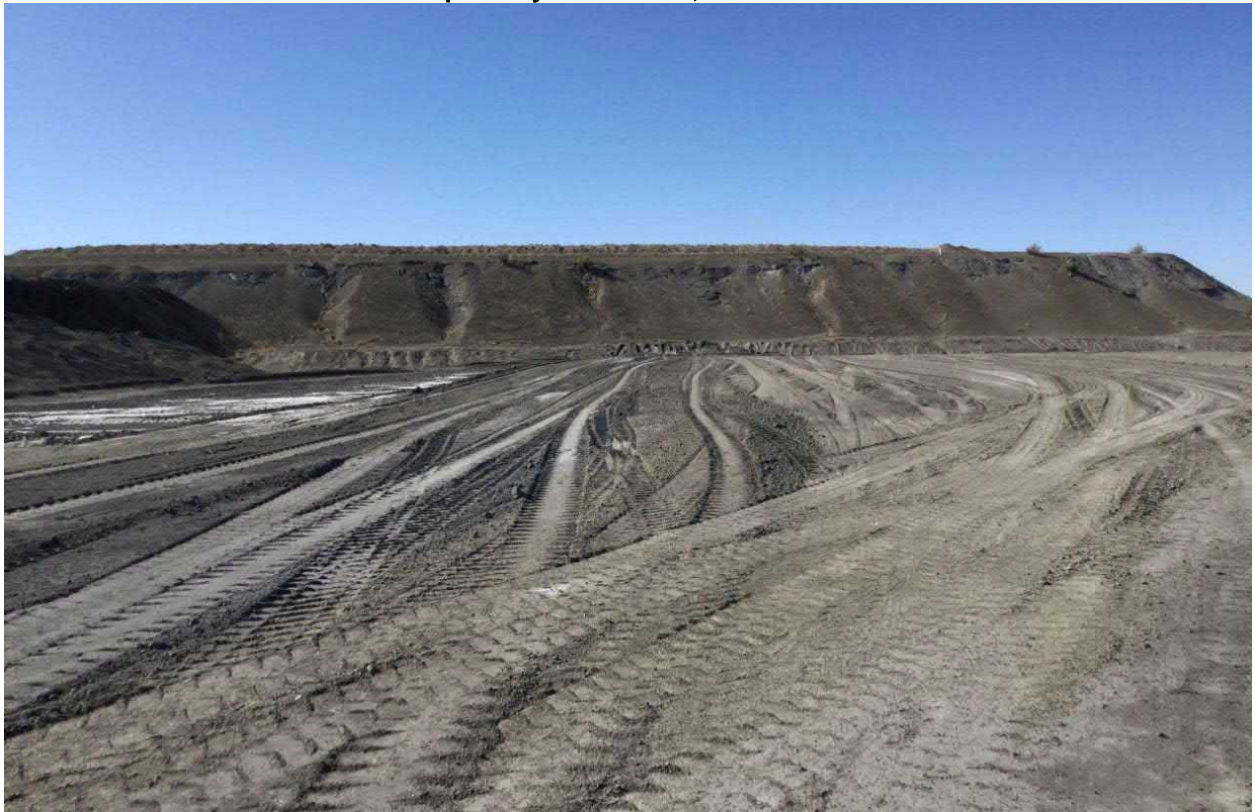
**Photograph No. 30** View of temporary north slope of CCR Landfill just west of Industrial Landfill, looking south.

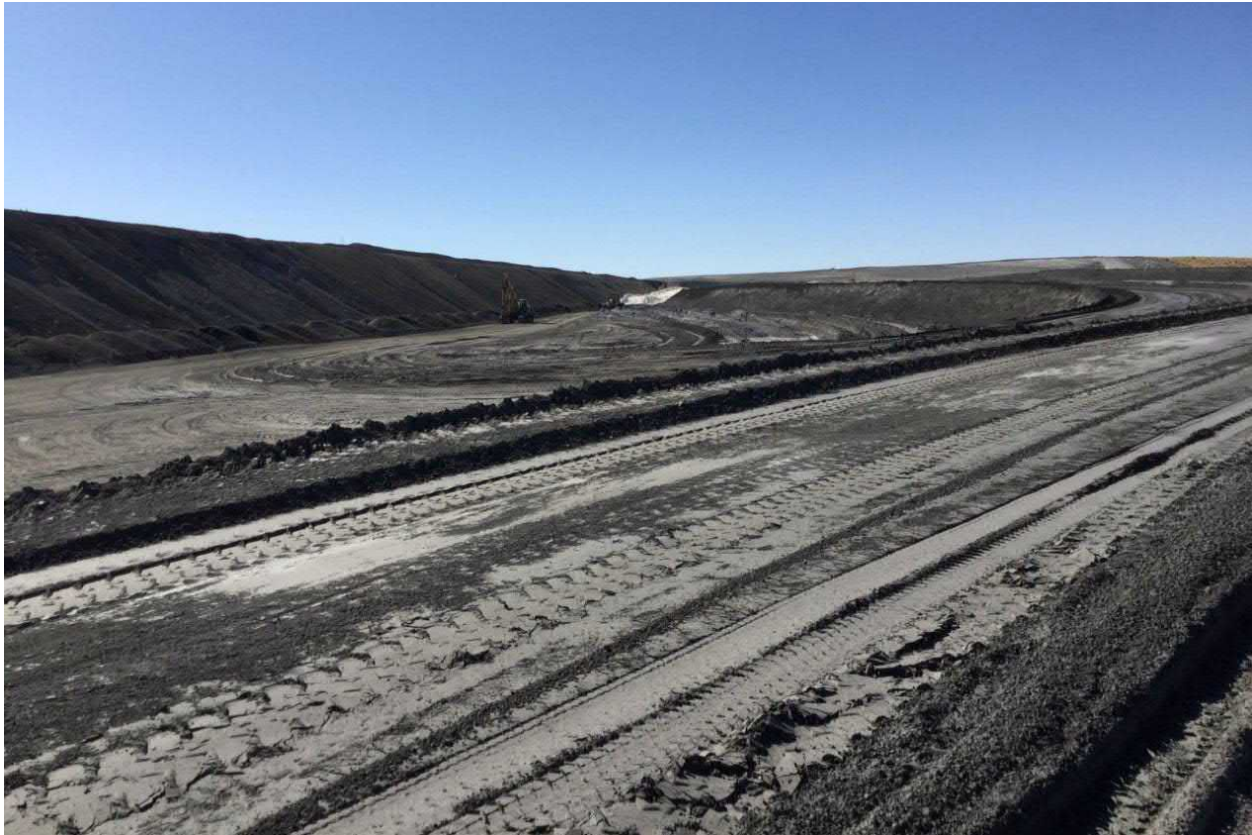
**Photograph No. 31** View of recently-placed CCR material near west edge of CCR Landfill.

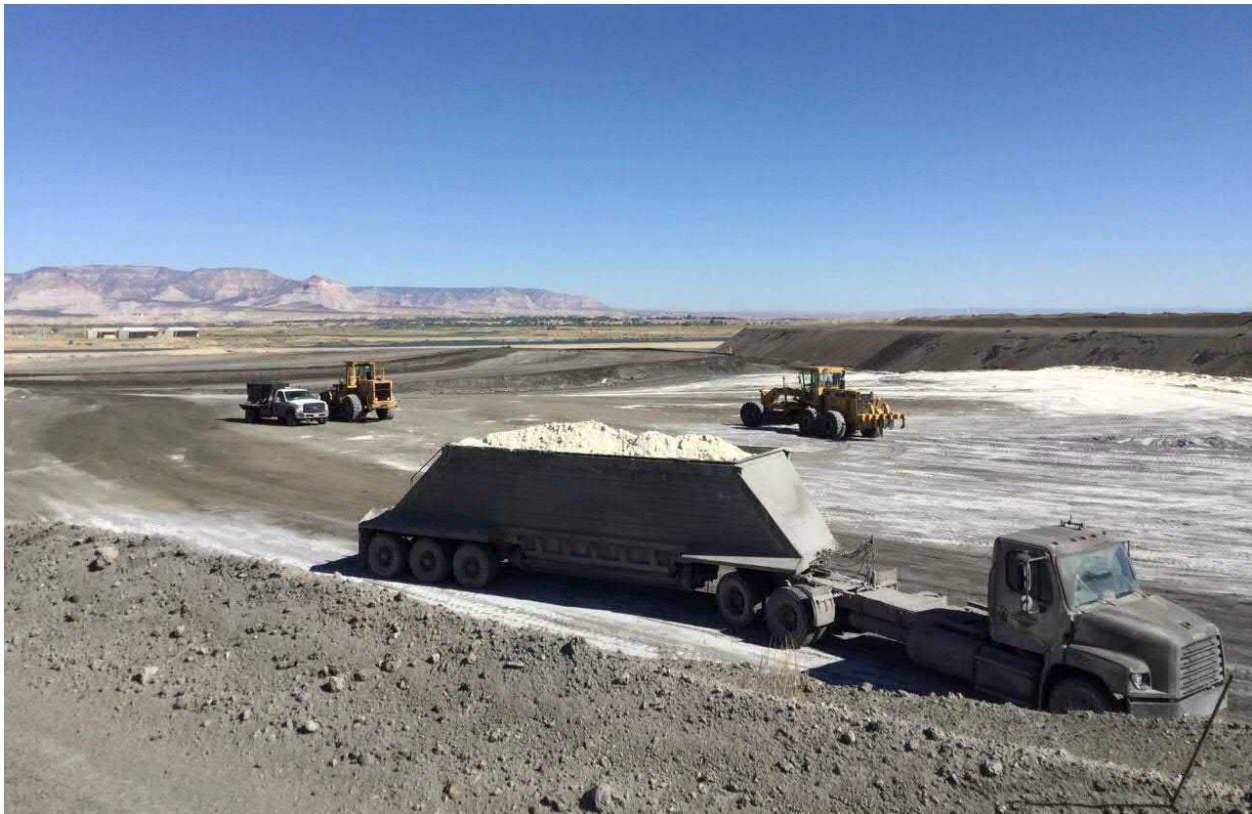
**Photograph No. 32** View of recently-placed CCR material near west edge of CCR Landfill near main haul road entrance. Note FGD material placement.
