# **CCR Rule Operating Criteria §257.84(b)(1) Annual Inspection by A Qualified Engineer Final**

## **CCR Landfill Hunter Power Plant Castle Dale, Utah**

**December 16, 2021**

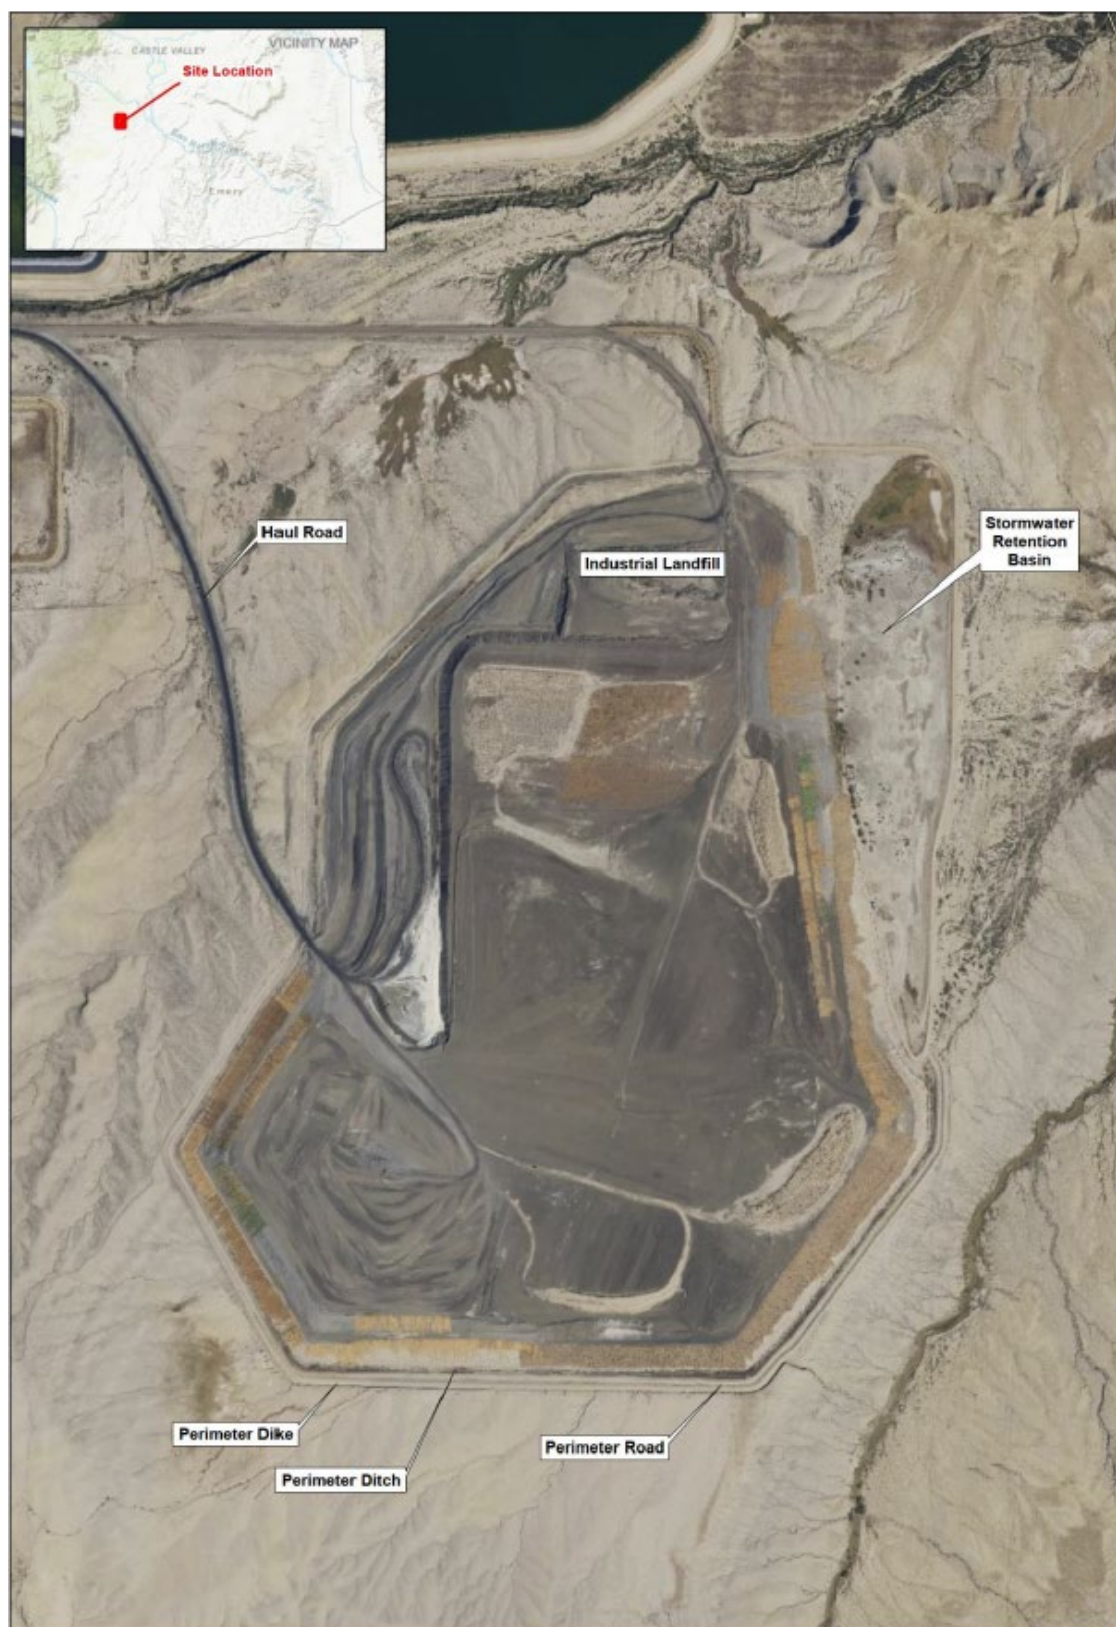
Figure 1 : Hunter CCR Landfill

The field inspection was performed on August 24, 2021 and found the principal project features of the Hunter CCR Landfill to be in satisfactory condition. Nothing was observed that would suggest an active or impending issue with stability of the landfill and the run-on and run-off control features were being maintained to preserve design capacity. The layout of the CCR Landfill is provided in **Figure 1**.

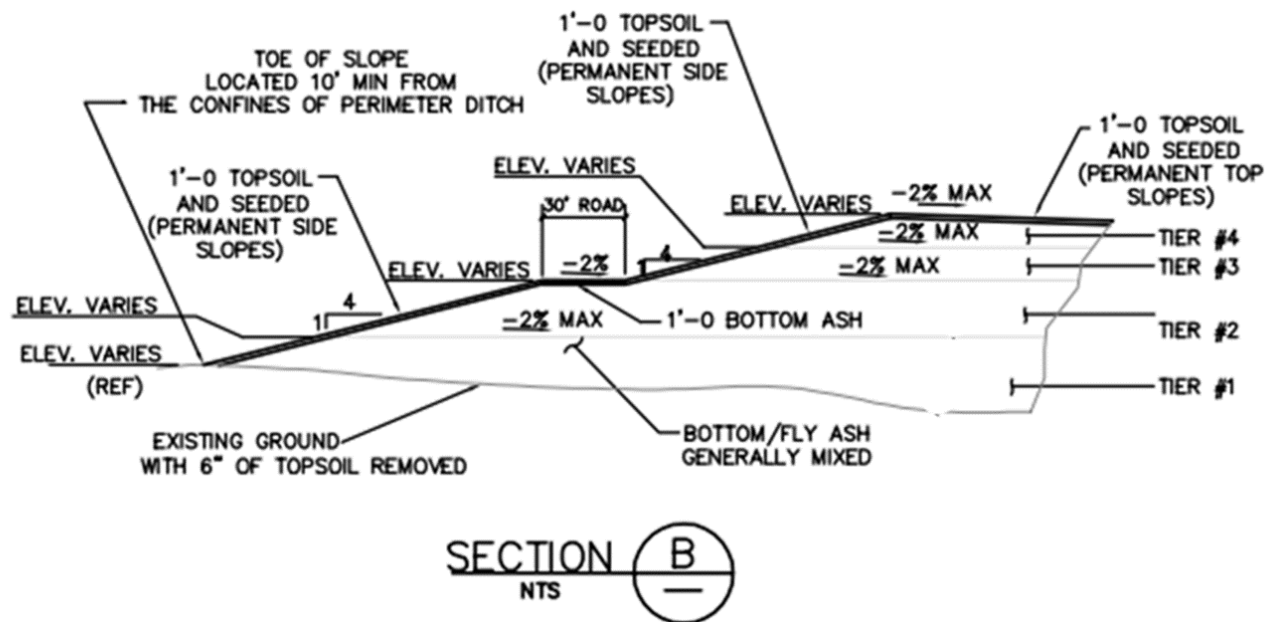
Figure 2 – Typical Cross Section of CCR Landfill

The CCR Landfill occupies approximately 230 acres and includes existing an access (haul) road, perimeter ditches, and the zero-discharge stormwater retention basis (104 acre-ft) with a total landfill; capacity of 44.5 million cubic yards. A typical cross-section of the CCR Landfill is presented in **Figure 2**.
