# **CCR Rule Operating Criteria §257.84(b)(1) Annual Inspection by A Qualified Engineer Final**

## **CCR Landfill Hunter Power Plant Castle Dale, Utah**

**December 16, 2022**

**Tetra Tech**

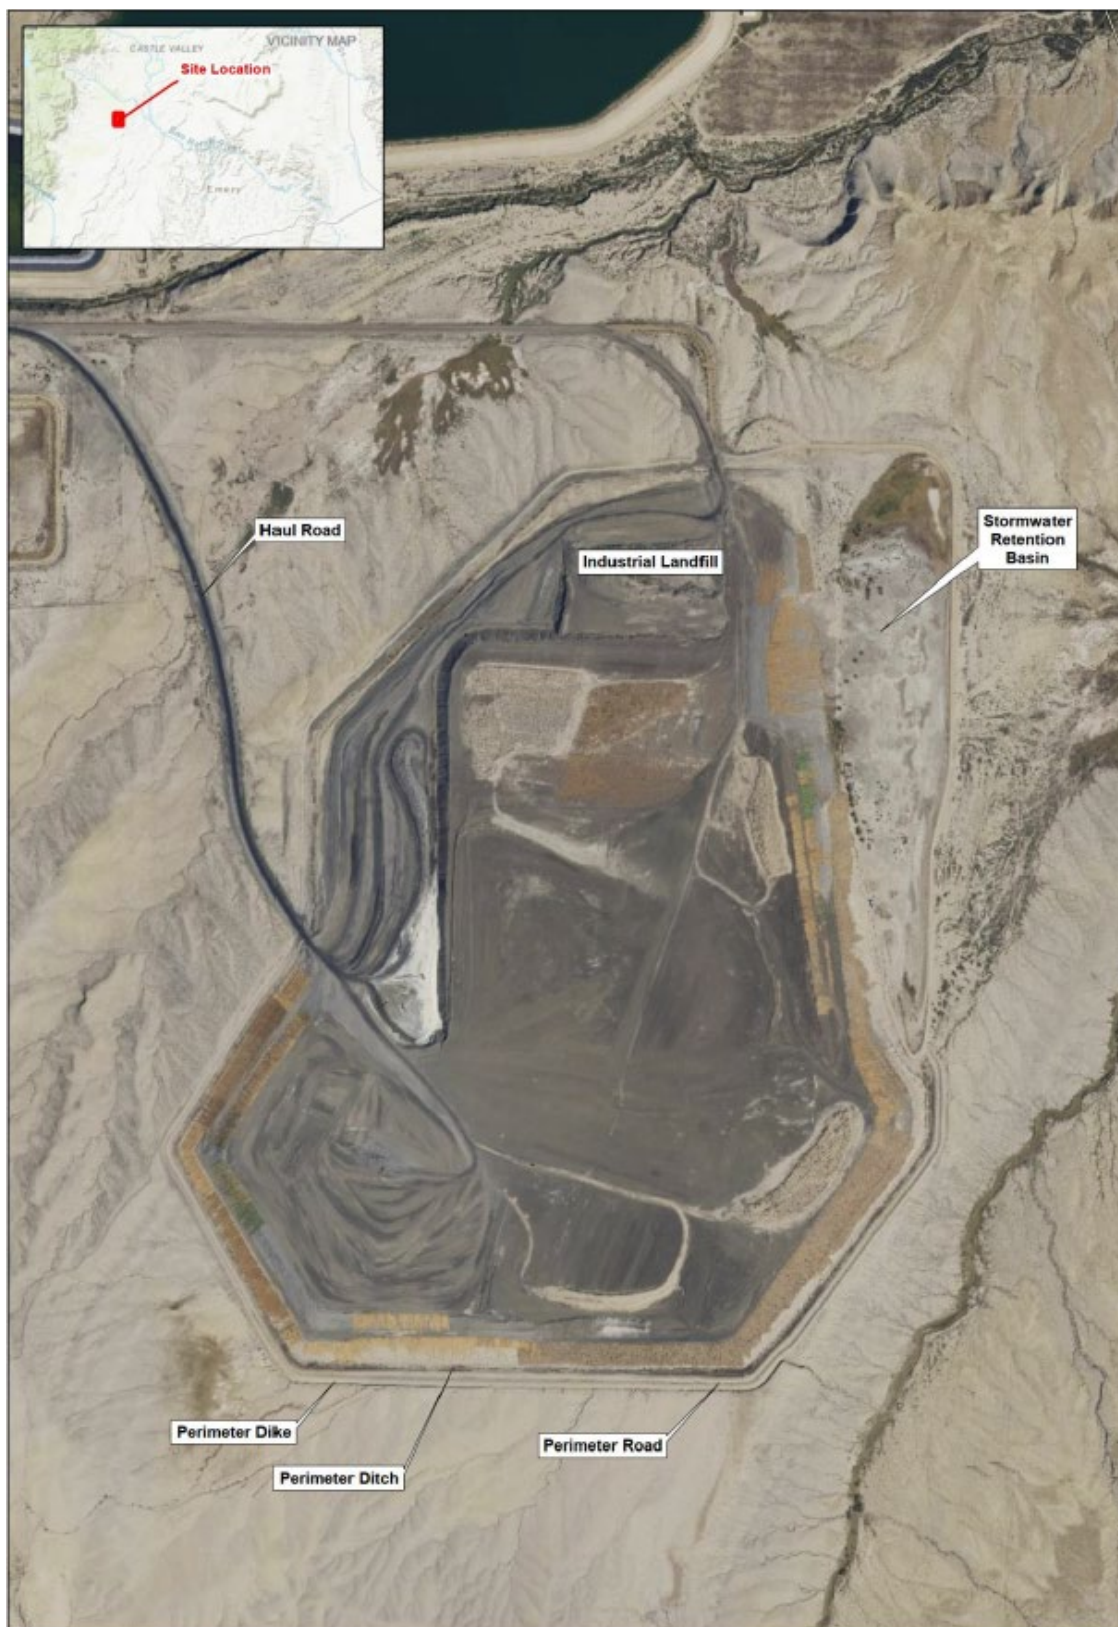
Figure 1 : Hunter CCR Landfill

The field inspection was performed on August 25, 2022 and found the principal project features of the Hunter CCR Landfill to be in satisfactory condition. Nothing was observed that would suggest an active or impending issue with stability of the landfill and the run-on and run-off control features were being maintained to preserve design capacity. The layout of the CCR Landfill is provided in **Figure 1**.
