CCR Rule Operating Criteria §257.84(b)(1) 2023 Annual Inspection by A Qualified Engineer Final

CCR Landfill Hunter Power Plant Castle Dale, Utah

December 15, 2023

Tetra Tech

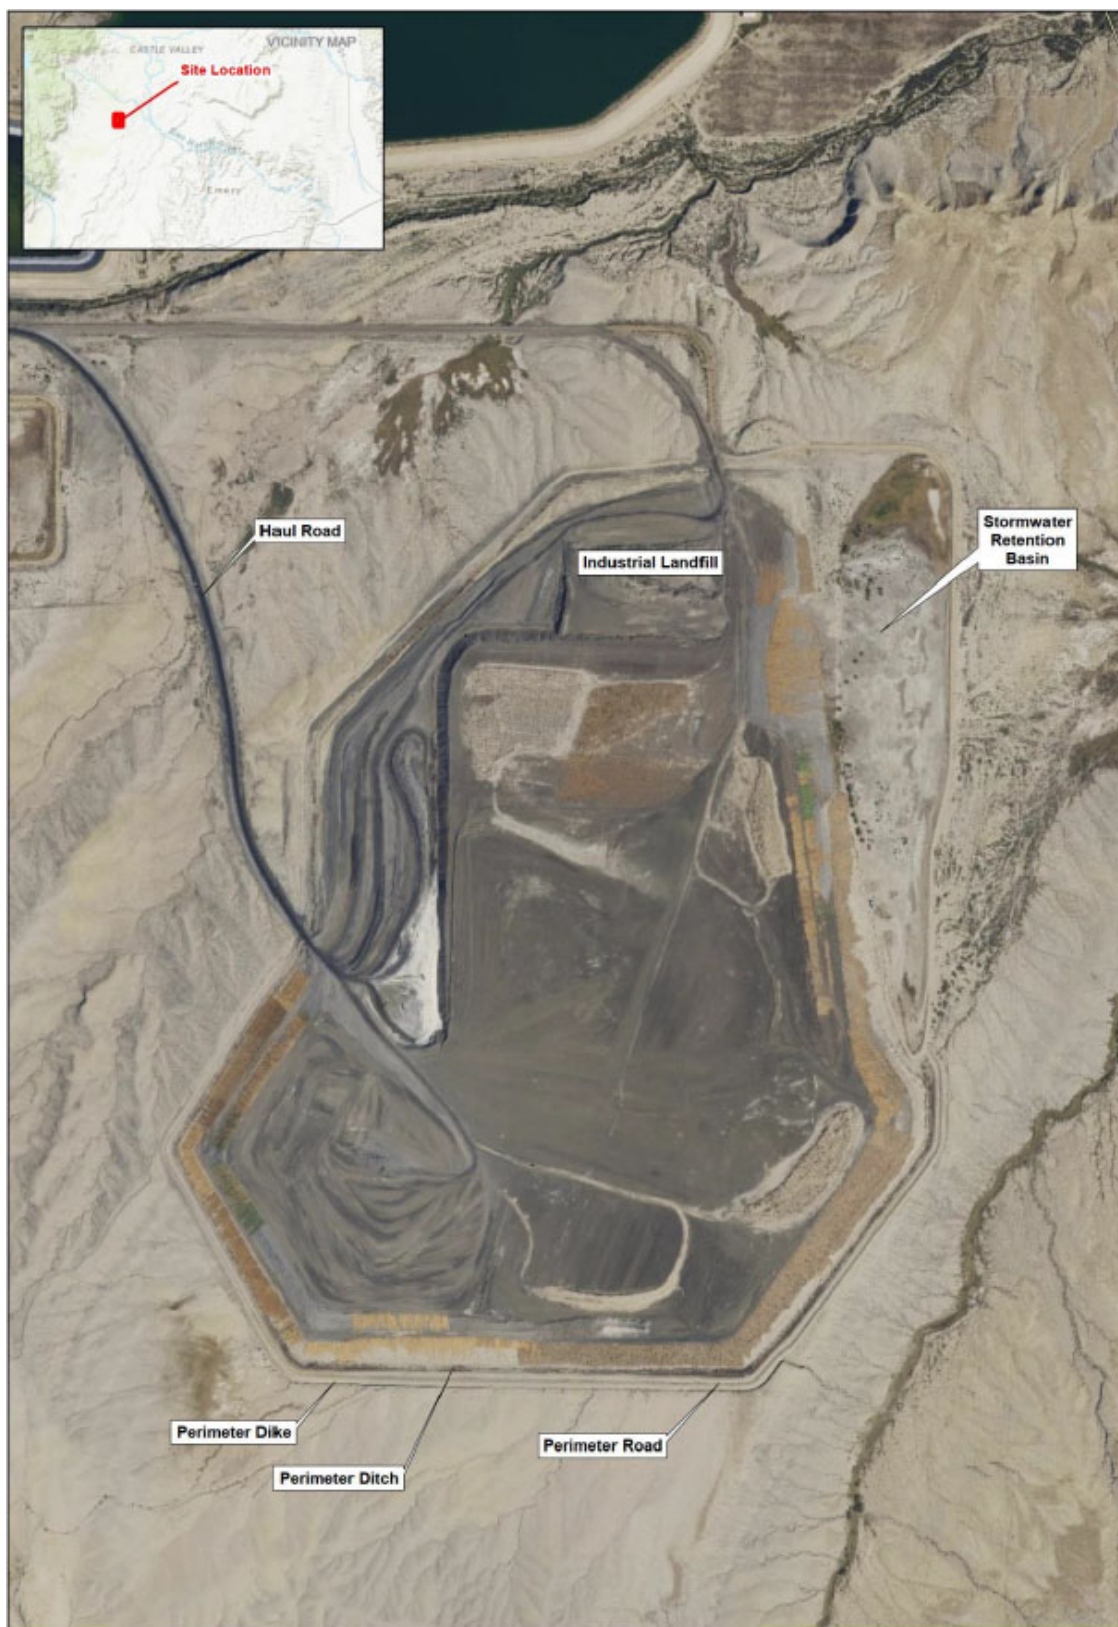
Figure 1 : Hunter CCR Landfill

The field inspection was performed on August 24, 2023 and found the principal project features of the Hunter CCR Landfill to be in satisfactory condition. Nothing was observed that would suggest an active or impending issue with stability of the landfill and the run-on and run-off control features were being maintained to preserve design capacity. The layout of the CCR Landfill is provided in **Figure 1**.
