CCR Rule Operating Criteria §257.84(b)(1) 2024 Annual Inspection by A Qualified Engineer Final

CCR Landfill Hunter Power Plant Castle Dale, Utah

December 13, 2024

Tetra Tech

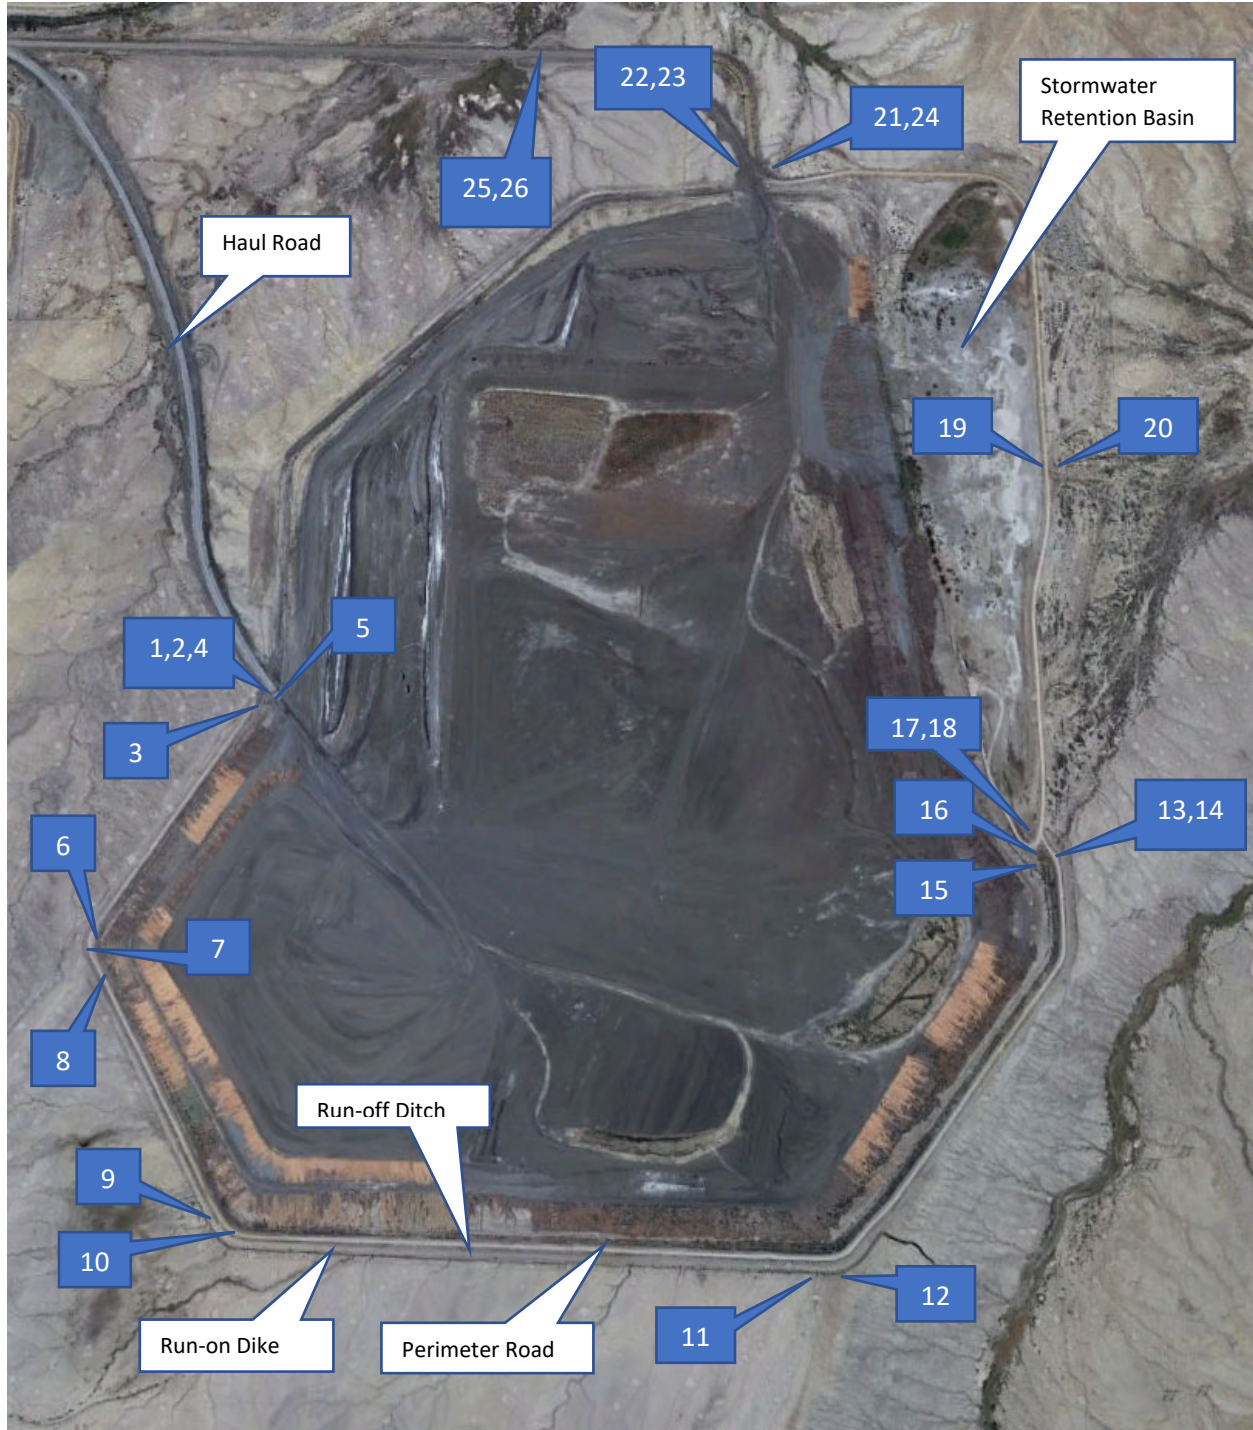
Photo Number: 1	Date: 8/22/2024 12:53 p.m.
Location: Hunter CCR Landfill	Comments: Looking north at inlet of culvert draining run-off channel shown in Photograph 2. Note minor amounts of ash deposited at inlet.
