2020 Coal Combustion Residuals Annual Inspection

Jim Bridger Power Plant *Industrial Landfill*

FINAL December 18, 2020

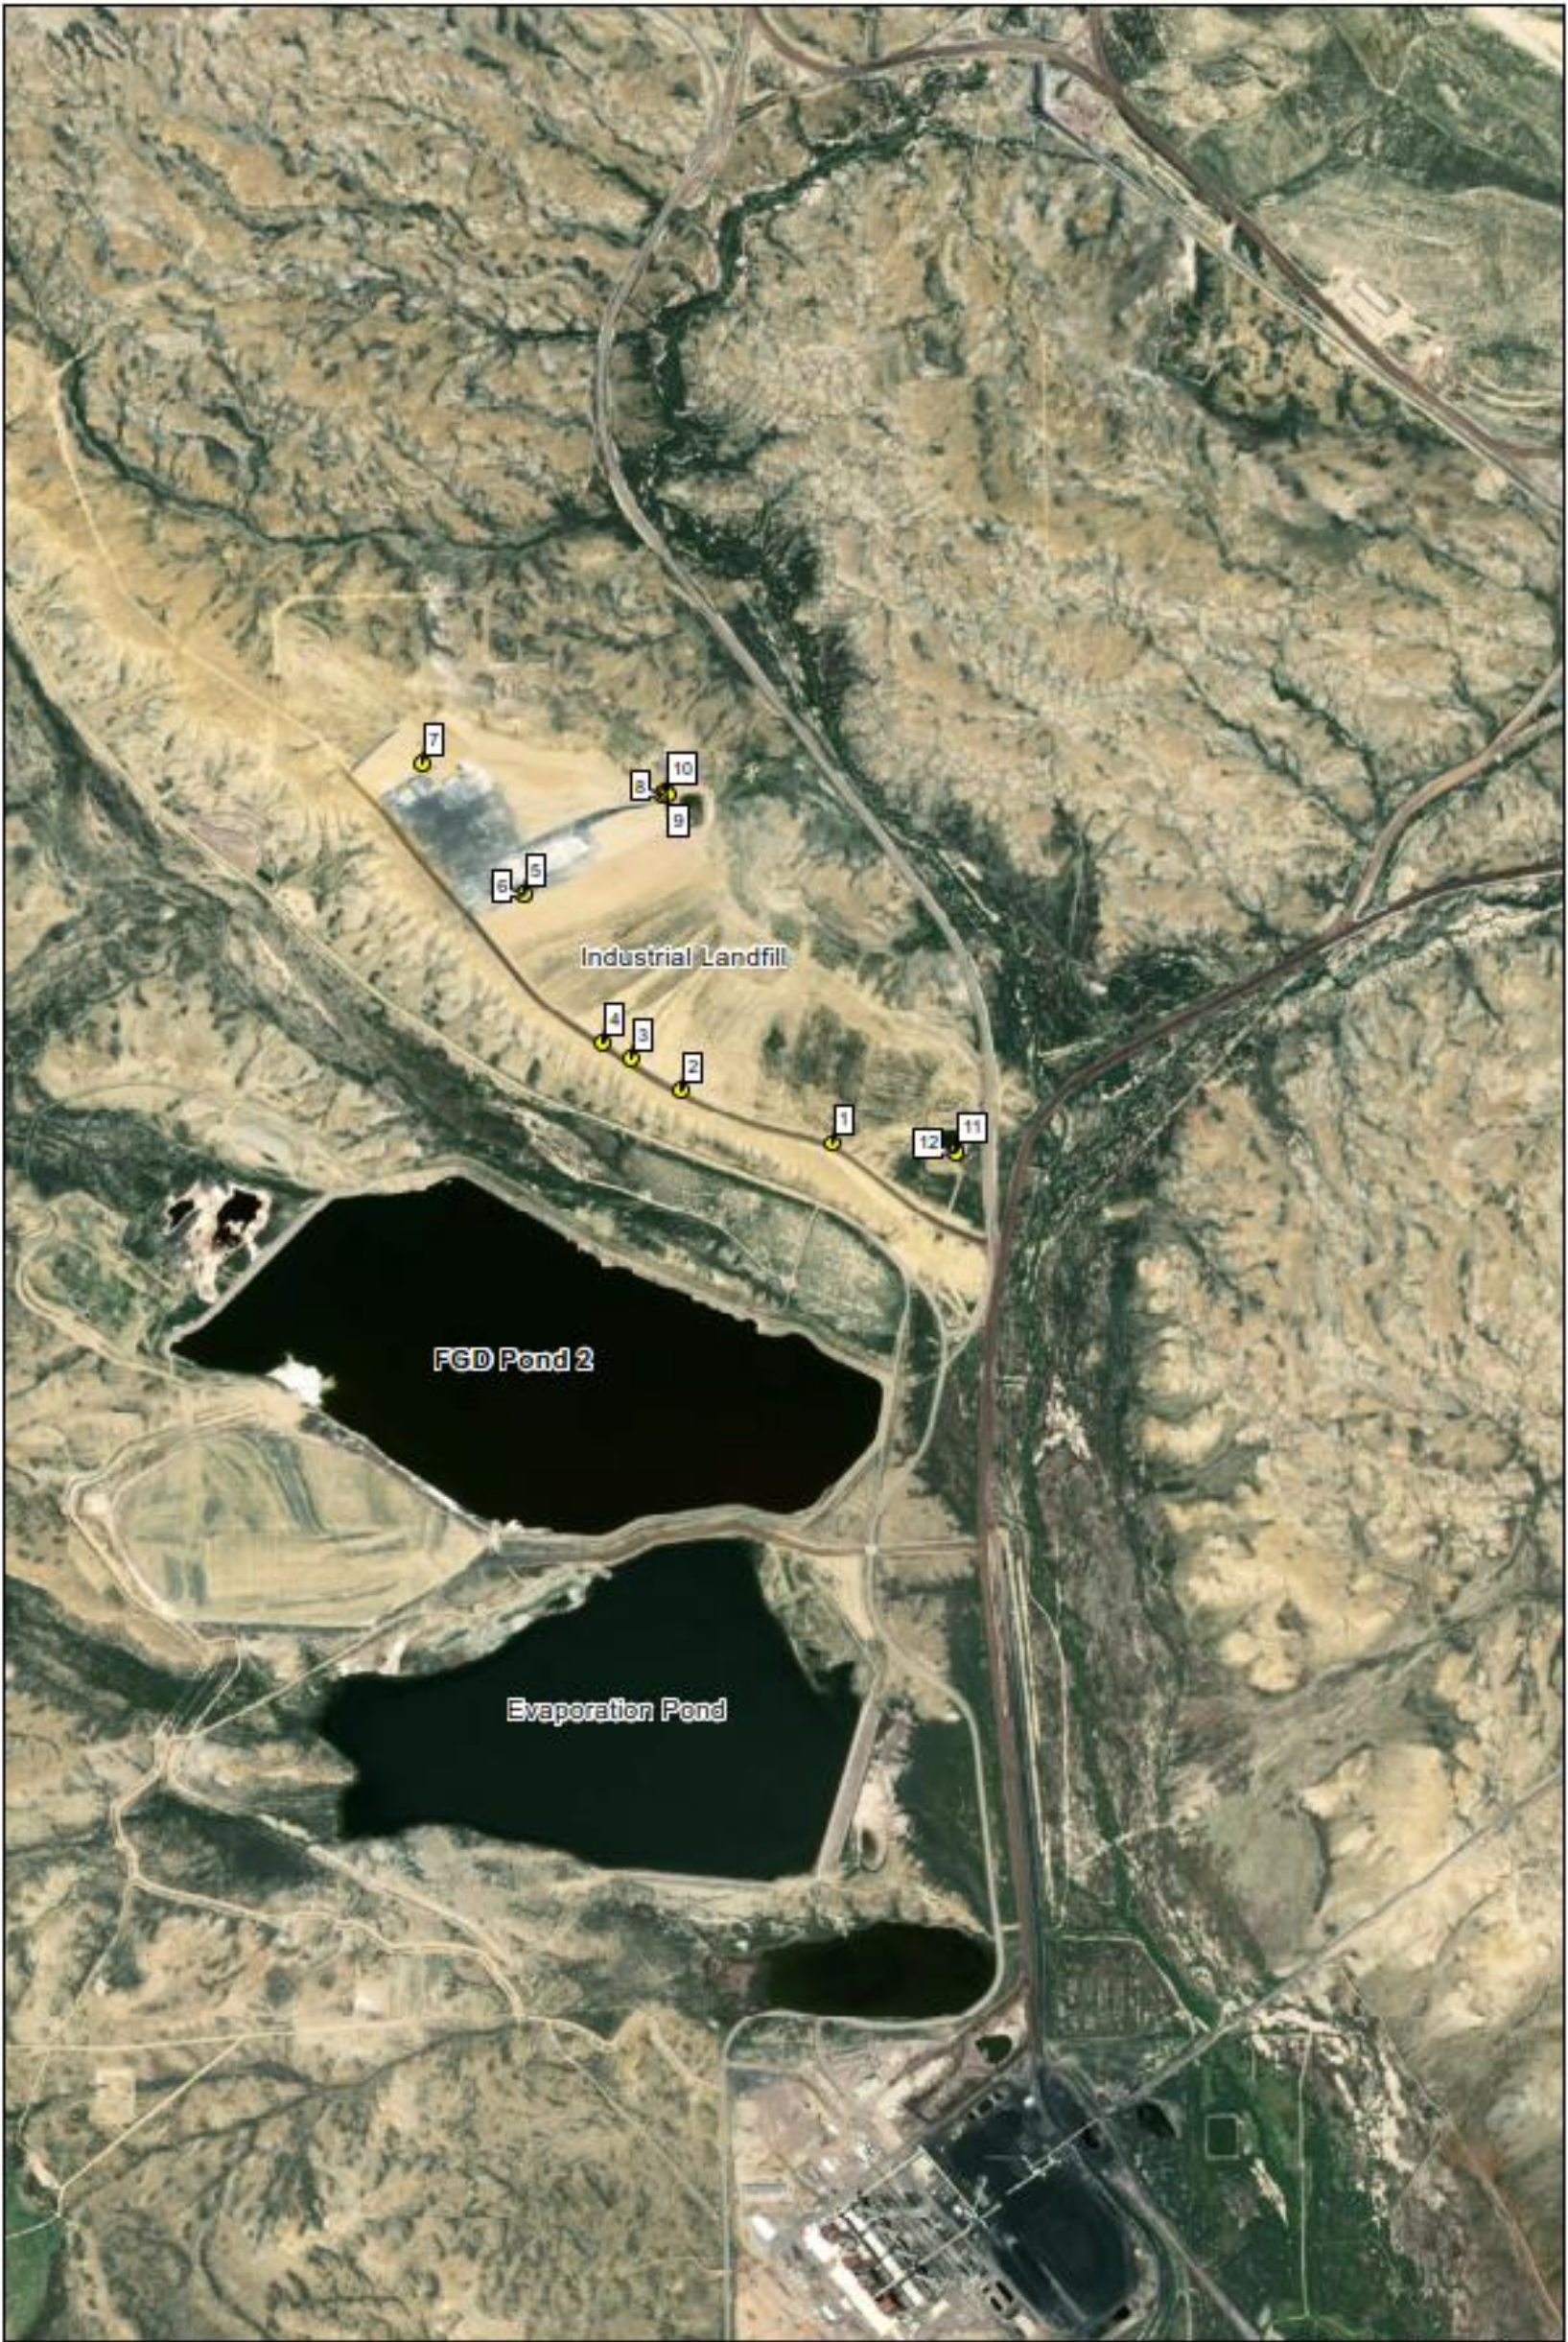
Features and conditions were documented on the Annual Inspection Report Form (Appendix B) and were photographed. The approximate locations of the photos are detailed in the inspection photograph log overview map located at the beginning of the Photograph Log in Appendix A. In addition to documenting current features, the photo log of existing conditions is intended to aid with future inspections.
