# 2019 Coal Combustion Residuals Annual Inspection

## Naughton Power Plant

### *North Ash Pond*

November 21, 2019

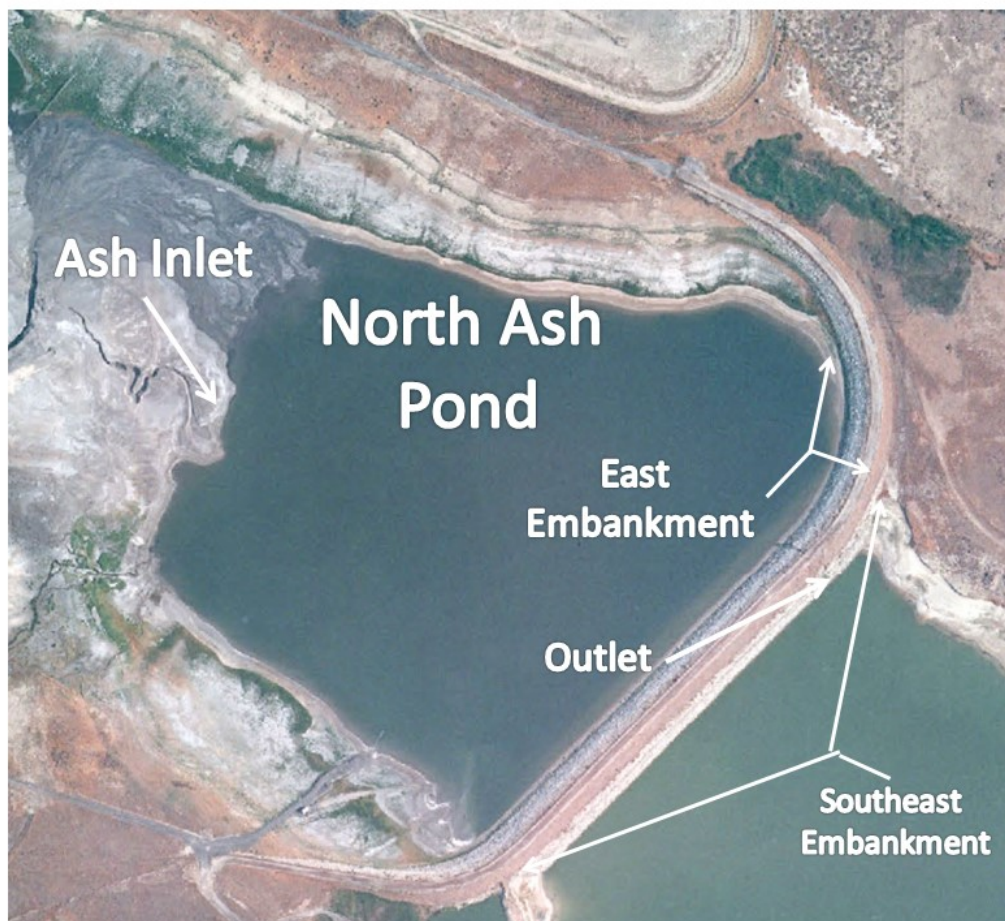
Figure 1-1. North Ash Pond

Figure 1-1 is an aerial image of the pond taken in 2018 by PacifiCorp (this is the most recent available aerial photo).

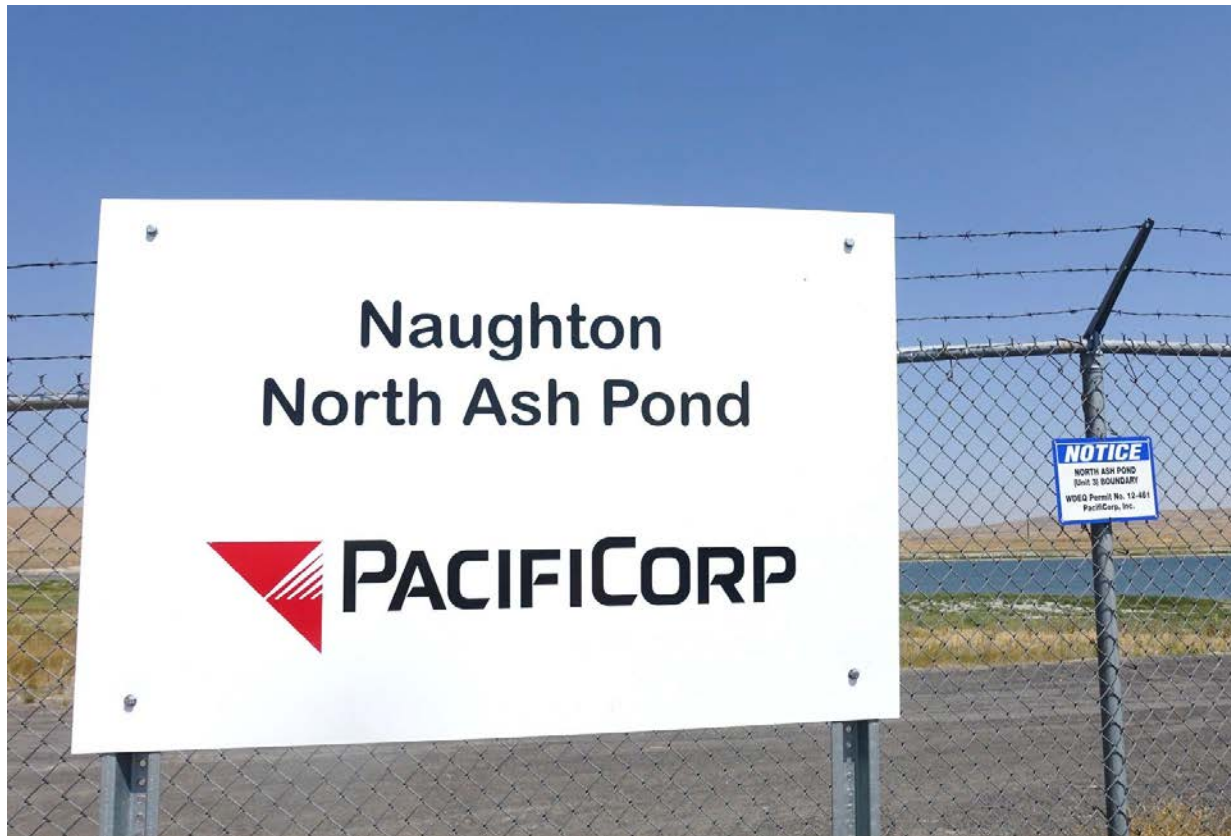
Figure 2-1. Signs for North Ash Pond

The Black & Veatch Construction Permit Application for Combustion Waste Disposal Expansion Volume 2 [2] contains a full set of drawings for the North and South Ash systems. Although it is stamped “Not to be used for construction”, it is also stamped by a professional engineer, and it is the most complete set of drawings. It was likely stamped not for construction because it was part of the application. AECOM relied on these drawings for this report on the assumption that few changes likely occurred between application and construction. Figure 2-1 shows the signs for the North Ash Pond. The smaller sign included the Wyoming Department of Environmental Quality Permit No. 12-461.

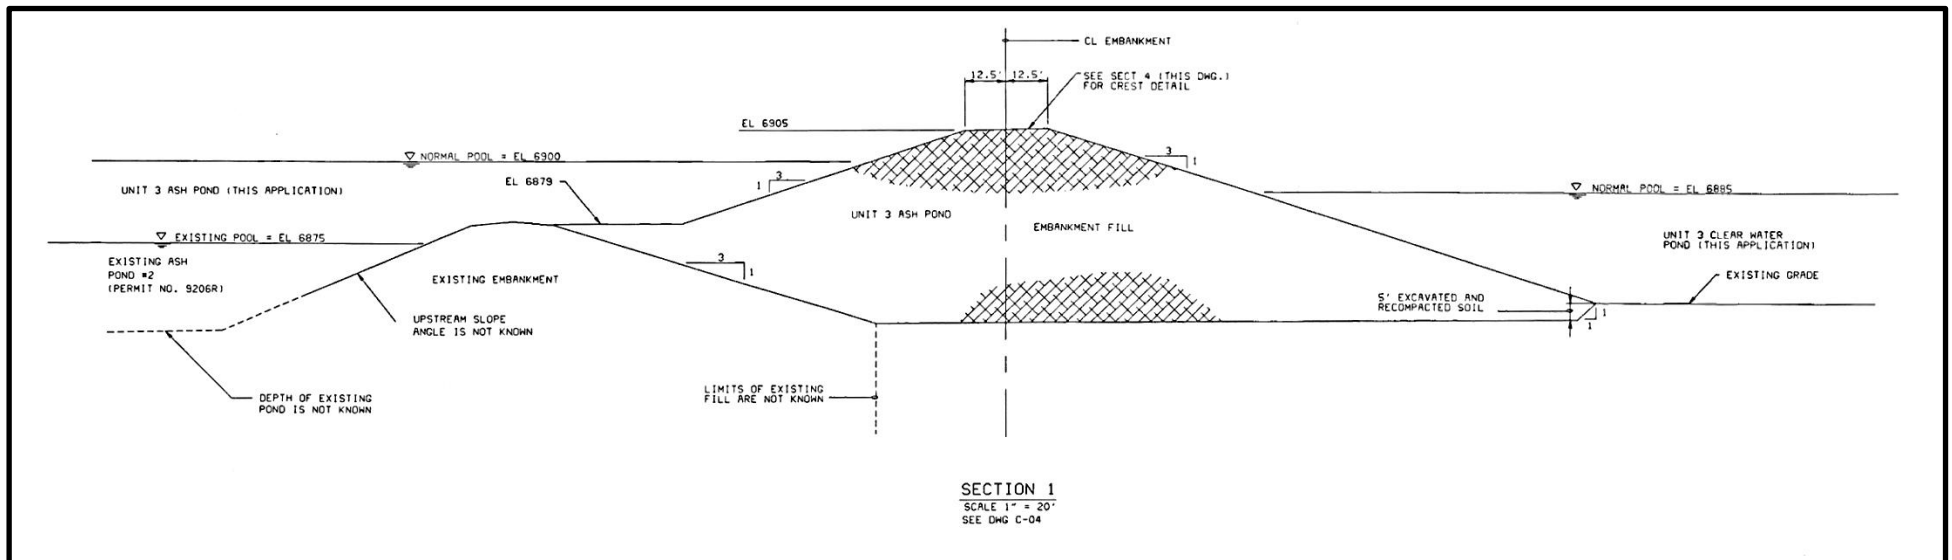
Figure 3-1. North Ash Pond Section [2]

The North Ash Pond is a homogeneous earthen embankment with no internal drainage system. The reservoir is unlined. Its horizontal configuration is comprised of a southeast and an east embankment as shown on Figure 1-1. Figure 3-1 below is a cross section of the current embankment showing its relationship to an earlier embankment at the upstream toe. It has a 25-foot crest width and upstream slopes of 3 vertical to 1 horizontal (3:1) and downstream slopes between 3 and 4 vertical to 1 horizontal [4]. Approximately half of the downstream face of the embankment is submerged by the North Clear Pond.
