Condit Hydroelectric Project Decommissioning

FERC Project No. 2342

POST-RESERVOIR-DEWATERING ASSESSMENT REPORT

February 22, 2012

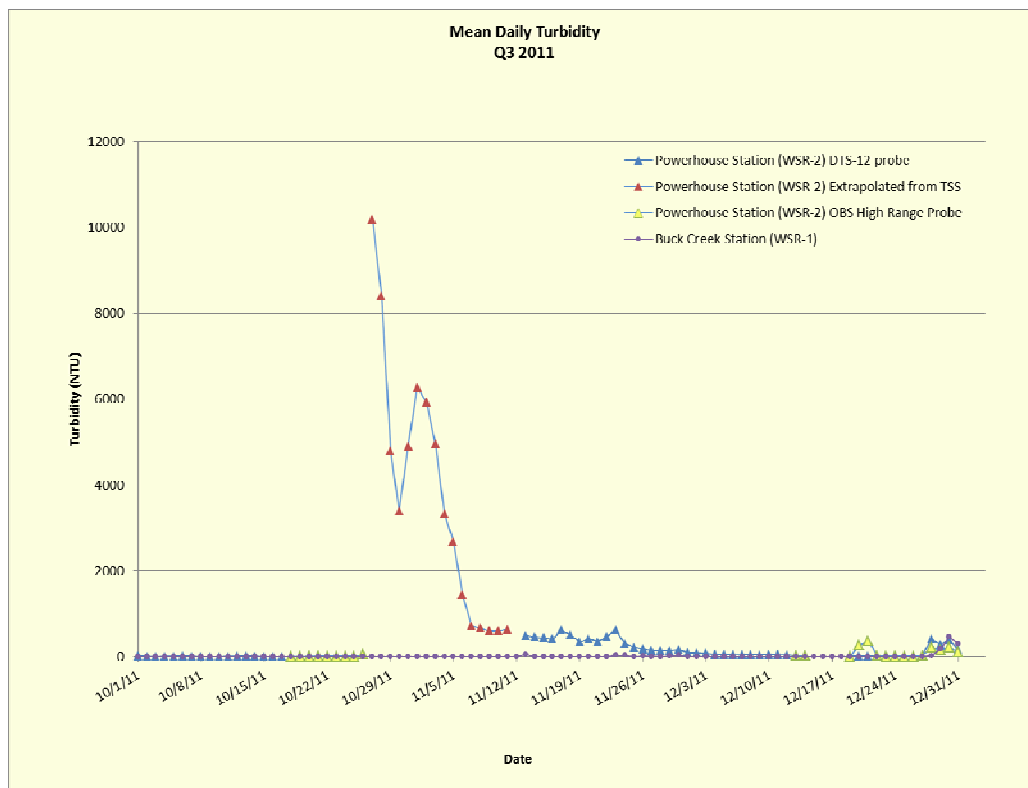
decreased, the turbidity measurements at the powerhouse also decreased, except during rainfall runoff events. Figure 1 indicates that baseline turbidity levels measured at the Powerhouse had dropped down to the range of 20-50 NTUs by early December.

Figure 1. Mean daily turbidity values October through December 2011. (Figure 2.1-3, Water Quality Monitoring Quarterly Report, October to December 2011)

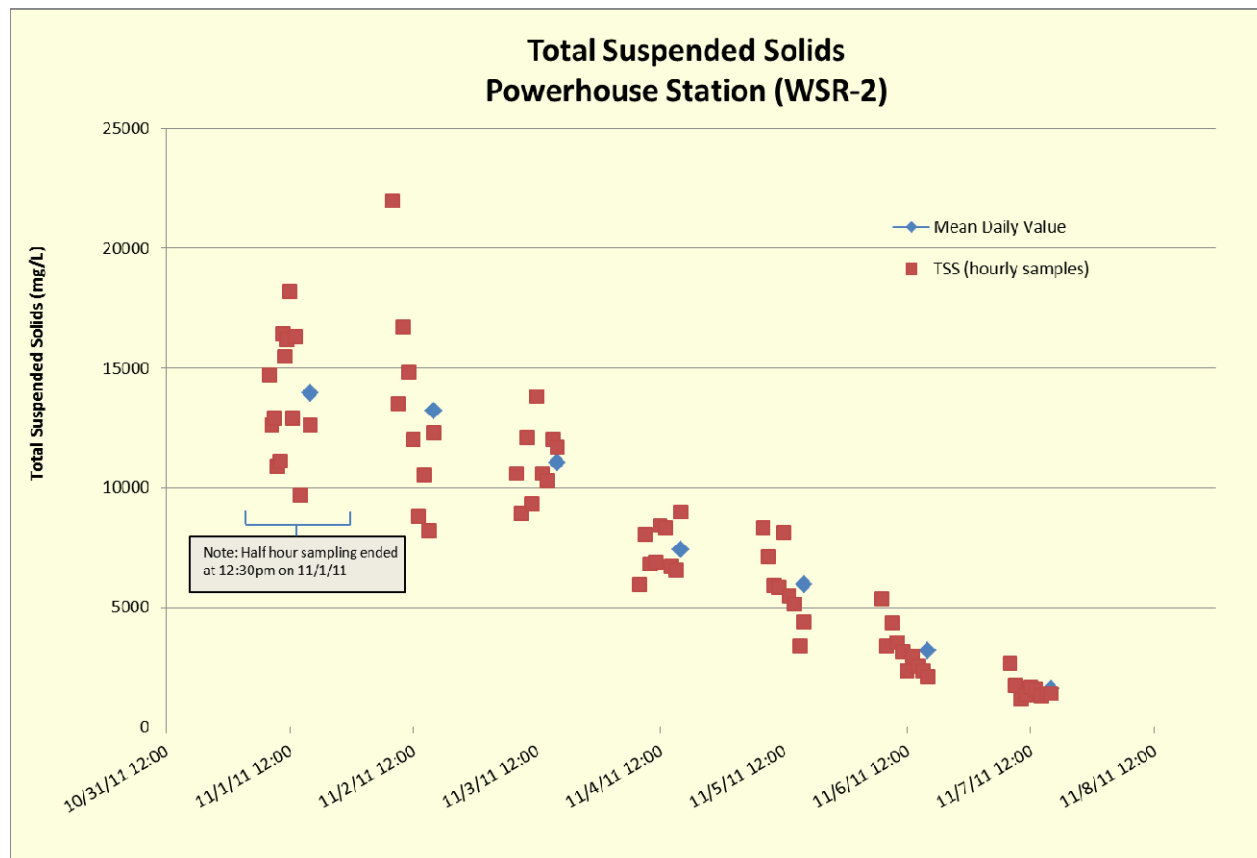
Sediment concentrations in the White Salmon River were observed to be extremely high as predicted in the Sediment Behavior Analysis Report (G & G Associates, 2004). The initial flood wave had a high concentration of suspended sediments (primarily silt size material) which quickly exceeded the upper limits for detection in the turbidity probes installed in the river. The probes had an upper limit for detection of 4,000 Nephelometric Turbidity Units (NTUs). Manual collection of water and suspended sediment samples commenced immediately and continued for the following two weeks, until the concentrations came down enough to be detected by the 4,000 NTU turbidity probe. Suspended sediment samples collected manually were tested in the laboratory for Total Suspended Solids (TSS). Measured data points are shown in Figure 2. The TSS fraction of the total sediment load was significant, but observations suggest that a large amount of bedload sediment transport was occurring simultaneously. Bedload sampling was not performed during or after the breach event, so there is no quantitative means to estimate the peak concentration of total sediment load in the White Salmon River. Based on field observations, it

is possible that the peak sediment load was in the range of 50,000 - 100,000 parts per million (PPM).

Figure 2. Total Suspended Solids for samples taken at the Powerhouse Station from October 26, 2011 to November 7, 2011.

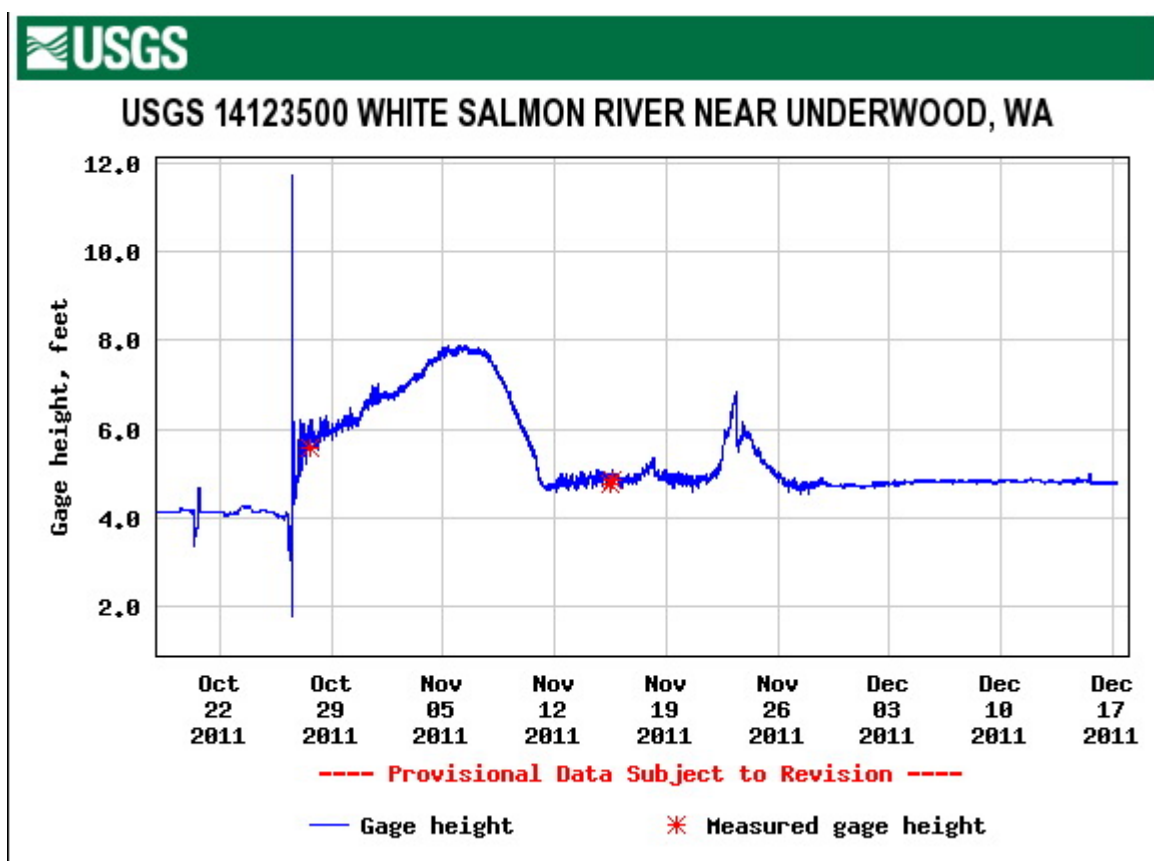
the river, allowing the excess sediments to be deposited in the riverbed. Beginning on approximately November 8, 2011, the sediment supply began to decrease, the sediment transport capacity of the river exceeded the supply, and channel bed elevations began to decrease (Figure 3). By approximately November 12, 2011, the river bed had returned to an elevation close to the pre-breach grade, and water stage readings stabilized.

Figure 3. White Salmon River gage height at USGS Gage 14123500. Provisional Data from October 22, 2011 to December 17, 2011 Subject to Revision.

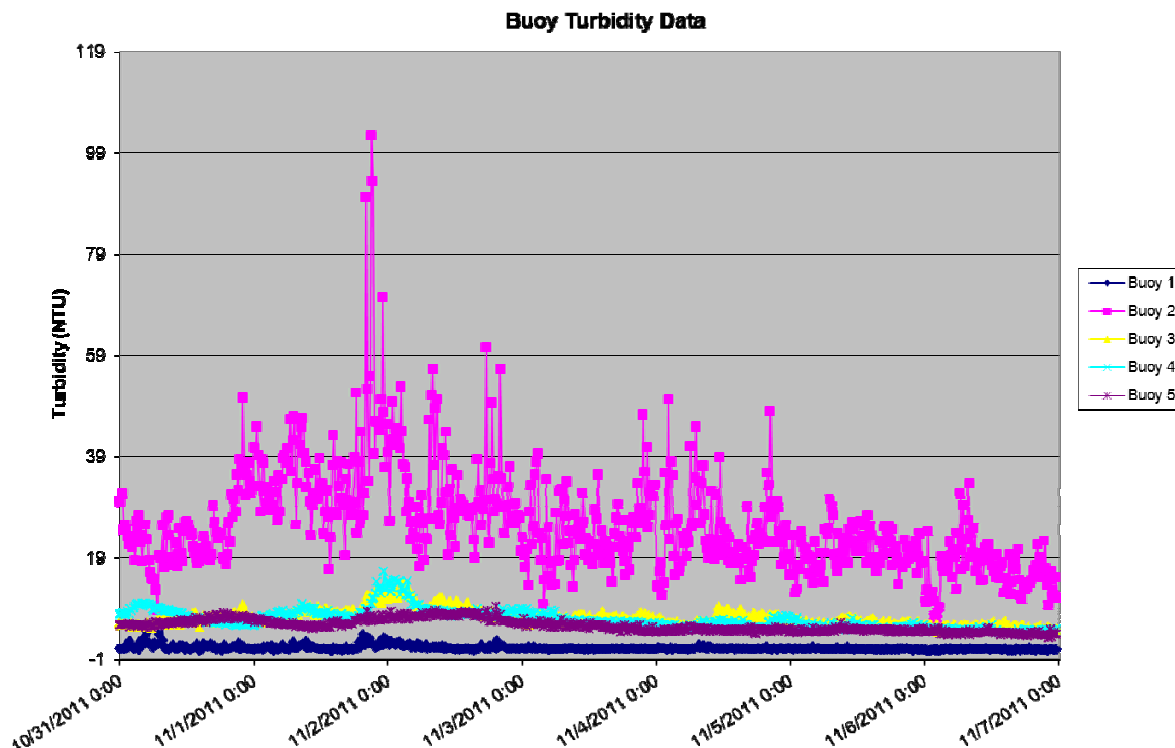
The dam breach event had an estimated peak flow rate of approximately 14,000 CFS, somewhat larger than the pre-breach estimate discharge of 10,000 - 11,000 CFS. Flows throughout the first week had significant suspended sediment concentrations (see Section 2.5). On the afternoon of October 26, 2011, a plume of muddy water was visible flowing out of the White Salmon River mouth and into the Columbia River. Increases in turbidity measured at buoys anchored in the Columbia River showed the progression of turbid water westward from the White Salmon River. Figure 4 shows the head of the suspended sediment plume reaching Bonneville Dam approximately seven days after the breach. The turbidity data collected at the buoys shows a general pattern of dilution as the sediment plume moved down the Columbia River. Buoy No. 2 was at the mouth of the White Salmon River, and buoys Nos. 3, 4, and 5 were progressively further downstream. Buoy No. 1 was also in the Columbia River, but it was upstream of the White Salmon River confluence.

Figure 4. Columbia River turbidity data from five monitoring buoys.

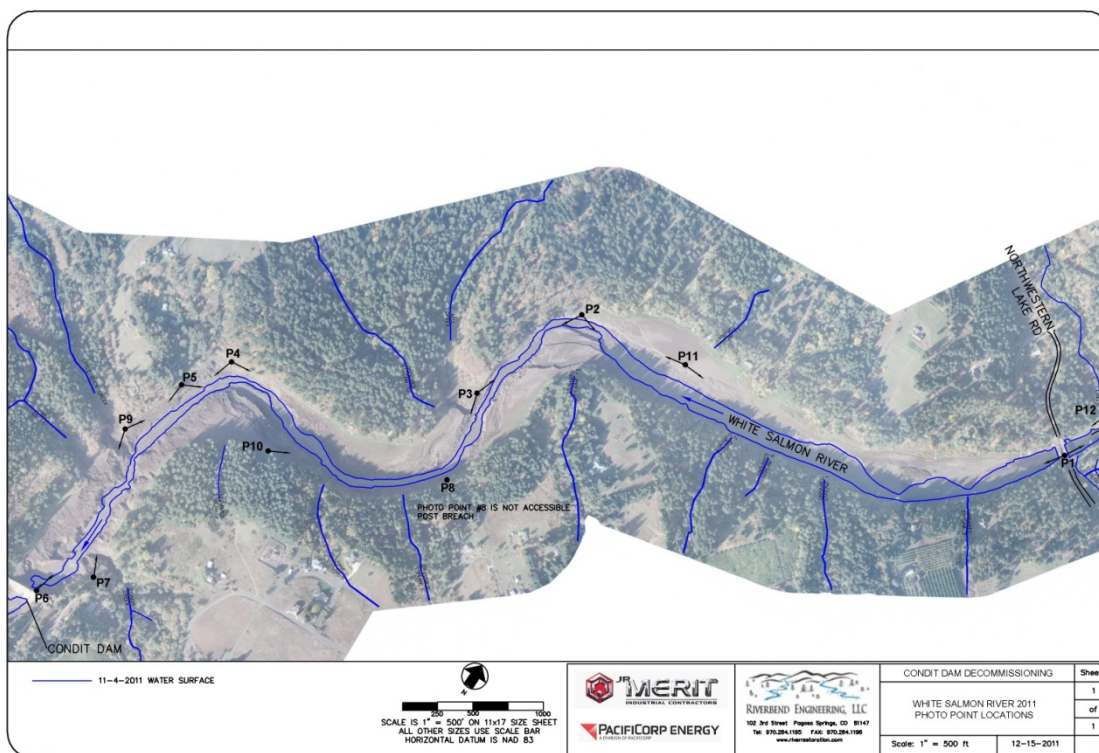
Figure 7. Photo point locations upstream of the Condit Dam.

Photographs of the changes in reservoir sediments were collected at 12 photo point locations. Photos were taken on breach day, on each of the following six days, and then weekly for a total of six weeks. These photo sequences show the evolution and erosion of sediments within the former reservoir area. Photo point locations (P1, P2, etc.) are shown in Figure 7. In some locations repeat photos were taken looking upstream and downstream. All of the photo sequences are provided in Appendix D. Each photo sequence in the appendix was continued until visible changes to the reservoir sediments were no longer evident. Data from Photo Point #8 had to be terminated when the soil at that location collapsed into the river. Data from Photo Point #12 commenced once the headcutting and erosion had moved upstream past Northwestern Lake Bridge.
