**CLEAR CREEK & CLEARWATER CREEK
GEOMORPHIC & HYDRAULIC
ASSESSMENT MEMO**

Gifford Pinchot National Forest
Mt Adams Ranger District
2455 Hwy 141
Trout Lake, WA 98650

DJ&A, P.C.
2000 Maple Street
Missoula, MT 59808

October 11, 2022

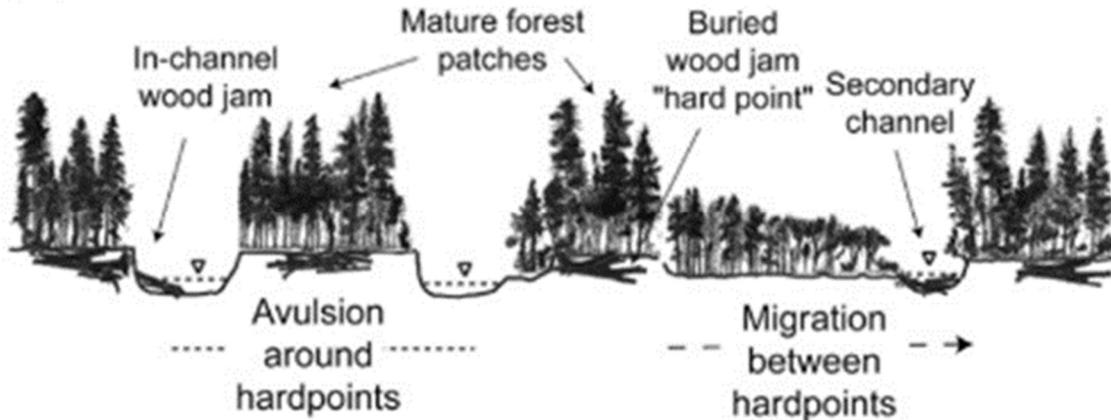
The geomorphic characteristics of Clear Creek appear to be primarily controlled by valley confinement and the recruitment of old growth trees. In locations where confinement is reduced, considerable habitat complexity is present as a result of the recruitment of key pieces and the formation of large, valley jams. Collins et al., (2012) described conceptual models of floodplain landform and forest development in western Washington, including an anastomosing channel pattern driven by avulsion (Figure 9). Hardpoints created by persistent wood jams protect patches of forest

by resisting lateral erosion and causing the channel to avulse around. This conceptual model was observed throughout, and fits well with the observed stream response in unconfined portions of Clear Creek. Fitting with field observations and with the conceptual model, increasing the number of stable hard points in the unconfined sections of Clear Creek will drive increases in habitat complexity and the large wood cycle.

Figure 9. Conceptualization of an anastomosing channel pattern and forest succession driven by avulsion around hardpoints (Collins et al., 2012).
