### Subject: Merwin Trap Upgrades

### **Merwin Trap Operating Condition Improvements**

# **MERWIN HYDROELECTRIC PROJECT**

# **FISH TRAP UPGRADES**

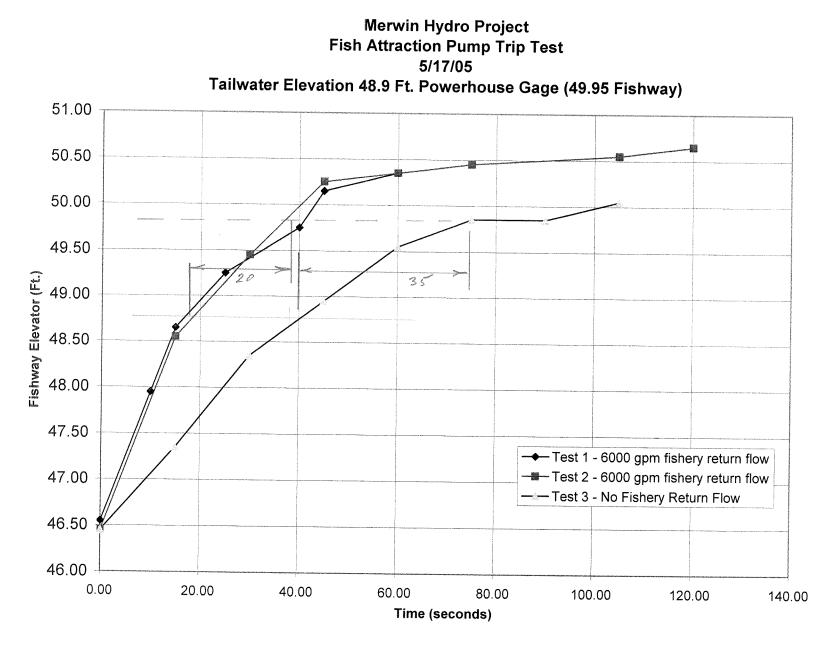
Figure 2

The data recorded during the pump trip tests is provided in Table 1 and is plotted on Figure 2. During the tests, flow meter measurements of the flow through the fish bypass piping were attempted but the readings are inconsistent and are not reliable; which may be caused by unstable flow conditions. The water level in the fishway was measured by both the staff gage in the fishway and the reading from the powerhouse control system. However, based on the calibration performed prior to the test, the staff gage readings in the fishway are considered the most accurate and have been used in this analysis.

As shown on Figure 2, the time for the water level to rise from elevation 48.75 ft (level when the fish are sorted) to the tailwater elevation of 49.8 Ft. during tests was determined to be:
