**Subject: Yale Hydroelectric Project, FERC No. P-2071
SA 11.2.2.2 and License Article 406, Yale/International Paper (IP) Road Phase One**

On June 26, 2008, the Federal Energy Regulatory Commission issued a new operating license for PacifiCorp Energy's Yale Hydroelectric Project (P-2071). Article 406, *Yale/International Paper (IP) Road Trail Plan*, of this license directs PacifiCorp to complete a trail technical assessment for approximately ten miles of former logging road on the eastern shore of Yale Lake, by the fourth anniversary of issuance of the new license (December 26, 2012). Furthermore, on June 28, 2012 PacifiCorp received an order granting an extension of time to submit for Commission approval by March 1, 2013. Much of this road has been closed since 2008 due to illicit activities and unsafe road conditions caused by erosion, landslides, and rock fall hazards.

The Yale Lake IP Road project is associated with the relicensing agreements for the Merwin, Swift, and Yale hydroelectric projects on the Lewis River. As part of the Yale Lake relicensing, PacifiCorp has been directed to complete a trail feasibility analysis for approximately ten miles of former logging road on

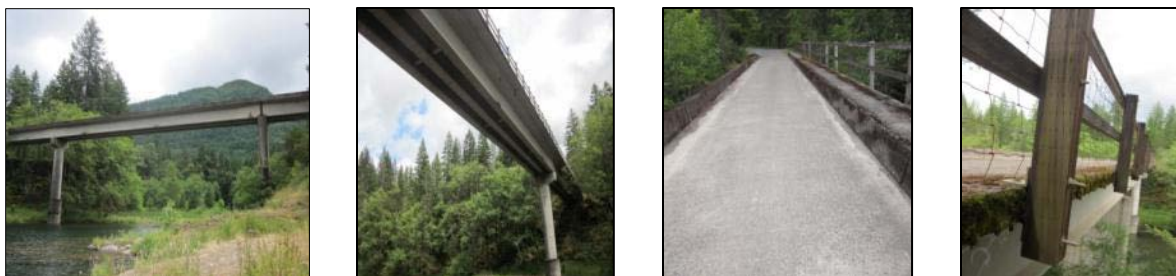
Figure 33: Lewis River Bridge (4 views)

The Lewis River Bridge, which spans Lewis River was built in 1967. This bridge is a high level pre-stressed (Bulb-T) concrete bridge with a total length of 325 feet (130-130-65). No defects were noted on the bridge, and all primary load carrying members appear fully structurally sound.

The bridge contains a 14-foot-wide roadway and a 3.5-foot-wide sidewalk.
