Yale Lake IP Road Trail

Implementation Plan

PacifiCorp

December, 2012

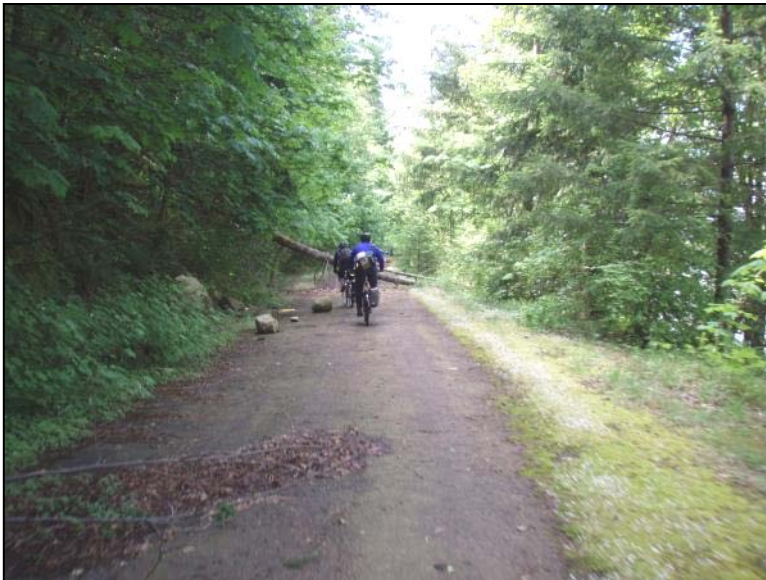
Figure 12: Pavement in Good Condition in Segment 2

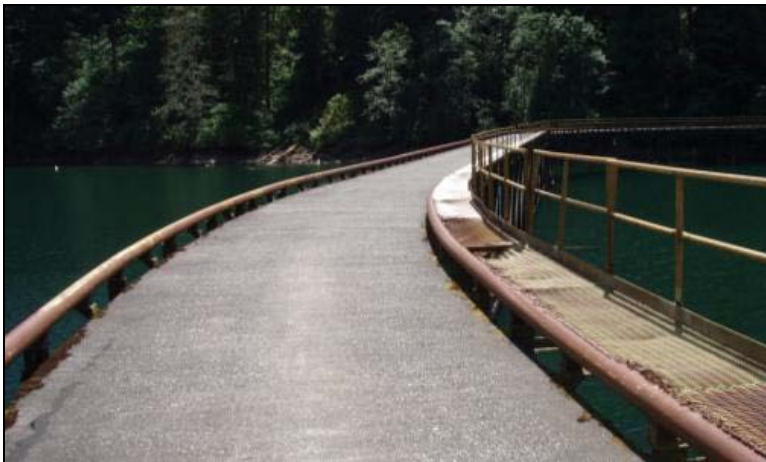
Overall the path surface in Segment 4 is in good condition for use as a trail. The beginning of the segment is at the Siouxon Bridge, which is in good condition but which will require guardrail and handrails for bicycle and pedestrian safety. However, this segment of the trail contains a large portion of unpaved road. In addition to the condition of the trail, there are several gates that limit access to the entire segment.

Figure 28: Siouxon Bridge at the Beginning of Segment 4

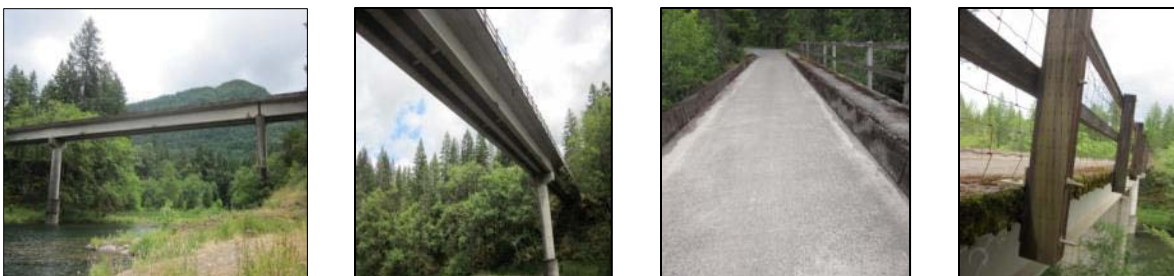
The Lewis River Bridge, which spans Lewis River was built in 1967. This bridge is a high level pre-stressed (Bulb-T) concrete bridge with a total length of 325 feet (130-130-65). No defects were noted on the bridge, and all primary load carrying members appear fully structurally sound.

Figure 33: Lewis River Bridge (4 views)
