Lewis River Dispersed Campsites Program

Dispersed Site Monitoring Report

**Prepared by
Mason, Bruce & Girard, Inc.
Portland, Oregon**

January 2010

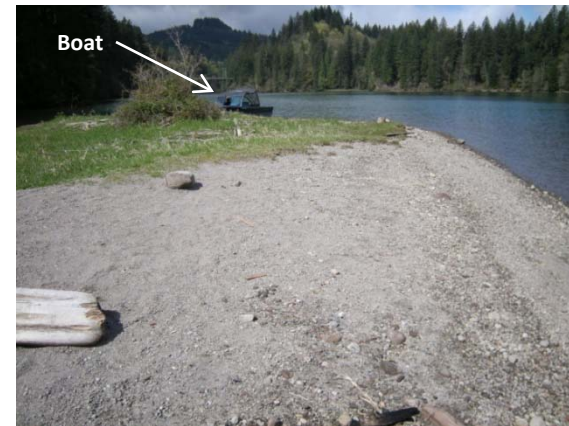
Photo Direction: West

Description/Notes: Western edge of campsite M1 S. Suitable boat access from western end of island.

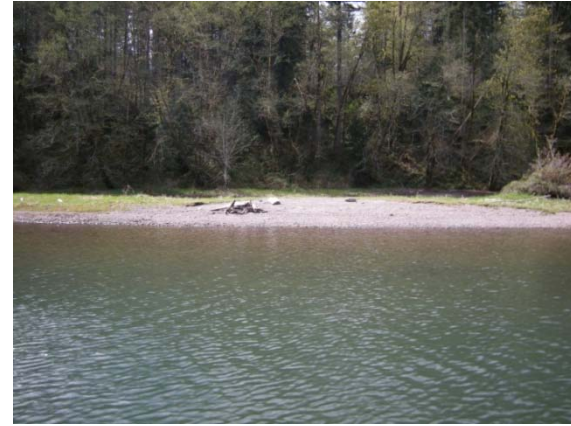
Photo Direction:
South

Description/Notes: View of campsite M1 S, as seen from the reservoir. Campsite encompasses gravel beach area.

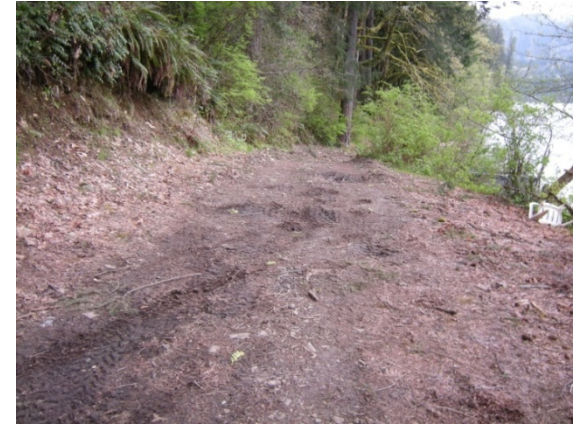
Photo Direction: West

Description/Notes: Western edge of campsite M2 S. Dirt road slopes steeply towards reservoir.

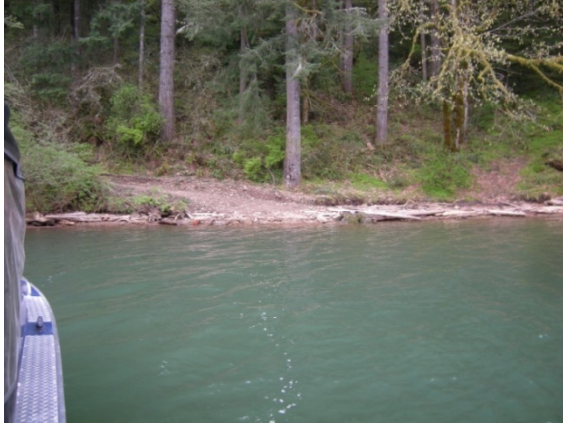
Photo Direction: East

Description/Notes: View of campsite M2 S, as seen from the reservoir, looking south. Suitable boat access point located at end of old dirt road.

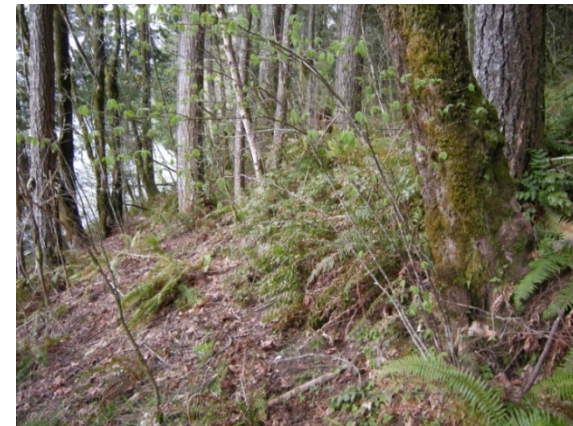
Photo Direction: West

Description/Notes: Mapped location of campsite M3 N. Location not suitable for campsite.

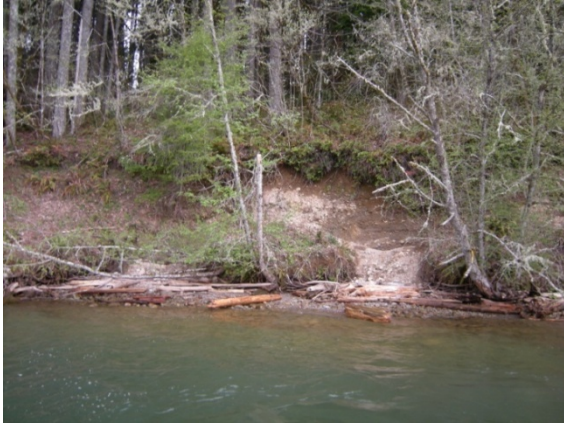
Photo Direction:
North

Description/Notes: View of campsite M3 N, as seen from the reservoir, looking north. Note steep slope and thick vegetation.

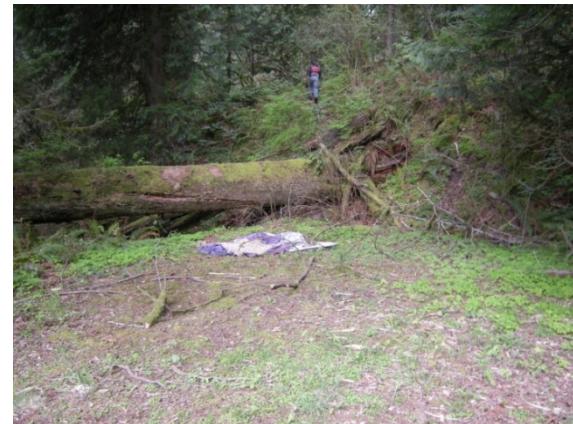
Photo Direction: West

Description/Notes: Large, open tent area at western end of M4 N. Faint trail extends to west.

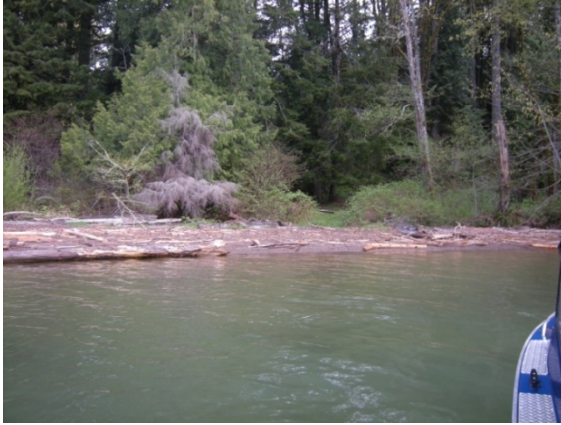
Photo Direction:
North

Description/Notes: View of campsite M4 N, as seen from the reservoir, looking north. Note wide beach and easy boat access.

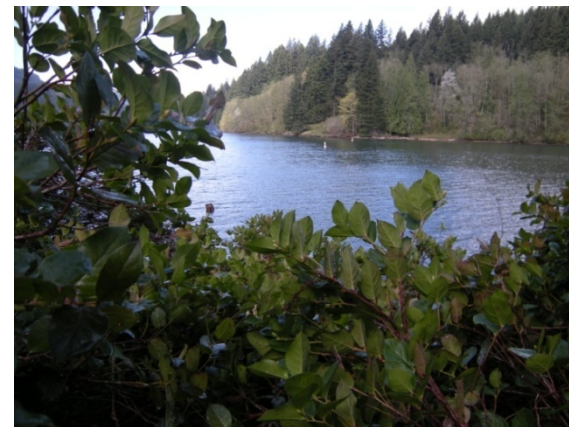
Photo Direction: West

Description/Notes: View towards Merwin Reservoir from mapped location of M5 N.

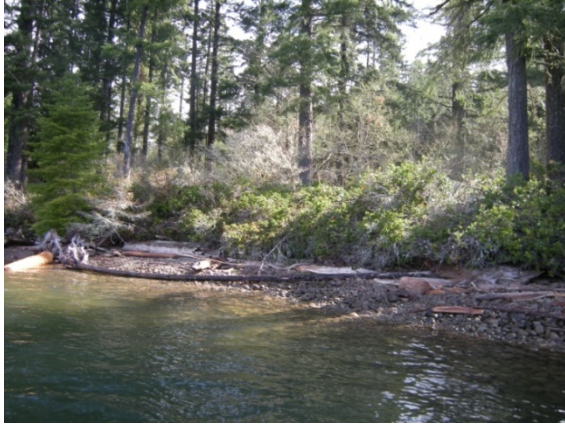
Photo Direction:
North

Description/Notes: View of mapped location of campsite M5 N, as seen from the reservoir. Note dense undergrowth. No evidence of use was observed.

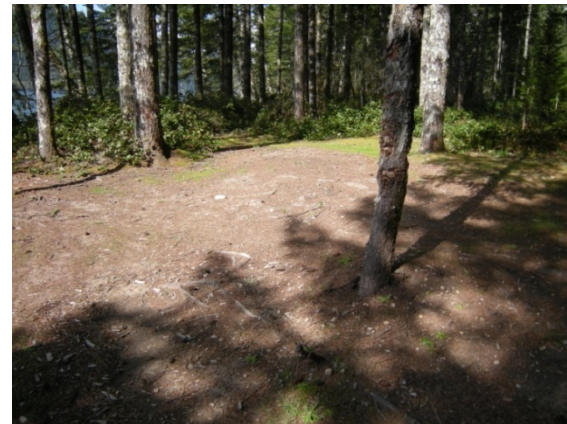
Photo Direction: West

Description/Notes: Western extent of campsite M6 N. Note exposed roots throughout site.

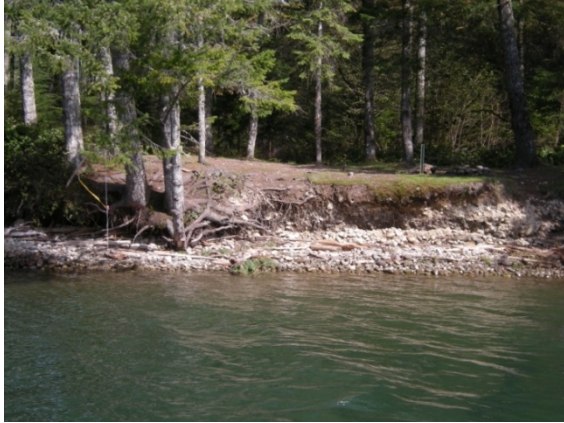
Photo Direction:
North

Description/Notes: View of campsite M6 N, as seen from Merwin Reservoir. Note steep cut bank between boat access point and campsite.

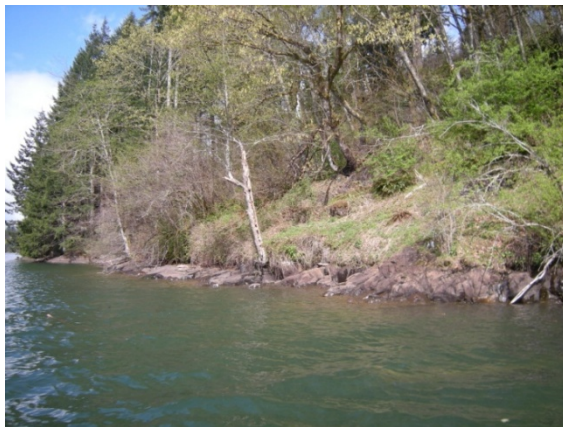
Photo Direction:
Northwest

Description/Notes: Mapped location of M7 N. Due to steep slope, this area is unsuitable for campsite.

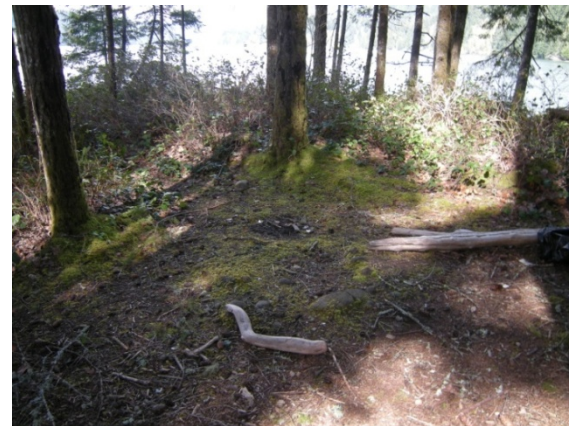
Photo Direction: West

Description/Notes: Western extent of campsite M8 N. Path extends to additional clearing.

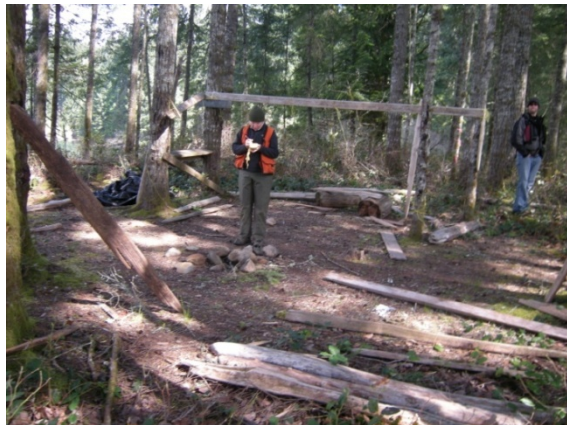
Photo Direction:
North

Description/Notes: General view of campsite M8 N. Note wooden structure and numerous driftwood pieces. Surveyor in orange vest is standing at site center (fire ring).

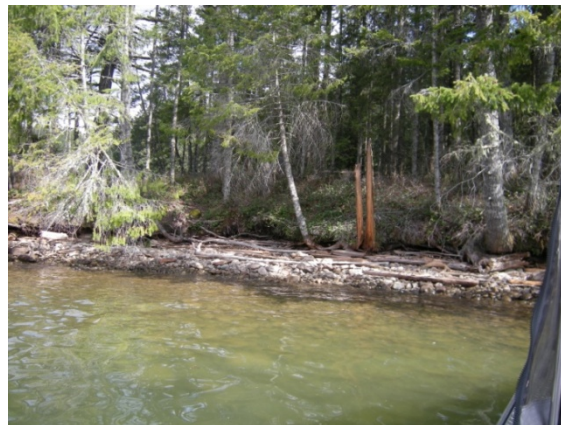
Photo Direction:
North

Description/Notes: View of campsite M8 N, as seen from Merwin Reservoir. Banks are undercut at this location, but campsite can still be easily accessed from the water.

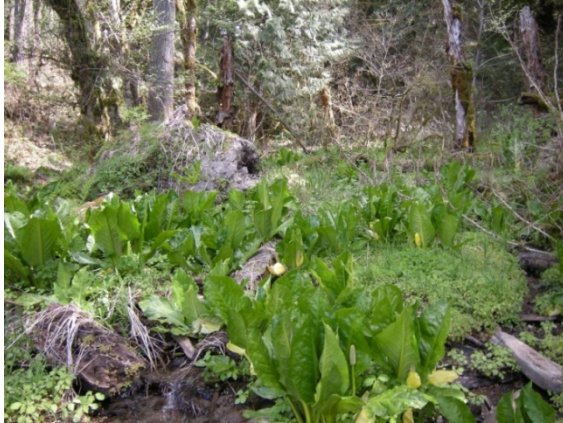
Photo Direction:
North

Description/Notes: Small stream and associated wetland encompass the mapped location of M9 N.

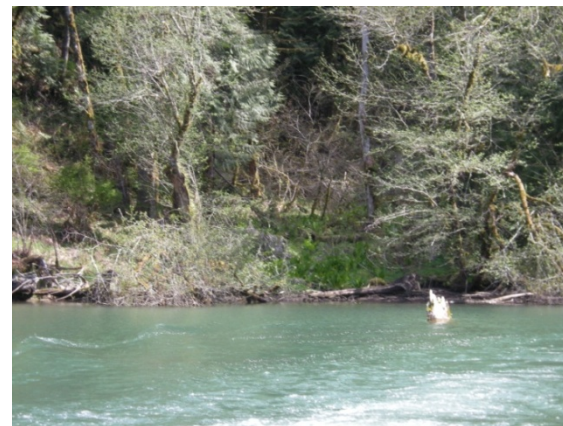
Photo Direction: West

Description/Notes: Mapped location of M9 N, as seen from reservoir. Note stream/wetland, center.

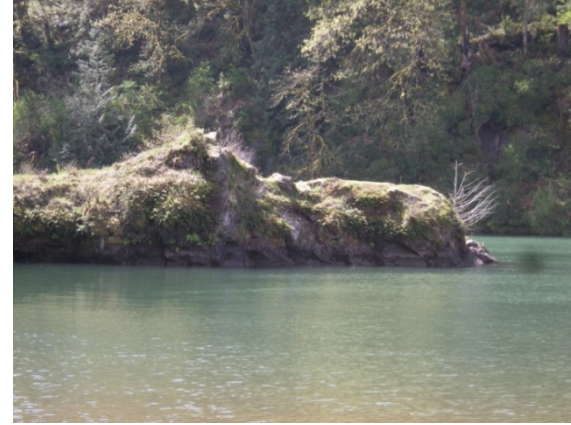
Photo Direction:
Southeast

Description/Notes: Mapped location of campsite M10 N. No evidence of site was observed.

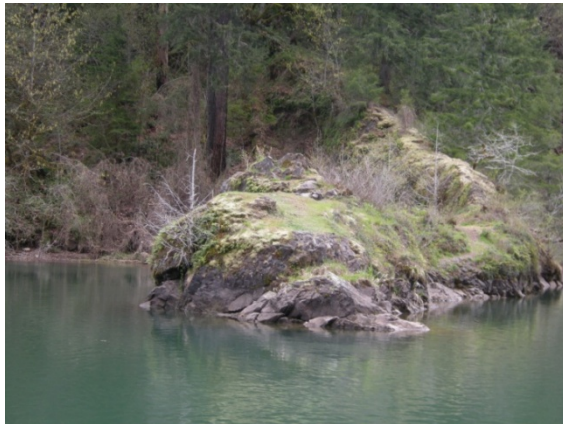
Photo Direction:
Northeast

Description/Notes: Steep, narrow, rocky peninsula is unsuitable for campsite. Footpath observed.

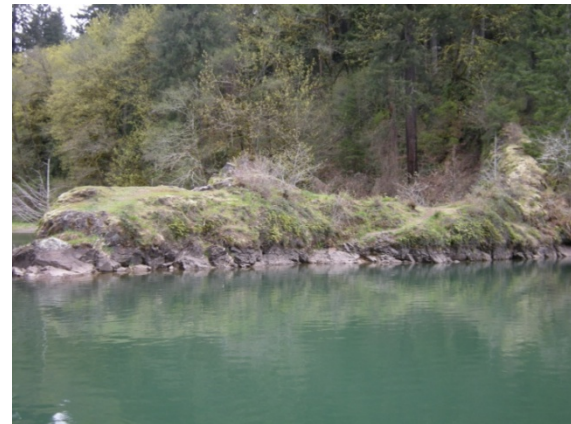
Photo Direction:
North

Description/Notes: Mapped location of M10 N, as seen from reservoir. Difficult access from water.
