# Lewis River Aquatic Fund Projects (SA 7.5.3.2)

## Project Closeout Report

<b>Project Title:</b>	<b>Lewis River Hydroelectric Project Cedar Creek Reach 1A Restoration</b>
<b>Project Approved By:</b>	Aquatic Coordination Committee March 27, 2013
<b>Original Project Sponsor:</b>	Lower Columbia Fish Enhancement Group
<b>Project Funding</b>	Aquatic Coordination Committee - \$53,000 + \$12,931.00 (insurance expense) -
<b>Project Description (work completed):</b>	<ul style="list-style-type: none"><li>• Installed 150+ pieces of large wood in stream channel</li><li>• Installed 15+ logjams</li><li>• Installed 4 floodplain roughness logs</li><li>• Excavated a 100' long alcove rearing channel</li><li>• Re-directed perennial tributary to increase habitat function</li><li>• Removed/ controlled 2 acres of invasive non-native vegetation</li><li>• Installed 2,000 native trees and shrubs</li><li>• Installed boater safety sign upstream of project site</li></ul>
<b>Workforce:</b> <ul style="list-style-type: none"><li>○ <b>Personnel (by craft)</b></li><li>○ <b>Contractors:</b></li></ul>	<ul style="list-style-type: none"><li>• Bill Norris, P.E. Interfluve</li><li>• Peter Barber, LCFEG Project Manage

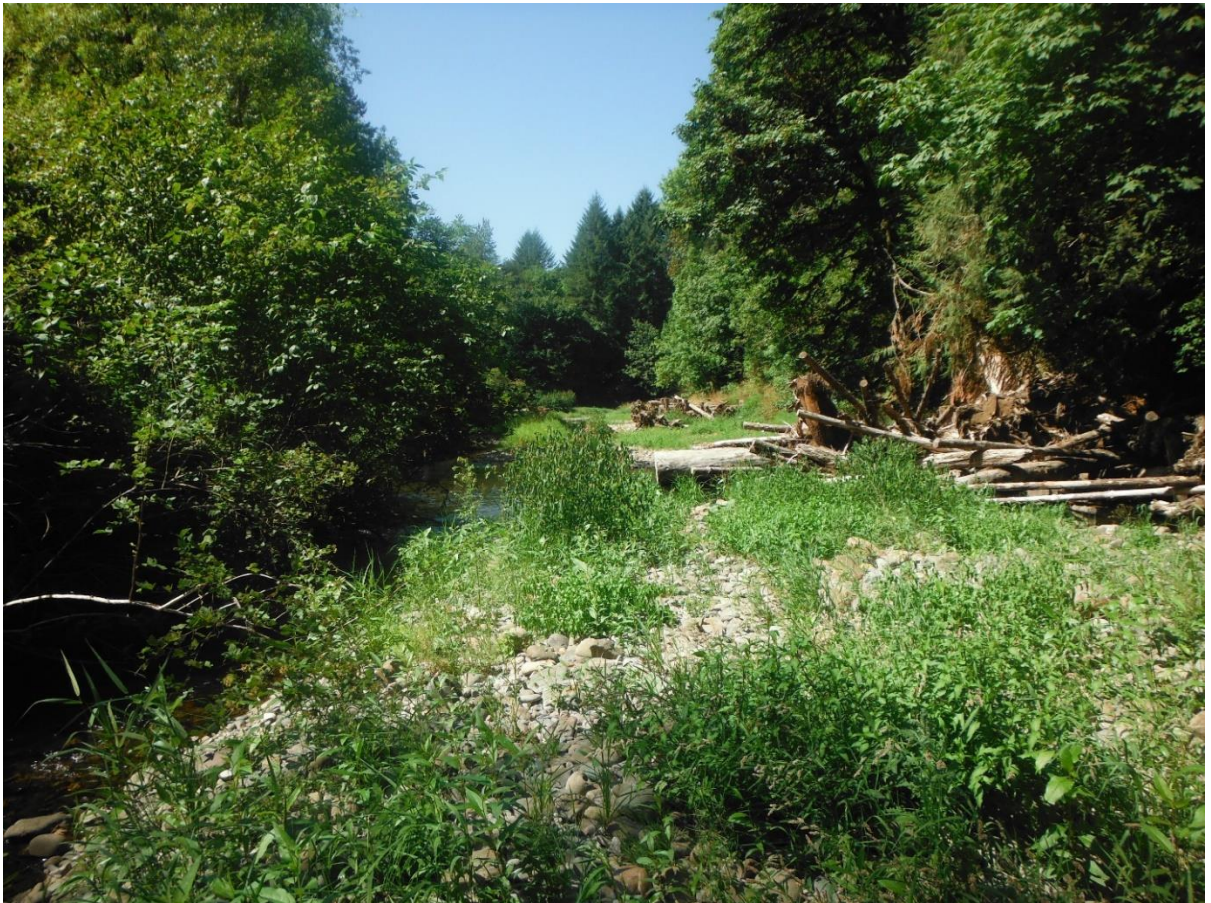
View downstream at OHW and OLW

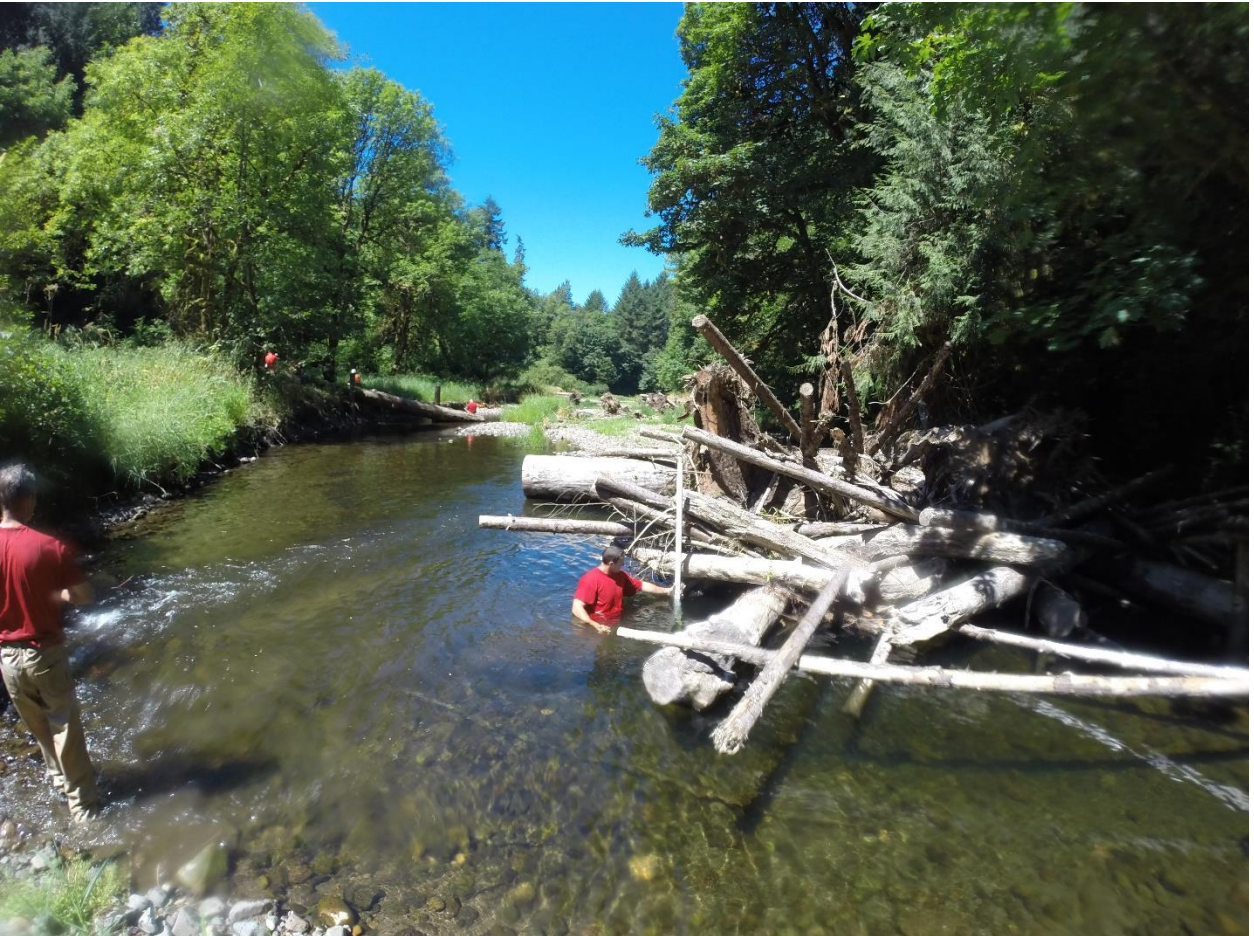
Checking post project pool depth
