## 5.7 TRIBUTARY STREAM STUDY (TER 7)

**Lewis River  
Hydroelectric Projects**

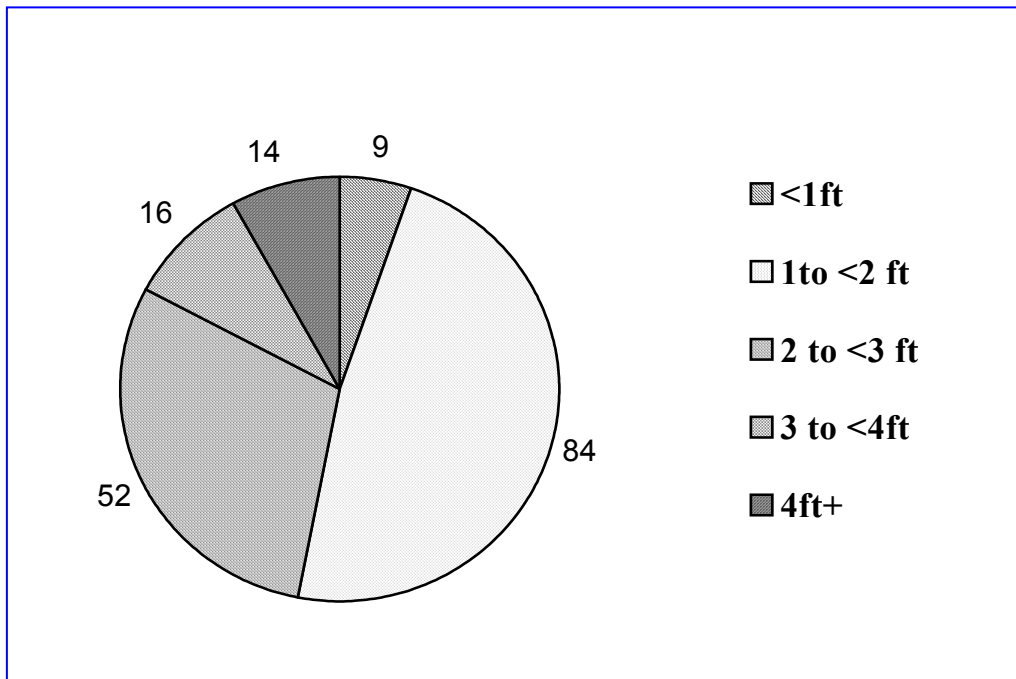
**Figure 5.7-3. Stream culvert diameter, 2000-2001 data (N=175).**

Stream culvert sizes in the study area were variable, ranging in diameter from about 1 to 10 feet (0.3 to 3 m) and in length from 4.3 to 143 feet (1.3 to 43.6 m) (Figure 5.7-3 and Table 5.7-3). The majority of culverts, however, are 1 to 2 feet (0.3 to 0.6 m) in diameter and average 42 feet (12.8 m) in length.

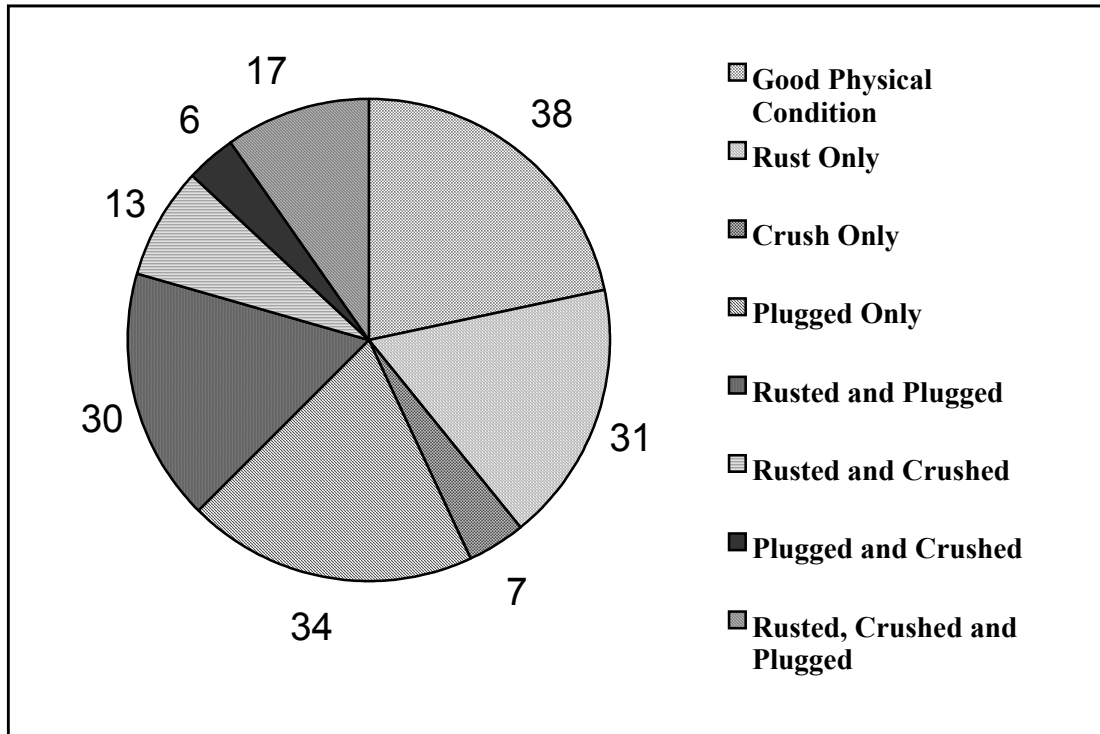
Figure 5.7-4. Stream culvert inlet condition, 2000-2001 data (N=176).

Overall, 78 percent of stream culvert inlets and 62 percent of the outlets show signs of rusting, crushing, and/or plugging (Figures 5.7-4 and 5.7-5). An example of a culvert with some rust, crushing, and plugging is shown in Figure 5.7-6.

Plugged and crushed culverts are a more significant concern than rusted culverts because they can result in flooding and erosion. Over 62 percent of culvert inlets were at least partially crushed or plugged, as were 20 percent of the outlets. Three culverts had either inlets or outlets that were crushed more than 50 percent. Plugging is a more extensive problem; 27 stream culvert inlets and 8 outlets were more than 50 percent plugged. Crushed and plugged culverts are also problematic for the passage of small mammals and amphibians.

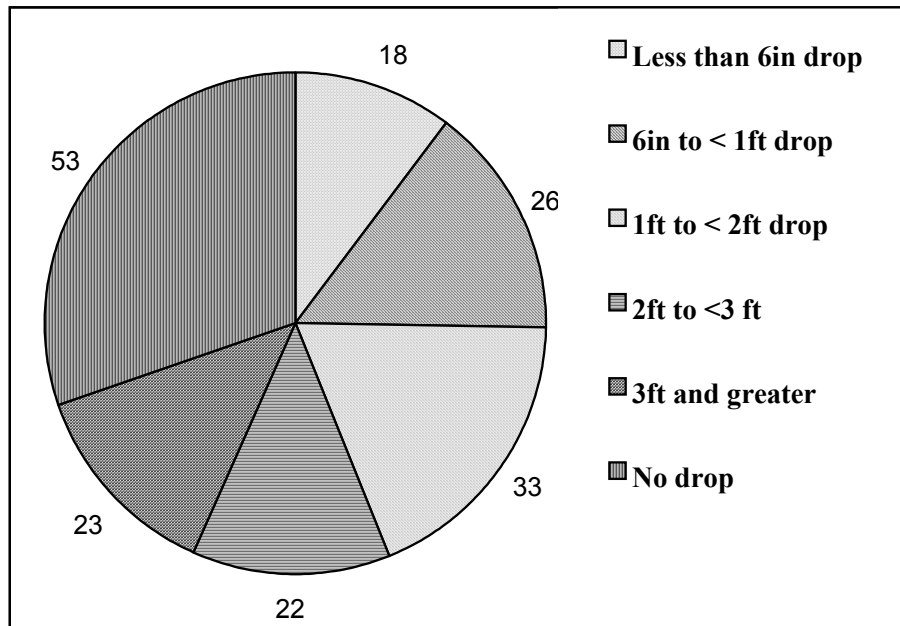
**Figure 5.7-7. Stream culvert outlet drop (shotgun), 2000-2001 data (N=175).**

Over 70 percent of the stream culverts surveyed had a drop from the outlet to the ground (Table 5.7-3 and Figure 5.7-7). An outlet drop example is shown in Figure 5.7-8.
