**EROSION CONTROL PLAN  
5-YEAR ROLLING ACTION PLAN  
CALENDAR YEAR 2023**

North Umpqua Hydroelectric Project  
FERC Project No. 1927

## **2022 ANNUAL EROSION CONTROL PLAN SUMMARY REPORT AND 5-YEAR ROLLING ACTION PLAN**

### **North Umpqua Hydroelectric Project (FERC Project No. 1927)**

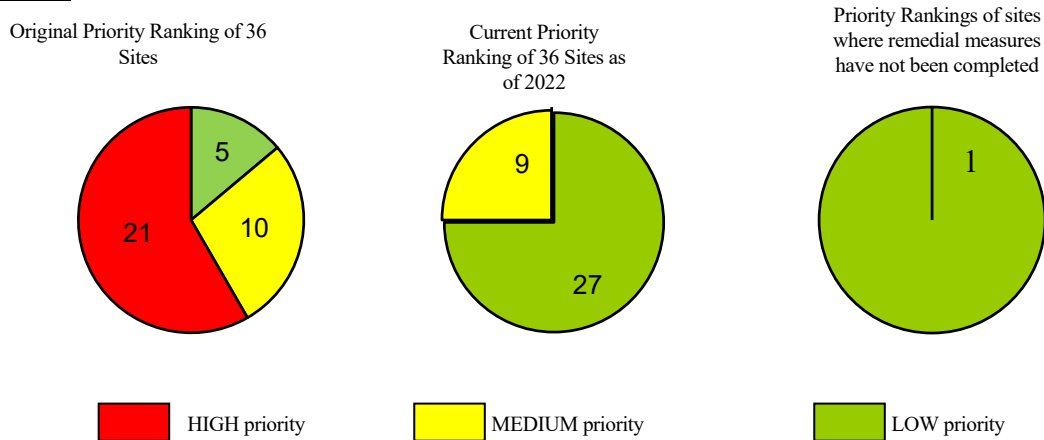
#### **Lemolo 2**

During the 2022 inspection, there were no LM2 sites rated as HIGH priority, 9 sites rated as MEDIUM priority, and 27 sites ranked as LOW priority. Remediation measures have not been completed at LM2-30(1). Site LM2-30(2) has only been partially remediated. Site LM2-24 was remediated in 2013 and LM2-8, LM2-25 and LM2-26 were remediated between the 2015 and 2016 inspections. Monitoring will continue at the following 5 sites where no remediation is currently planned: LM2-1, LM2-2, LM2-3, LM2-5, and LM2-16.

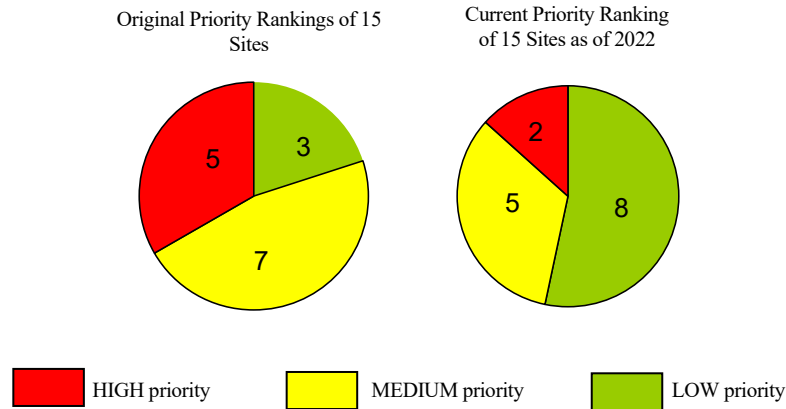
**Clearwater 2**

Of the 15 sites, remedial measures were implemented at 10 of them (CW2-1, CW2-3, CW2-4, CW2-5, CW2-6, CW2-8, CW2-9 (both), CW2-11, and CW2-14), including replacement of the Tunnel Creek culvert, which was part of the Q100 culvert upgrades. No other remediation actions are currently required by the ECP; however, monitoring is recommended at the following 5 sites: CW2-2, CW2-7, CW2-10, CW2-12, and CW2-13. Maintenance at CW2-12 and CW2-13 was originally scheduled for

2010; however, PacifiCorp engineers evaluated the sites and determined they would prefer annual monitoring.

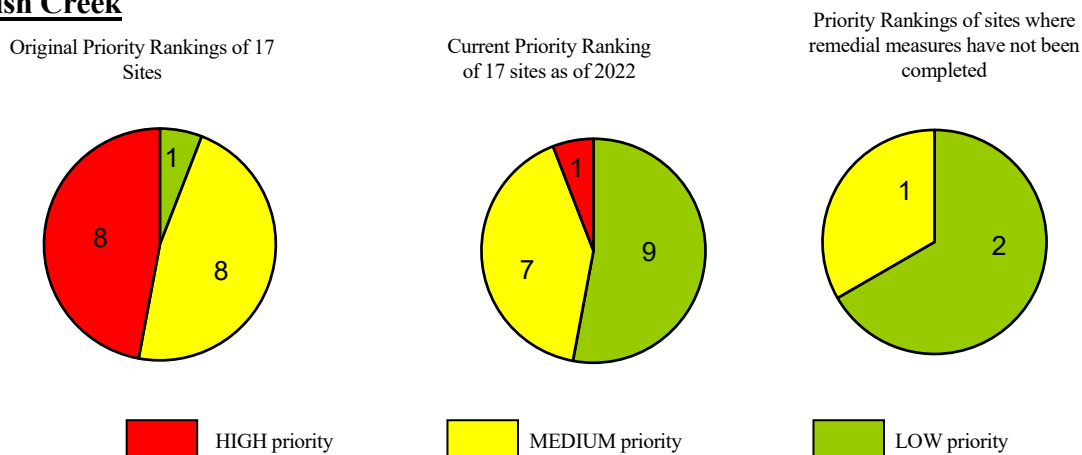
**Fish Creek**

Remediation measures have been completed at 12 of the 17 sites. Remediation is necessary at FC-3 and FC-4. New tree fall was observed at FC-3 during the 2022 inspections. Because no changes had been observed prior to 2021, FC-3 was reduced from a Medium priority to Low priority site. Site FC-3 has been assigned Medium priority in 2022 due to the changes observed. Partial remediation was conducted at FC-2 and FC-13. Monitoring is presently recommended at FC-3, FC-4, FC-8, FC-9(1), FC-9(2), FC-13, and FC-15.
