Erosion Control Plan

North Umpqua Hydroelectric Project (FERC Project No. 1927)

Volume 2 - Appendix A HIGH and MEDIUM Priority Sites Remediation Data

April 26, 2004

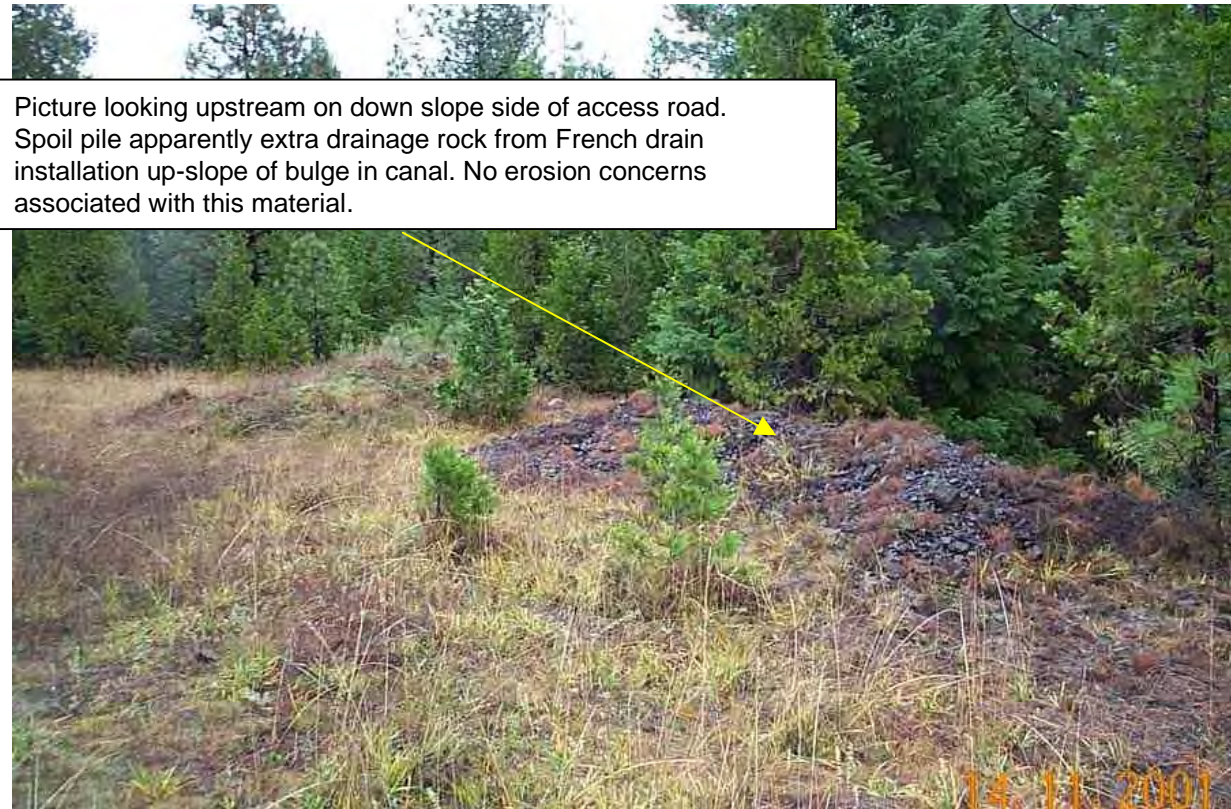
LM2-6 Site Photos

Picture looking upstream on down slope side of access road. Spoil pile apparently extra drainage rock from French drain installation up-slope of bulge in canal. No erosion concerns associated with this material.

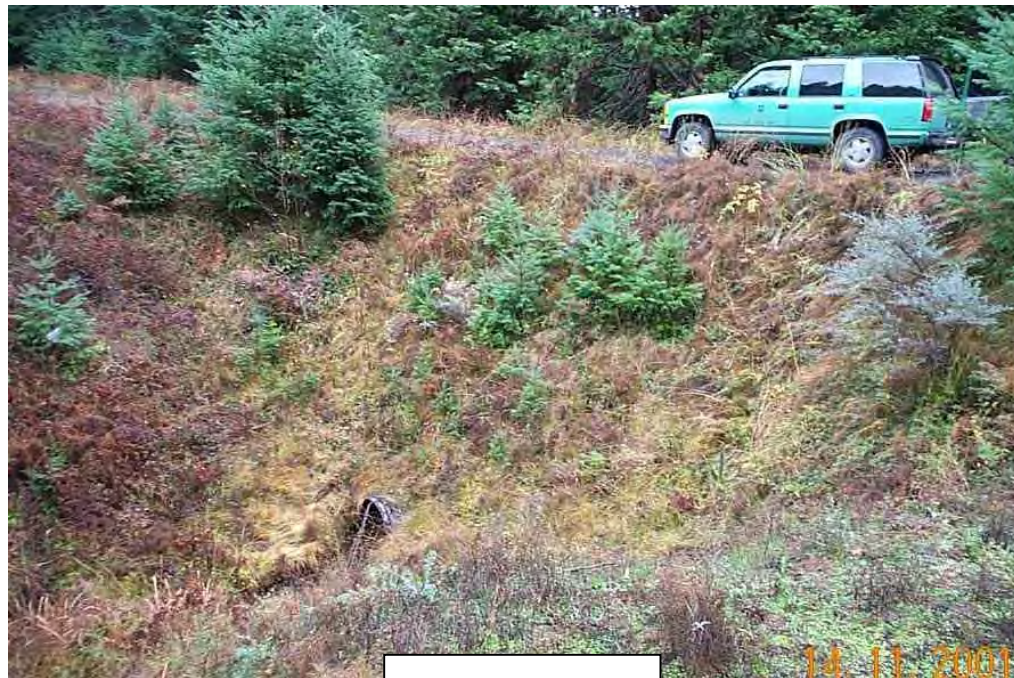
LM2-8 Site Photo Alvin Creek

Inlet side of culvert.

Site #	LM2-8		Priority Ranking	High		Locator Information/GPS		
			Impact Rating	3		GPS reports 28 ft accuracy		
			Risk Rating	3		Start	Lat:	Long:
Project Development:		Lemolo 2				Reference Point	43' 19.530"	122' 19.839"
Nearest Project Feature:		Waterway	Structure Type:		Access Road, Culvert	End		
Description of Concern: Alvin Creek stream crossing - potential for plugging of culvert causing overtopping of and erosion of embankment fill. Shotgun culvert on downstream side of embankment with scour beneath culvert outlet								
Proposed Remediation: Assuming culvert capacity is adequate, install slotted T riser pipe on upstream end of culvert. If culvert is undersized and requires replacement, replace culvert and rebuild embankment with larger diameter rock.								
Remediation Task Breakdown:			Approx. quantity	units	unit price	Estimated Costs (2001\$)	Additional Comments/Sketches	
							Detail for slotted "T" section attached. Place riprap around riser and to fill scour hole at culvert outlet.

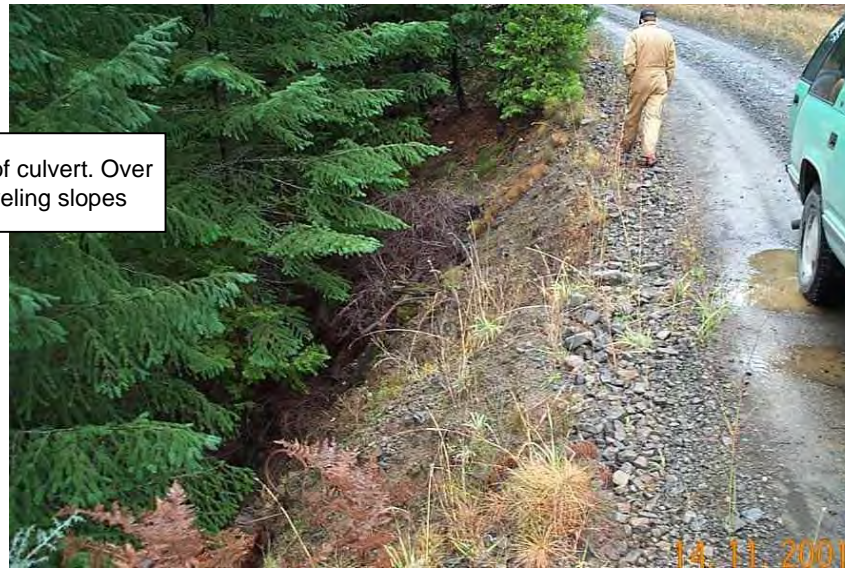
LM2-9 Site Photos

Outlet side of culvert. Over
steep raveling slopes

Steel flume section at inlet
side of culvert. Channel
protection to be provided at
outlet to canal drainage pipe

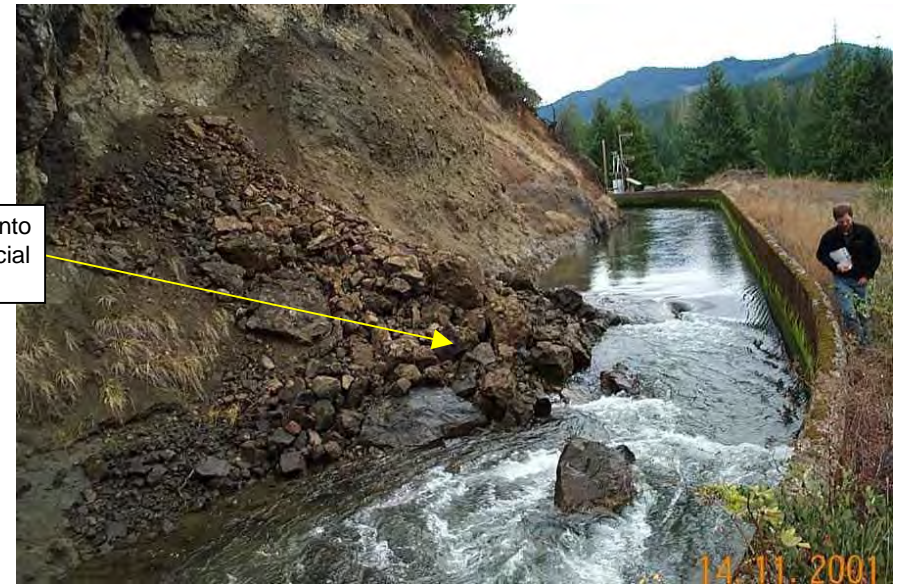
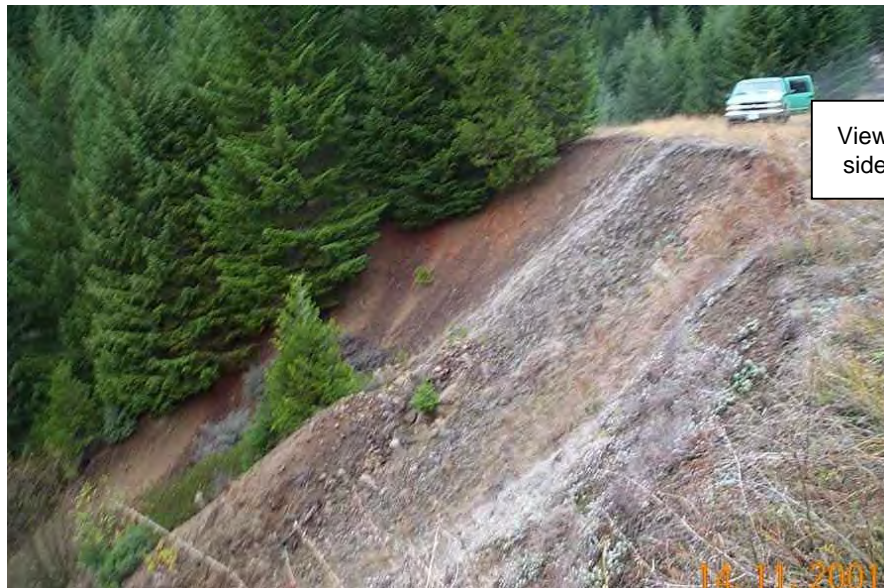
LM2-12 Site Photos Patricia Creek

Small rockslide into
canal near Patricia
Creek

Views of 'typical'
sidecast section

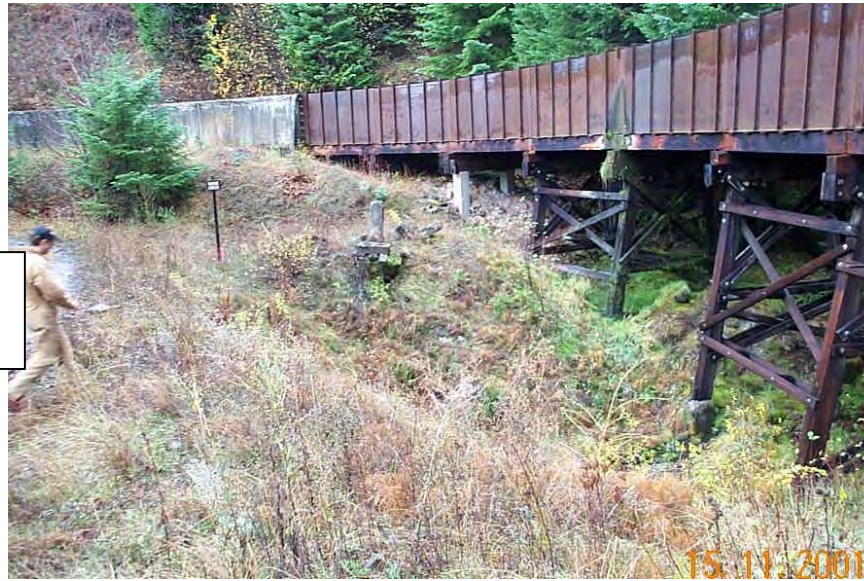
View of steel
flume on up-
slope side of
Nurse Creek

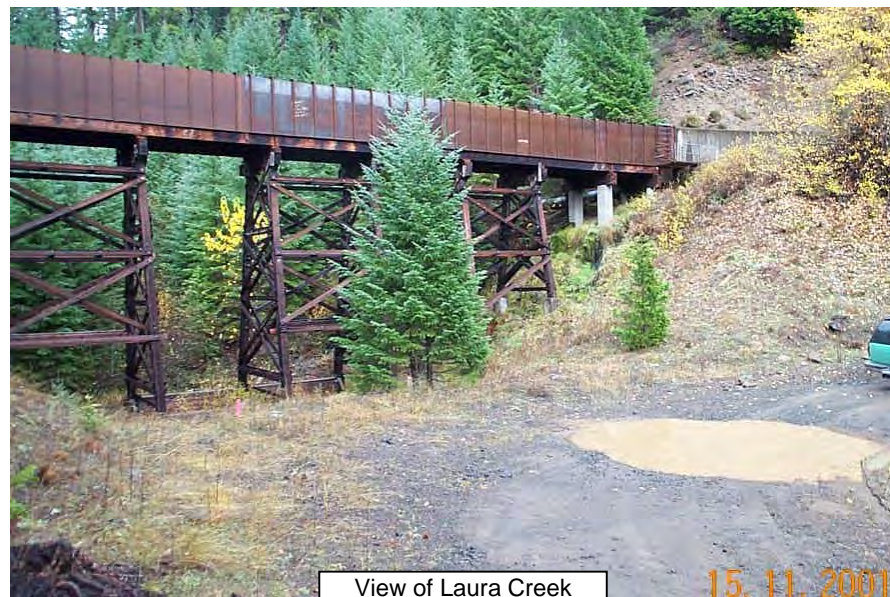
LM2-18 Site Photos Laura Creek

View of Laura Creek
culvert and
embankment looking
North-Northeast

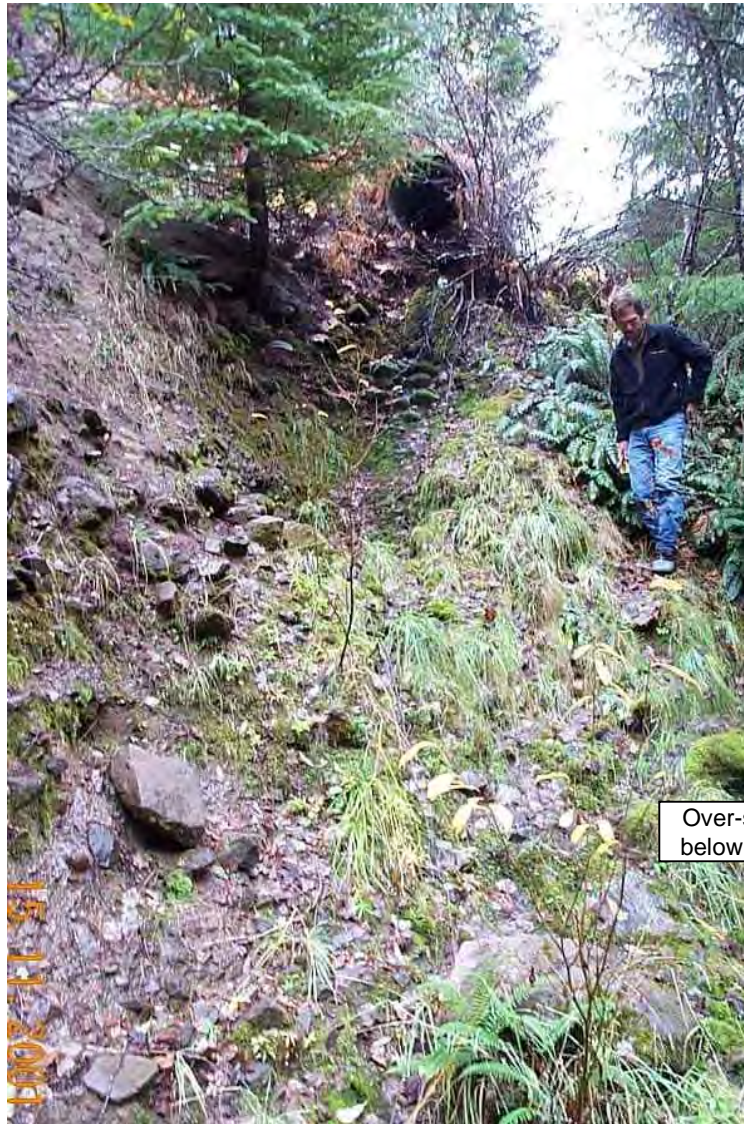
LM2-18 Site Photos Laura Creek

Over-steep slopes
below access road

Site #	LM2-18		Priority Ranking	High	High		Locator Information/GPS		
			Impact Rating	3	3		GPS shows 46' accuracy		
			Risk Rating	2	2		Start	Lat:	Long:
Project Development:		Lemolo 2					Reference Point		
Nearest Project Feature:		Waterway	Structure Type:			Access Road & Culvert	End	43' 20.393"	122' 17.910"
Description of Concern: Potential fill failure, also has potential for plugging of upstream end of culvert, causing overtopping and fill failure. Poor draining on access road on both east and west side of fill, drainage is directed down road surface and onto embankment fill. Existing culvert is 48" diameter.									
Proposed Remediation: Install new culvert and rebuild embankment. Lower embankment crest by approximately five feet to reduce size of embankment. Install larger culvert. On access road west of fill remove approximately 200 ft section of oversteepened sidecast. Extend existing gabion wall approximately 100 ft. Install 70 ft of new 6 ft high gabion wall on upslope side to maintain road width. To east of fill, selectively remove sidecast in 350 ft section, and install 100 ft of gabion wall.

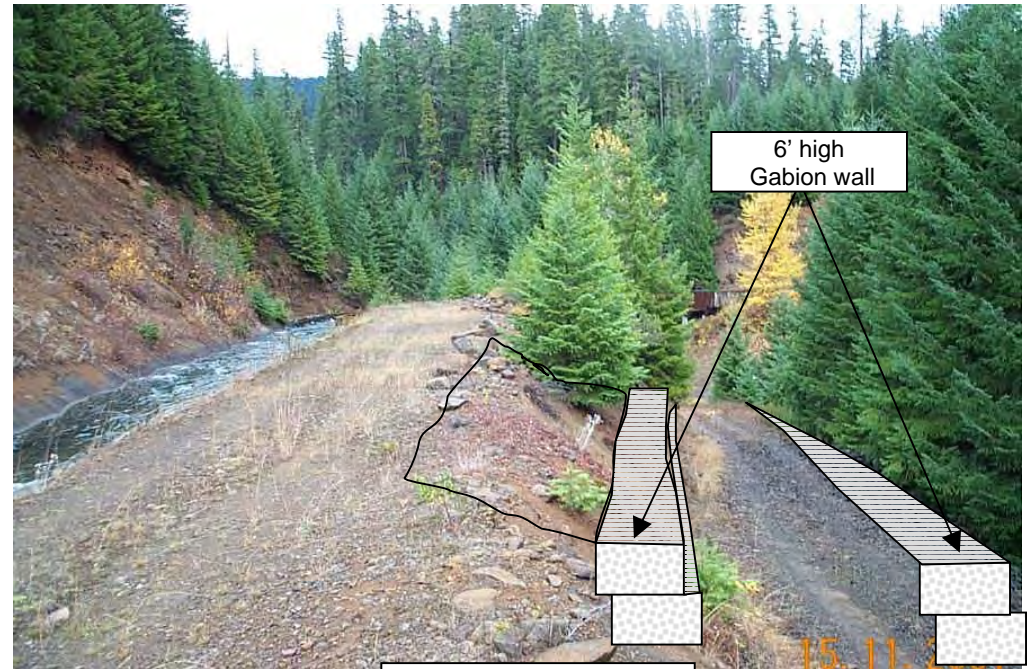
View of road along canal
looking upstream
towards Laura Creek

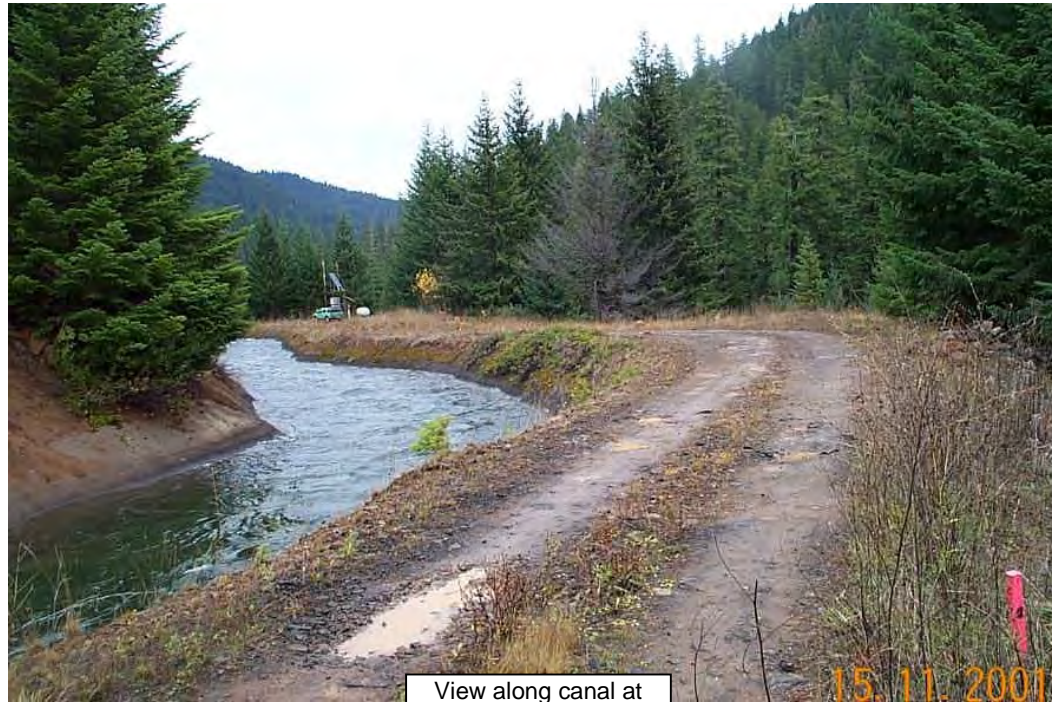
LM2-19 Site Photo

View along canal at beginning of section with selective side cast removal. Pink stake indicates the start of the sidecast removal section.

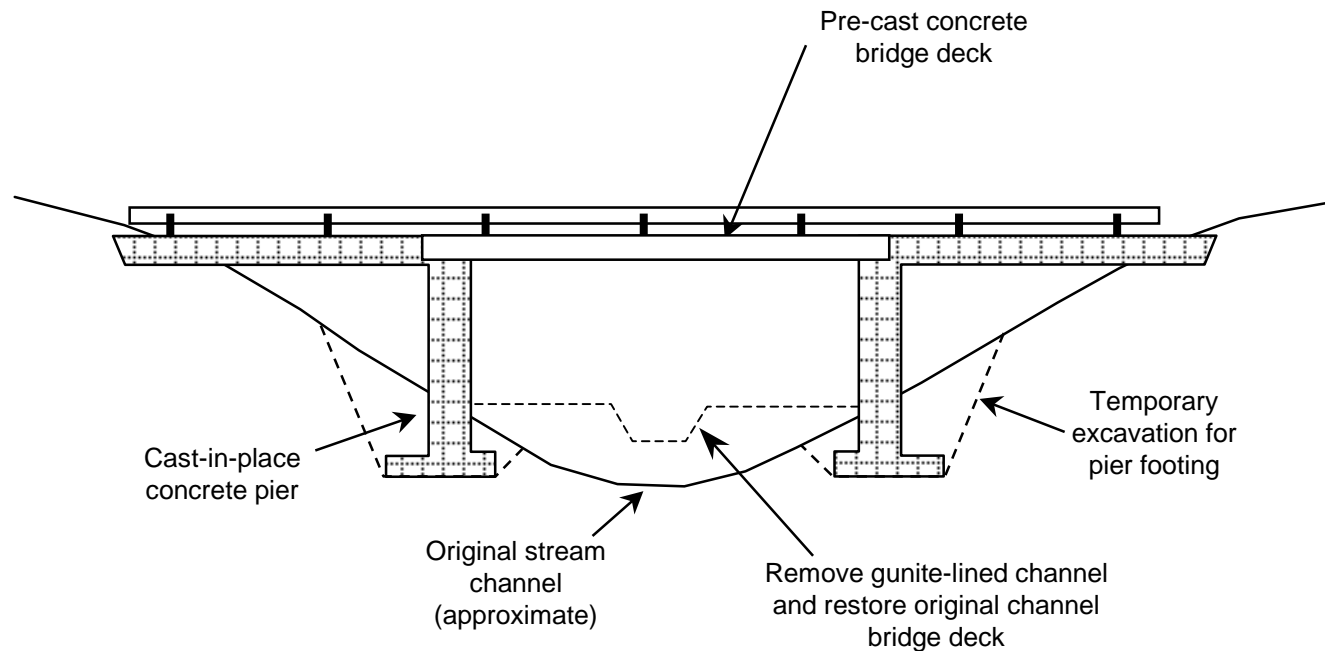
Section C
NTS

Cross-section showing removal of existing gunite-lined channel and access road bridge including abutment structures and precast deck

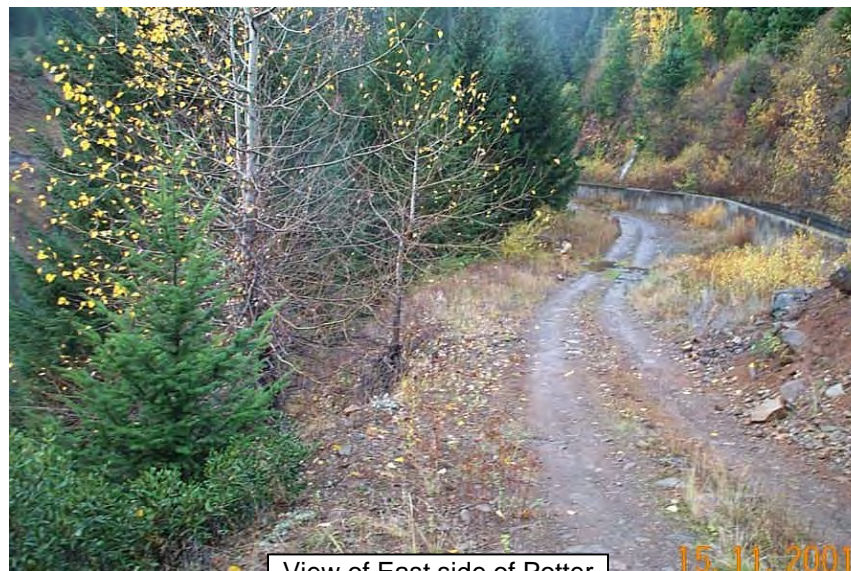
LM2-20 Site Photos Potter Creek

View of East side of Potter
Creek near seepage area
where there will be selective
sidecast removal

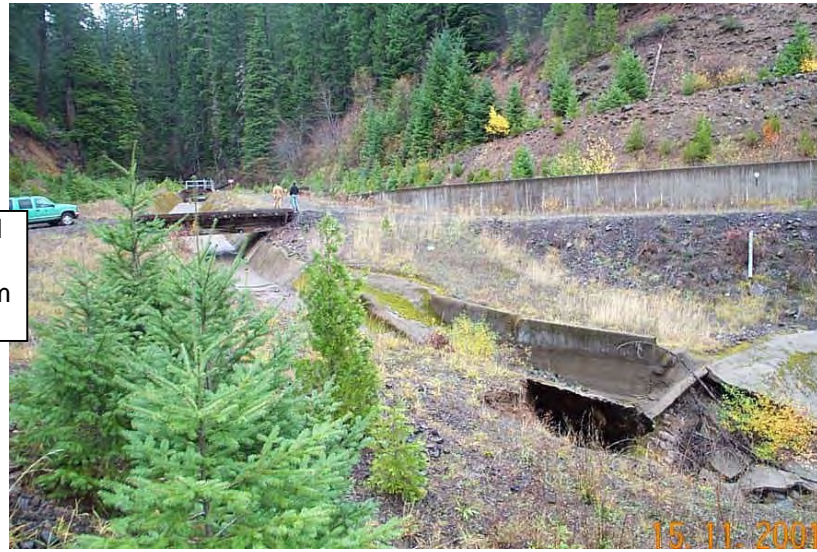
Potter Creek gunite lined
spillway canal, to be
removed as part of stream
restoration effort

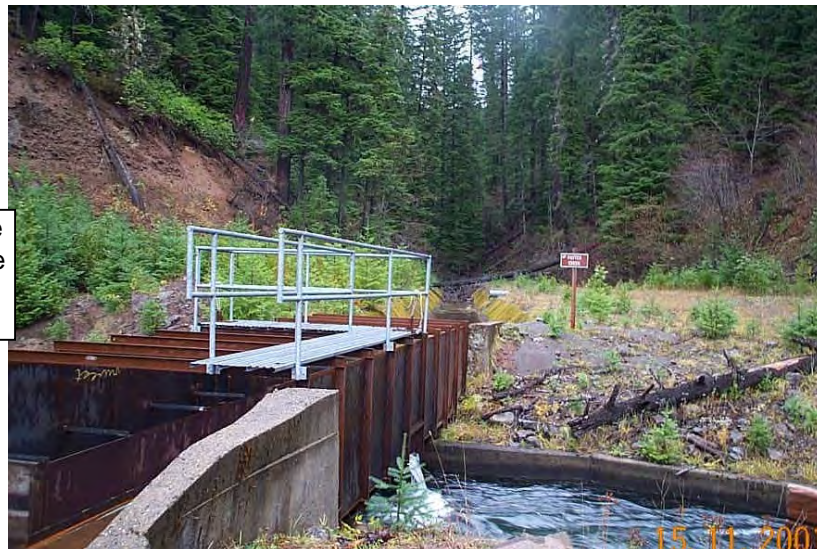
Potter Creek Inlet structure
into the canal system, to be
removed as part of stream
restoration effort

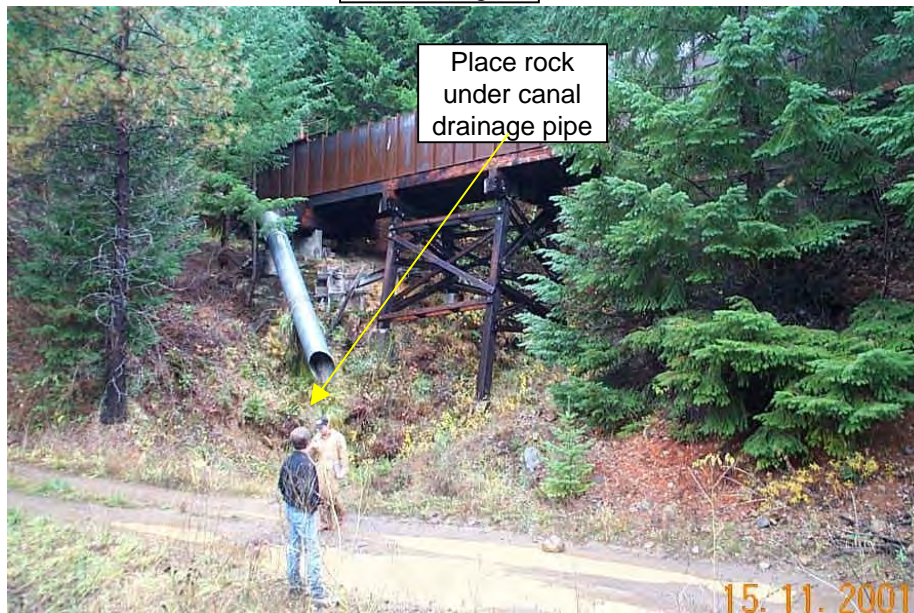
View of West
creek flume
crossing

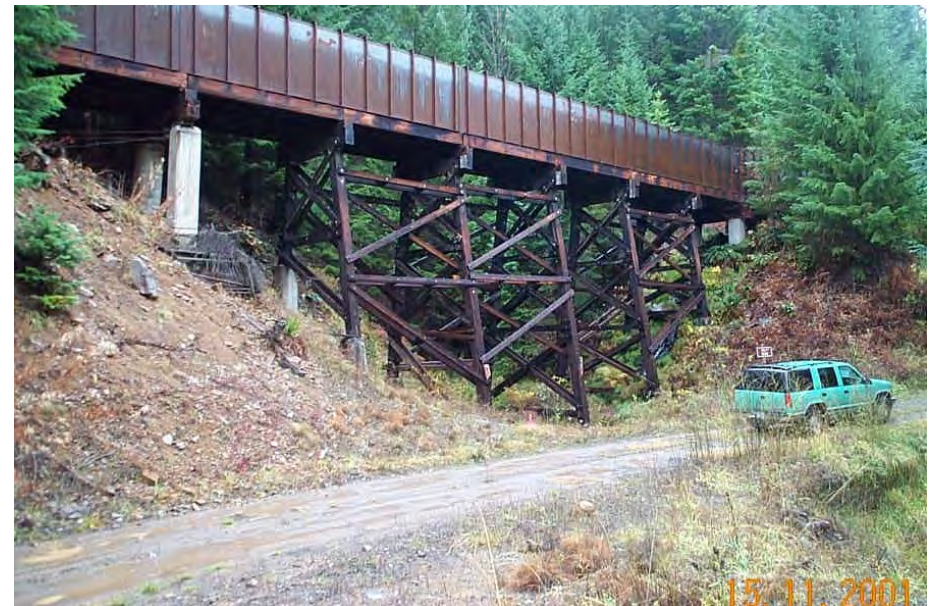
View of East
creek flume
crossing

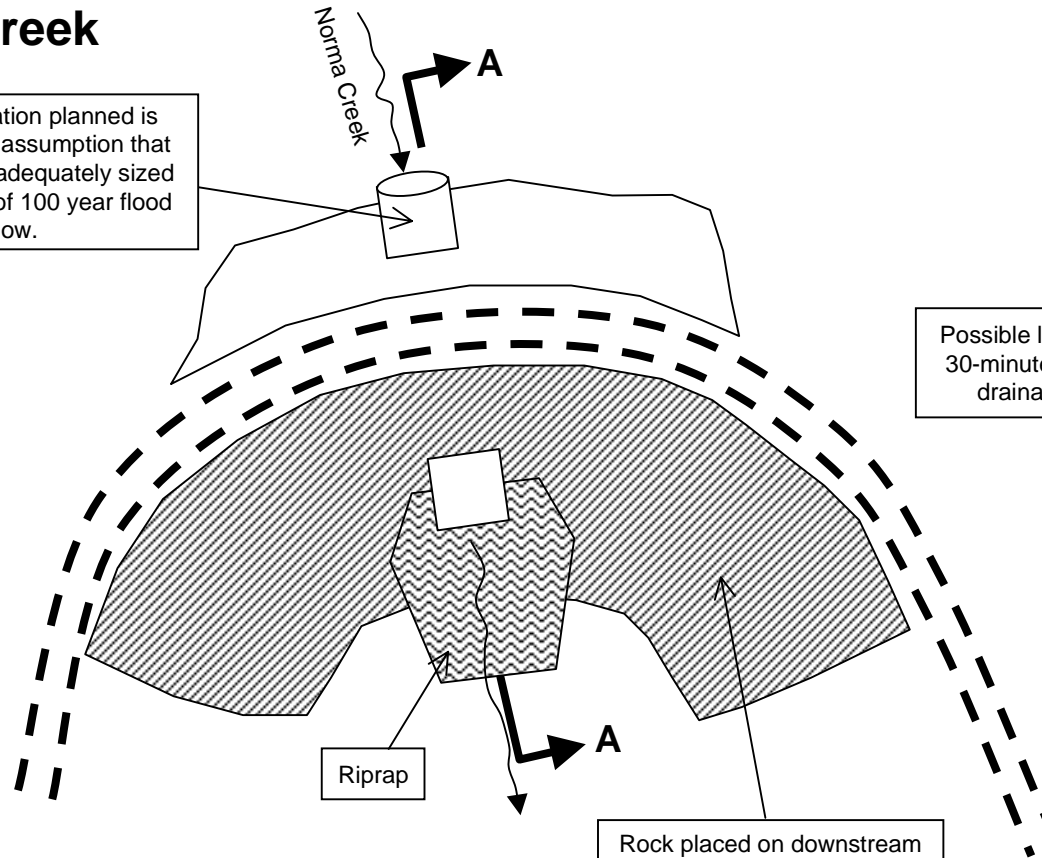
The remediation planned is based on the assumption that the culvert is adequately sized for minimum of 100 year flood flow.

Possible locations for 30-minute waterway drainage pipe.

Rock placed on downstream face of existing embankment to create 1.5:1 slope. Bring rock up to elevation of culvert outlet and armor slope above culvert.

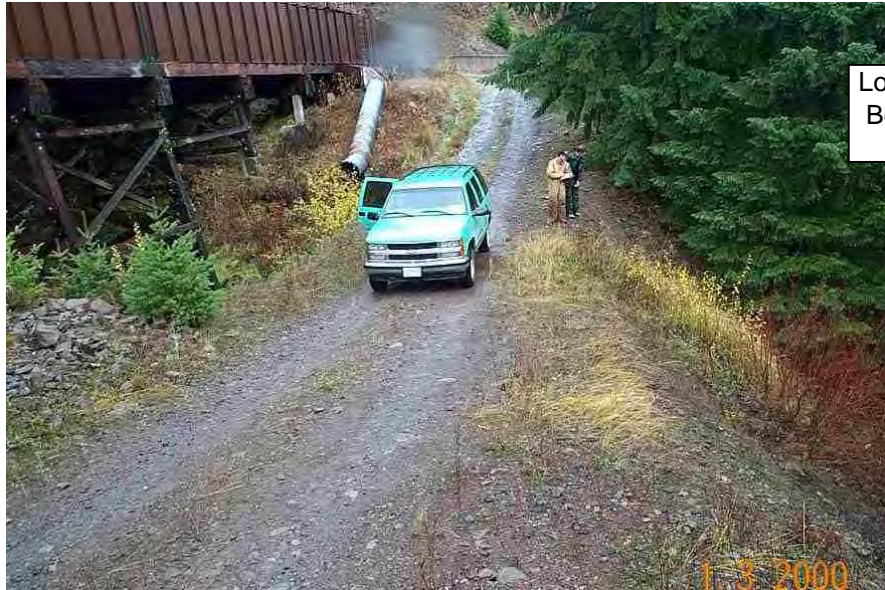
Looking East at
Beverly Creek
Crossing

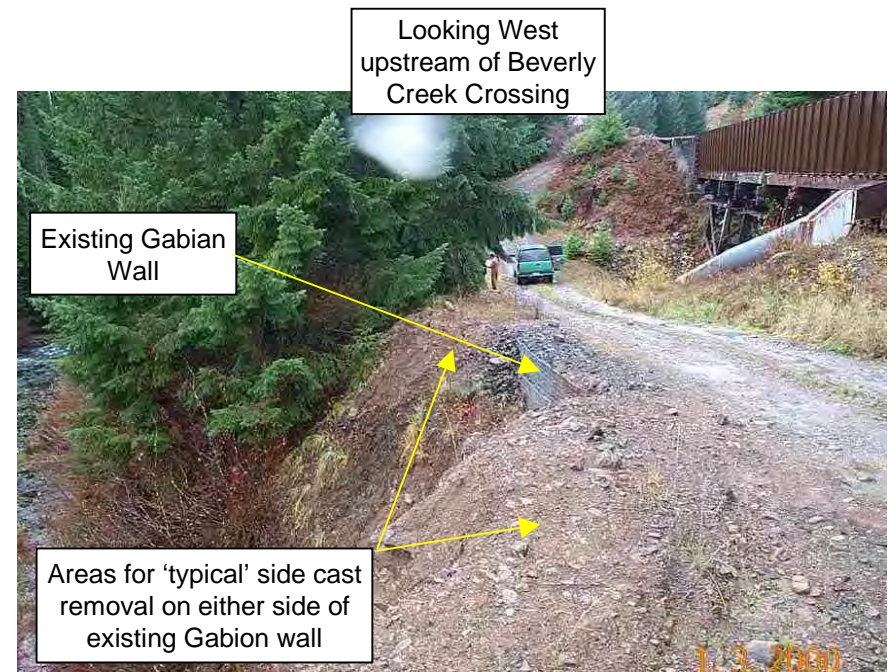
Looking West
upstream of Beverly
Creek Crossing

Existing Gabion
Wall

Areas for 'typical' side cast
removal on either side of
existing Gabion wall

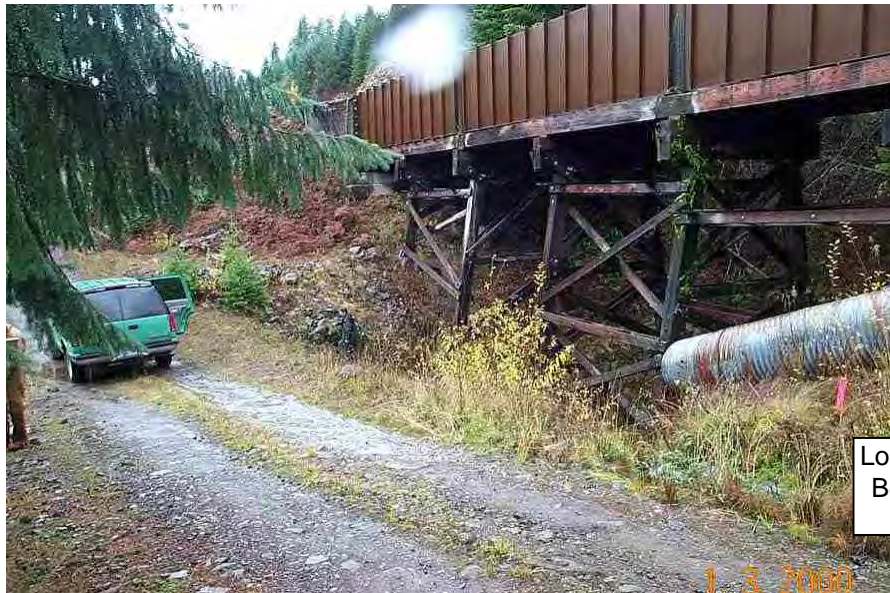
Looking West at
Beverly Creek
Crossing

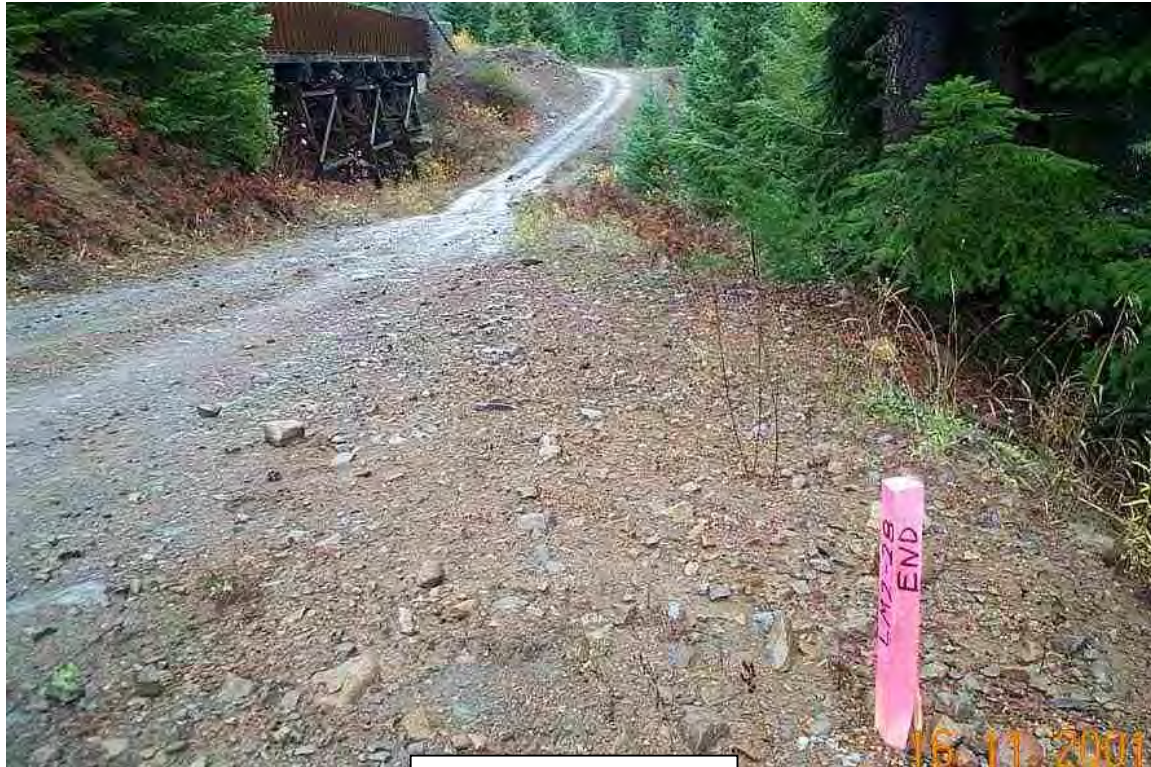
LM2-28 Site Photo

View of eastern (upstream)
end of LM2-28 looking
towards Nancy Creek

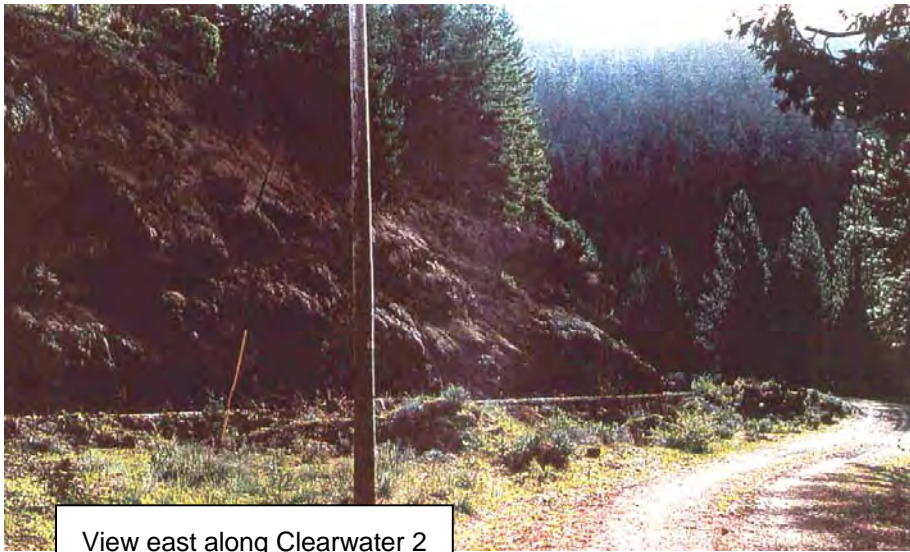
View east along Clearwater 2 canal in area of concrete and rock flume at west end of site.

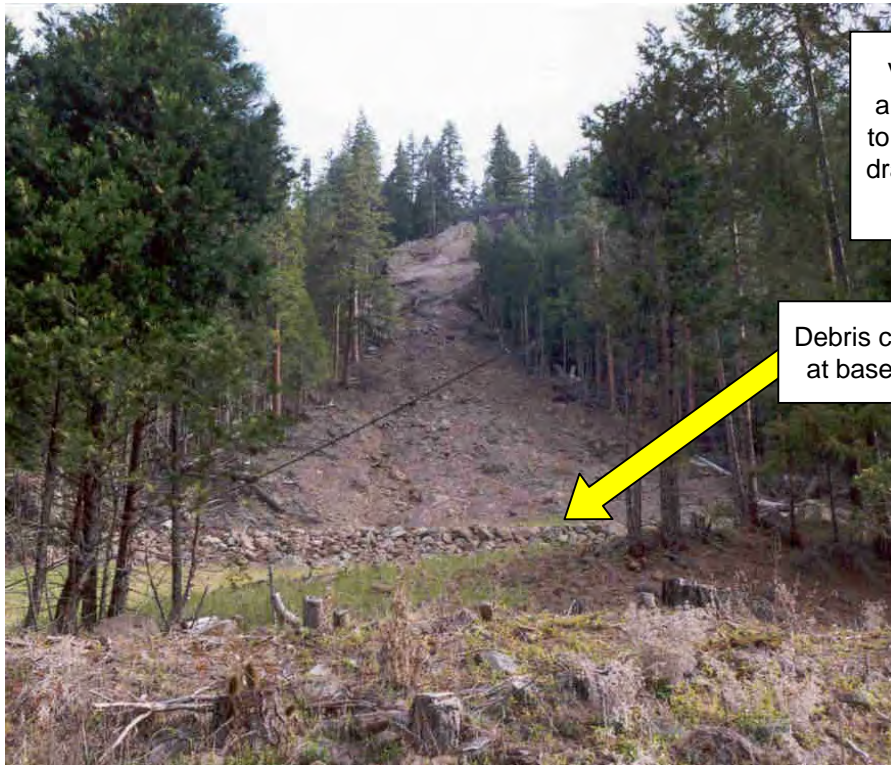
View north across canal showing area of 1997 debris flow. Mitigation to be provided through installation of drainage system that will allow canal to be drained within 30 minutes.

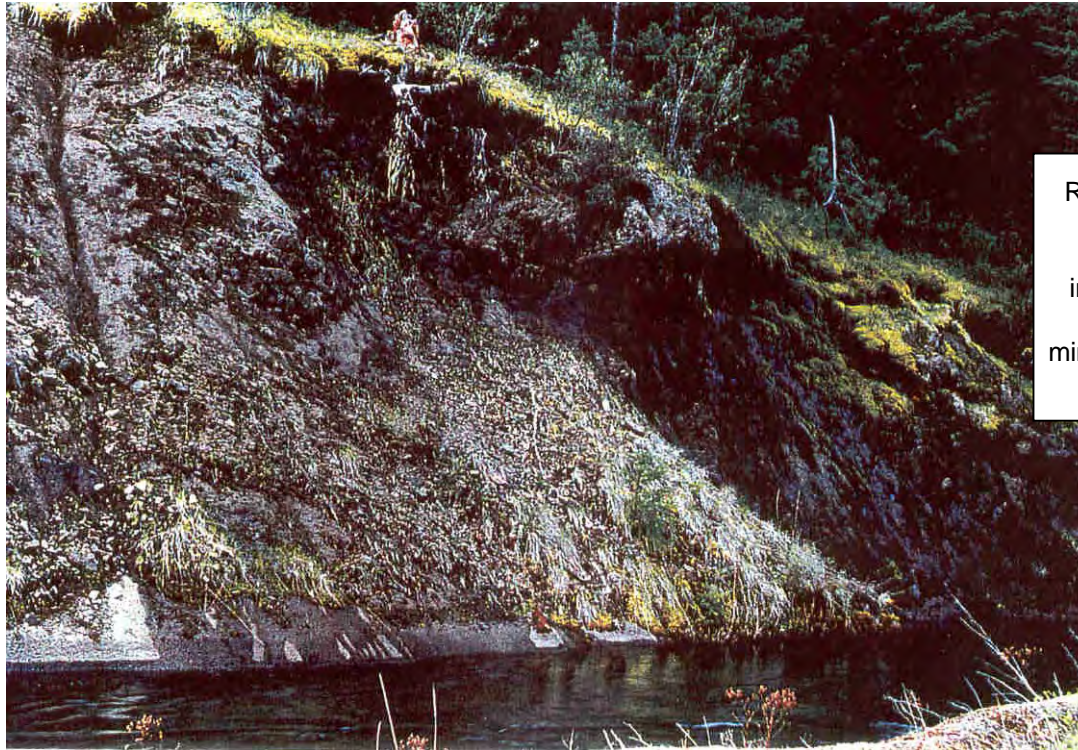
CW2-5 Site Photo

Representative view north across canal showing concrete and rock flume. Mitigation to be provided through installation of drainage system that will allow canal to be drained within 30 minutes. Also place rockfall padding along 2-wall concrete flume (not shown).

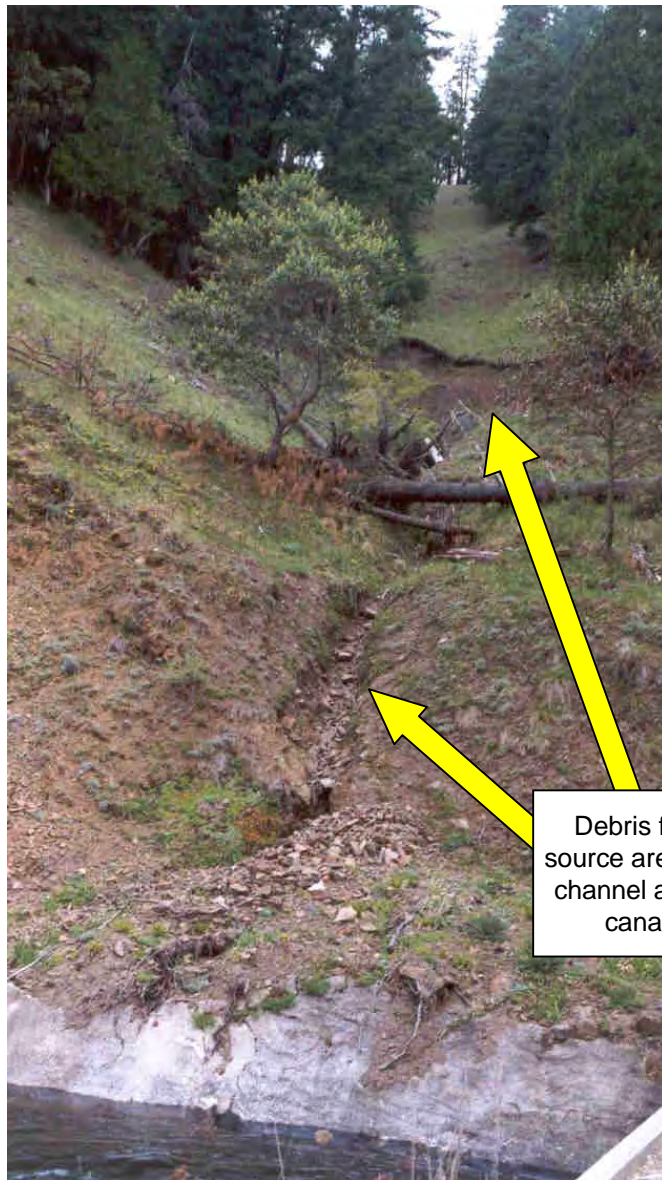
CW2-6 Site Plan

Debris flow source area and channel above canal.

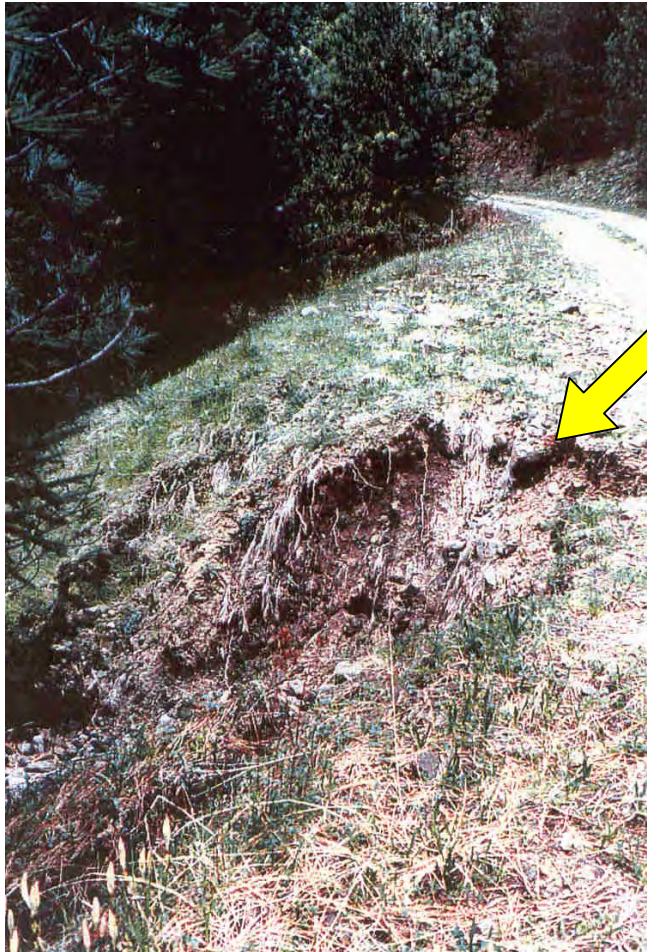
CW2-8 Site Photos No Tunnel Creek

Six-ft deep slump failure in
downstream side of fill. Restore
through embankment
replacement (if culvert is
undersized) or by backfilling

Slope failure on downslope side of access road embankment caused by drainage across road surface from upslope ditch. Embankment and culvert to be replaced.

Remove existing access
road embankment &
replace culvert (if culvert
is found to be undersized)

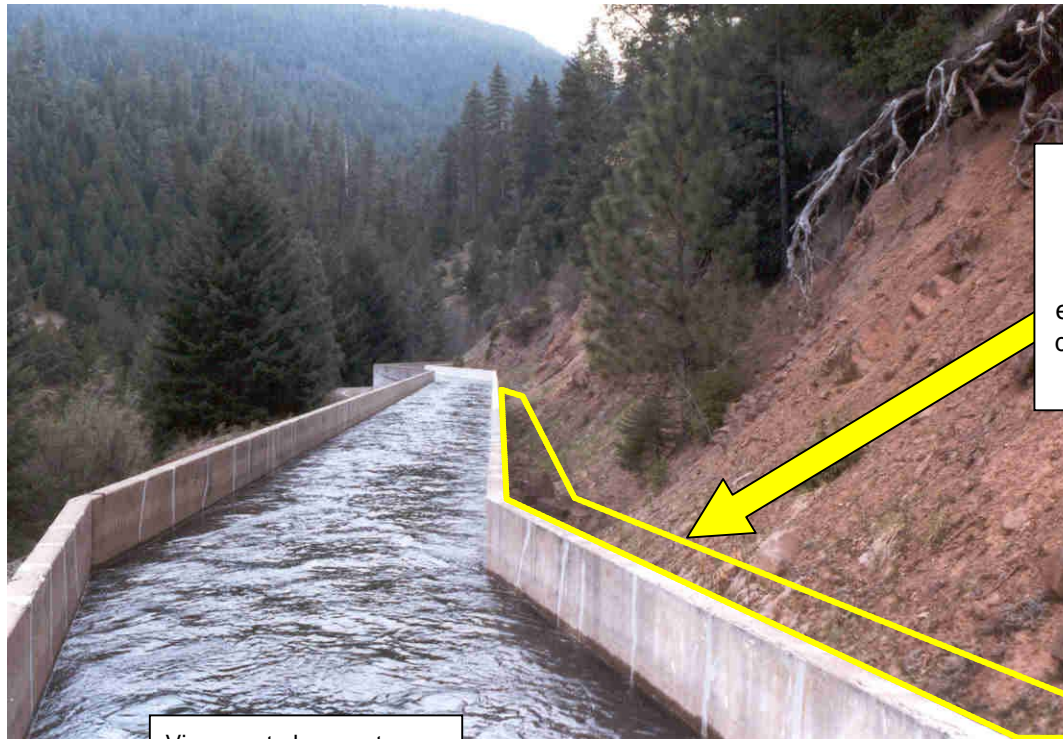
CW2-9 Site Photo

View west along waterway
showing typical 2-wall
concrete flume structure.

Where appropriate, place padding
material on upslope side of 2-wall
concrete flume to provide rockfall
protection, add slotted risers to
existing drainage culverts to maintain
drainage from behind flume. Existing
trees to remain in place.

Provide mitigation against effects of
any future slope failures through
installation of drainage system along
waterway which will allow canal
drainage within 30 minutes of any
flume failure.

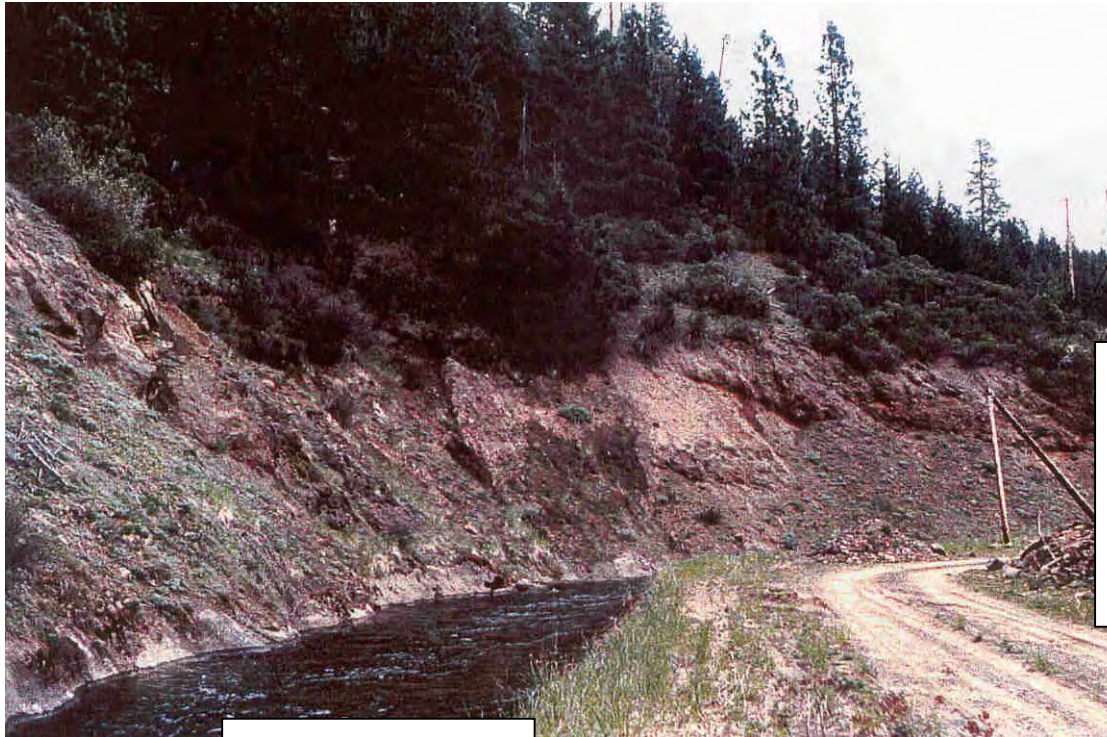
CW2-10 Site Photo

View east along waterway
showing typical gunitelined canal.

Provide mitigation against effects of any future slope failures through installation of drainage system along waterway which will allow canal drainage within 30 minutes of any flume failure. Field work during spring 2002 to verify need for additional mitigation beyond that provided by 30-minute drainage system.

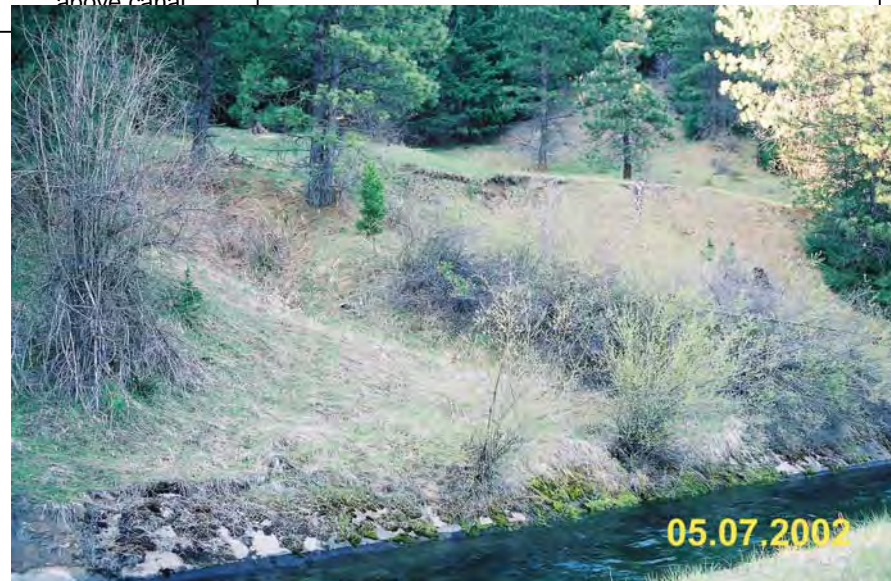
CW2-11 Site Photos

Slump in mudflow/ash
deposit on slope
above canal

Install horizontal drains to stabilize slope in area showing signs of creep deformation. Provide additional mitigation against effects of any future slope failures through installation of drainage system along waterway which will allow canal drainage within 30 minutes of any flume failure. Nearest drainage pipe will be approximately 100 ft upstream of site where horizontal drains to be installed.

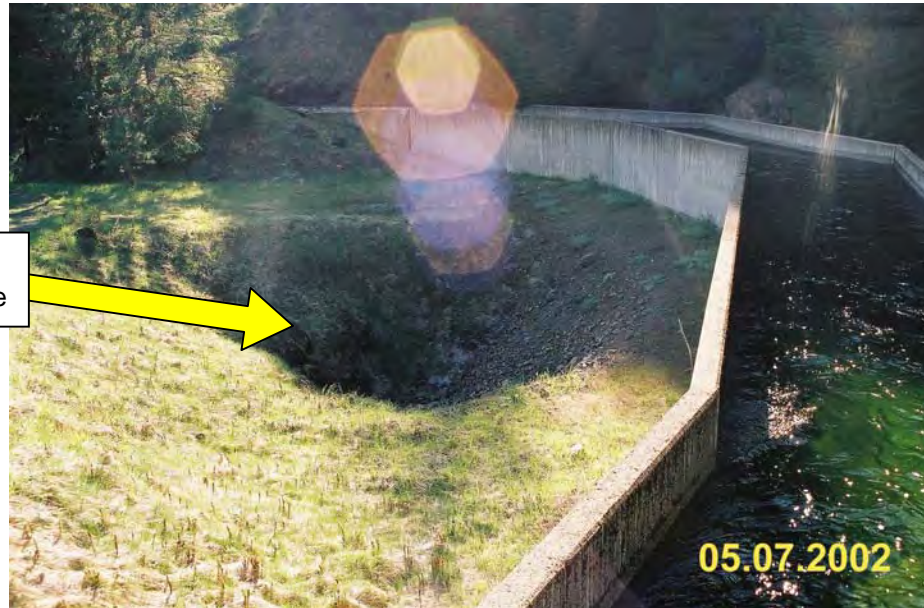
Surface Depression
approx. 50'x35' in size

Exposed Culvert at
bottom of depression

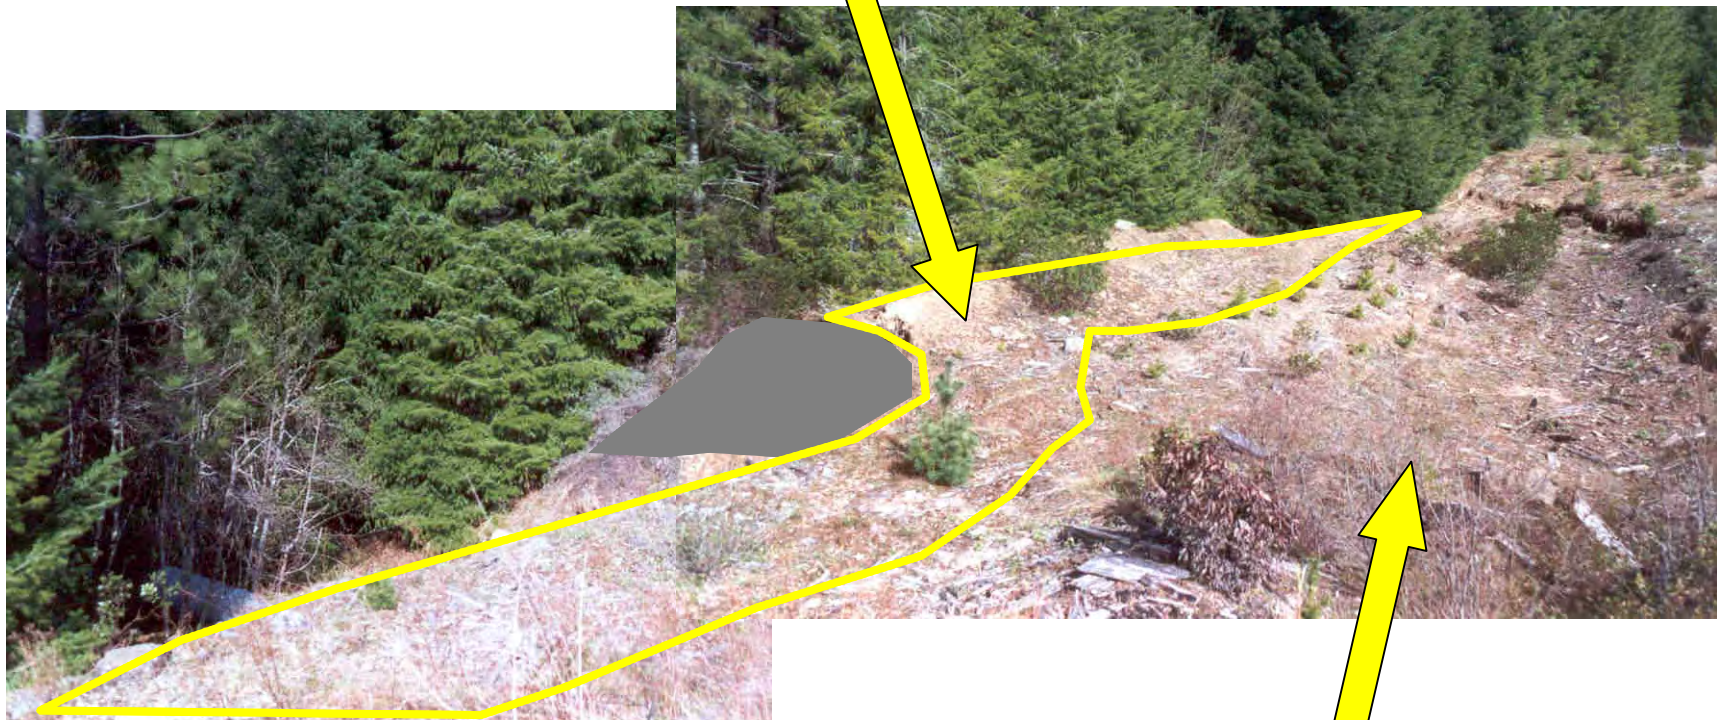
View is looking west
along south side of
canal access road

Remove 'typical' sidecast
section in non-vegetated
areas, do not remove trees
greater than 6" in diameter

Regrade additional sidecast
areas adjacent to canal
access road and revegetate
restored surface.
