Erosion Control Plan

North Umpqua Hydroelectric Project (FERC Project No. 1927)

Volume 2 - Appendix A HIGH and MEDIUM Priority Sites Remediation Data

April 26, 2004

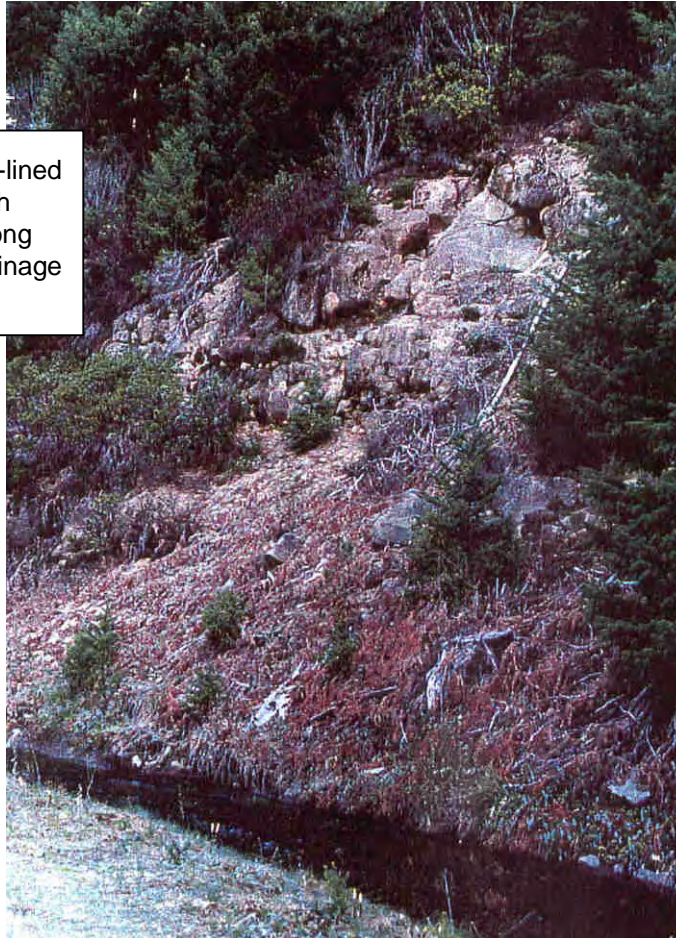
Typical slope on north side of gunite-lined canal. Provide mitigation through installation of drainage system along waterway which will allow canal drainage within 30 minutes.

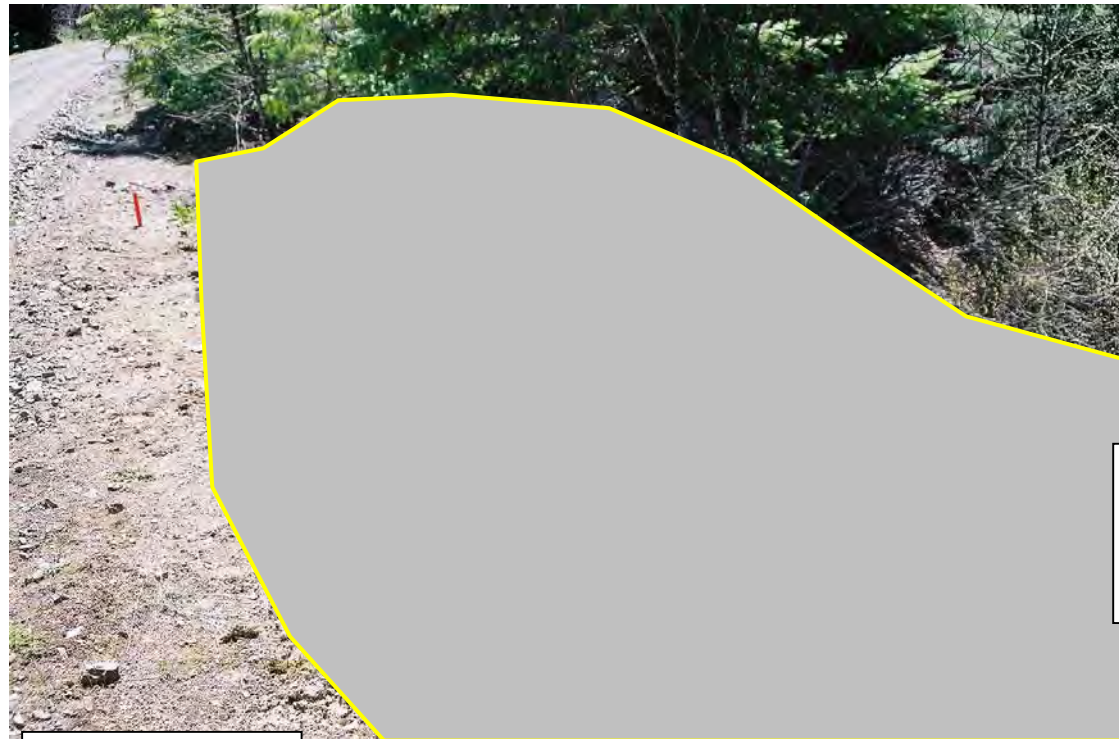
FC-5 Site Photo

View is looking east
along downslope side
of canal access road.

Typical area with
sidecast to be
removed and
revegetated.

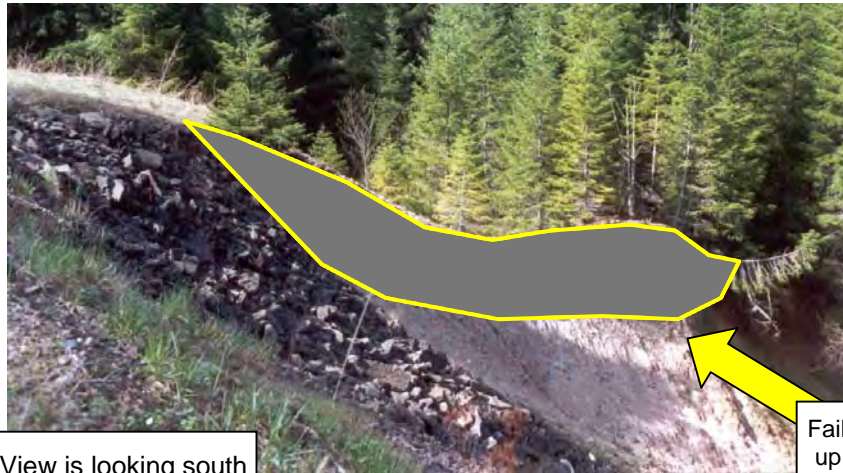
FC-6 Site Photos

Failed area in pumice slope,
up to 65 ft wide and 30 ft
deep, vegetated along sides,
recontour sides of failure area,
place rock to buttress slope

View is looking south
at southern side of
failure area

Trees along
sides of failure
area to remain

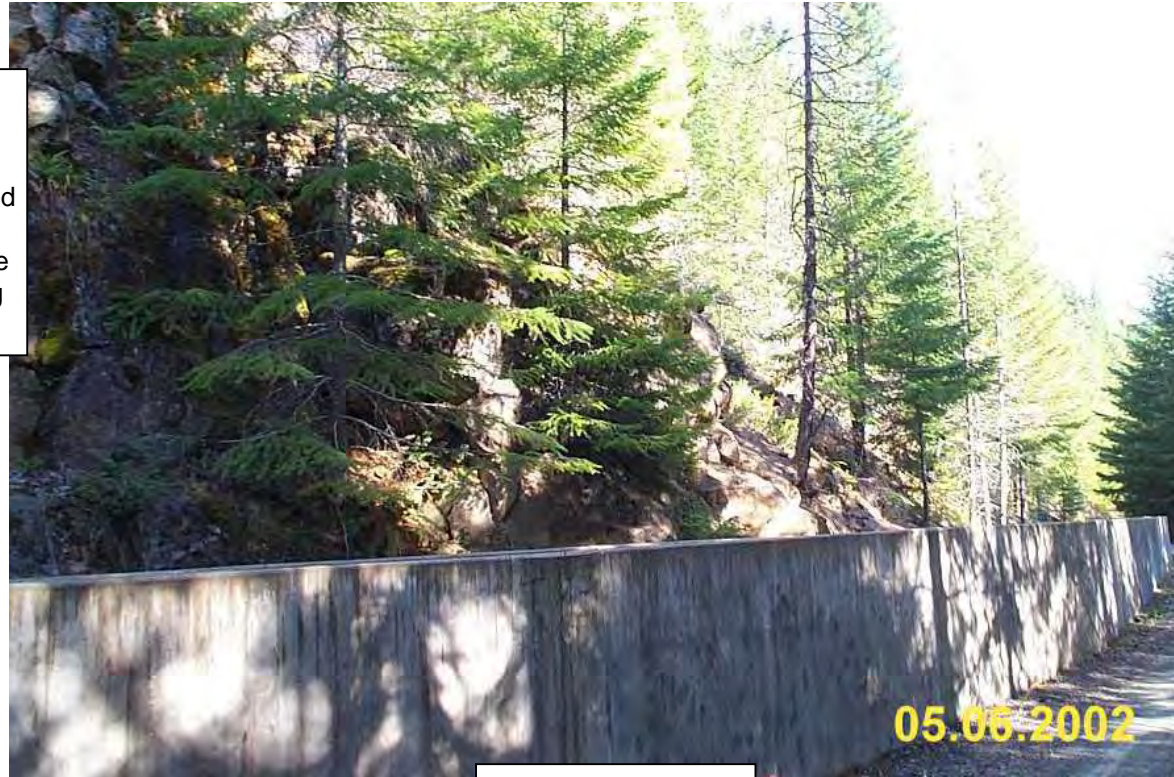
View is looking east
along south side of
canal access road.

Place padding material on upslope side of 2-wall concrete flume to provide rockfall protection, add slotted risers to existing drainage culverts to maintain drainage from behind flume. Existing trees to remain in place.

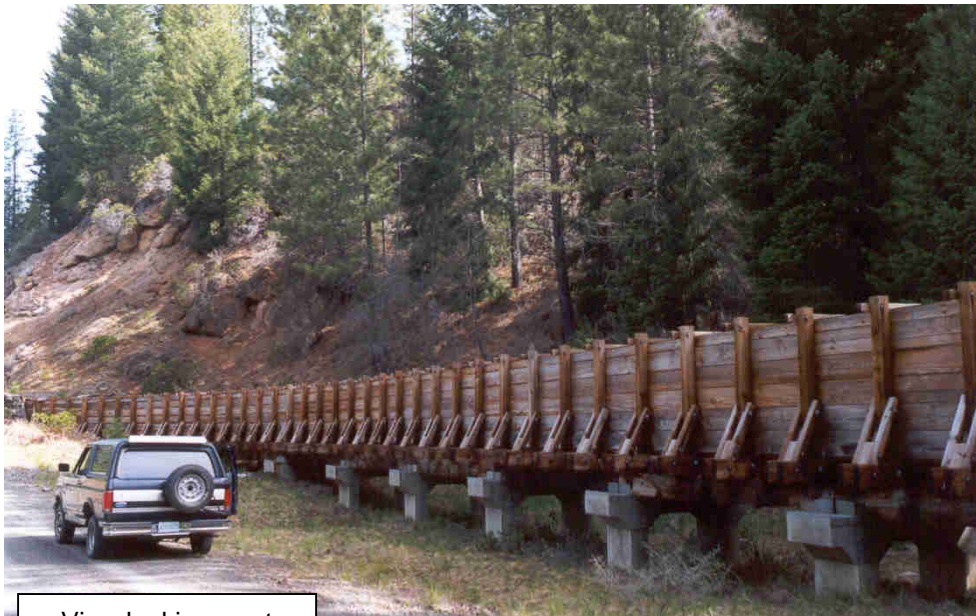
FC-8 Site Photos

View looking west
across area underlain
by earthflow

Failed area in slope below
access road. Monitor for
signs of additional movement.
If movement/failure occurs,
develop access and
implement remedial
measures.

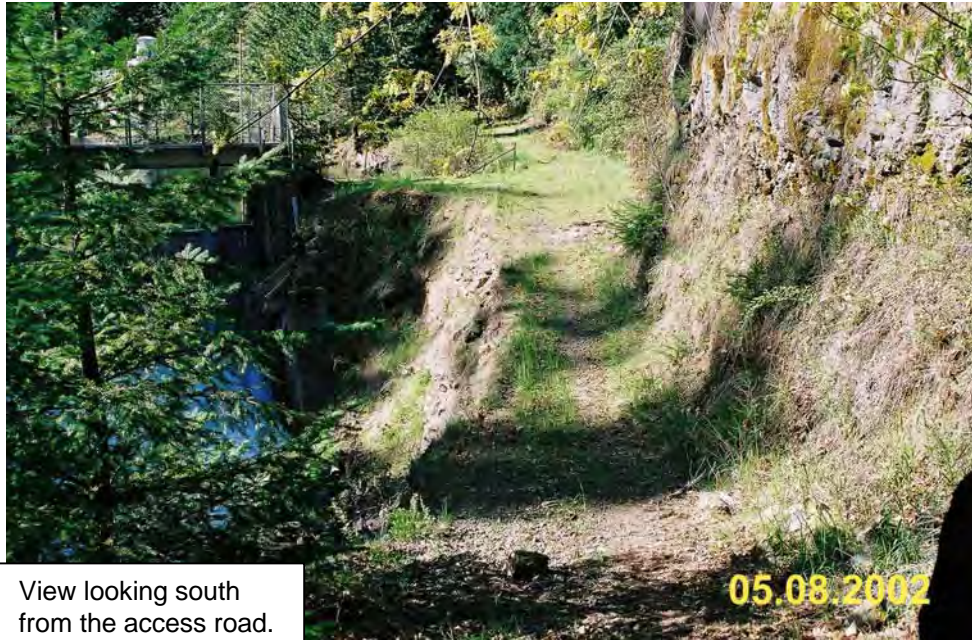
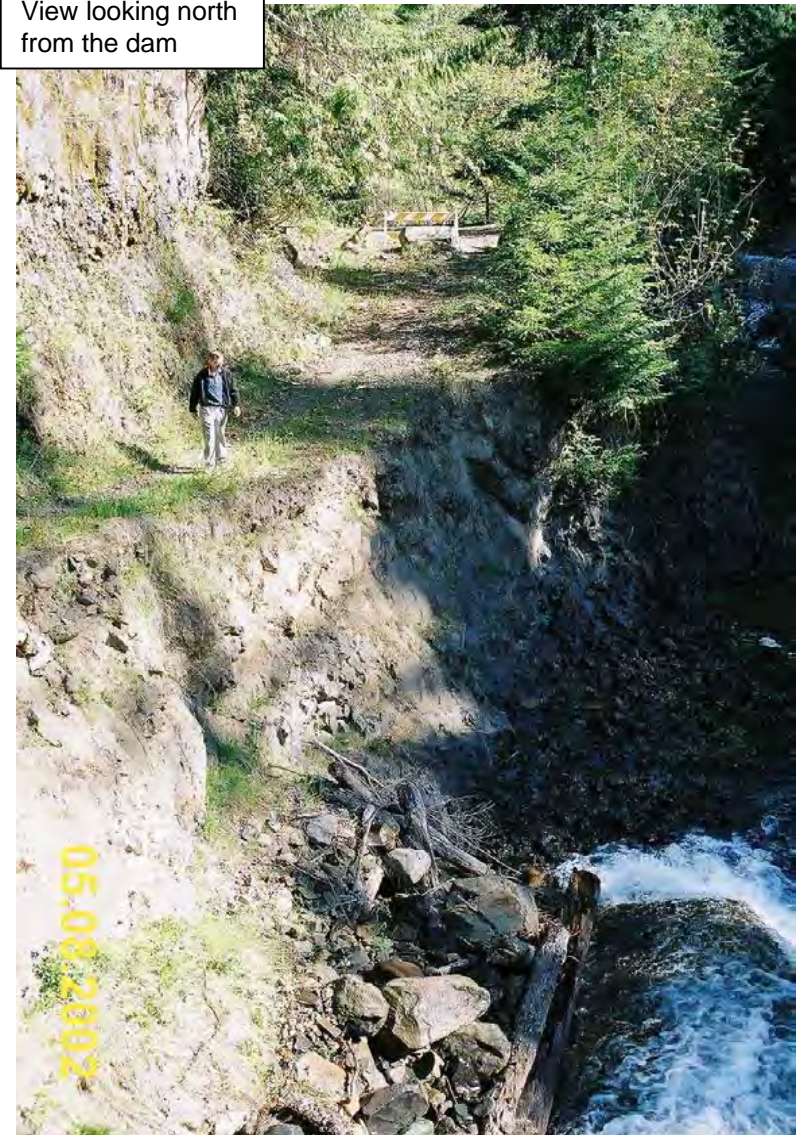
SC1 Site Photos Slide Creek Diversion Dam

Bank erosion along edge of spillway channel has removed material from bank and caused failure of access road surface. Access to dam still available from upstream side. Material exposed on bank is largely bedrock and little additional erosion is likely to occur. Restoration only needed if improved access is needed to dam.

View looking north from the dam

Note:
If road is not needed for maintenance access, no restoration needed.

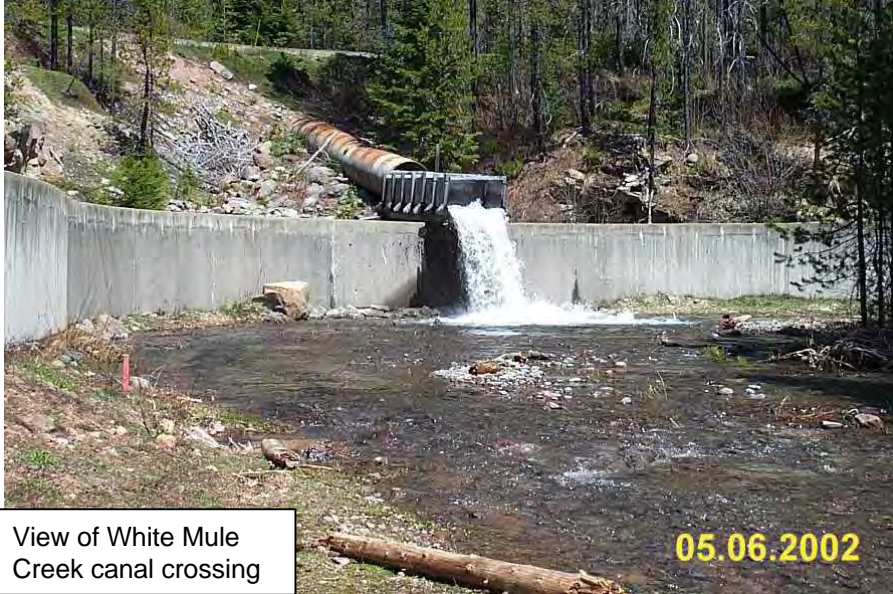
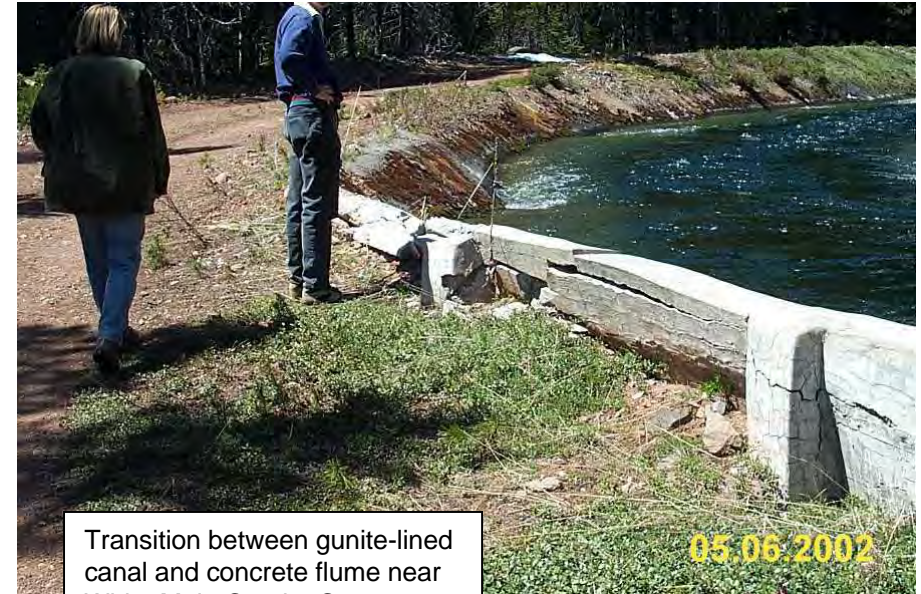
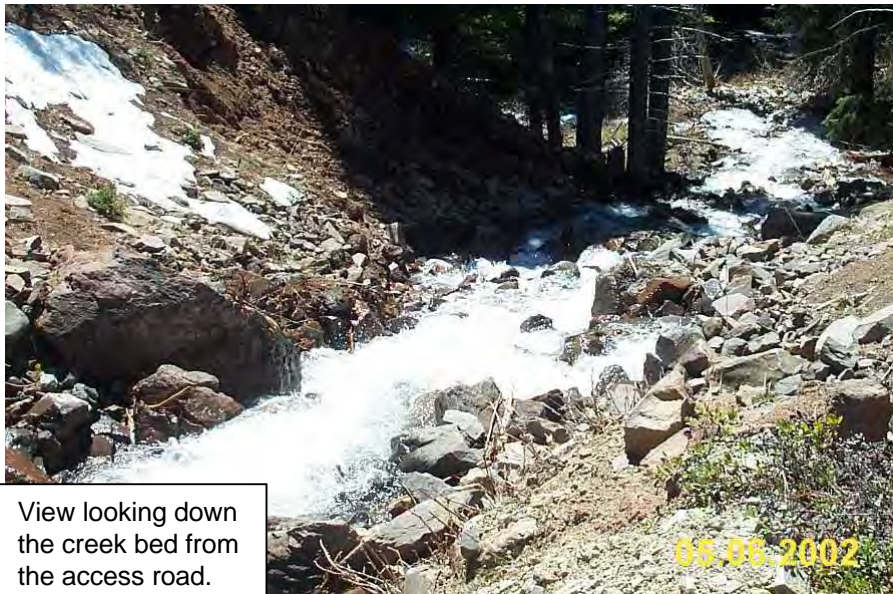
LM1-1 Site Photos White Mule Creek

WHITE MULE CREEK - STREAM RESTORATION
AT LEMOLO NO.1 CANAL

1. Preparatory Work
 - 1.1 Mobilize Contractor and Construction Equipment
2. Diversion during construction – Sandbag Cofferdam and Continuous Piping
3. Crossing over existing concrete flume
