## Clearwater Creek In-stream Habitat Restoration Project Closeout Report

**Project Title:** Clearwater Creek in-stream Habitat Restoration

**Agency:** US Forest Service  
Gifford Pinchot National Forest  
Mount St. Helens National Volcanic Monument

# Post-implementation Status Report Clearwater Creek Fish Habitat Restoration

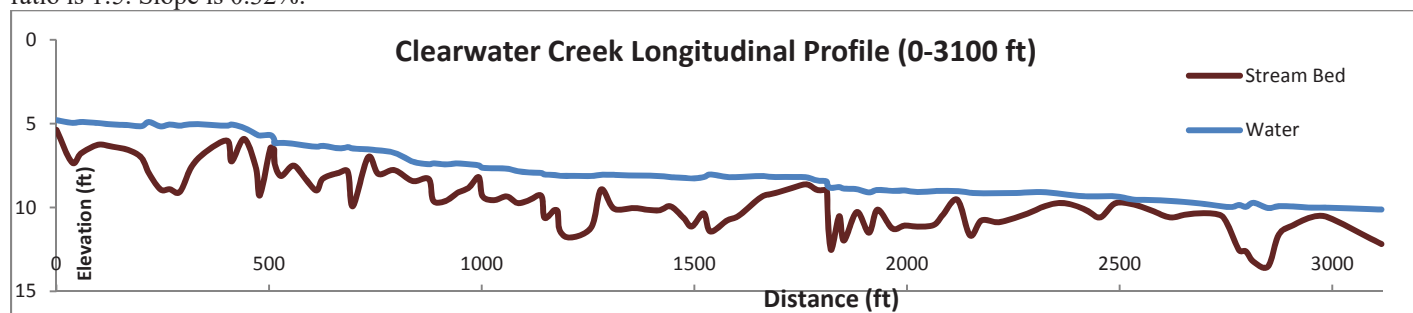
2: Clearwater 2014 Longitudinal Profile (0-3100 ft)

The baseline longitudinal project is shown in Figure 2 and Figure 3. Within the project reach there are 16 distinct pools with a baseflow water depth of 3 feet or deeper, and a residual pool depth of at least 1.0 feet. The pool:riffle ratio is 1:5. Slope is 0.32%.

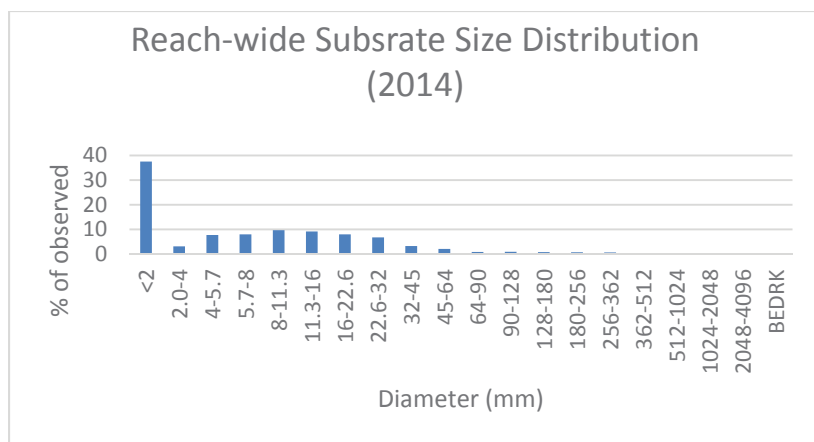
**4: Clearwater Creek Reach-wide Substrate Size Distribution**

Baseline post-installation survey of substrate size distribution confirms previous data and reconnaissance reports. Throughout the Clearwater Creek restoration reach substrate size is small, with an average median substrate size of 7.2 mm and a D84 of 27.4 mm.
