# Fish Screen Operations Report

January 2021

Bigfork Hydroelectric Project  
FERC Project No. 2652

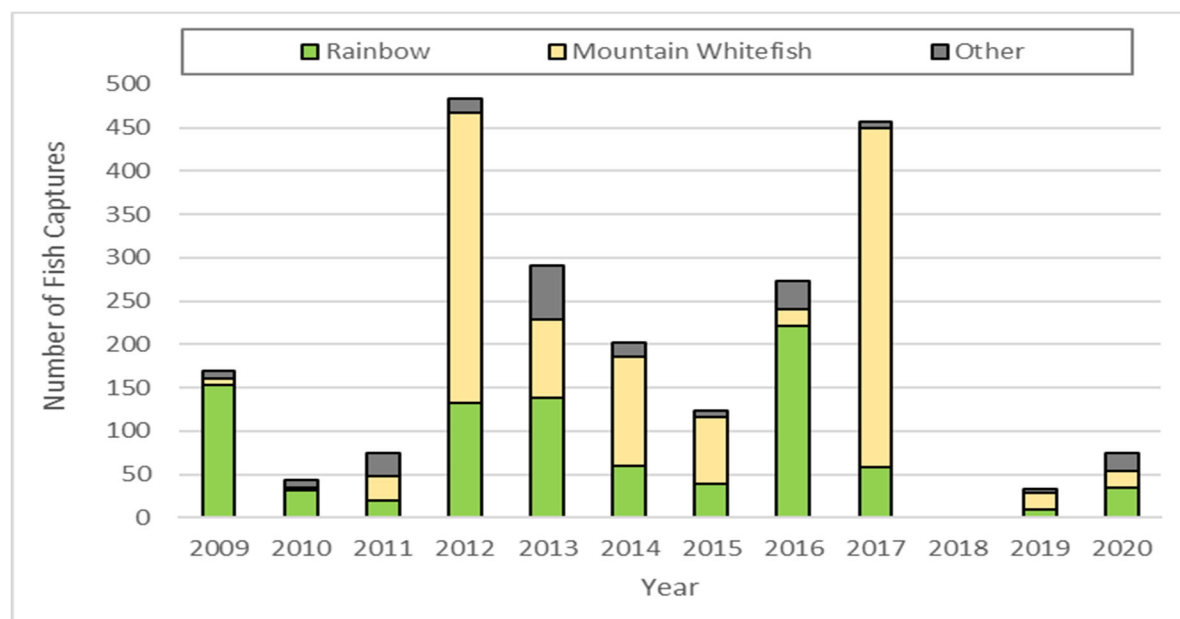
**Figure 3. Total number of fish removed from the Bigfork Canal by year: 2009 – 2020.**

The number of fish captured in the canal in 2020 represents the second smallest total number of fish captured in any previous year. For the first time since surveys began in 2009, smallmouth bass were observed as part of the fish collection. While bass are reported on the fish screens in some years, no bass have been collected in the canal during previous surveys. The proportion of smallmouth bass (26%) observed as part of the total catch was also surprising. All smallmouth bass measured less than 100 mm in total length, indicating these captures are all subyearlings (hatched in the spring or early summer of 2020).
