Fish Screen Operations Report

Bigfork Hydroelectric Project
FERC Project No. 2652

Prepared by
PACIFICORP

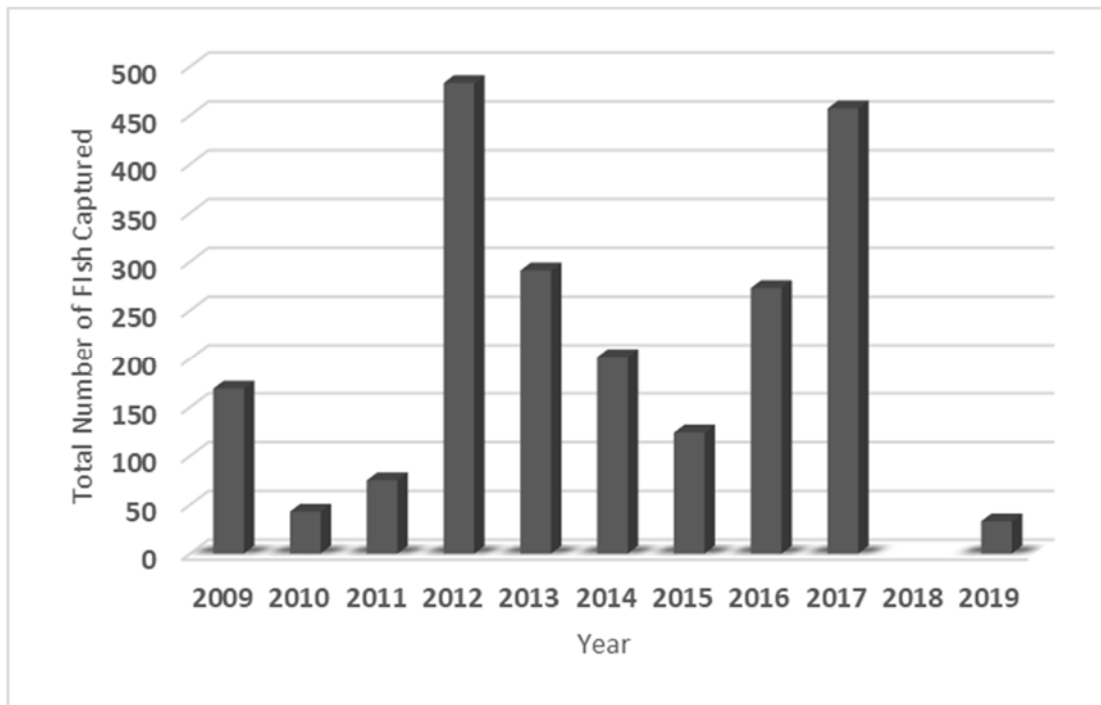
The number of fish captured in the canal in 2019 represented the smallest total number of fish captured in any previous year. The low number of captures may be related to an emergency dewatering event occurring between August 6, and October 26, 2018, whereby the canal was dry while crews installed a liner to prevent erosion along a portion of the earthen canal. This prolonged drawdown caused fish that may have been in the canal to be directed through the canal drain leading to the Swan River. Additionally, a minor one day drawdown in April 2019 was noted to install a steel plate in a leaking portion of the concrete flume.

Figure 1. Bigfork Vicinity Map	2
Figure 2. Bigfork Fish Screen Panel Configuration and Flow Pattern	3
Figure 3. Total number of fish removed from the Bigfork Canal by year: 2009 - 2019	9
