9.1 AESTHETIC / VISUAL RESOURCE STUDY (VIS 1) ..... VIS 1-1

Table 9.1-2. Key Observation Points (KOPs) for the Merwin, Swift No. 1,  
 and Swift No. 2 projects..... VIS 1-13

## 9.0 VISUAL RESOURCES

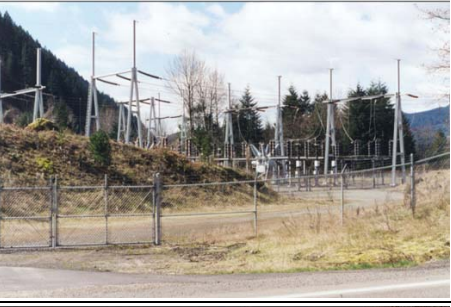
<b>Swift No. 2 / Lewis River Bypass Reach</b>	22	View of Swift No. 2 Substation from Lewis River Road (SR 503 Spur).

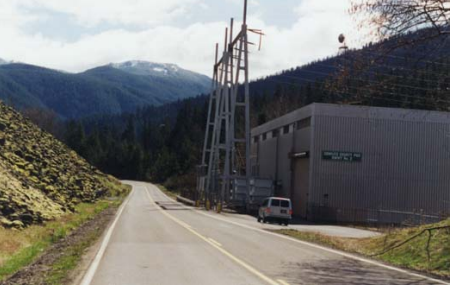
23	View of Swift No. 2 Powerhouse from Lewis River Road (SR 503 Spur).

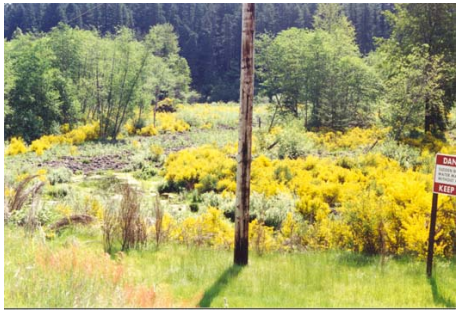
26	Forest Road 90 (FR 90) roadside at pullout before rise to the Swift No. 2 canal road crossing.

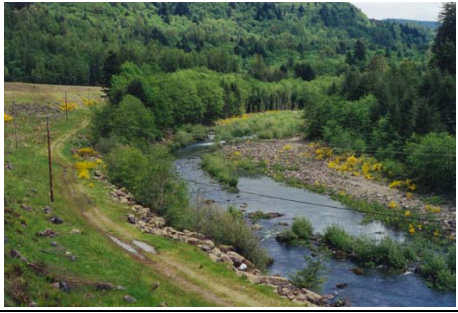
27	View of the Lewis River, looking upstream from FR 90 crossing of the Swift No. 2 canal.

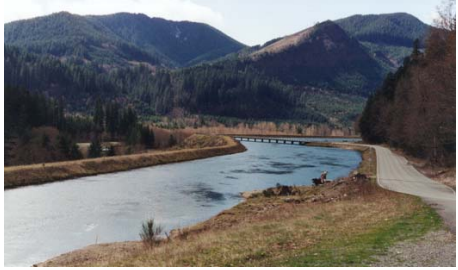
28	View of the Swift No. 2 canal from FR 90.

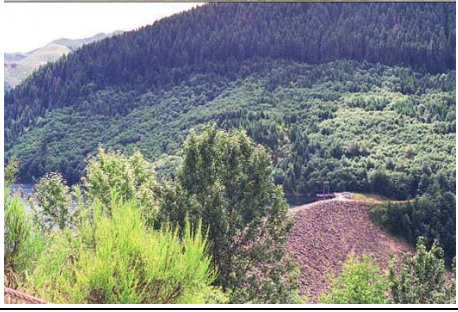
<b>Swift Reservoir</b>	29	View of Swift Dam from the Reservoir Viewpoint on FR 90.

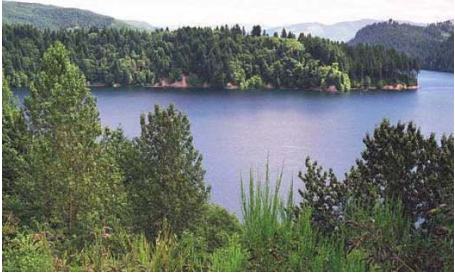
<b>Table 9.1-2. Key Observation Points (KOPs) for the Merwin, Swift No. 1, and Swift No. 2 projects (cont.)</b>			
<b>Project Area</b>	<b>KOP #</b>	<b>KOP Description</b>	<b>KOP Photograph</b>
<b>Swift Reservoir</b>	30	View of Swift Reservoir from the Reservoir Viewpoint on FR 90.

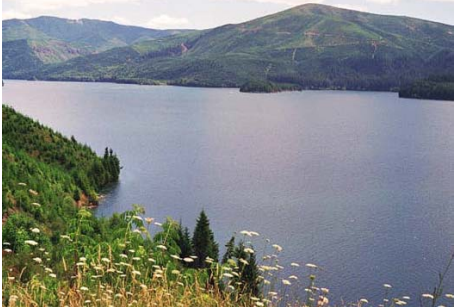
33	View of Swift Reservoir from Drift Creek area pullout on FR 90.

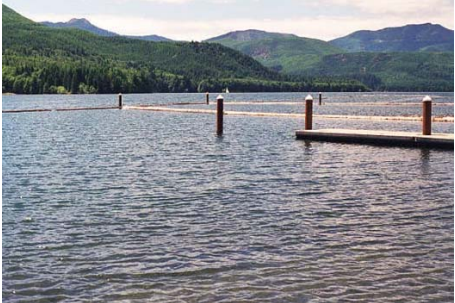
34	View of Swift Reservoir from the Swift Camp boat ramp.

From foreground viewing locations at the Swift Boat Ramp and Northwoods Village Marina, the change in reservoir conditions is noticeable. At the Swift Boat Ramp, an inlet is formed due to the exposed shoreline and a portion of the docks are out of the water. Looking west from the Northwoods Village Marina, docks are floating, but there are no boats because the water is too shallow for ingress and egress. Looking north along the shoreline, most of the docks are out of the water and there is exposed shoreline along the reservoir edge. A large sand bar is exposed between the marina and the old Lewis River bed that runs along the northern shoreline. The summer low pool elevation detracts from the high scenic quality of the reservoir that is experienced at high pool. However, the exposed shoreline and sandbars do not dominate the view as occurs at low pool because water still covers most of the reservoir area.

When water surface elevation drops to low pool, in the vicinity of the Swift Boat Ramp (KOP 34) and the Northwoods Village Marina (KOPs 35 and 36), the change in reservoir conditions is more dramatic than in the lower portions of the reservoir. Drawdown of more than 10 feet below full pool (El. 990) results in the exposure of broad expanses of the reservoir floor in the upstream end of the reservoir. At this elevation, the water in the upper reaches of the reservoir is confined to the Lewis River channel cut through the sediment deposited by Mount St. Helens. In the background view from KOPs 29 and 30, the ring of exposed soil is readily noticeable and detracts from the scenic quality of the reservoir viewshed; however, it does not dominate the view. While the drawdown does

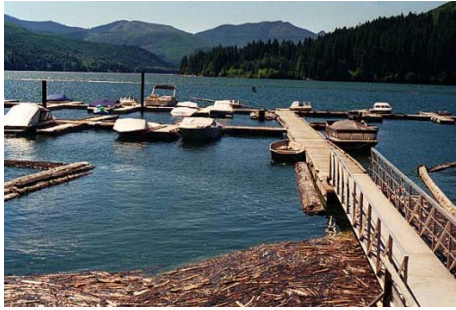
<b>Table 9.1-2. Key Observation Points (KOPs) for the Merwin, Swift No. 1, and Swift No. 2 projects (cont.)</b>			
<b>Project Area</b>	<b>KOP #</b>	<b>KOP Description</b>	<b>KOP Photograph</b>
<b>Swift Reservoir</b>	35	View of Swift Reservoir looking west from the Northwood Village Marina.

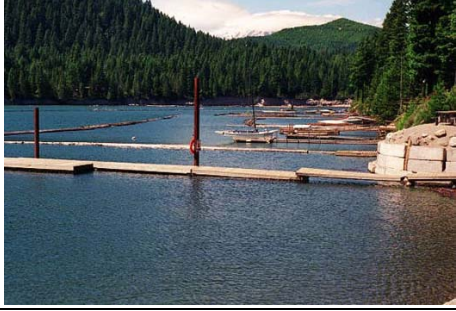
36	View of Swift Reservoir looking north from the Northwood Village Marina.

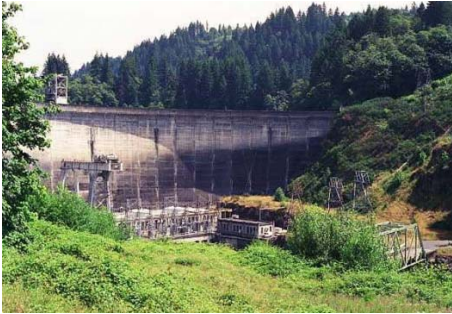
Project Area	Photo #	Photo Description	Facility Photograph
Merwin Project Area	1	Merwin Dam and Powerhouse

A large concrete dam structure built into a deep valley, with a powerhouse building at its base. The surrounding area is lush with green vegetation and forested hills.
	2	Merwin Substation

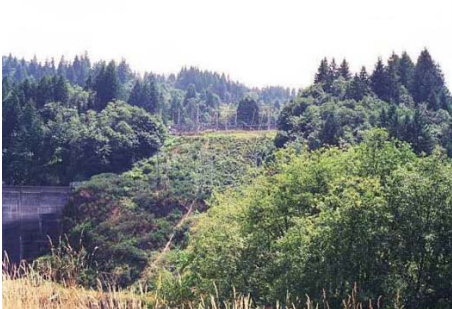
A view of a substation area situated on a hillside, surrounded by dense evergreen and deciduous trees. The terrain appears to be cleared for the facility.
	3	Merwin Village

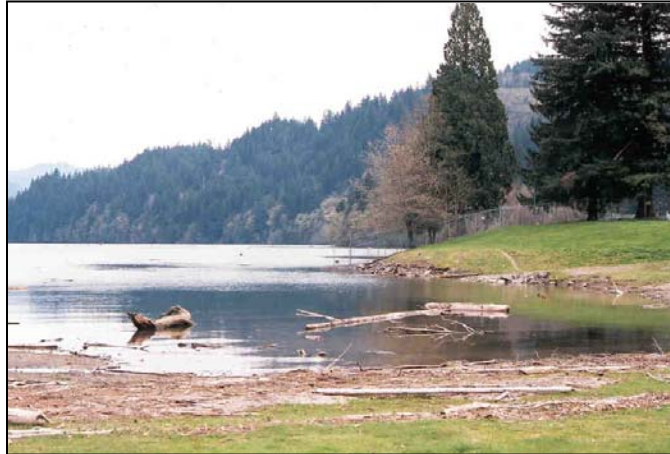
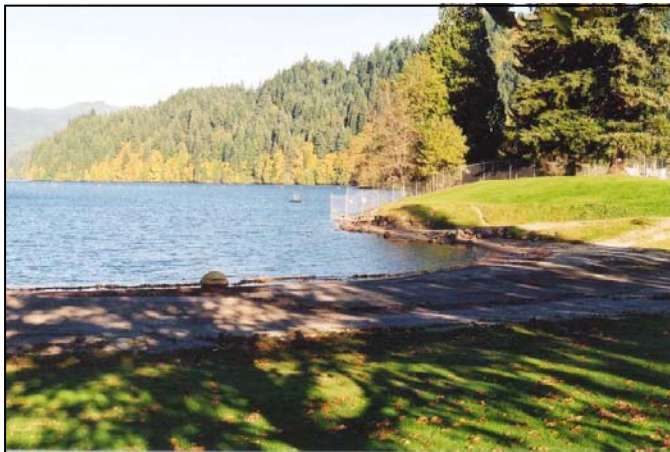
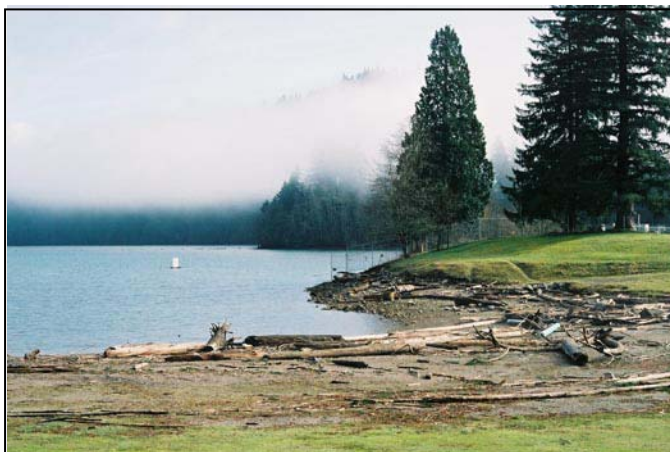
**Figure 9.1-2. KOP 4-Comparative photographs of summer high, summer low and low pool conditions at Merwin Dam Park.**

Summer High Pool (El. 238)

Summer Low Pool (El. 236)

Low Pool (El. 234)

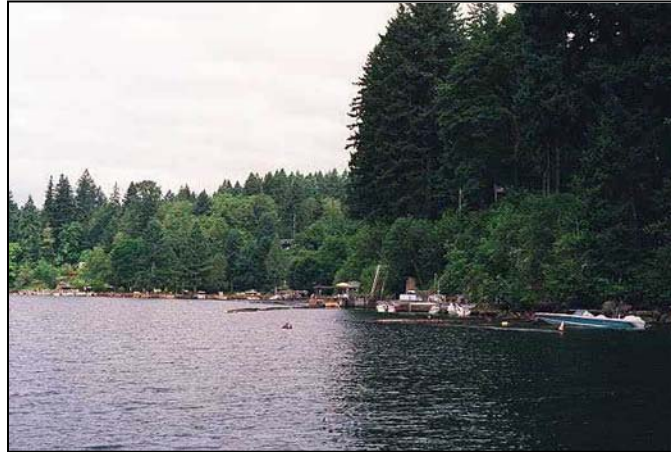
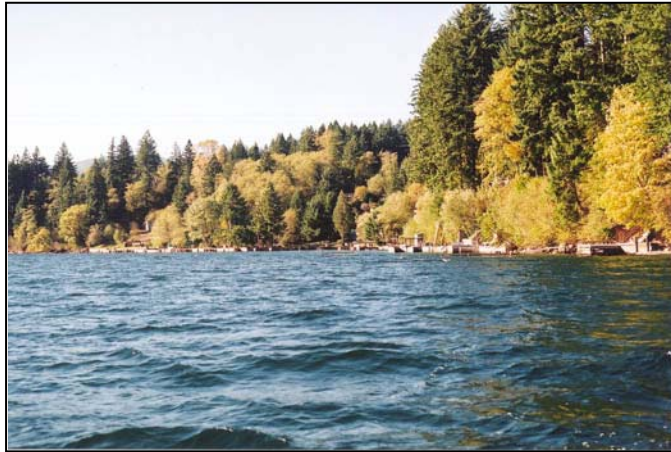
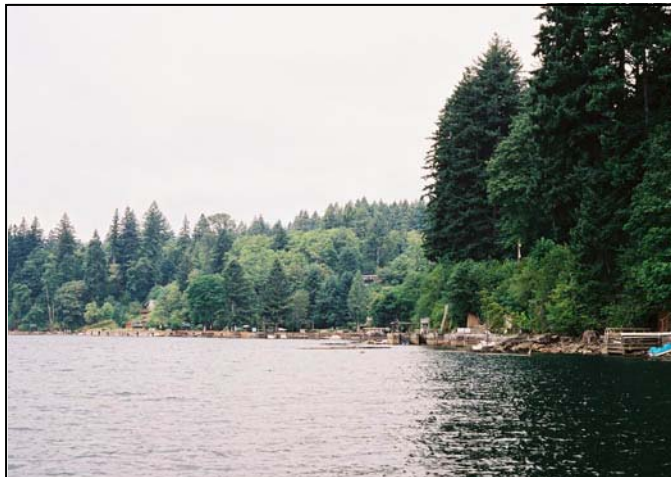
**Figure 9.1-3. KOP 7-Comparative photographs of summer high, summer low and low pool conditions at Woodland Park.**

Summer High Pool (El. 238)

Summer Low Pool (El. 236)

Low Pool (El. 234)

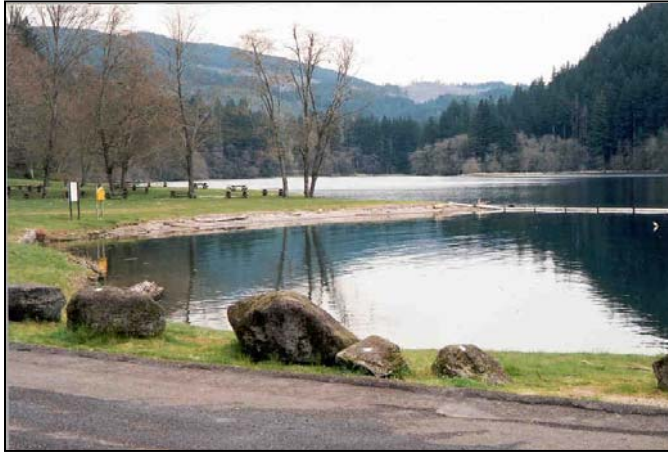
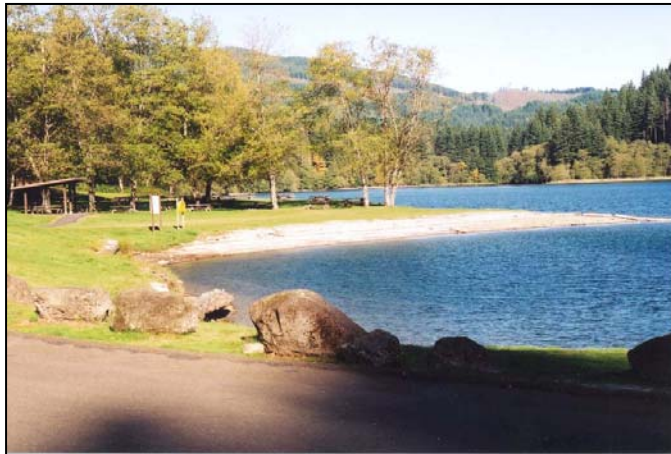
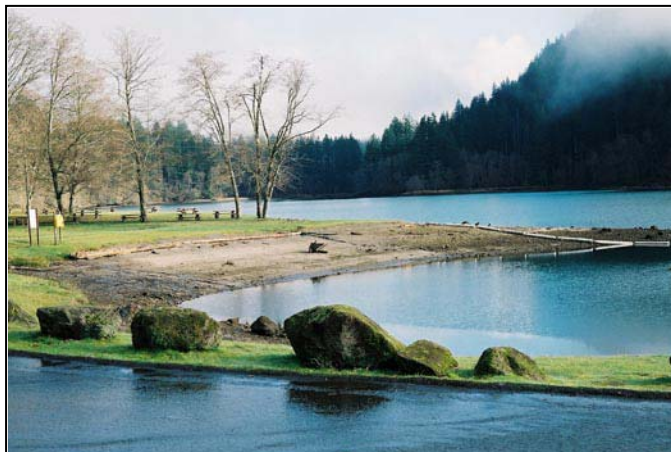
**Figure 9.1-4. KOP 8-Comparative photographs of summer high, summer low and low pool conditions at Speelyai Bay Park.**

Summer High Pool (El. 238)

Summer Low Pool and Low Pool (El. 236)

Low Pool (El. 234)

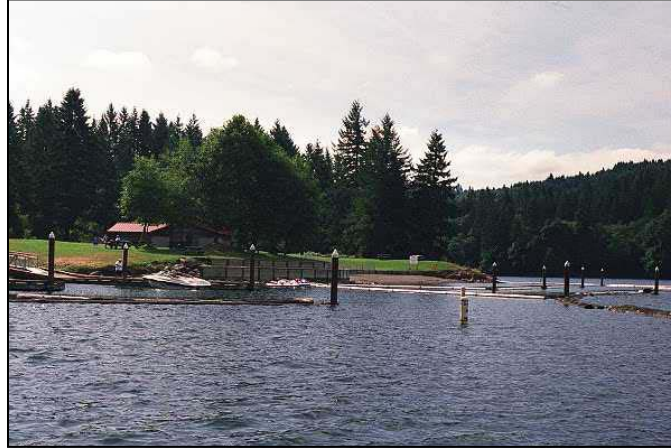
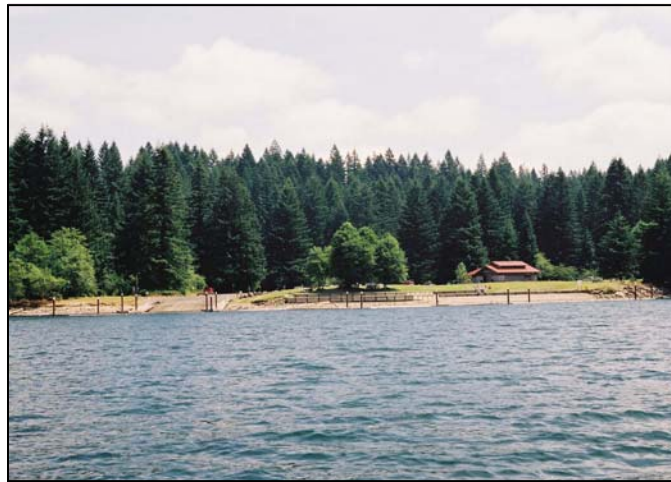
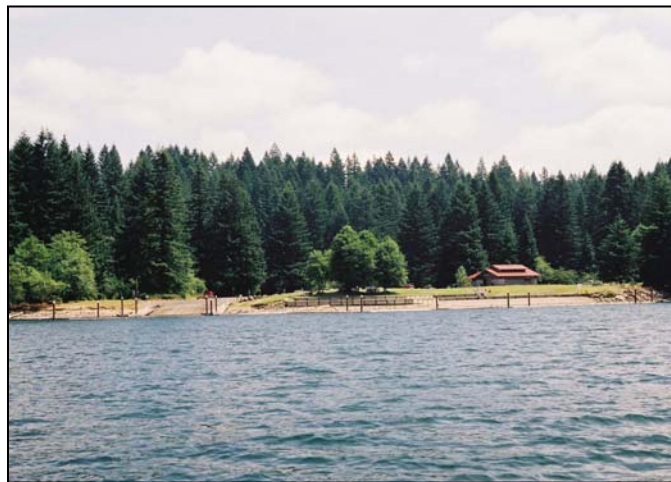
**Figure 9.1-5. KOP 10-Comparative photographs of summer high, summer low, and low pool conditions at Cresap Bay Recreation Area.**

Summer High Pool (El. 238)

Summer Low Pool and Low Pool (El. 236)

Low Pool (El. 234)

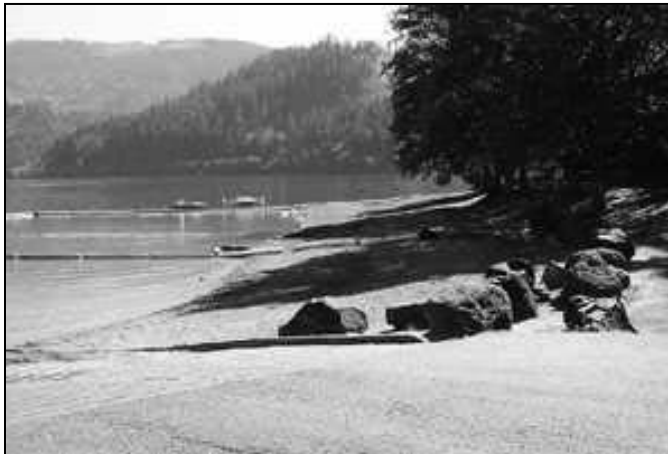
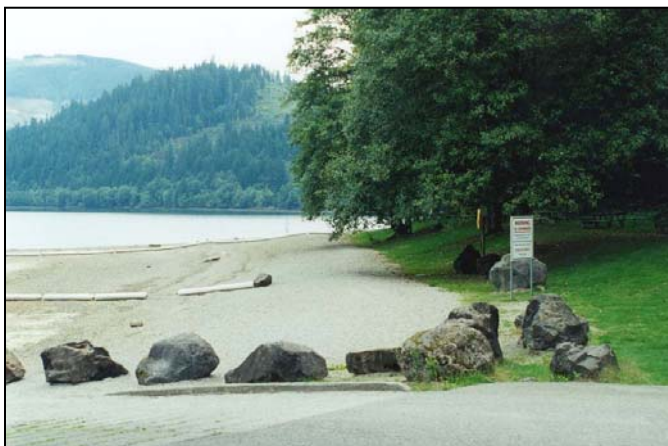
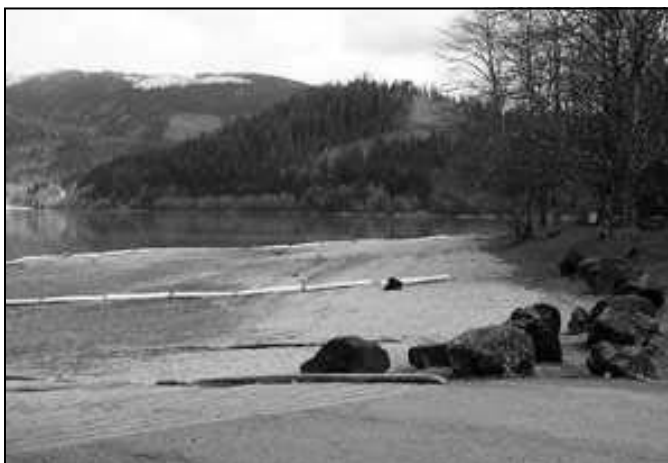
**Figure 9.1-6. KOP 12 - Comparative photographs of summer high, summer low, and low pool conditions at Saddle Dam Park.**

Summer High Pool (El. 490)

Summer Low Pool (El. 481)

Low Pool (El. 470)

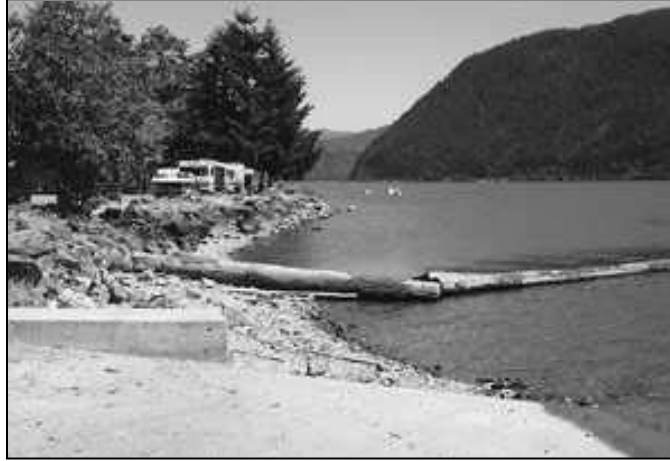
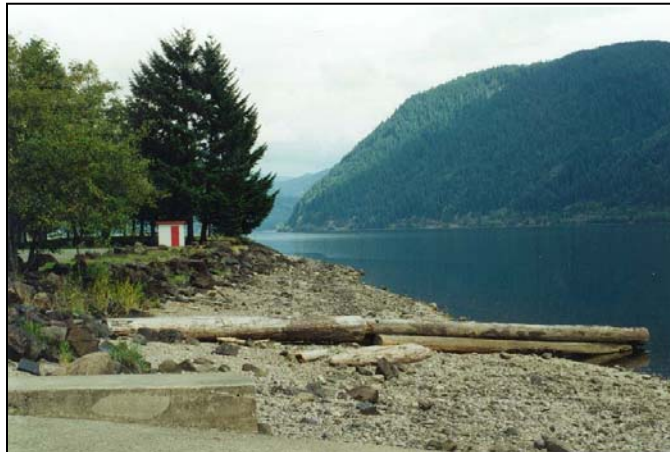
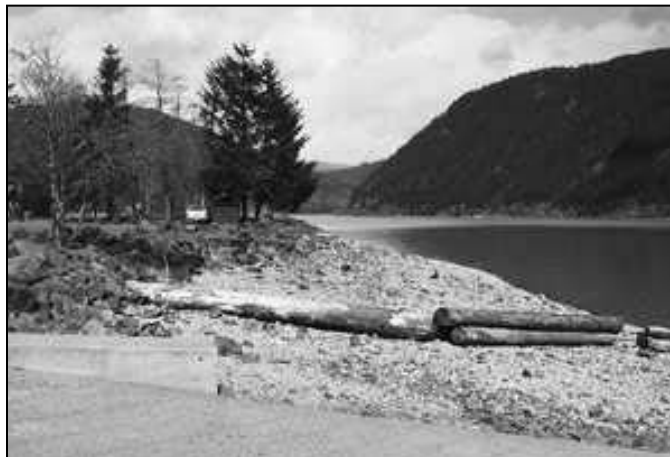
**Figure 9.1-7. KOP 15 - Comparative photographs of summer high, summer low, and low pool conditions at Yale Park.**

Summer High Pool (El. 490)

Summer Low Pool (El. 481)

Low Pool (El. 470)

*Summer High, Summer Low and Low Pool* - Conditions vary depending on the locations. In general, at maximum pool, sandbars are exposed in some places, for example west of the boat ramp at Yale Park. The lake bottom can be seen in shallow areas, particularly in and around the places where swimming is allowed. Accumulated driftwood appears along the shore in many areas.

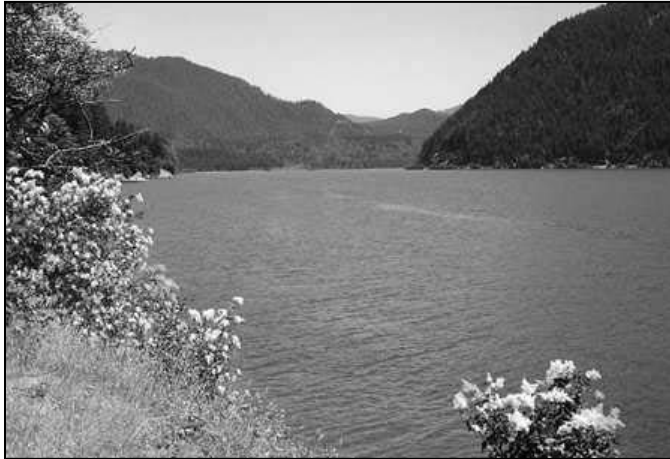
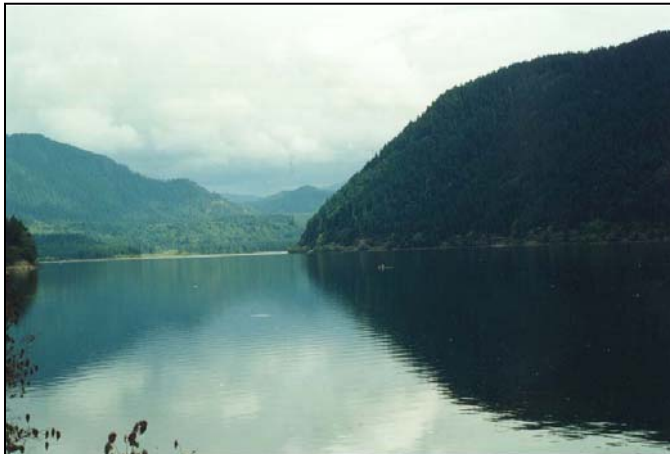
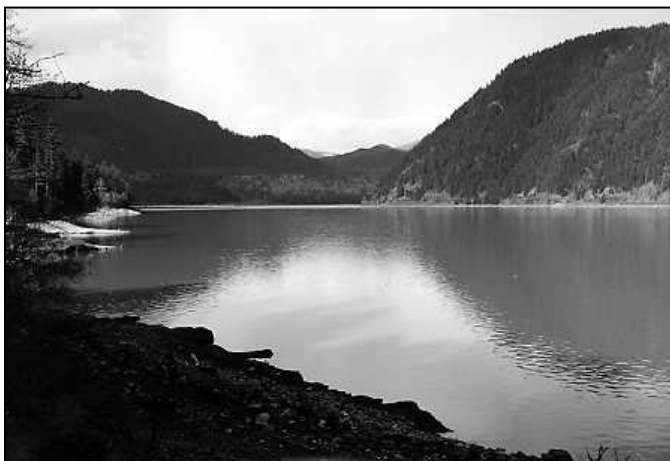
**Figure 9.1-8. KOP 17 – Comparative photographs of summer high, summer low, and low pool conditions at Yale Lake as seen from SR 503 Spur east of Yale Park.**

Summer High Pool (El. 490)

Summer Low Pool (El. 481)

Low Pool (El. 470)

Trees and brush limit views of Yale Lake from Lewis River Road (SR 503 Spur). In locations where openings occur and the lake is in view, areas of exposed lake bottom can be seen, including some that contain tree stumps. Conditions associated with drawdown, however, are much less evident from the road than from recreation sites located at the shore.

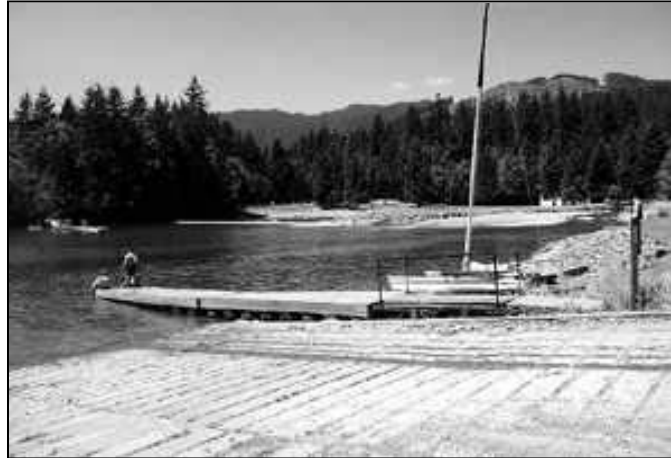
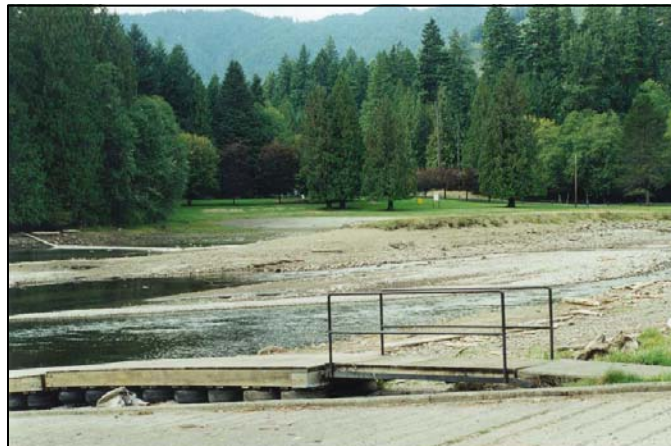
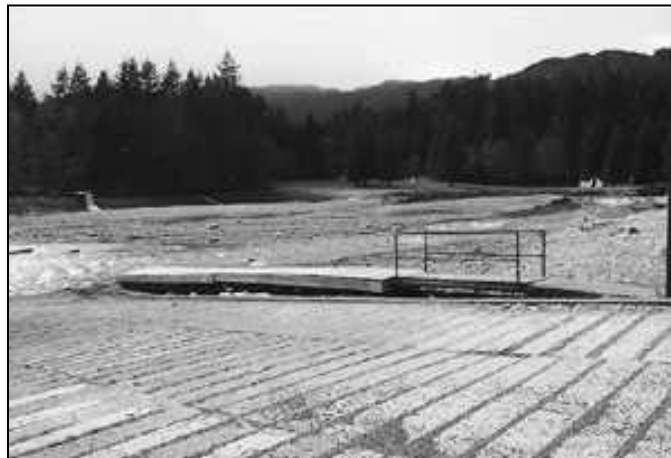
**Figure 9.1-9. KOP 21 – Comparative photographs of summer high, summer low, and low pool conditions at Cougar Park as seen from the boat ramp at Cougar Campground.**

Summer High Pool (El. 490)

Summer Low Pool (El. 481)

Low Pool (El. 470)

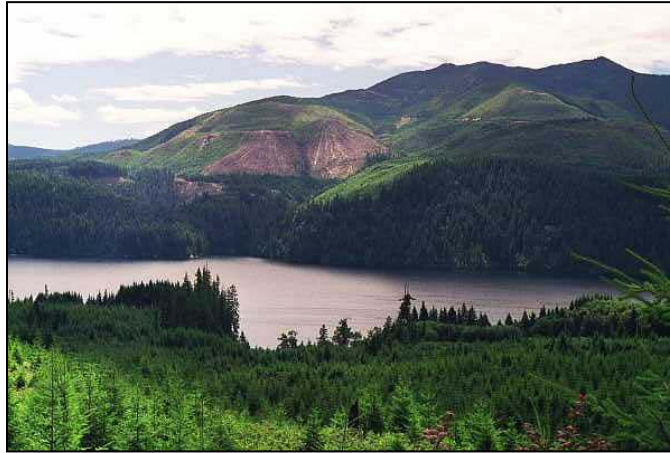
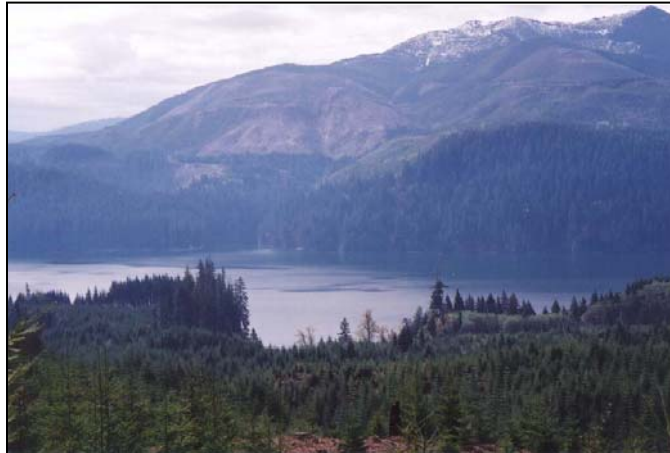
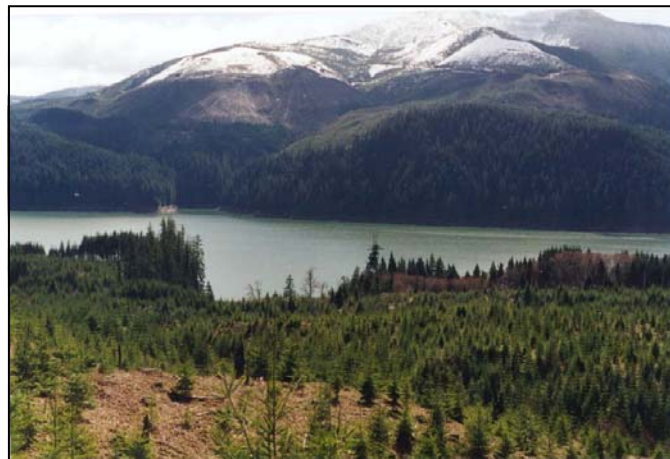
**Figure 9.1-10. KOP 30-Comparative photographs of summer high, summer low, and low pool conditions from the Reservoir Viewpoint off of FR 90.**

Summer High Pool (El. 999)

Summer Low Pool (El. 991)

Low Pool (El. 964)

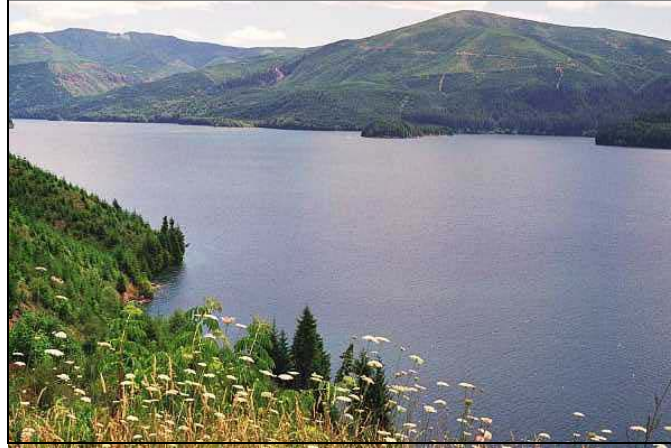
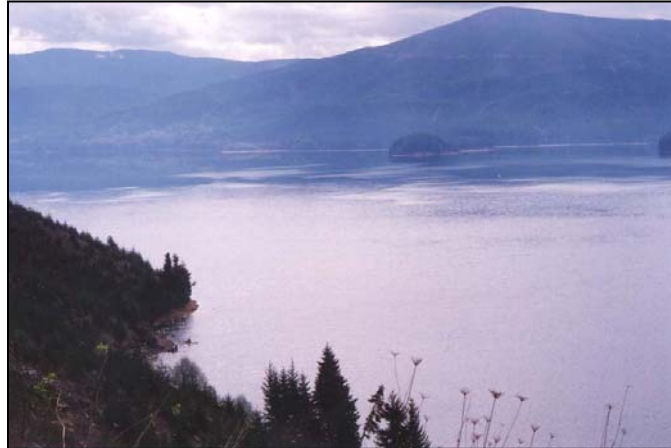
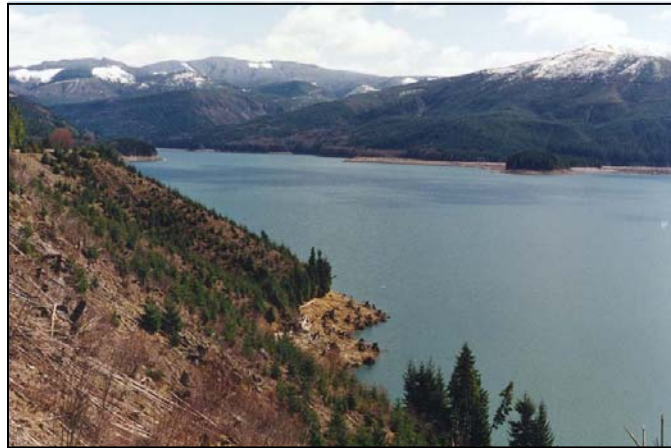
**Figure 9.1-11. KOP 33- Comparative photographs of summer high, summer low, and low pool conditions from Drift Creek Pullout off of FR 90.**

Summer High Pool (El. 999)

Summer Low Pool (El. 991)

Low Pool (El. 964)

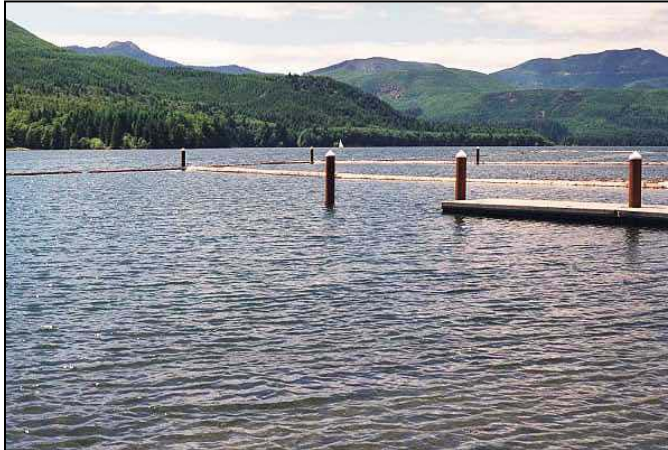
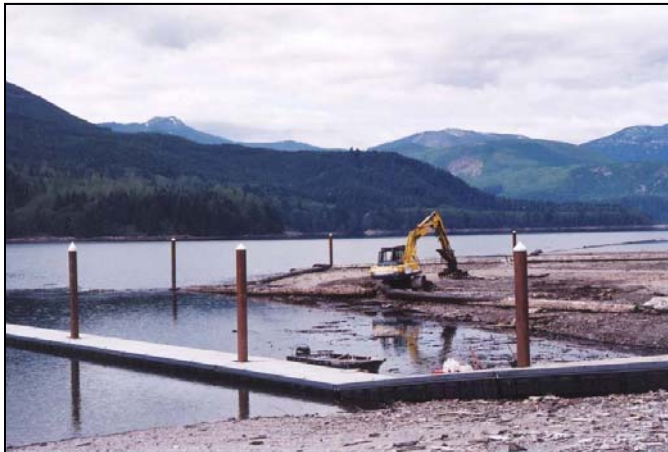
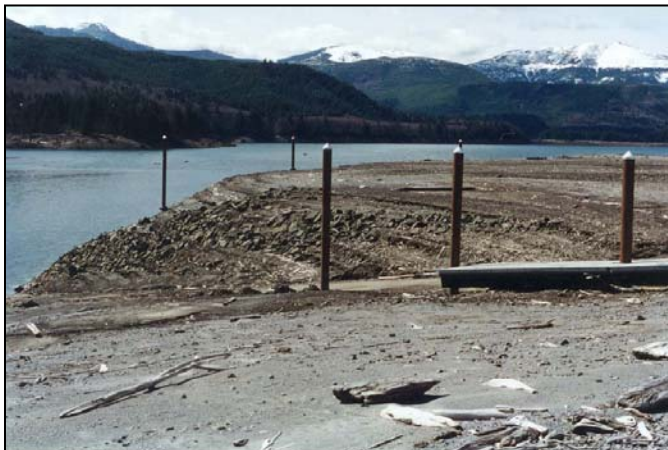
**Figure 9.1-12. KOP 34- Comparative photographs of summer high, summer low, and low pool conditions from Swift Boat Ramp.**

Summer High Pool (El. 999)

Summer Low Pool (El. 991)

Low Pool (El. 964)

At the upstream end of the reservoir, the low pool conditions shown in KOPs 34, 35 and 36 are representative of the foreground views that visitors could experience in the fall, winter, and spring when the reservoir is at low pool. However, visitation is low at these times of the year. From these foreground viewing locations, the exposed soil of the reservoir bottom dominates the view and adversely affects the scenic quality of the reservoir viewshed. However, the effect is not considered significant due to the low level of recreation use during this time of year.

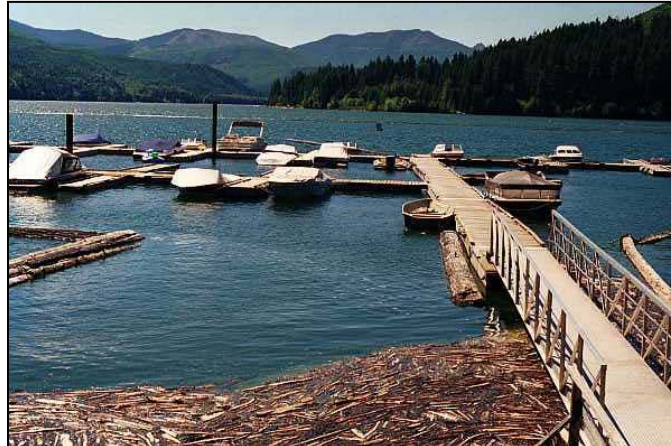
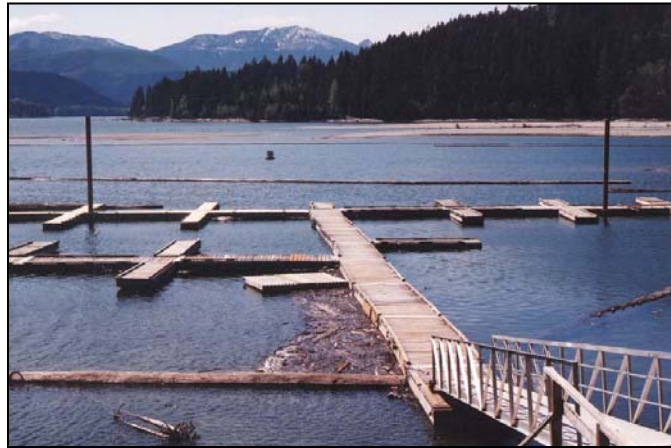
**Figure 9.1-13. KOP 35 - Comparative photographs of summer high, summer low, and low pool conditions from the Northwoods Village Marina, looking west.**

Summer High Pool (El. 999)

Summer Low Pool (El. 991)

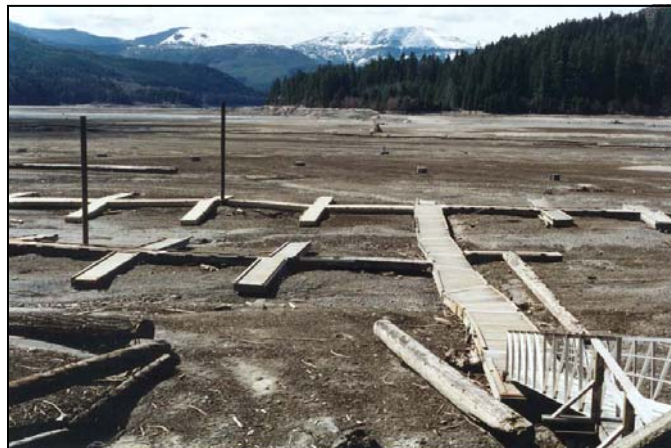
Low Pool (El. 964)

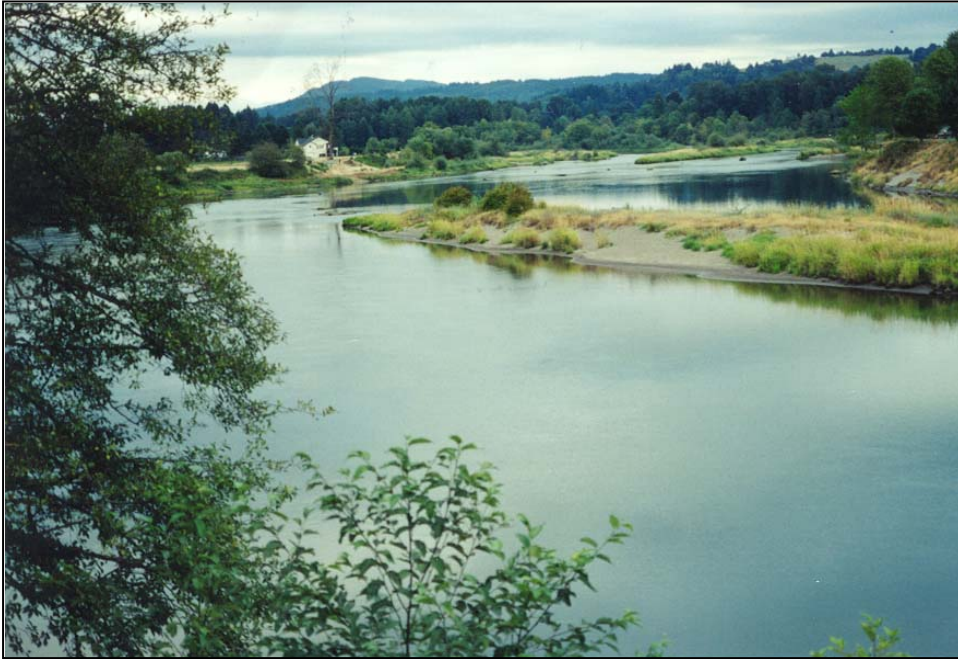
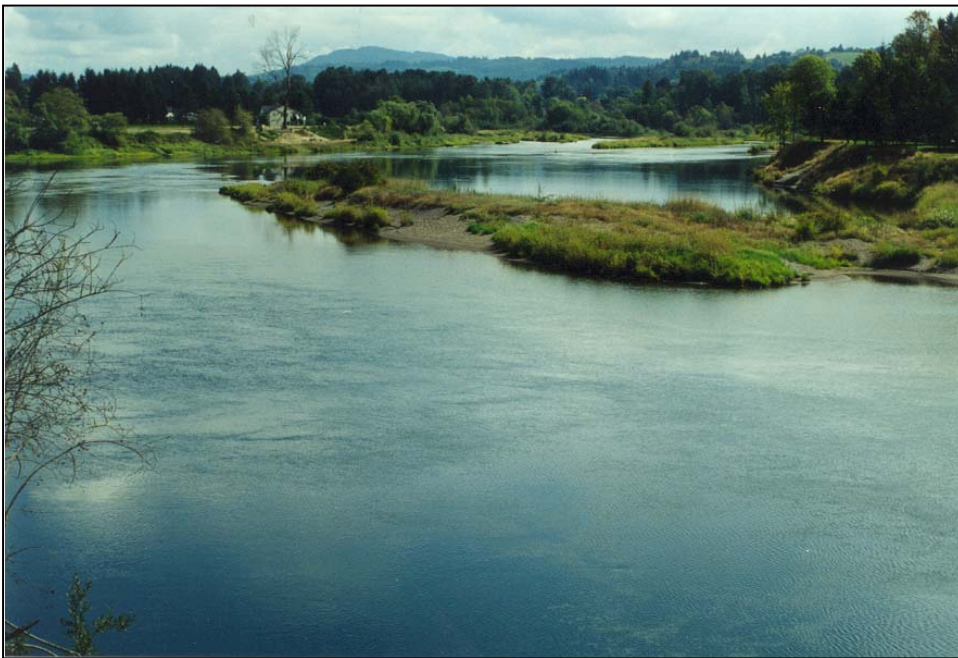
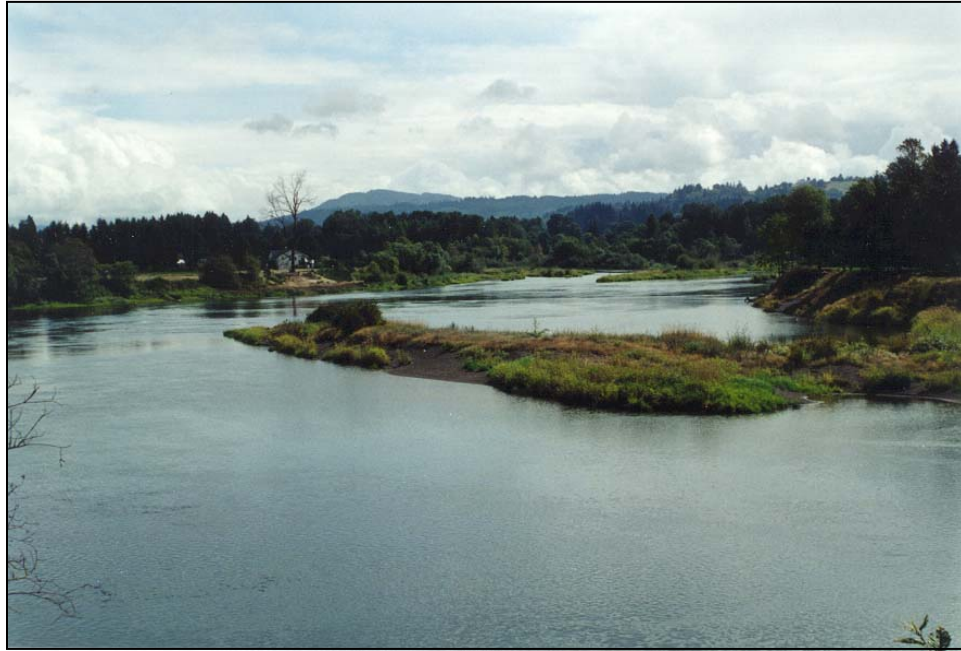
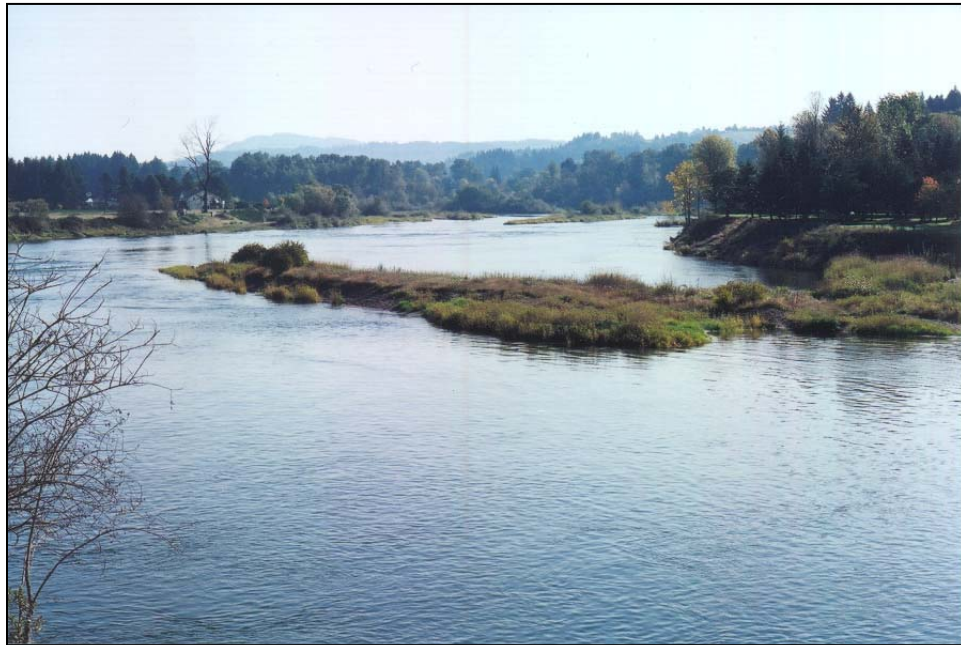
August Flow (1,430 cfs)

July/September Flow (2,150 cfs)

**Figure 9.1-14. Comparative photographs of representative flows in the Lewis River as seen from SR 503 in the city of Woodland (KOP 1).**

June Flow (2,990 cfs)

April/May/October Flow (4,989 cfs)

**Figure 9.1-14. Comparative photographs of representative flows in the Lewis River as seen from SR 503 in the city of Woodland (KOP 1) (cont.).**

Photo documentation of the 4 river flows indicated a change in the visual appearance of the river at the lower flows. At the lowest flow (August flow) there is a sand bar just downstream of the boat launch. At 2,150 cfs, just the tip of the sand bar is exposed, but the flow of water around the shallow area is apparent. At 2,990 cfs water covers the surface of the sand bar, but the shallowness of the water depth is apparent from the change in color and the current of the water around the shallow area. At the highest flow, (4,989 cfs), the bar is completely covered and the flow of water across the bar is similar to the flow in the rest of the channel. Other changes in shoreline and water surface conditions are not apparent at any of the flows documented (Figure 9.1-16)

*Summary Conclusion* – The range of flows that typically occur in the Lewis River below Merwin Dam during periods of popular recreation use do not adversely affect the visual quality of the river corridor. Analysis of flows ranging between approximately 1,400 and 5,000 cfs indicate that the river maintains its scenic quality. While the August flow of around 1,400 cfs may result in expanded areas of exposed shoreline or an occasional sand bar, the appearance of the river is not substantially different from higher flows in the 2,000 to 3,000 cfs range. Flows around 5,000 cfs that occur in April, May and October tend to have somewhat of a flooded or bank-full appearance as compared to flows in the 2,000 to 3,000 cfs range. At flows around 5,000 cfs, beach areas are limited, the sand bar at KOP 3 is not visible, and there is more of a current in the pool and run-pool sections of the river. Of the flows assessed, the middle-range flows around 3,000 cfs appear the most visually pleasing, although as stated above, the visual differences between the entire range of flows is not significant.

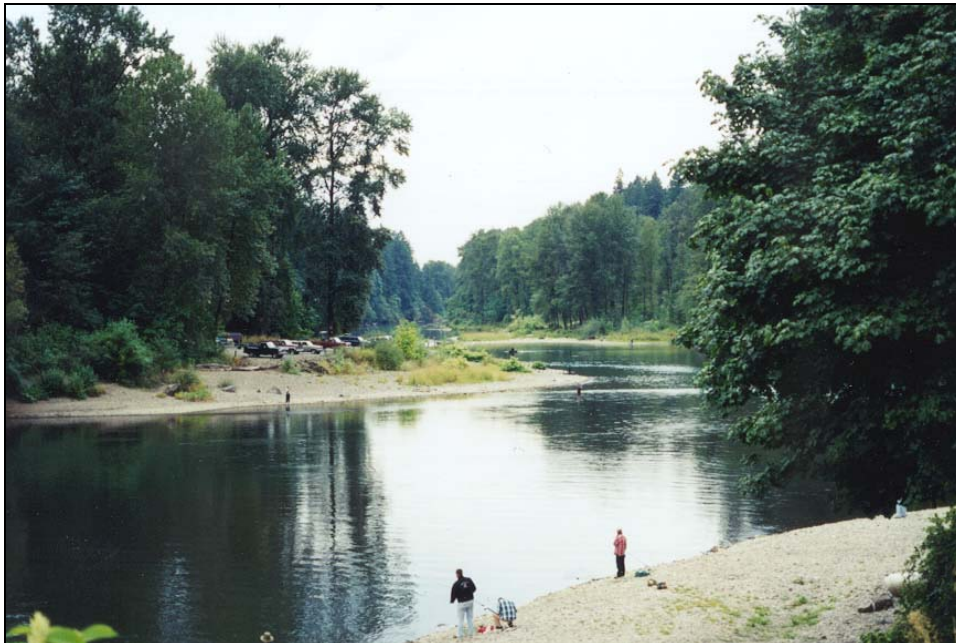
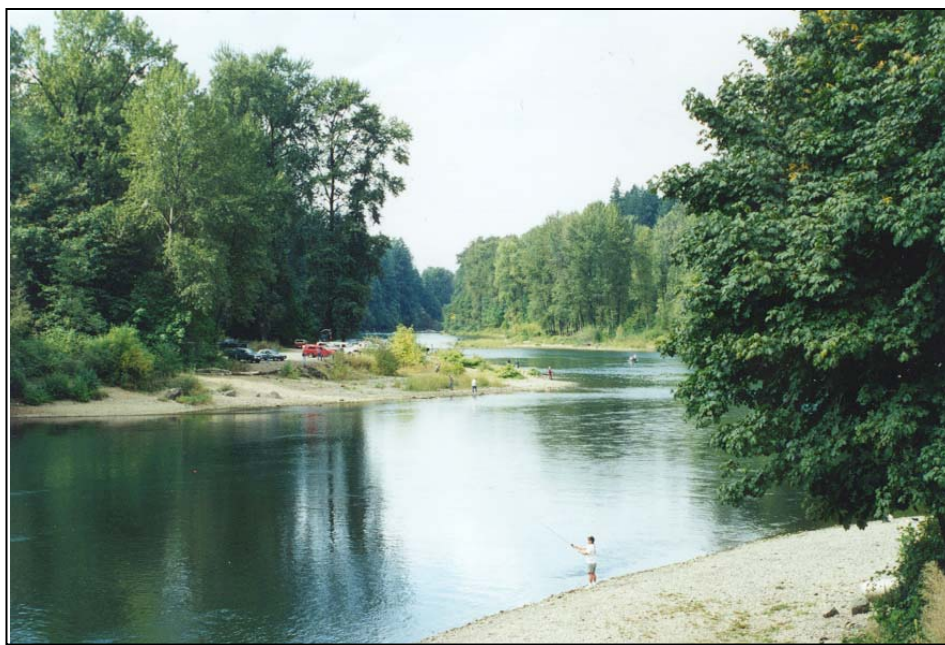
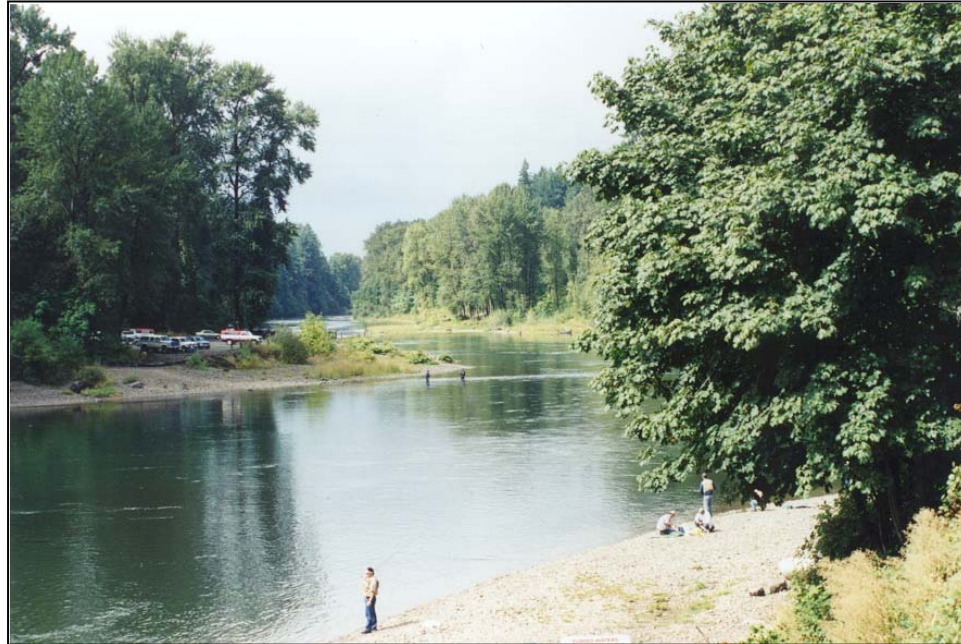
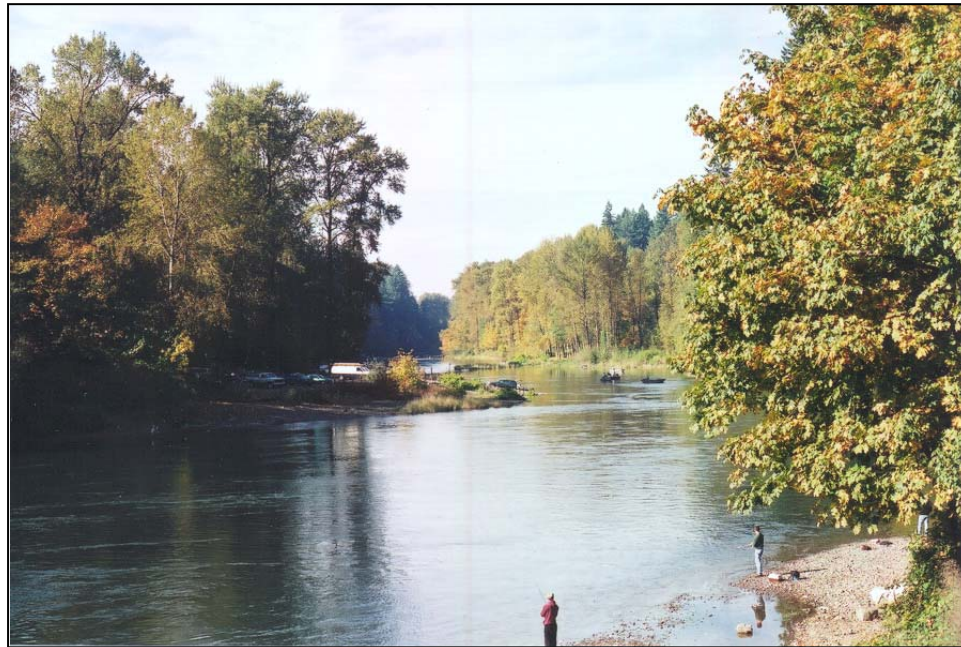
August Flow (1,430 cfs)

July/September Flow (2,150 cfs)

**Figure 9.1-15. Comparative photographs of representative flows in the Lewis River as seen from the Eagle Island Boat Ramp (KOP 2).**

June Flow (2,990 cfs)

April/May/October Flow (4,989 cfs)

**Figure 9.1-15. Comparative photographs of representative flows in the Lewis River as seen from the Eagle Island Boat Ramp (KOP 2) (cont.).**
