9.1 AESTHETIC / VISUAL RESOURCE STUDY (VIS 1) ..... VIS 1-1

Table 9.1-2. Key Observation Points (KOPs) for the Merwin, Swift No. 1,  
 and Swift No. 2 projects..... VIS 1-13

## 9.0 VISUAL RESOURCES

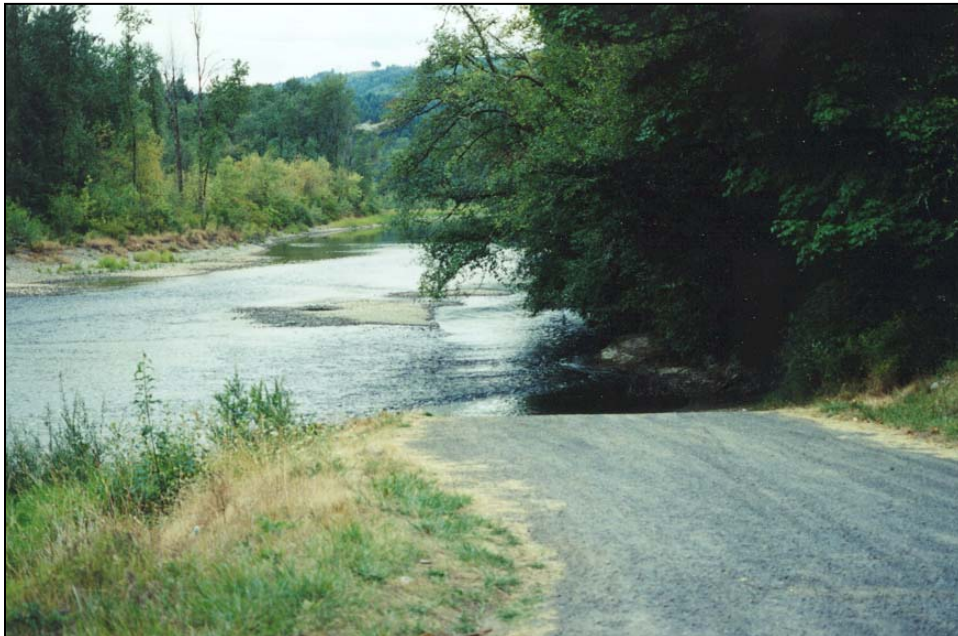
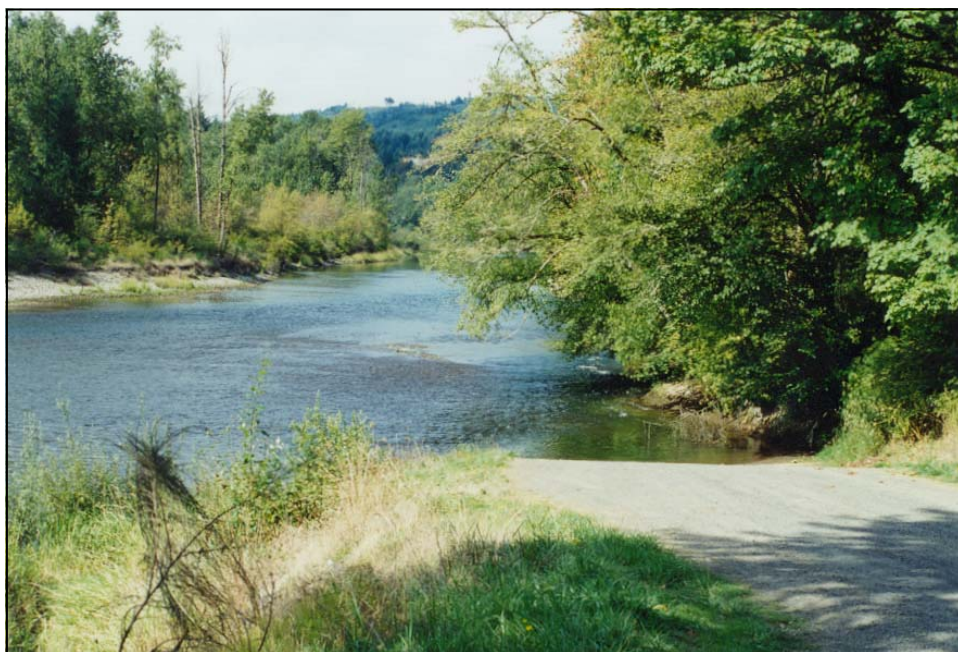
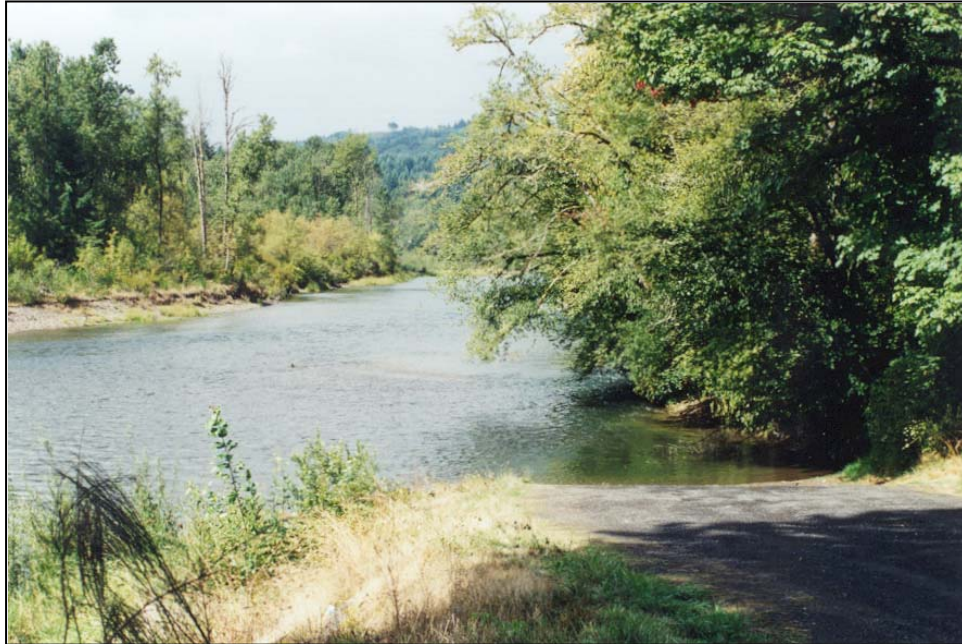
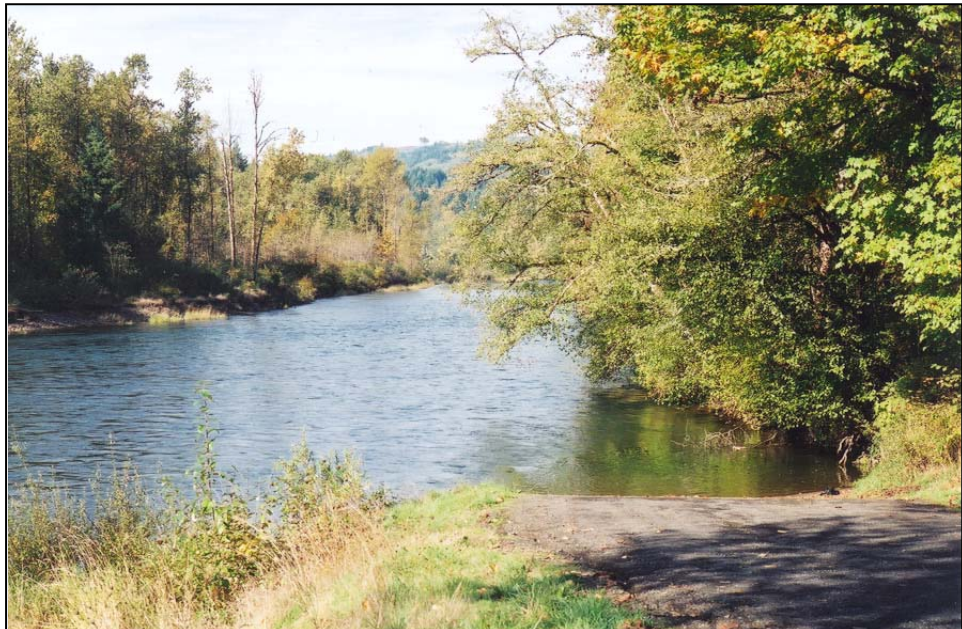
August Flow (1,430 cfs)

July/September Flow (2,150 cfs)

**Figure 9.1-16. Comparative photographs of representative flows in the Lewis River as seen from the Hatchery Boat Ramp (KOP 3).**

June Flow (2,990 cfs)

April/May/October Flow (4,989 cfs)

**Figure 9.1-16. Comparative photographs of representative flows in the Lewis River as seen from the Hatchery Boat Ramp (KOP 3) (cont.).**

Photo documentation of the 4 river flows indicated a change in the visual appearance of the river at the lower flows. At the lowest flow (August flow) there is a sand bar just downstream of the boat launch. At 2,150 cfs, just the tip of the sand bar is exposed, but the flow of water around the shallow area is apparent. At 2,990 cfs water covers the surface of the sand bar, but the shallowness of the water depth is apparent from the change in color and the current of the water around the shallow area. At the highest flow, (4,989 cfs), the bar is completely covered and the flow of water across the bar is similar to the flow in the rest of the channel. Other changes in shoreline and water surface conditions are not apparent at any of the flows documented (Figure 9.1-16)

*Summary Conclusion* – The range of flows that typically occur in the Lewis River below Merwin Dam during periods of popular recreation use do not adversely affect the visual quality of the river corridor. Analysis of flows ranging between approximately 1,400 and 5,000 cfs indicate that the river maintains its scenic quality. While the August flow of around 1,400 cfs may result in expanded areas of exposed shoreline or an occasional sand bar, the appearance of the river is not substantially different from higher flows in the 2,000 to 3,000 cfs range. Flows around 5,000 cfs that occur in April, May and October tend to have somewhat of a flooded or bank-full appearance as compared to flows in the 2,000 to 3,000 cfs range. At flows around 5,000 cfs, beach areas are limited, the sand bar at KOP 3 is not visible, and there is more of a current in the pool and run-pool sections of the river. Of the flows assessed, the middle-range flows around 3,000 cfs appear the most visually pleasing, although as stated above, the visual differences between the entire range of flows is not significant.

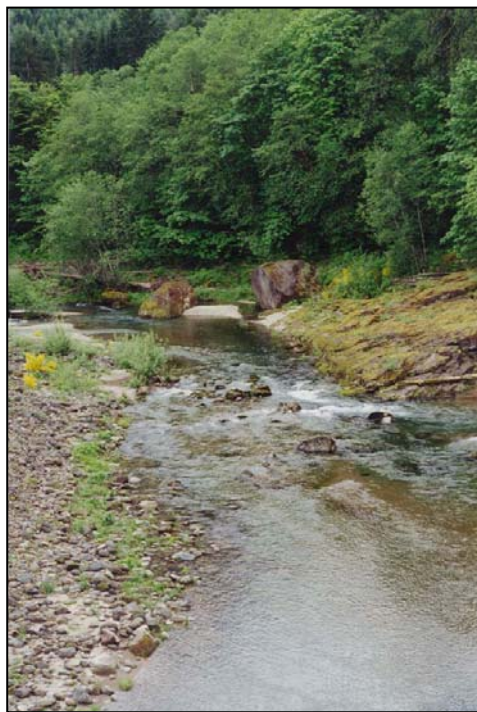
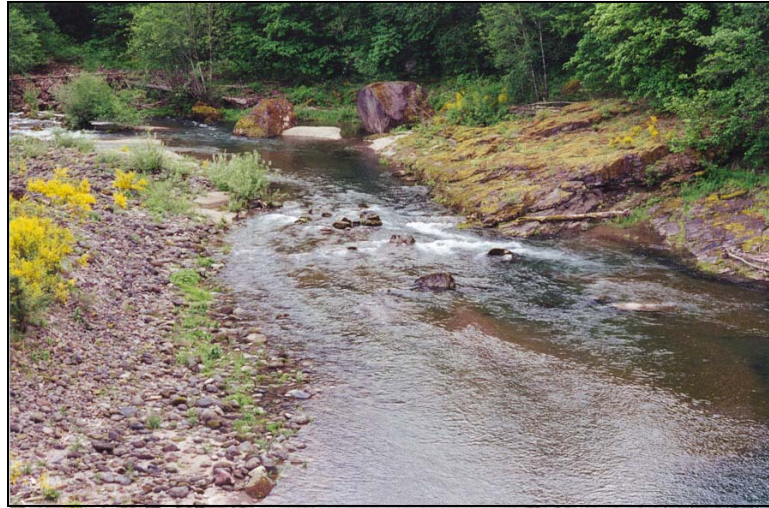
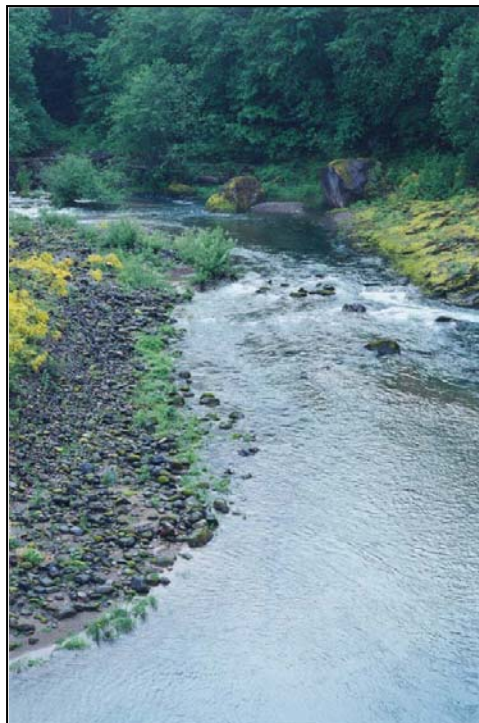
Flow #1 (68 cfs)

Flow #2 (134 cfs)

**Figure 9.1-17. Comparative photographs of the Lewis River bypass reach as seen from the IP Road bridge looking upstream (KOP 24).**

Flow #3 (200 cfs)

Flow #4 (290 cfs)

**Figure 9.1-17. Comparative photographs of the Lewis River bypass reach as seen from the IP Road bridge looking upstream (KOP 24) (cont.).**

*Summary / Conclusion.* Change in the visual characteristics of the Lewis River bypass reach at 4 flow levels was not very noticeable even though the highest flow (290 cfs) was more than 5 times the lowest flow (68 cfs). From KOPs 25 and 26, there was little change in the visual appearance as flows increased. For KOP 25, this was due to the pool structure, whereas KOP 26 was more distant from the river and therefore changes in river conditions were more difficult to discern. KOP 24 had the most changes in stream conditions with increases in flow. The visual appearance of KOP 24 improved when flows were between 200 and 290 cfs, mostly due to increased water depth and increased reflection of the sky colors.

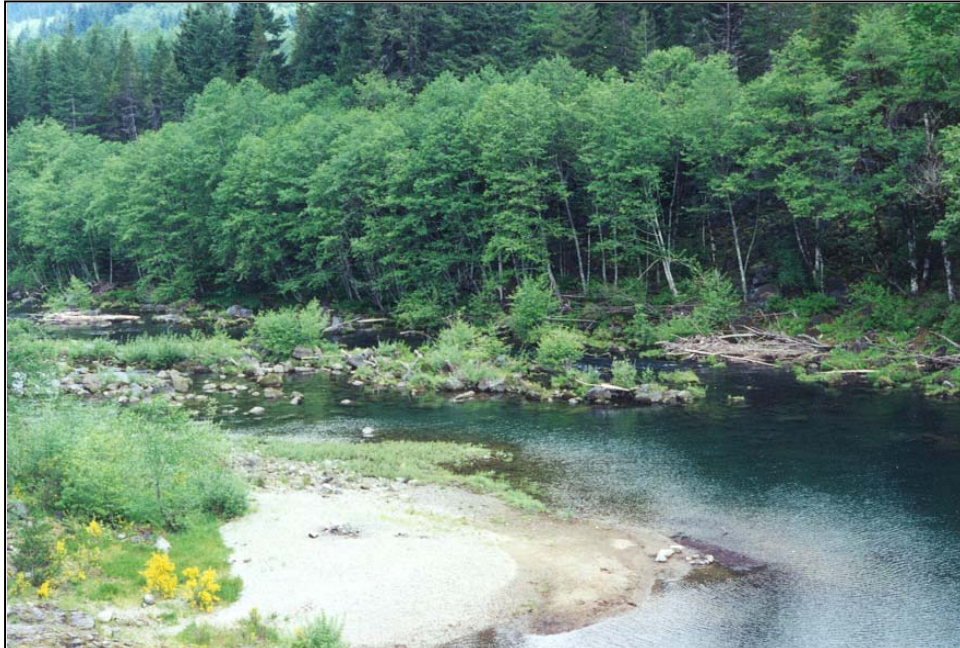
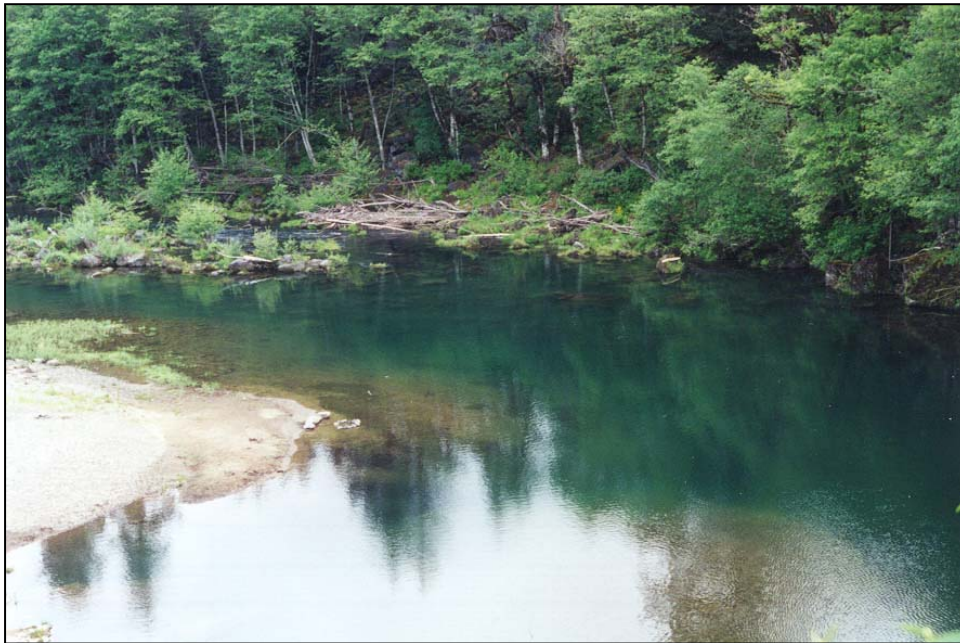
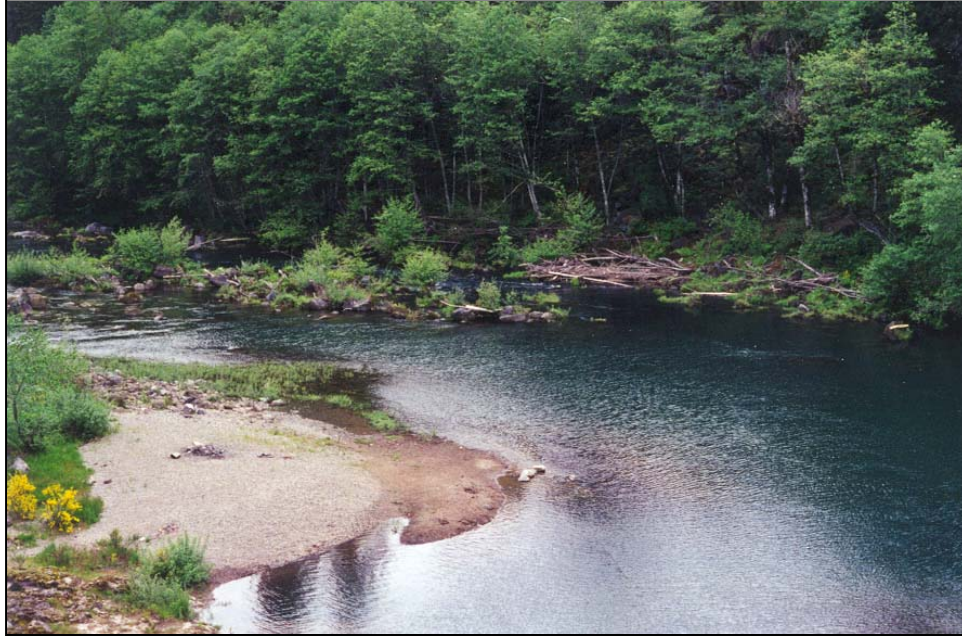
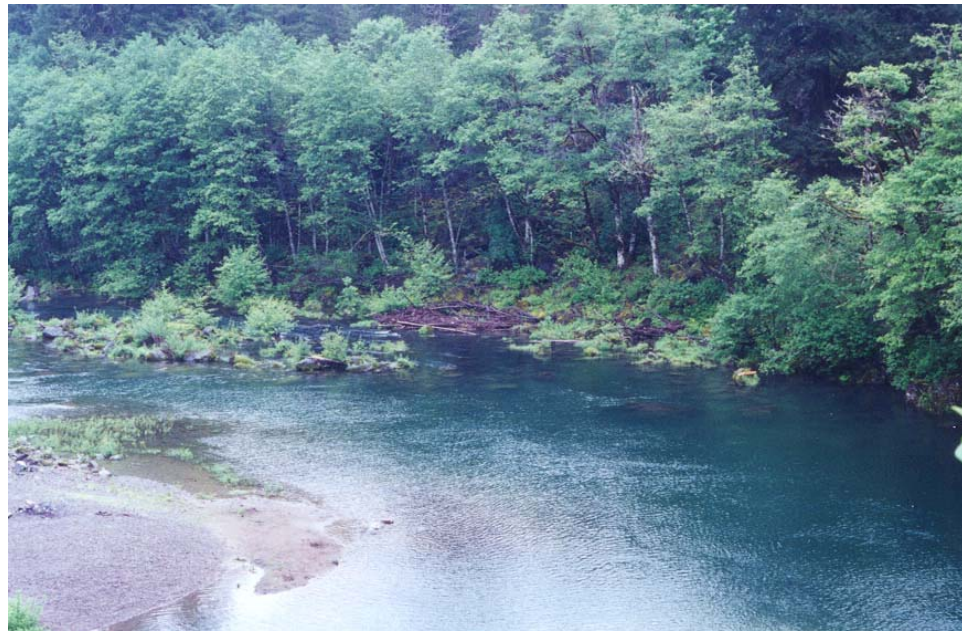
Flow #1 (68 cfs)

Flow #2 (134 cfs)

**Figure 9.1-18. Comparative photographs of the Lewis River bypass reach as seen from the IP Road bridge looking downstream (KOP 25).**

Flow #3 (200 cfs)

Flow #4 (290 cfs)

**Figure 9.1-18. Comparative photographs of the Lewis River bypass reach as seen from the IP Road bridge looking downstream (KOP 25) (cont.).**

Photo documentation of the 4 flows assessed from KOP 25 indicates that there is no significant difference in the visual appearance of the river. There is some increase in the width of the pool as evidenced by the changes in shoreline conditions on the left bank; however, the changes are not substantial enough to be readily noticeable. At the lower flows of 68 and 134 cfs (flows #1 and #2, respectively) there is no visible sign of water movement in the pool. At the higher flows of 200 and 290 cfs (Flow #3 and #4,

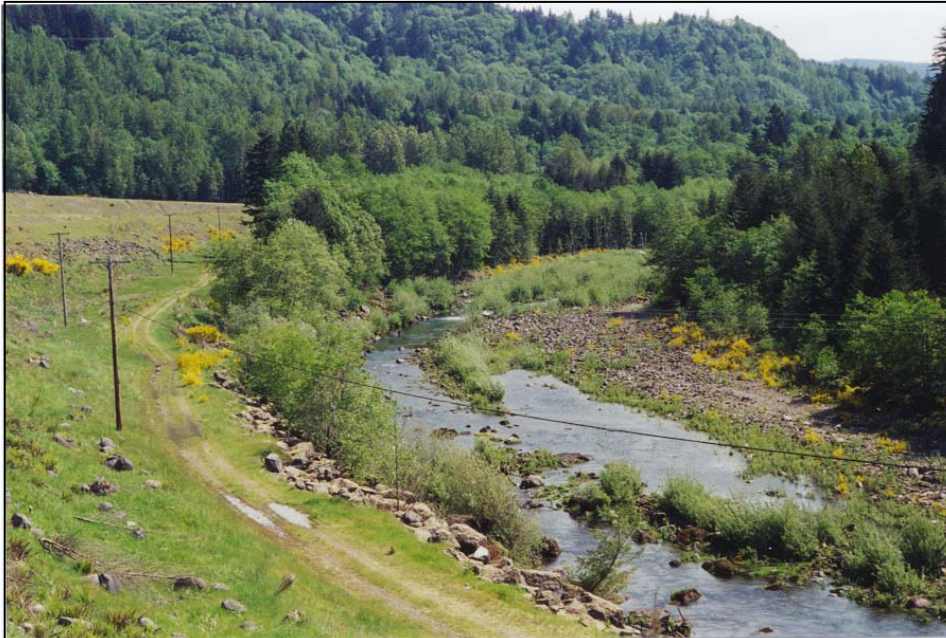
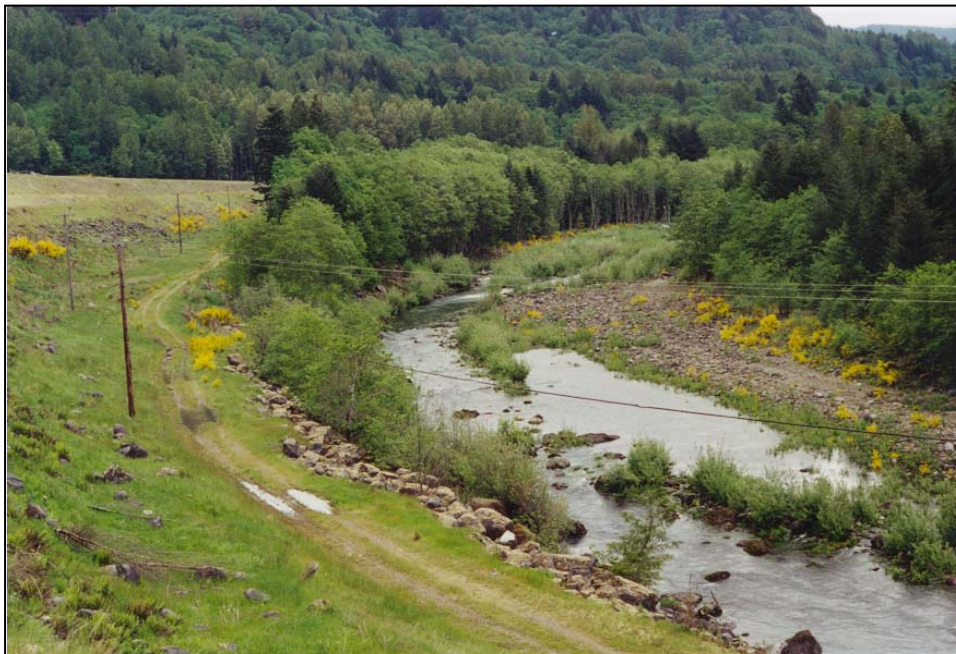
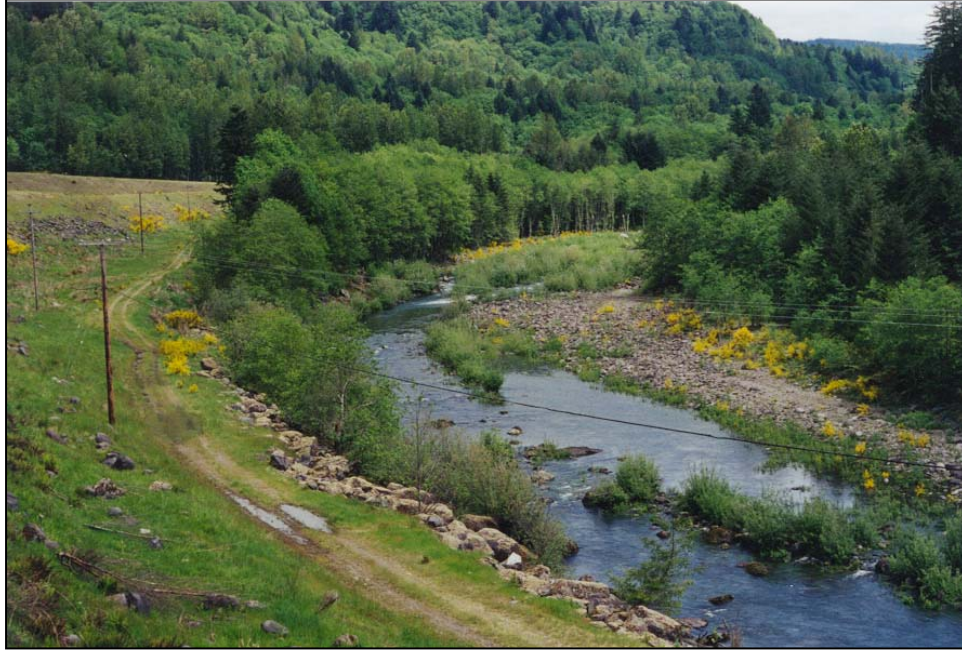
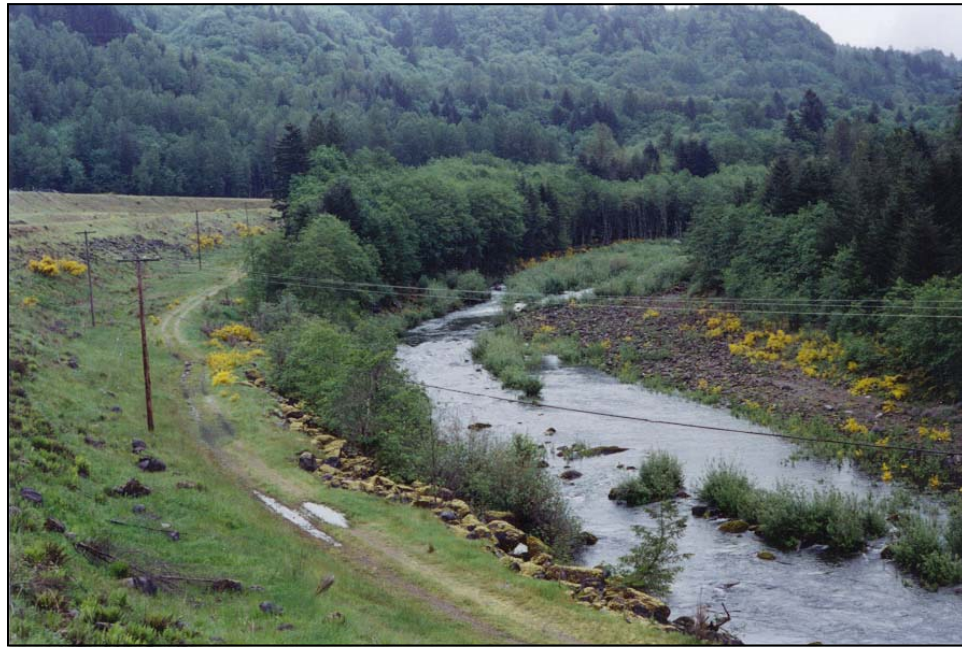
Flow #1 (68 cfs)

Flow #2 (134 cfs)

**Figure 9.1-19. Comparative photographs of the Lewis River bypass reach as seen from FR 90 near the Swift No. 2 Canal (KOP 27).**

Flow #3 (200 cfs)

Flow #4 (290 cfs)

**Figure 9.1-19. Comparative photographs of the Lewis River bypass reach as seen from FR 90 near the Swift No. 2 Canal (KOP 27) (cont.).**
