## THE ONEIDA POWER PLANT DISASTER

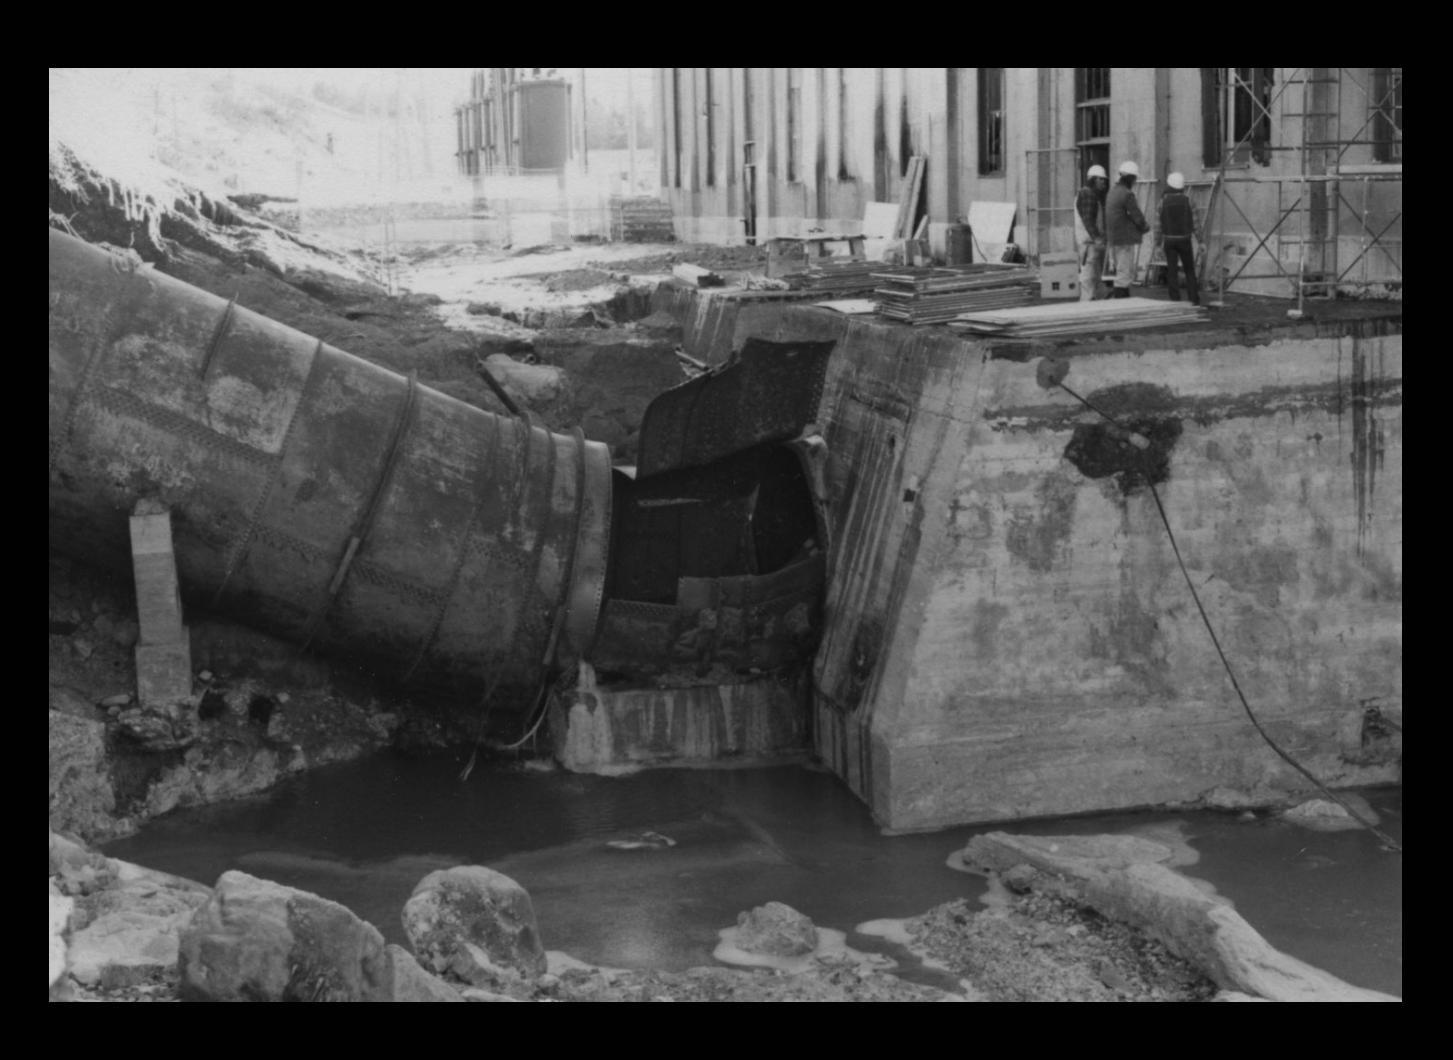
powerhouse.

Damaged penstock at the Oneida

The crew had just finished routine maintenance on a turbine generator set at the Utah Power & Light Oneida plant. Just before midnight they began to reopen the valve controlling water flow from the penstock to the turbine. The valve malfunctioned, causing a tremendous surge of water (or "water hammer") to develop in the penstock behind it, rupturing the 12-foot-diameter penstock.

An intensive investigation conducted later concluded that a faulty weld on a penstock joint was to blame. For reasons that remain unknown, air was able to enter the valve while it was closed during the turbine generator maintenance. When workers reopened the valve and water began to flow from the penstock to the turbine, the air inside the valve was compressed, causing

the valve to cycle open and closed very quickly. This cycling of the valve created the catastrophic water hammer event. The faulty weld, made more than 35 years before the disaster, was not strong enough to withstand the water hammer and failed, releasing water into the powerhouse.

The Occupational Health and Safety Administration (OSHA) ultimately determined the cause was failure to bleed off the built-up air in the valve before opening it, and recognized the role of the bad weld in the tragedy.
