Lewis River Fish Passage Program 2017 Annual Report (Final)

FERC Project Nos. 935, 2071, 2111 and 2213

PacifiCorp & Public Utility District No.1 of Cowlitz County

April 10, 2018

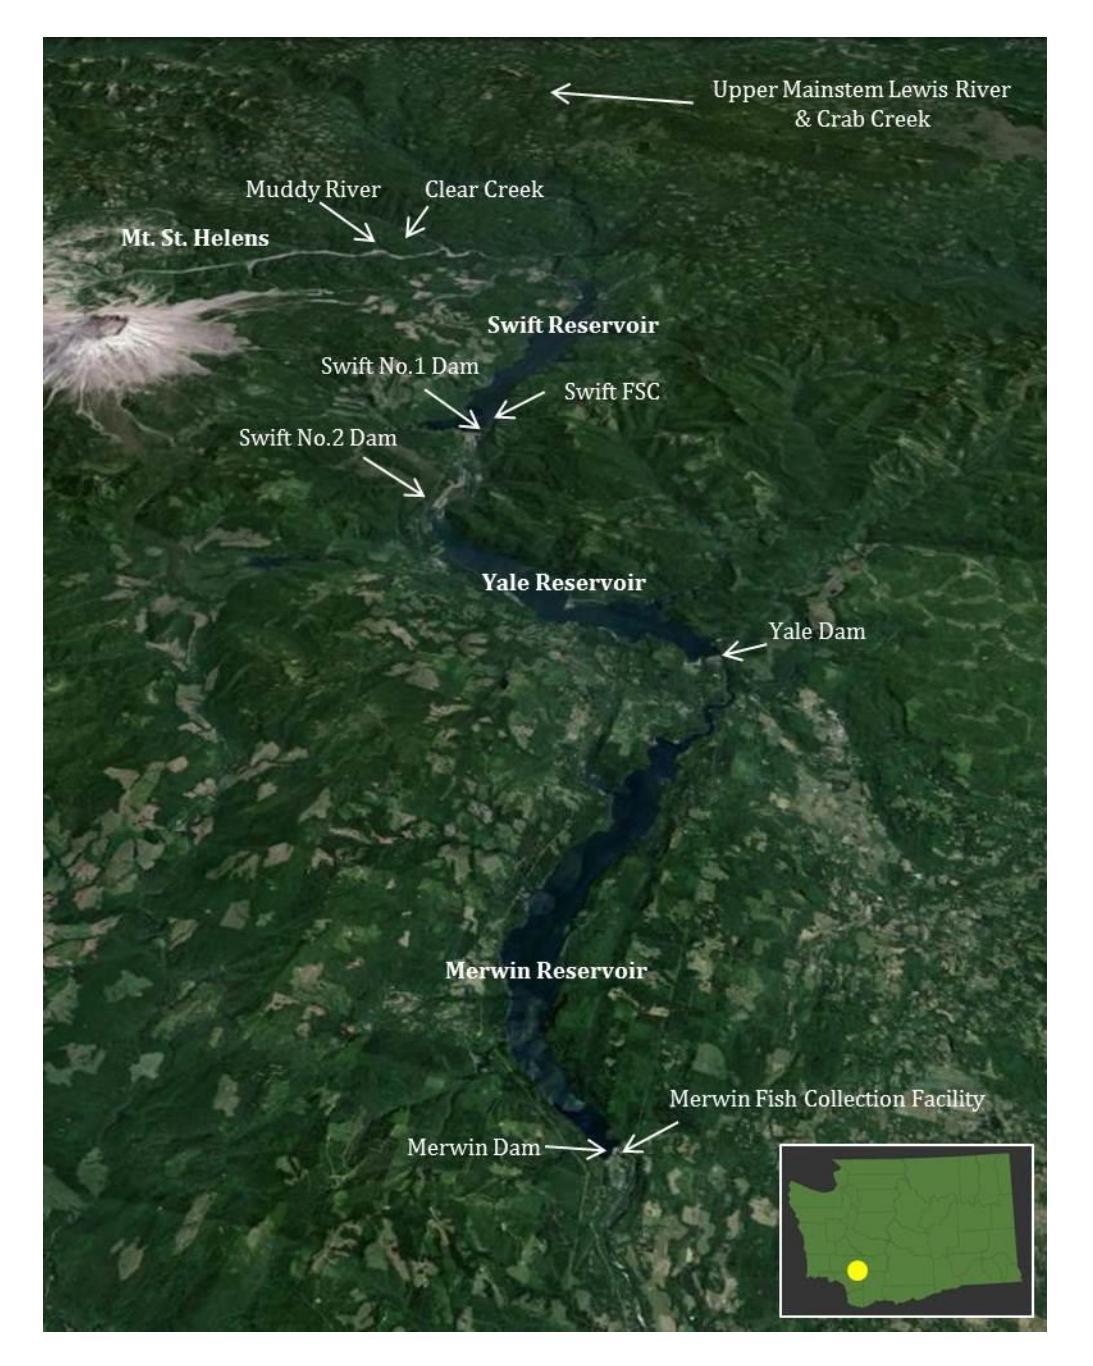
Figure 1.0-1. An overview of key features of the North Fork Lewis River Hydroelectric Project area located in southwest Washington.

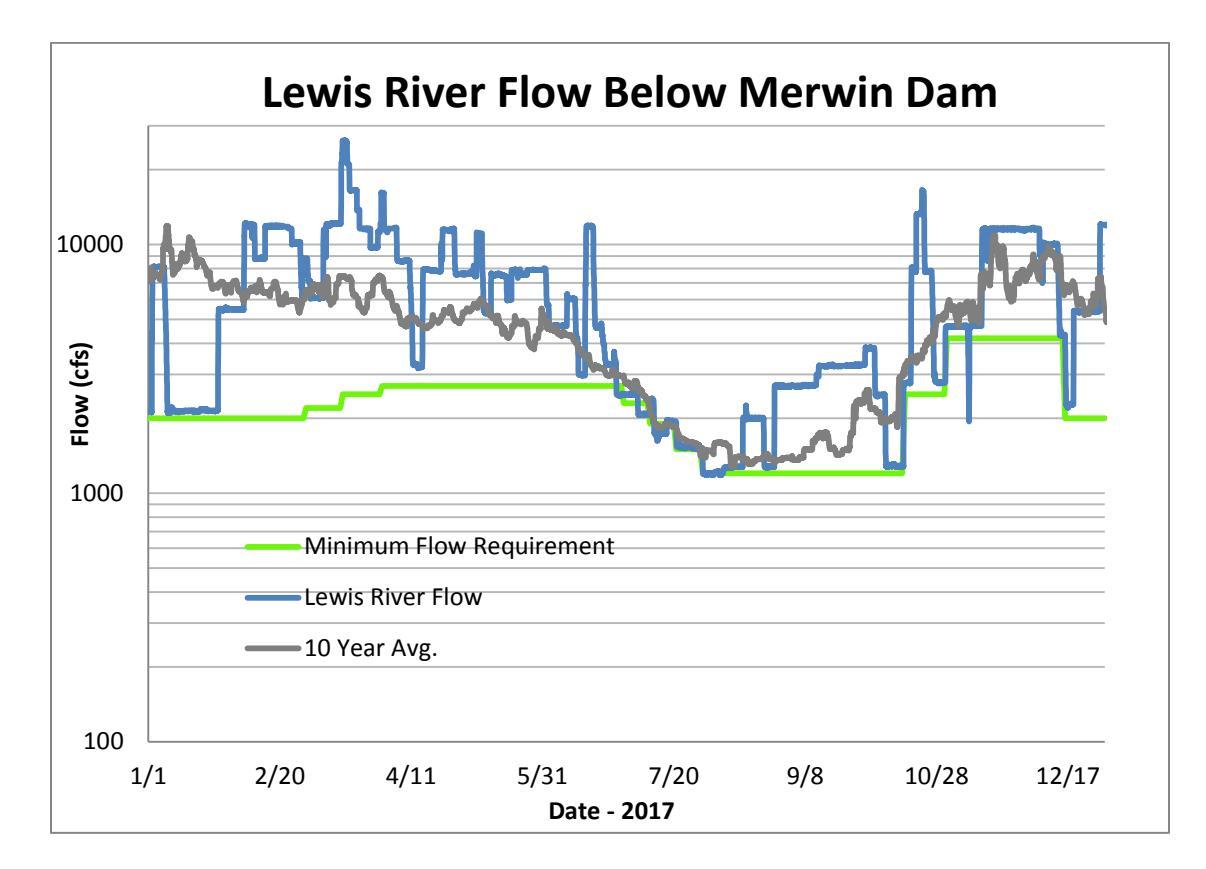
Figure 1.0-2. Lewis River flow below Merwin Dam as recorded by USGS gage (14220500 Ariel WA). Minimum flow requirements for 2017 requirements are also shown. The sharp 'dips' in flow during November are scheduled drawdowns associated with WDFW fall Chinook surveys.

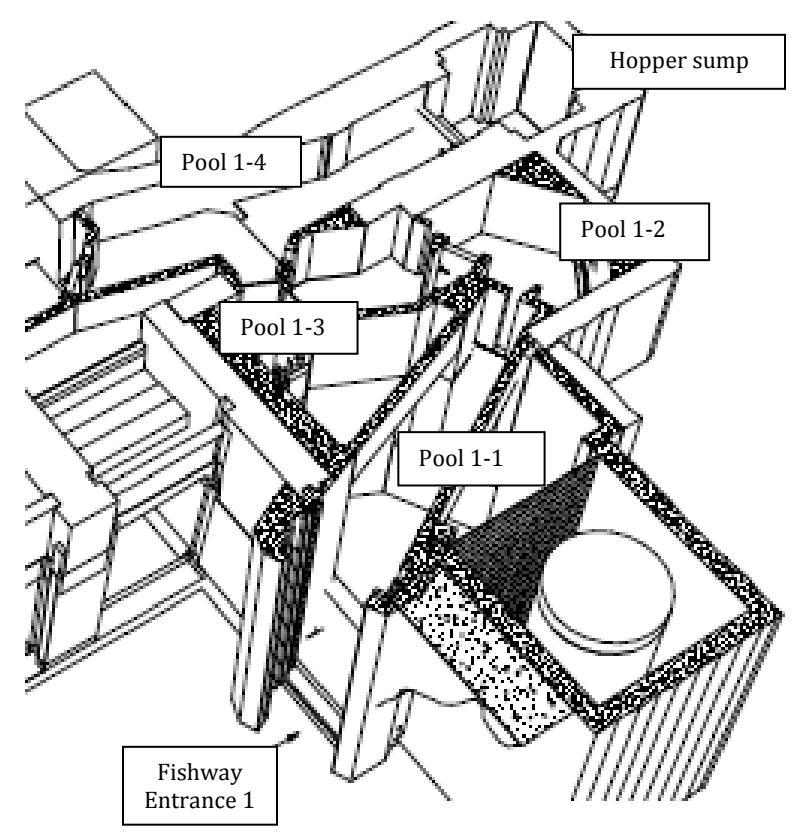
Figure 2.2-2. Merwin Sorting Facility ladder entrance and pool configuration.

To prevent fish from returning to the tailrace once they have entered the lower fish ladder, a vertical fyke was installed on the upstream side of the Pool 1-2 weir in November 2016. The "V" style fyke was constructed with one inch stainless steel bars with a spacing of two inches on center and has an exit slot width of six inches.

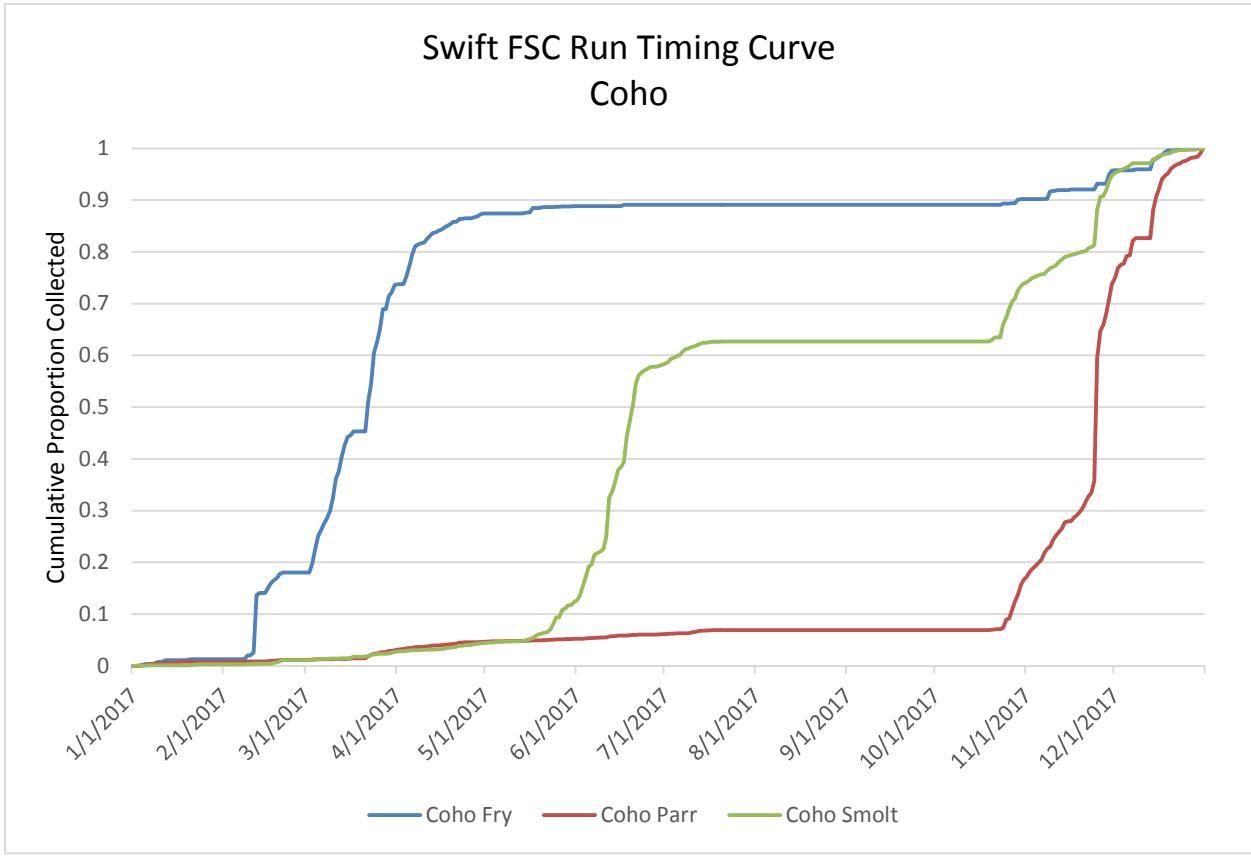
Figure 3.3-4. Cumulative migration timing of juvenile coho at Swift FSC.

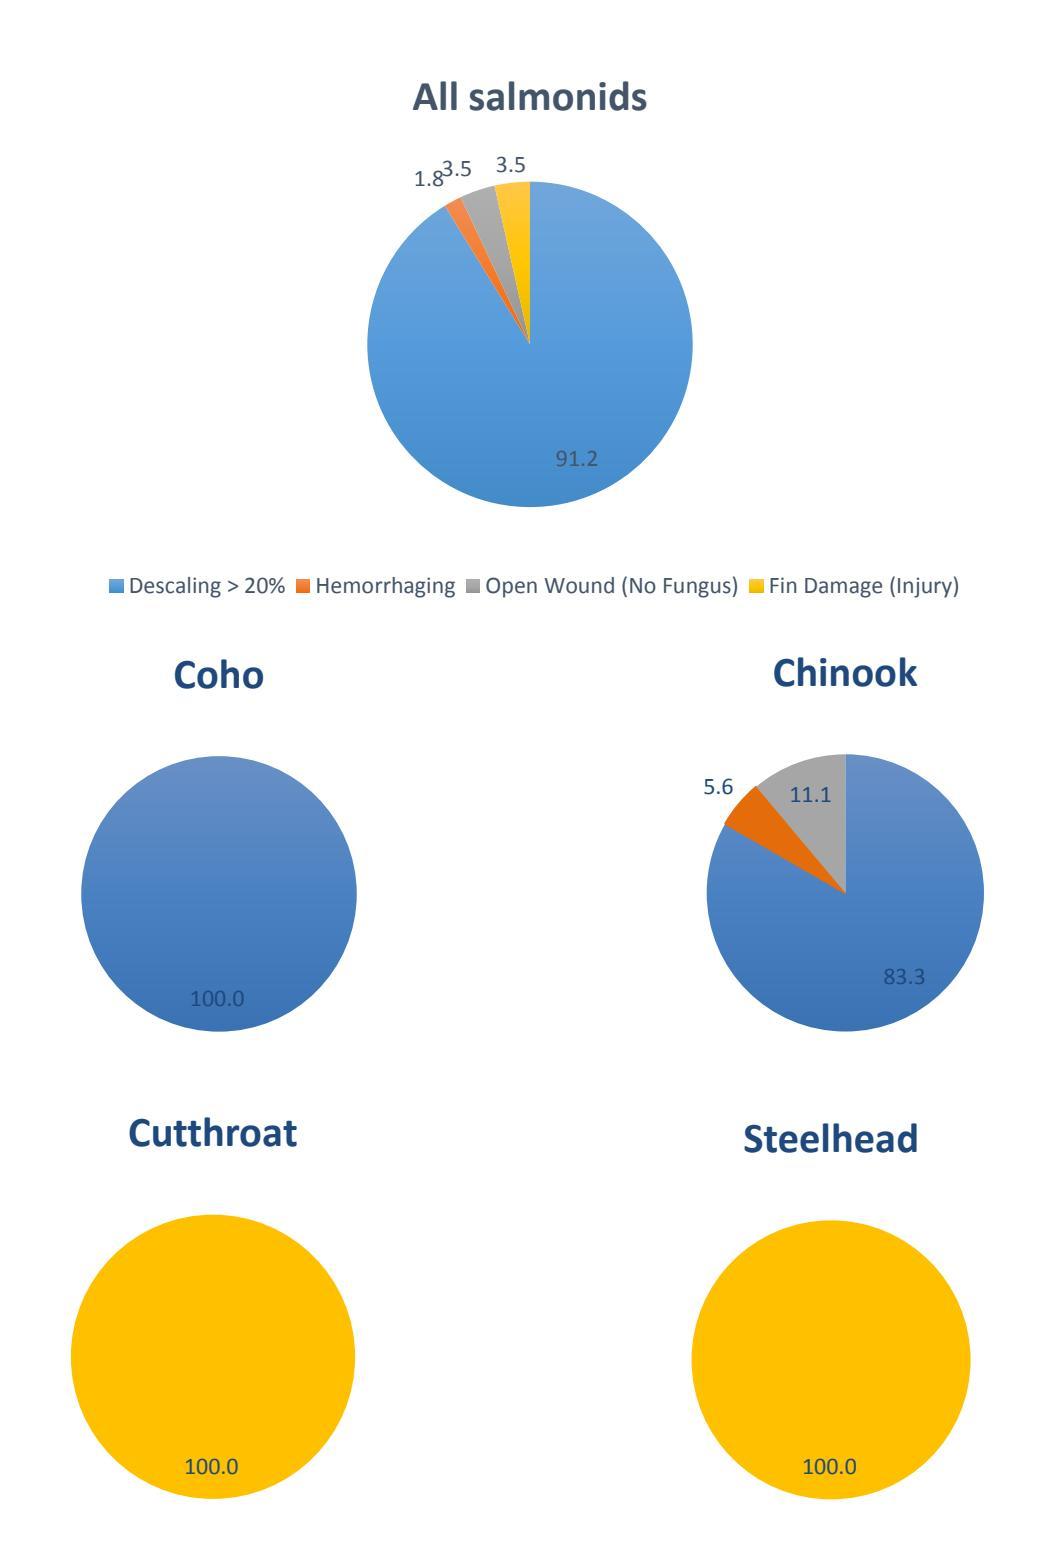
Figure 3.5-2. Composition of injury type occurrences by species. Percentages reflect parr and smolts numbers collected that are referenced in Table 3.5-3.

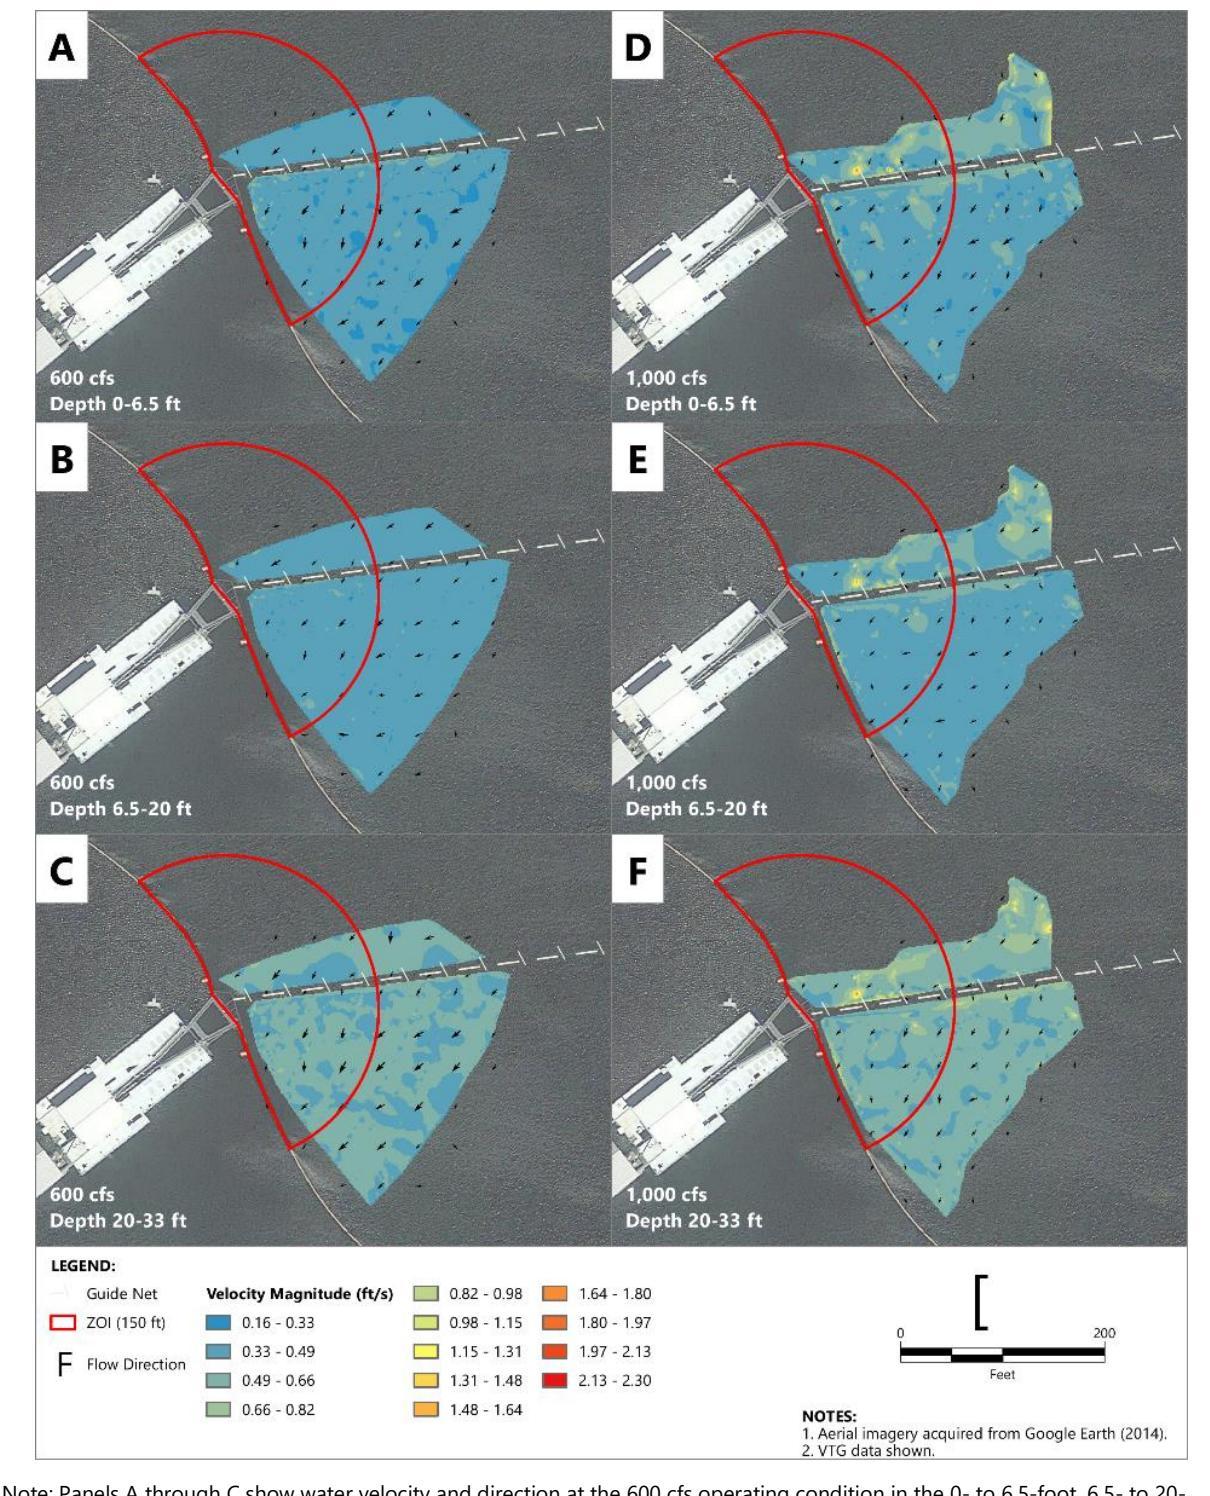
Note: Panels A through C show water velocity and direction at the 600 cfs operating condition in the 0- to 6.5-foot, 6.5- to 20-foot, and 20- to 33-foot depth bins. Panels D through F show the same depth bins at the 1,000 cfs operating condition.

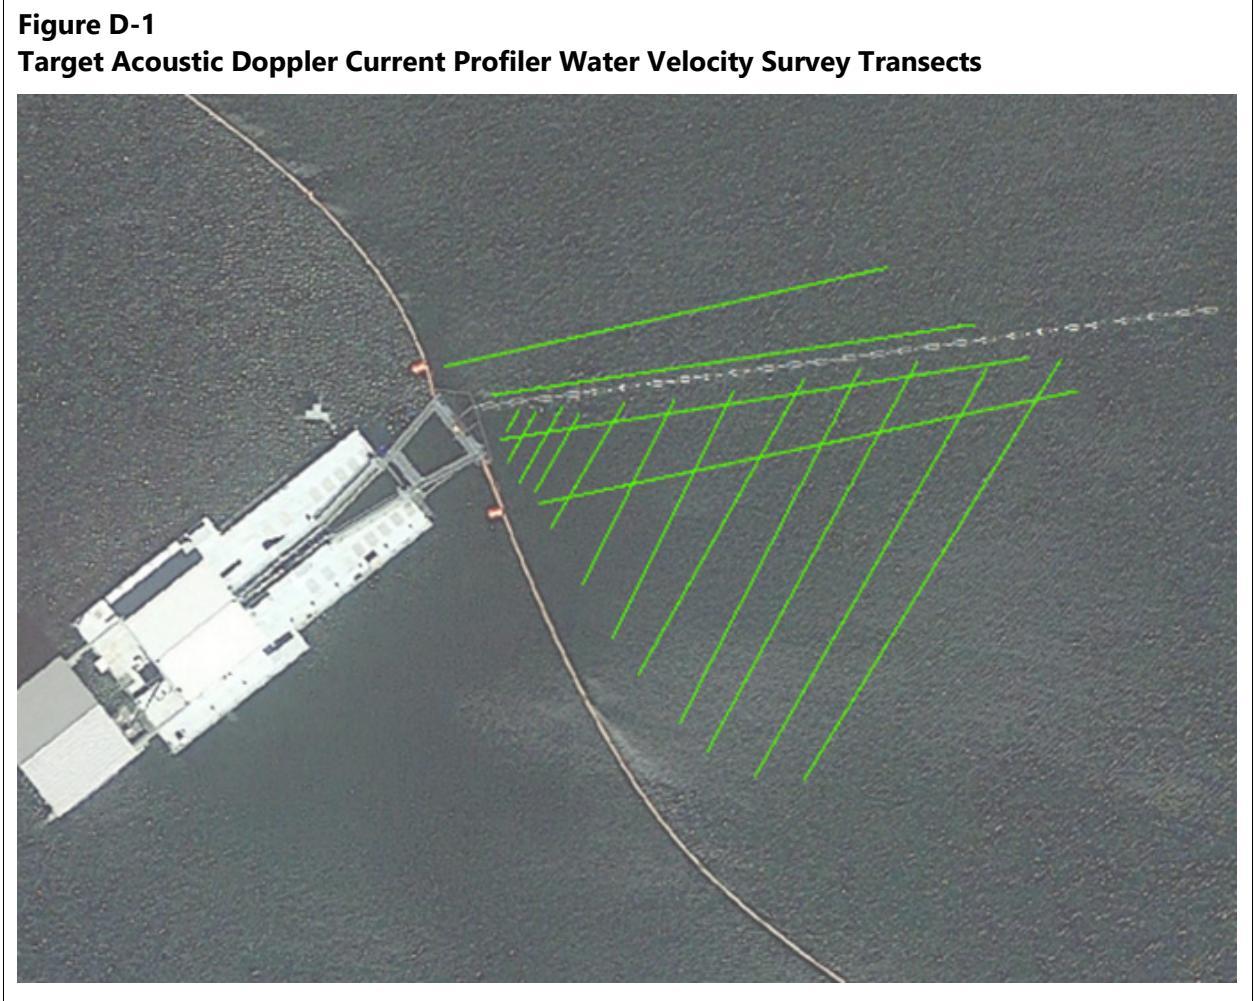
Note: Transects were developed for collecting water velocity data under FSC pump operations of 600 and 1,000 cfs.

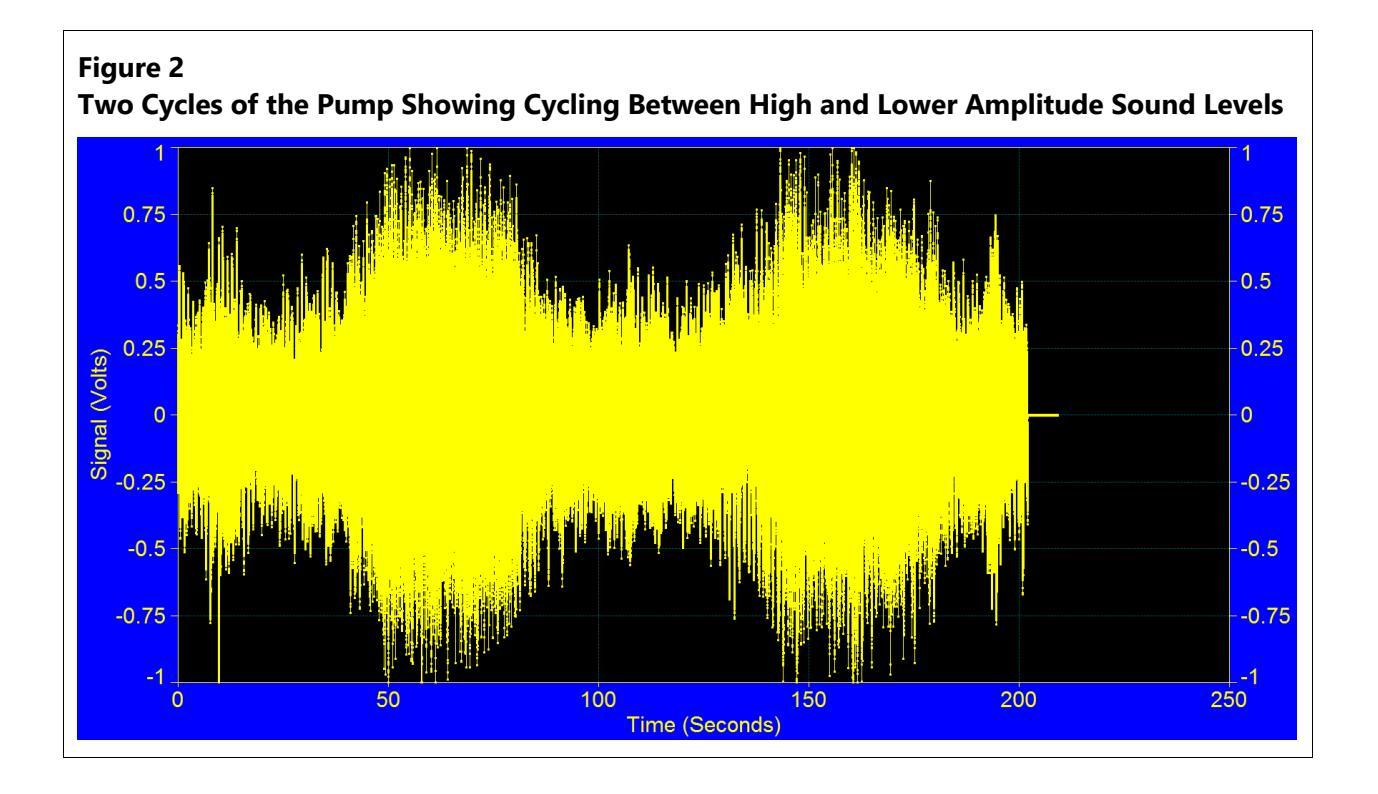
A 50-second time interval from when the pump was ramping up to when it was ramping down again was isolated and analyzed to estimate the frequency content of the sample (Figure 3). This time interval is equivalent to one on/off cycle of the pump. A peak at about 22 hertz (Hz) and 3 peaks between 0.9 and 2 Hz had the highest amplitude. The 22.1-Hz peak and the lower frequency components are within the infrasound and near infrasound frequency ranges that have been shown to elicit an avoidance response from juvenile salmonids (Hawkins 2015³), whose hearing system responds primarily to the particle motion component of low frequency sound. The sound generated by the pumps probably vibrates the collector, which then is the source for low frequency sound detected in the water around, and near the entrance to, the collector.

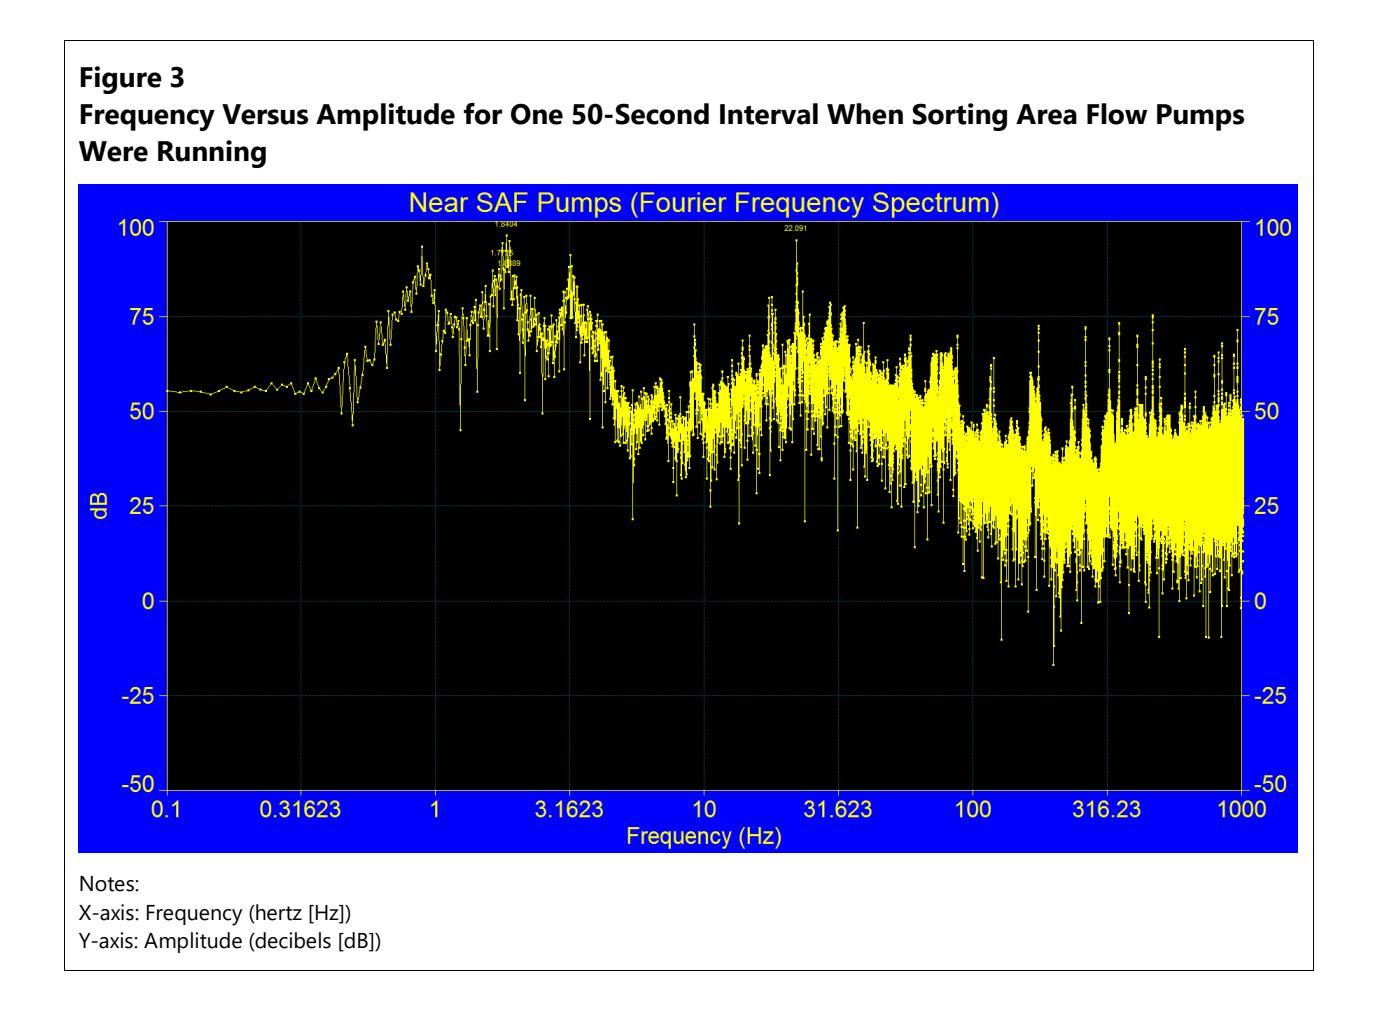
Sound measurements collected near the entrance to the FSC had sound peaks at both near infrasound (22.1 Hz) and infrasound (1 and 3 Hz) frequencies, as was the case for sound measurement near the SAF pumps. The spectra of sound observed at the two locations were similar with some differences in frequency content, probably a result of changes in the vibratory motion of the collector near the in-water locations where measurements were made (Figure 4).

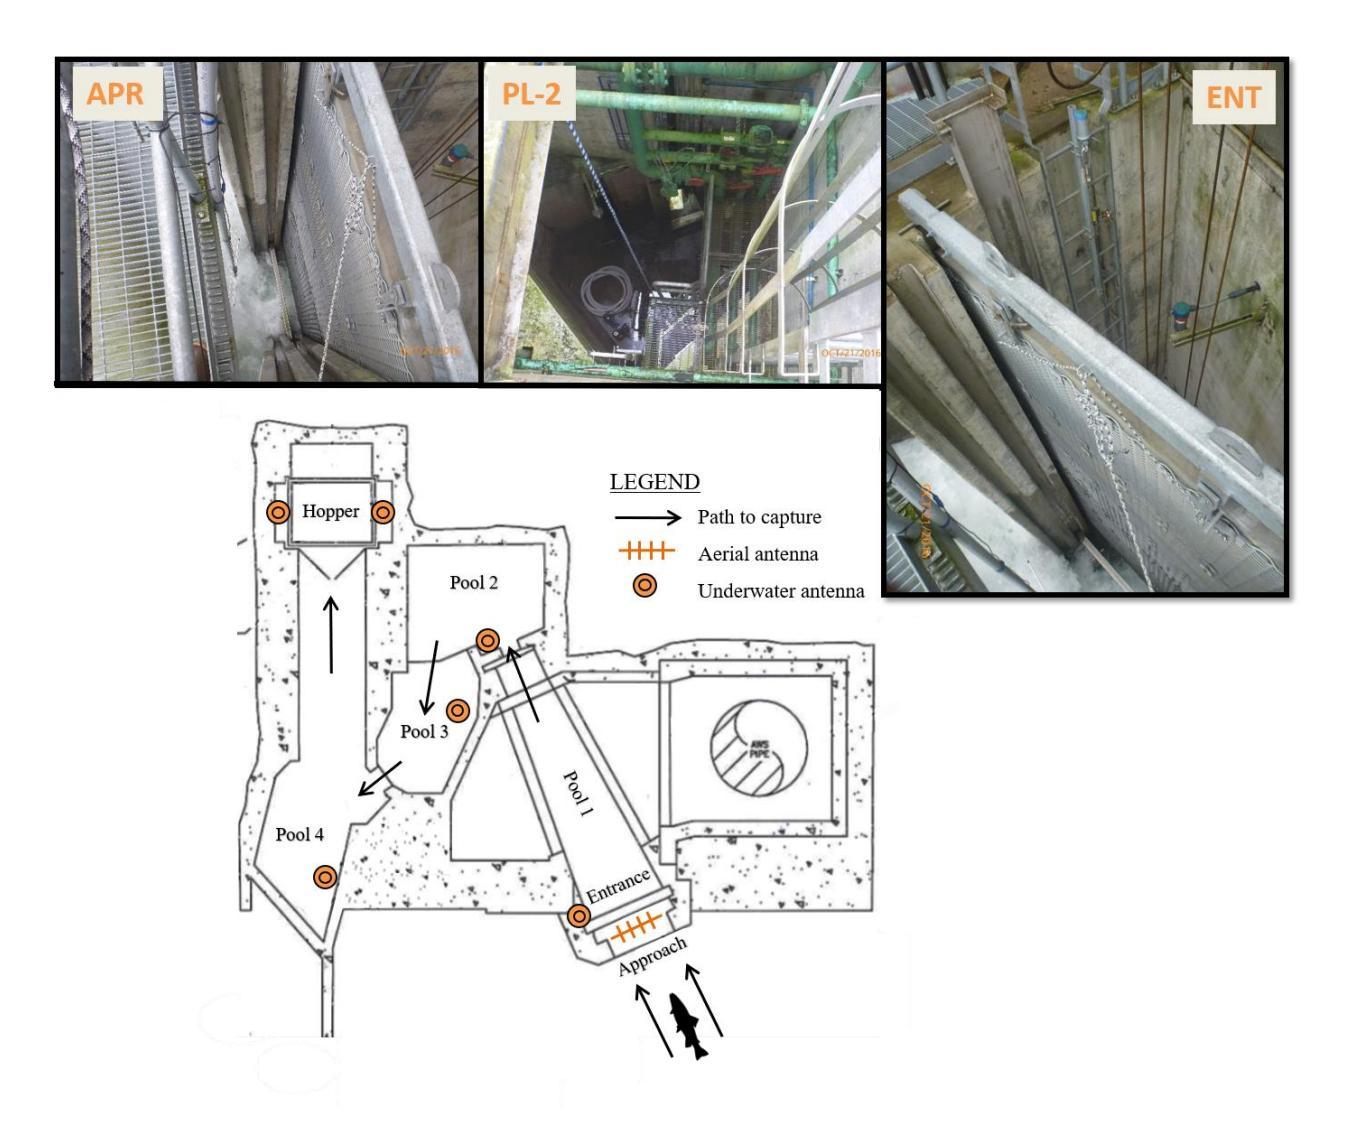
Figure 3. Trap schematic showing the locations of antenna arrays, with arrows showing the progressive movements fish make to reach the hopper and pictures of select antenna orientations. The approach antenna is aerial, and the entrance site comprised two underwater dipole antennas located on the left-hand side within Pool 1-1 at two depths. The hopper site also comprised two-dipole antennas, located outside the path of the ascending and descending hopper. All other trap sites comprised one dipole depth and one dipole location. After moving to the hopper, fish are crowded and then transported toward the Trap antenna at the fish facility (not shown).

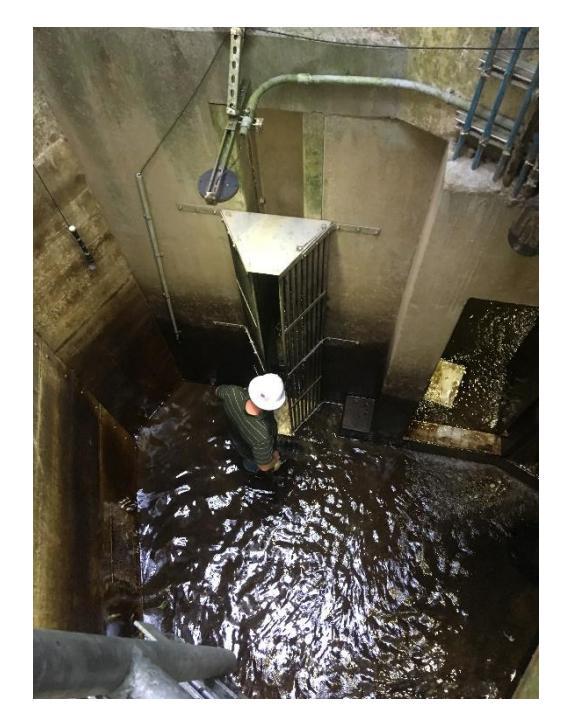
Figure 6. Photo of fyke installed at the entrance to Pool 2 within the trap area. Photo was taken looking down into Pool 2 from above during dewatering. Note there is a gap above fyke, where fish could potentially exit through. Photo Credit: L. Caldwell, August 22, 2017 during trap dewatering.

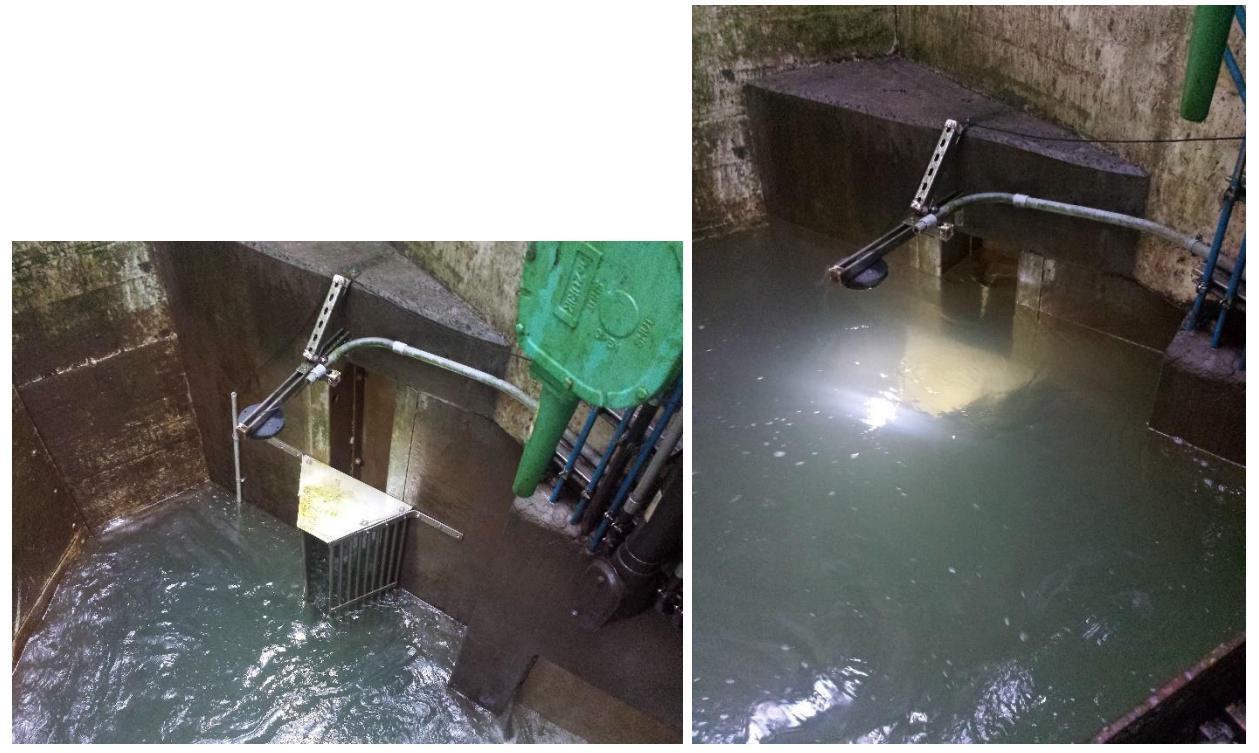
Figure 7. Photos of the entrance between Pool 1 and 2 within the trap ladder where the fyke was installed. The photos show the entrance during low (< 7,000 cfs; left photo) and high ($\sim 8,000$ cfs; right photo) discharge when the water height was below and above the fyke height, respectively. Photo Credit: Chris Karchesky.

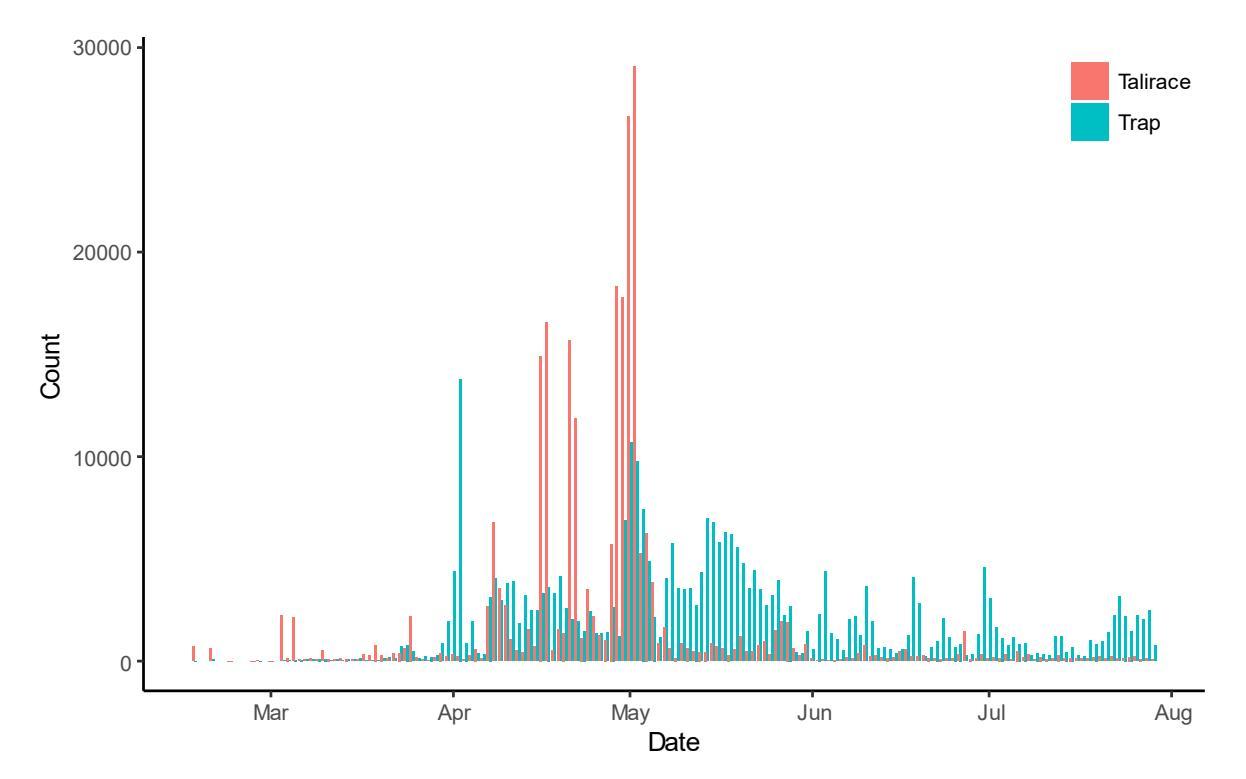
Figure 9. Total number of noise detections for trap (red) and tailrace (blue) receivers.

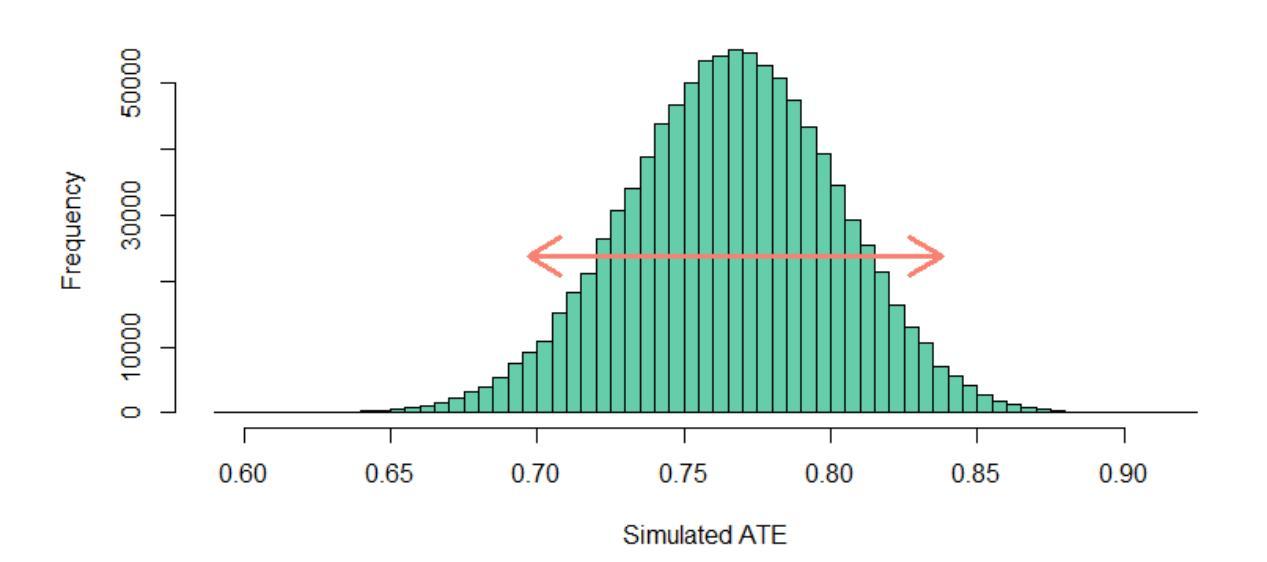
Figure 11. Bootstrap simulated frequencies of *ATE* calculated from one million iterations of randomly resampling (with replacement) the sample of 139 fish that reached the Merwin Dam tailrace. Horizontal bi-directional gray arrow indicates BCA 95% CI (69.7 - 83.8%); vertical gray line indicates target *ATE* of 98%. Note that target *ATE* was reached in zero of one million simulations. Note that a small amount of random noise was added to each bootstrap to create a "smoothed bootstrap".

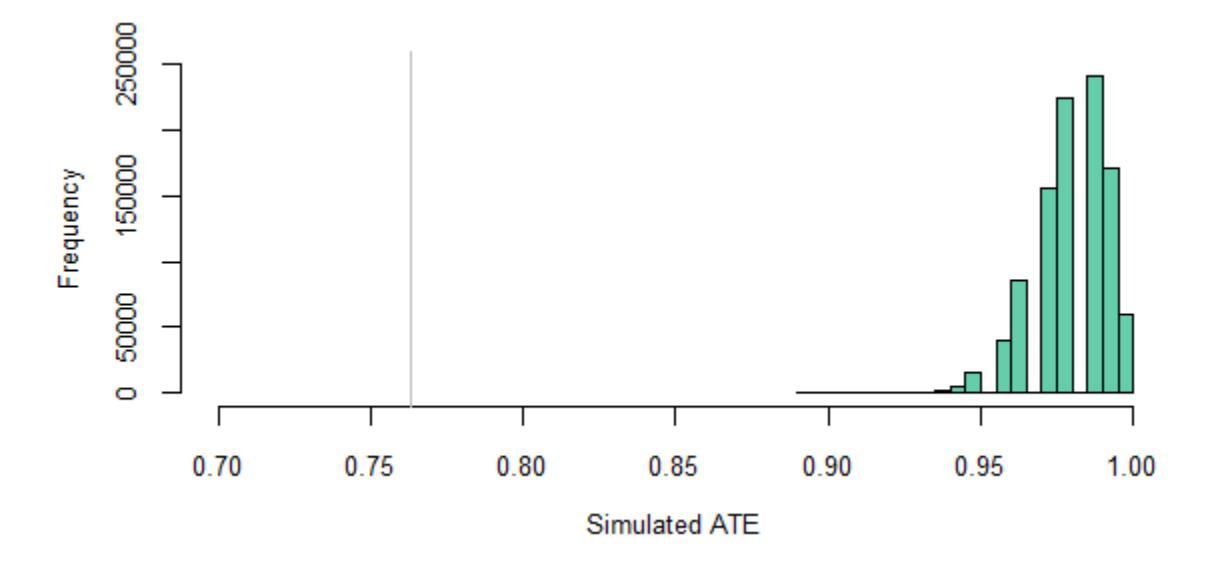
Figure 12. Simulated frequencies of *ATE* calculated from one million iterations of randomly subsampling a set of 139 fish from a simulated "urn" population of 10,000 fish that truly exhibited 98% *ATE*. Vertical gray line indicates observed ATE_{test} of 76.3%. Note that ATE_{test} reported here for 2017 was reached in zero of one million simulated subset samples of 139 fish from the parent population of 10,000.

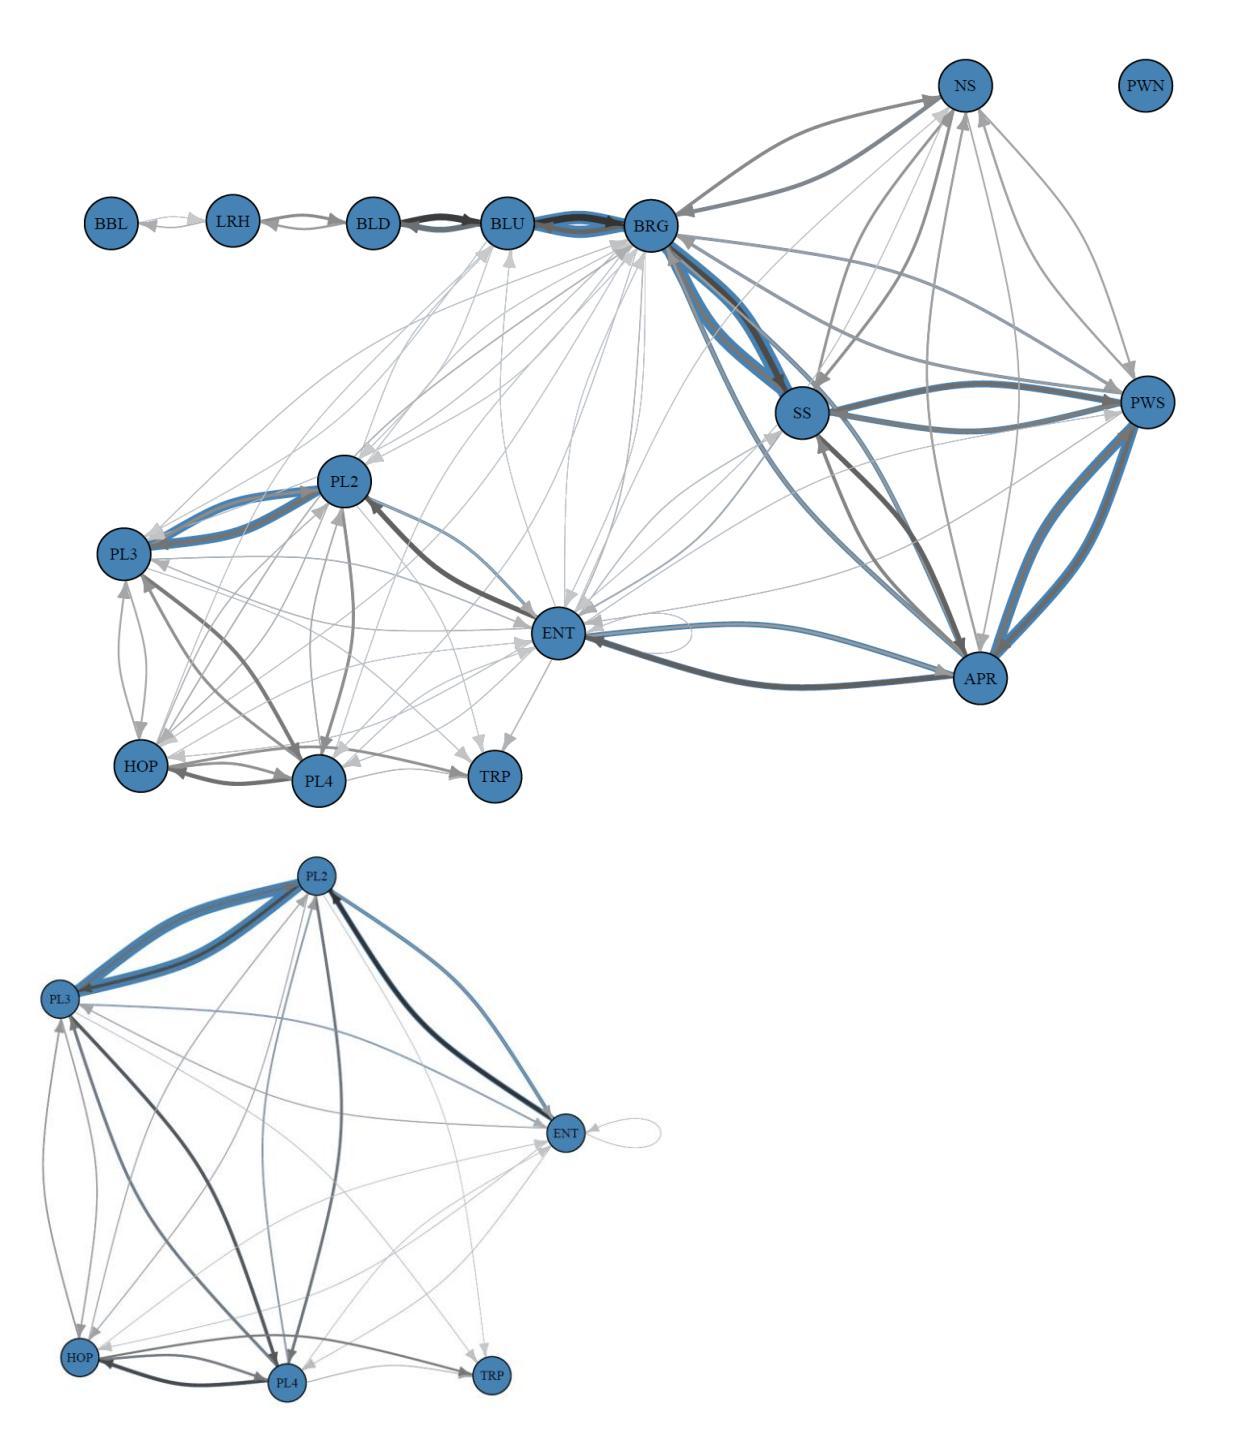
Figure 13. Network diagram of fish movement within study area. Path thickness and color are scaled based on the total number of individual fish traveling the paths (e.g., thicker paths represent a higher number of fish taking the path at least one time across their detection history). Grey paths are scaled to represent the total number of fish that traveled between sites (individuals as the sample unit), and blue paths are scaled to represent the total number of times that a path was used (total number of behaviors, with movements as sample units; *non-independent*). Top figure shows all sites; bottom figure shows only trap sites and includes re-normalized transitional probabilities calculated using detections at trap sites only.

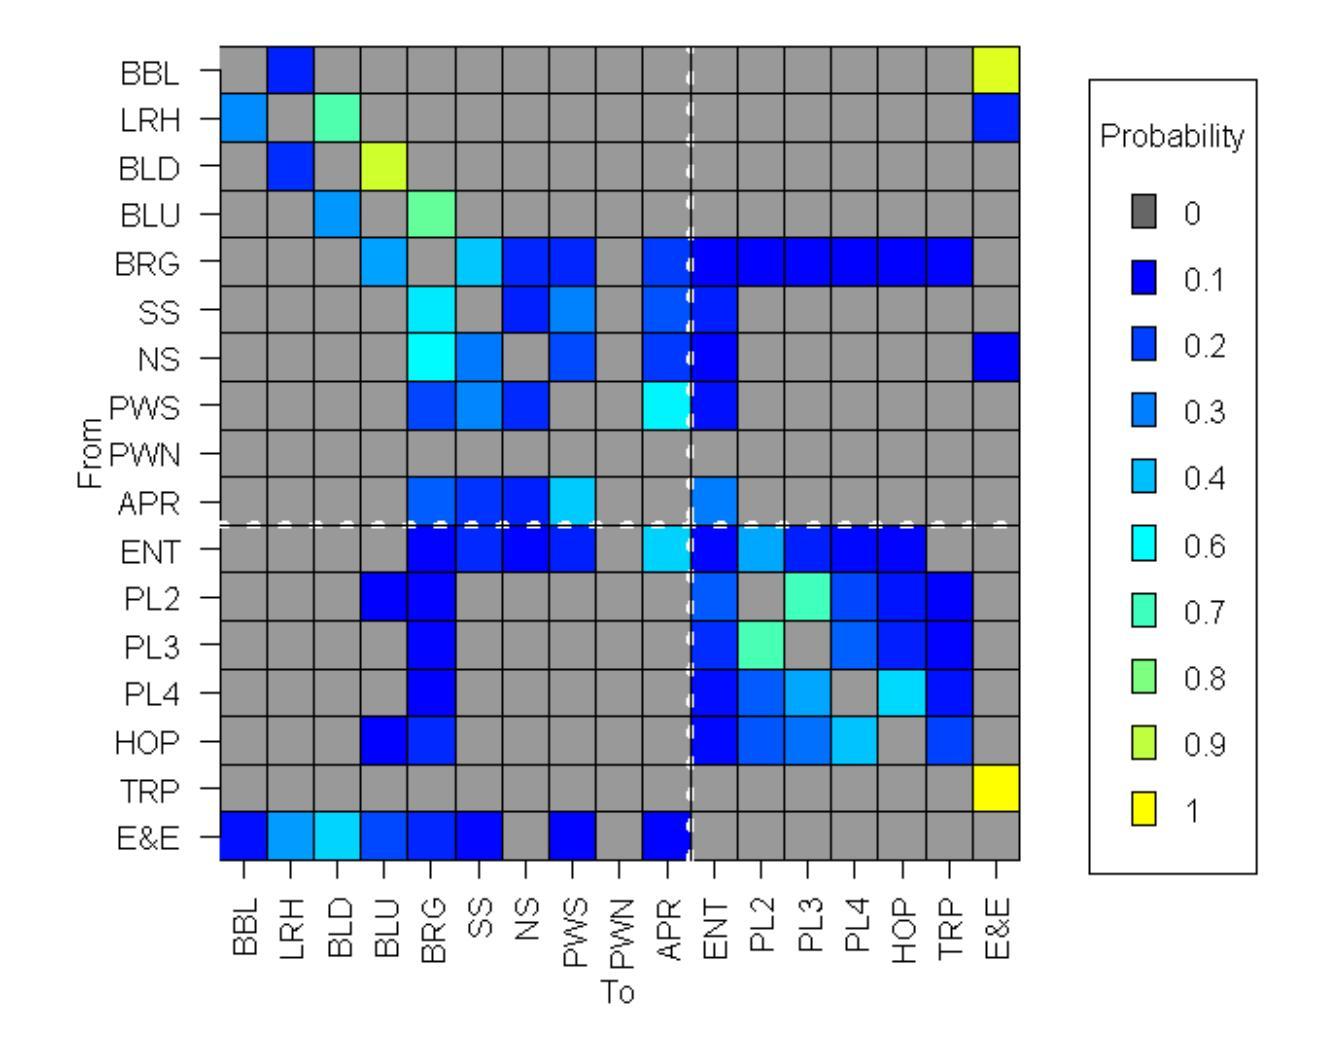
Figure 14. Heat map of the transition probabilities of fish moving from an origin site to all potential destination sites, where each row sums to a probability of 1.0. The black reference lines are added between the receivers Approach and Entrance to show the distinction of a fish being located within or outside of the trap. Probabilities in the upper left box represent movements that begin and end in the river or tailrace, while those in the bottom right begin and end in the trap. Probabilities in the upper right box represent paths that begin in the river or tailrace and end in the trap, and the lower left box begin in the trap and end in the river or tailrace (e.g., exiting the trap). E&E represents entrance and exit locations from the study system. For example, fish that are at the Trap always exit the system (e.g., they cannot leave), so there is a probability of 1.0 at the Trap row and E&E column).

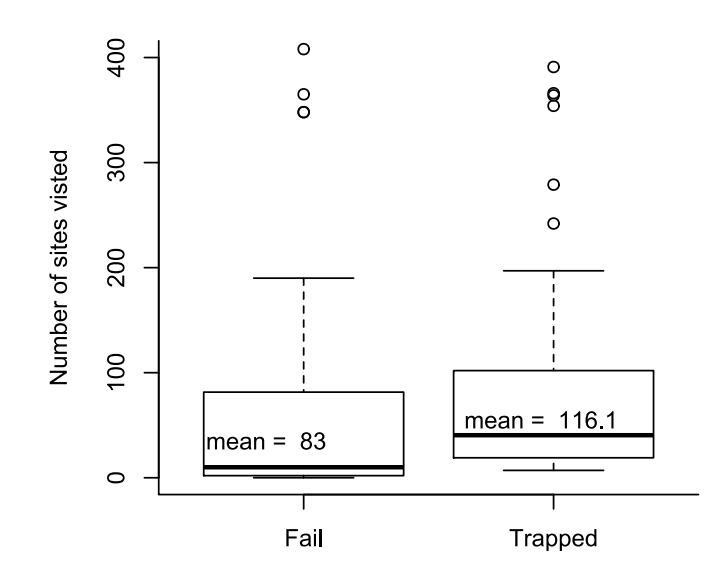
Figure 15. Number of sites visited before being captured (Trapped) or not captured (Fail).
