Lewis River Fish Passage Program 2017 Annual Report (Final)

FERC Project Nos. 935, 2071, 2111 and 2213

PacifiCorp & Public Utility District No.1 of Cowlitz County

April 10, 2018

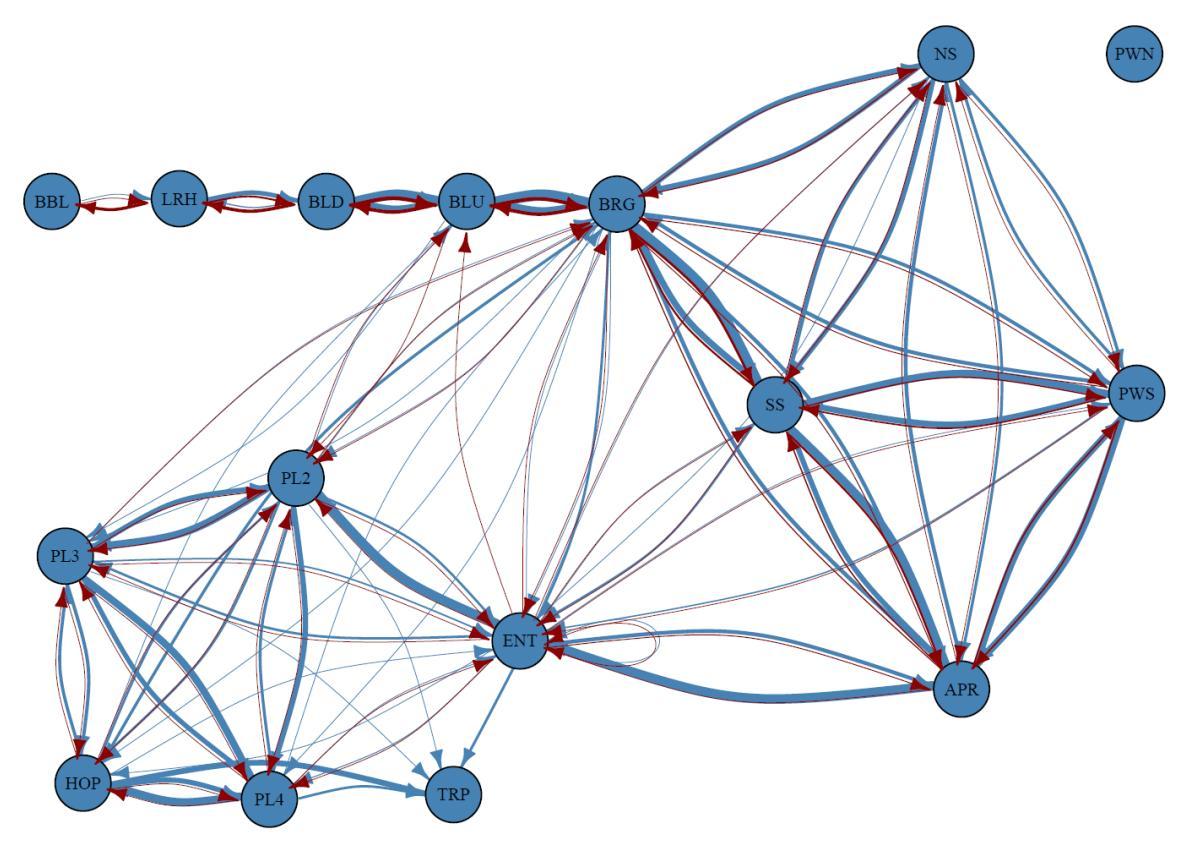
Figure 16. Network diagram of fish movement within the study area at Merwin Dam grouped by fish that ultimately are trapped (blue) or failed to be trapped (red) from 2017. Path thickness and color are scaled based on the total number of transitions which occurred between sites with fish as the sample unit. This figure suggests that there are essentially no significant differences in the spatial patterns between successfully and unsuccessfully passed fish in Merwin tailrace. This graphic depicts the movements of 146 fish; 106 that were successfully passed (i.e., last detected at Trap) and 40 that were unsuccessful (i.e., last detected downriver at Hatchery or Bed and Breakfast).

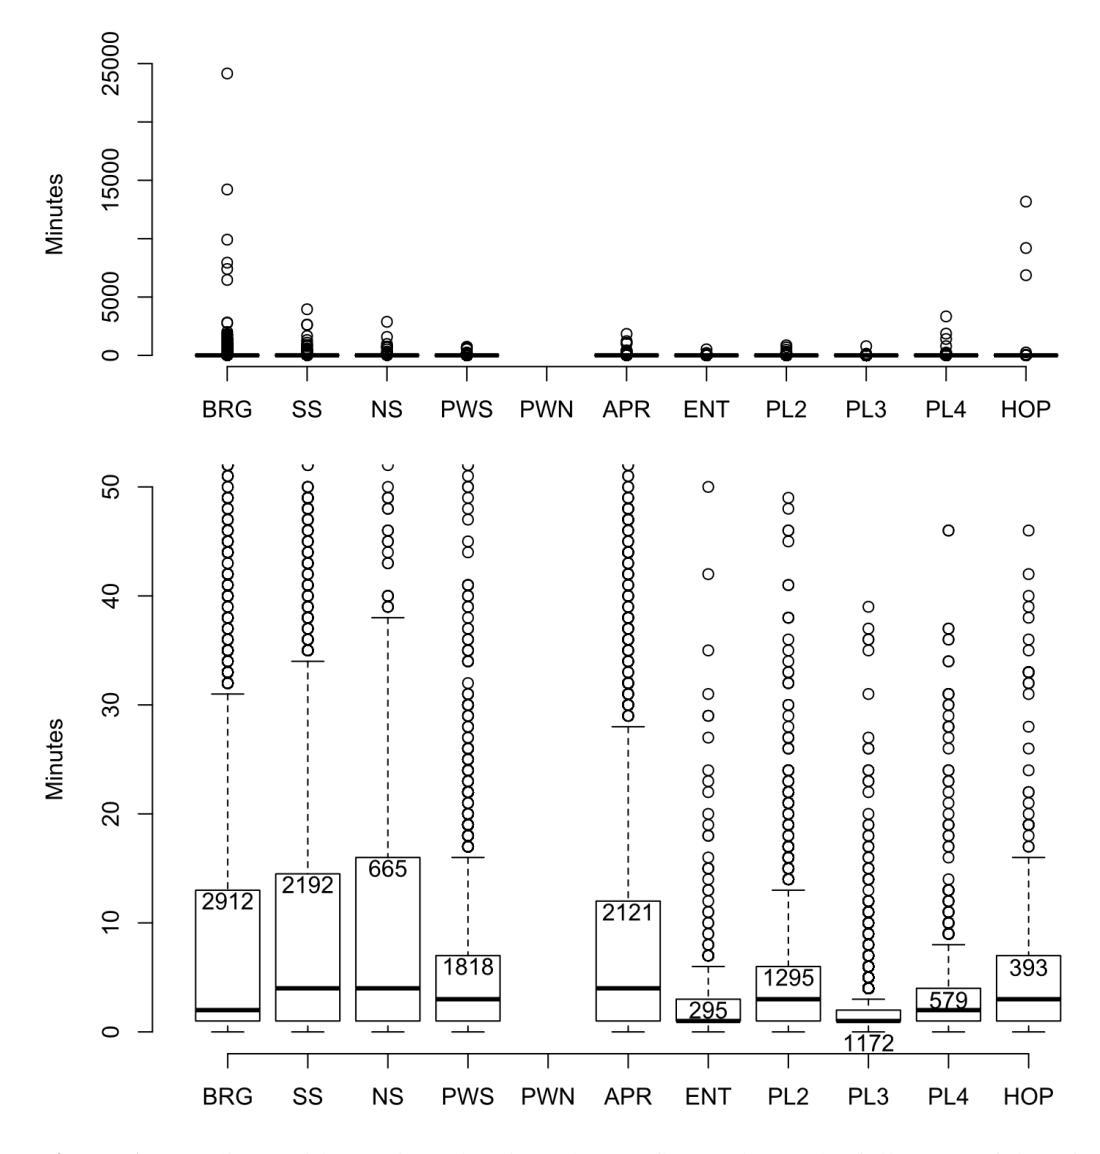
Figure 17. Median residence times by site. The top figure shows the full range of data, including outliers, while the bottom figure zooms in to show the box and whisker plots, focusing on inter-quartile range. Sample size (n) is displayed in the top of the box plots for each site. Caveat: these data are not scaled based on the detection ranges of each site.

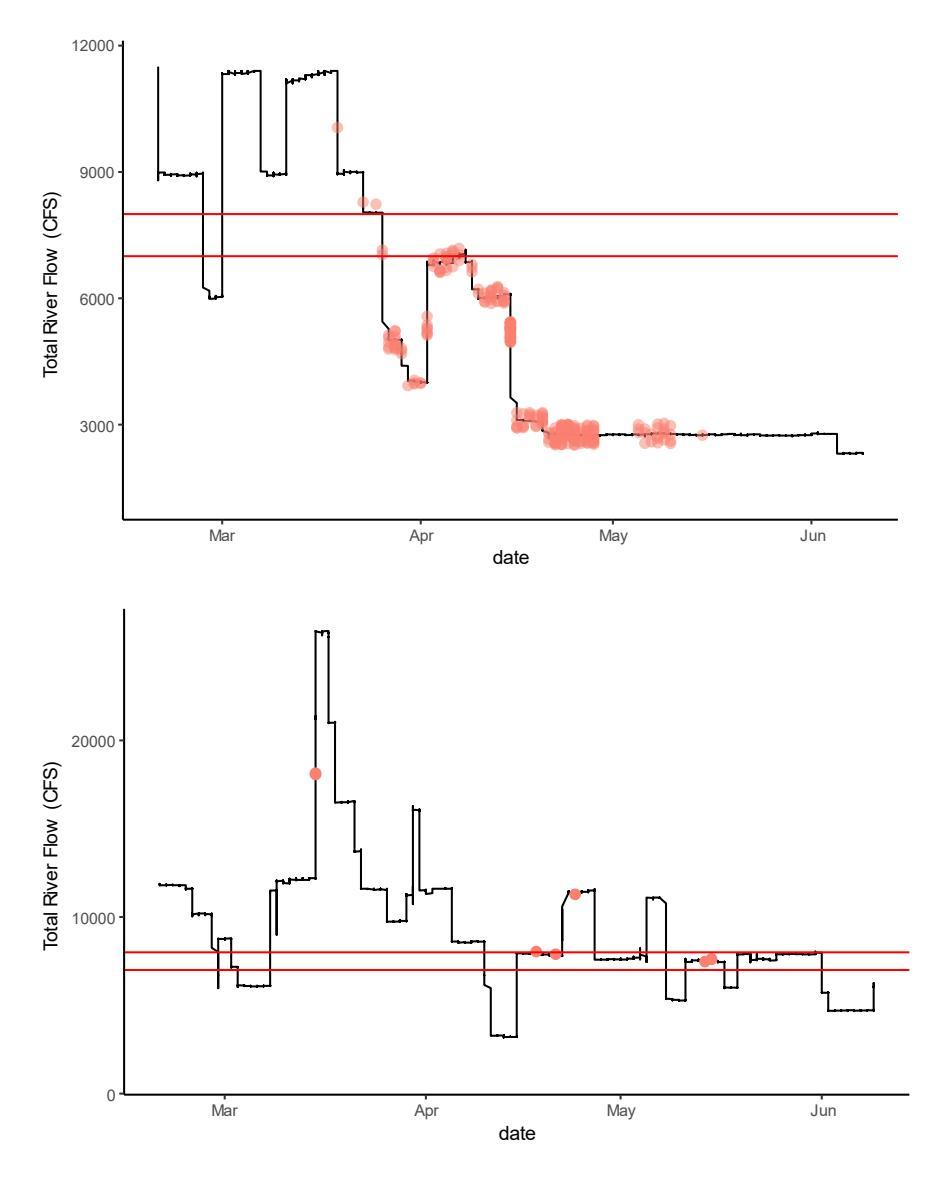
Figure 21. Timing of PL2 \rightarrow ENT transitions (i.e., backwards through the fyke) during varying levels of total river flow over two study years, 2016 (top panel) and 2017 (bottom panel). Horizontal red bars denote flow less than 7,000 cfs and greater than 8,000 cfs. Red dots indicate PL2 \rightarrow ENT transitions.

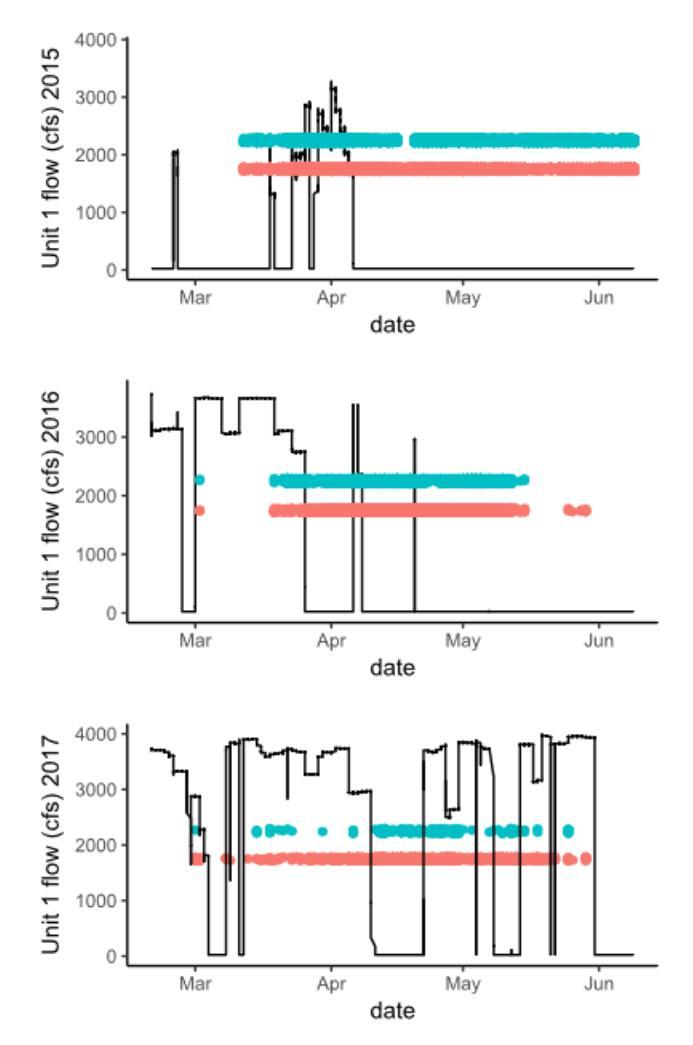
Figure 22. Unit 1 discharge over time for three years of study. Solid black line indicates discharge. Red and blue dots indicate individual detections at the Approach and Entrance sites, respectively. Data for total river flow was collected from PacifiCorp. See Appendix A, Figures A-1 to A-4 for plots of all operational variables across years.

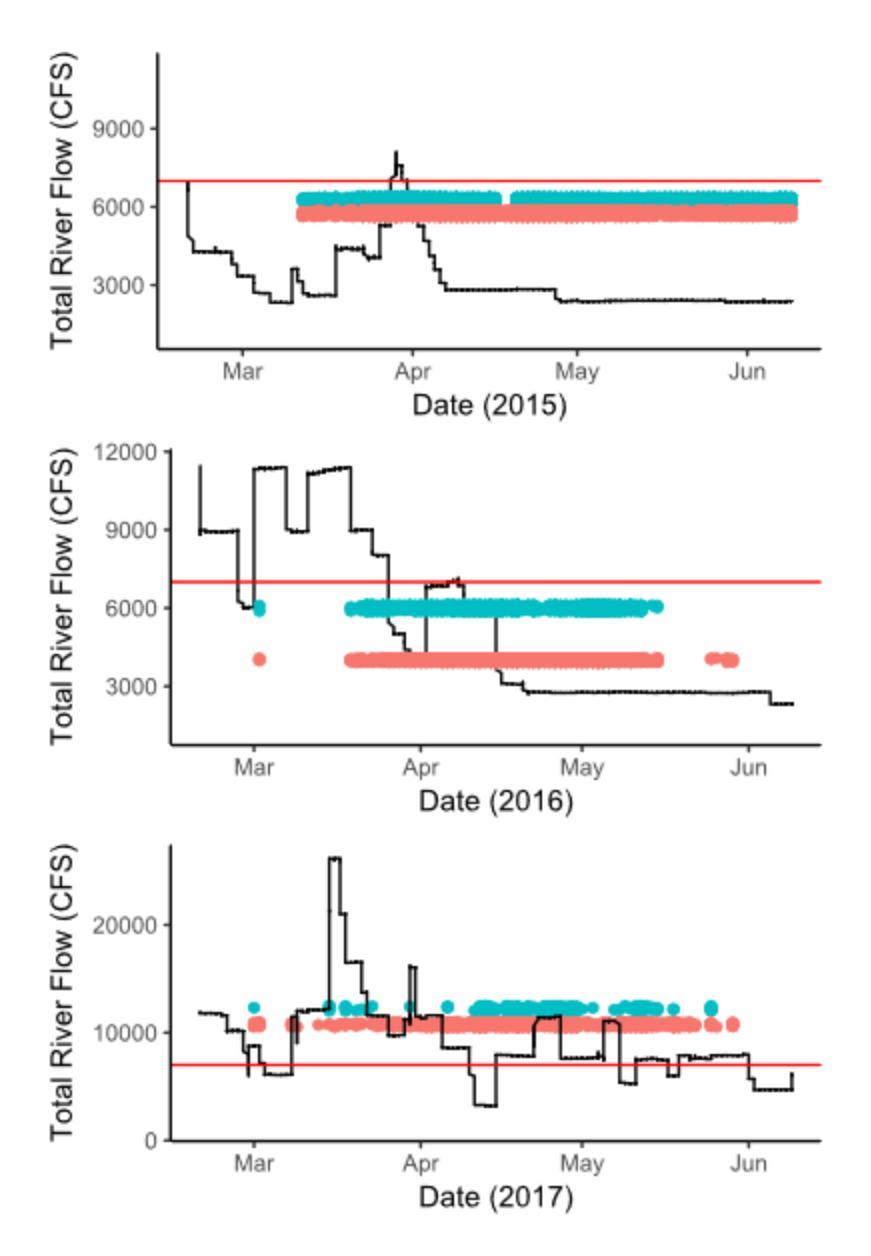
Figure 23. Total river flow over time for three years of study. Solid black line indicates discharge. Red and blue dots indicate individual detections at the Approach and Entrance sites, respectively. Data for total river flow was collected from USGS (USGS 2017). See Appendix A, Figures A-1 to A-4 for plots of all operational variables across years.

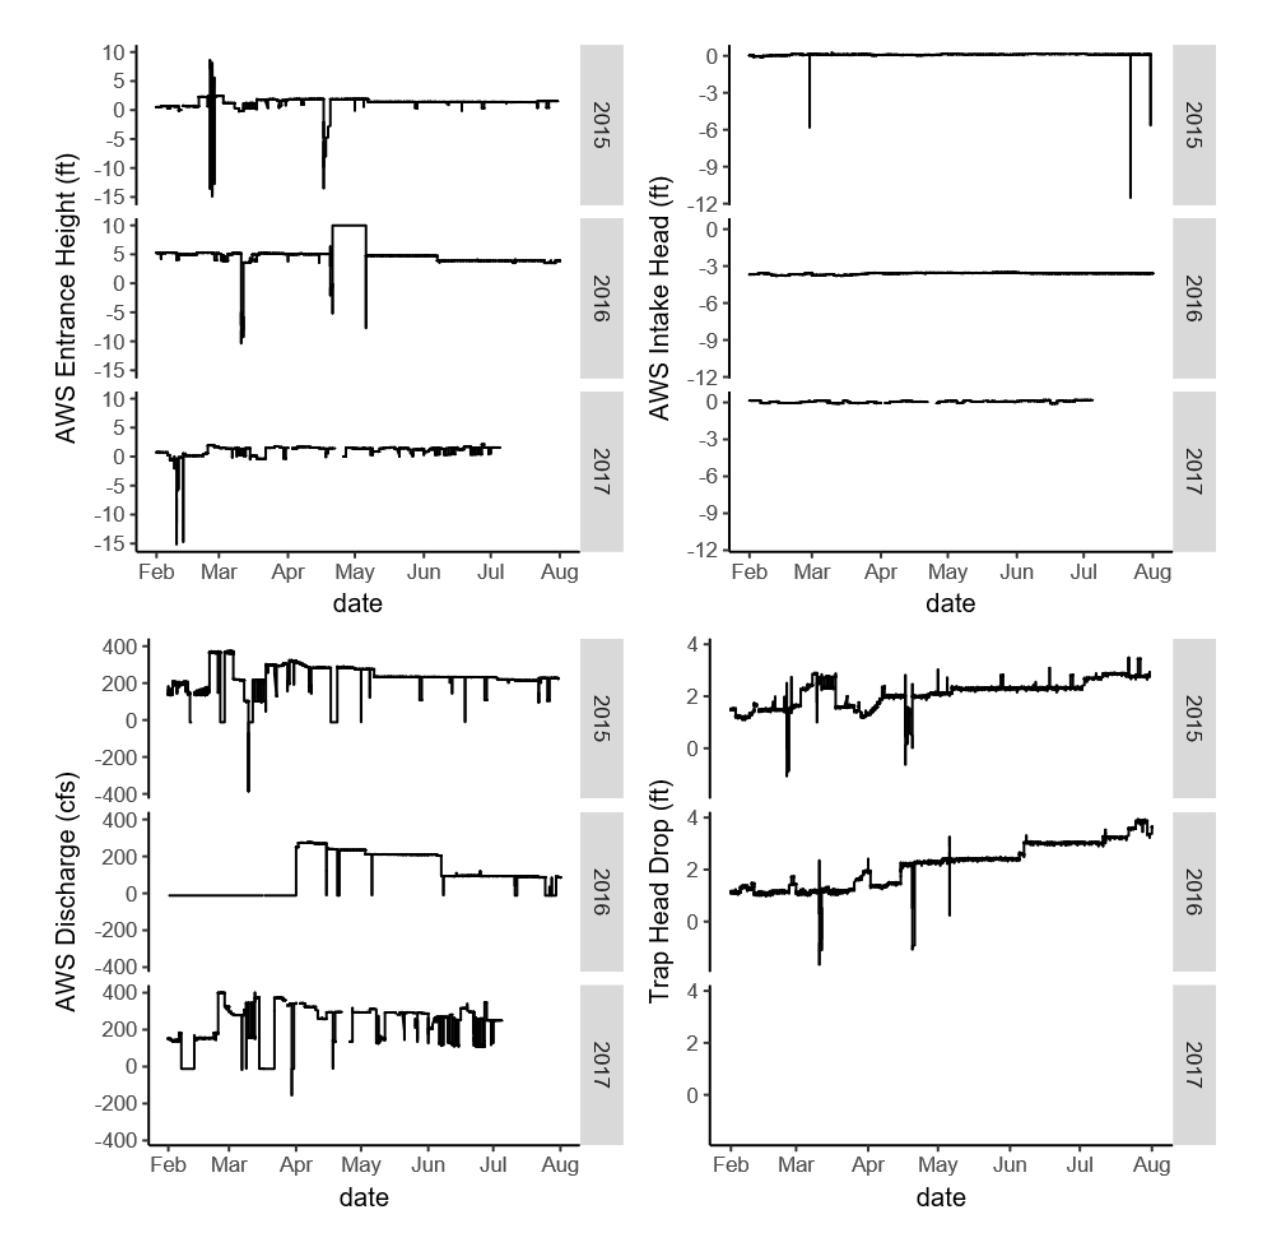
Figure A-3. Hourly mean AWS entrance height (top left), AWS intake head (top right), AWS discharge (bottom left), and trap head drop measured in the trap area at Merwin Dam during months of winter steelhead tagging across three years (2015, 2016, 2017).

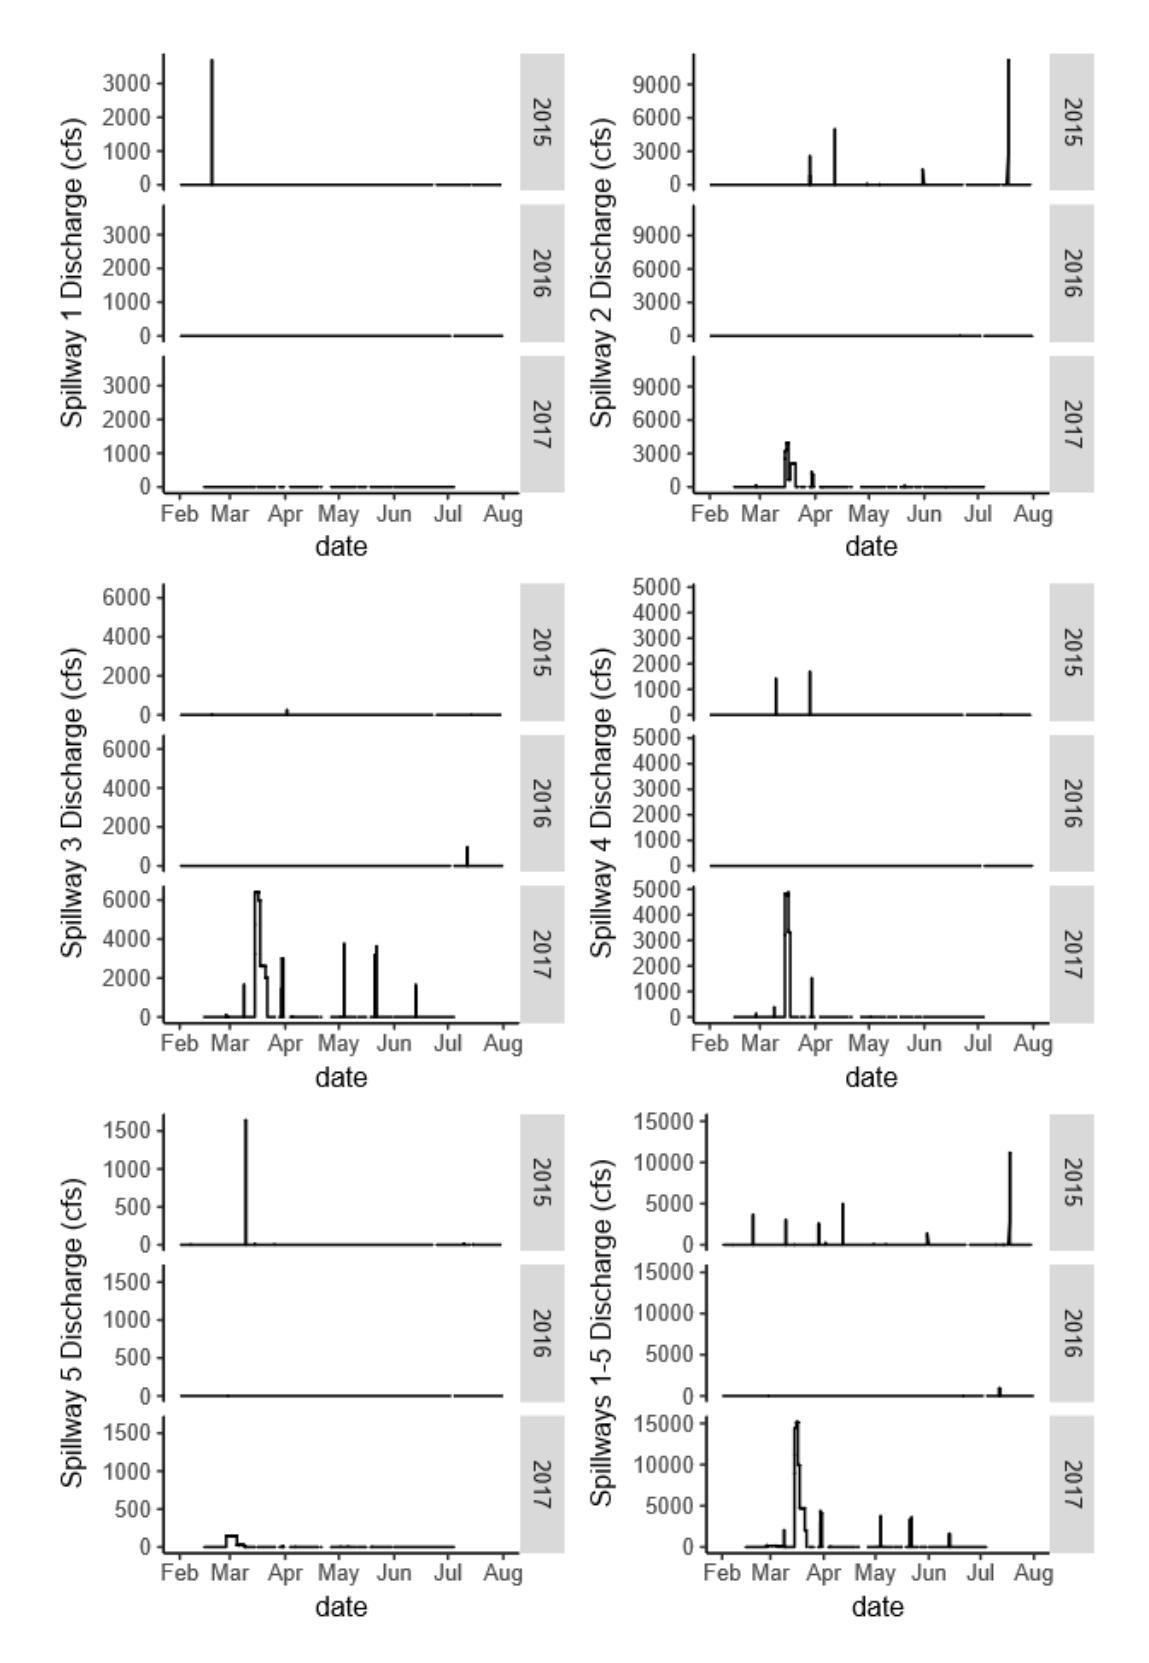
Figure A-4. Hourly mean discharge from five Spillways at Merwin Dam during months of winter steelhead tagging across three years (2015, 2016, 2017).

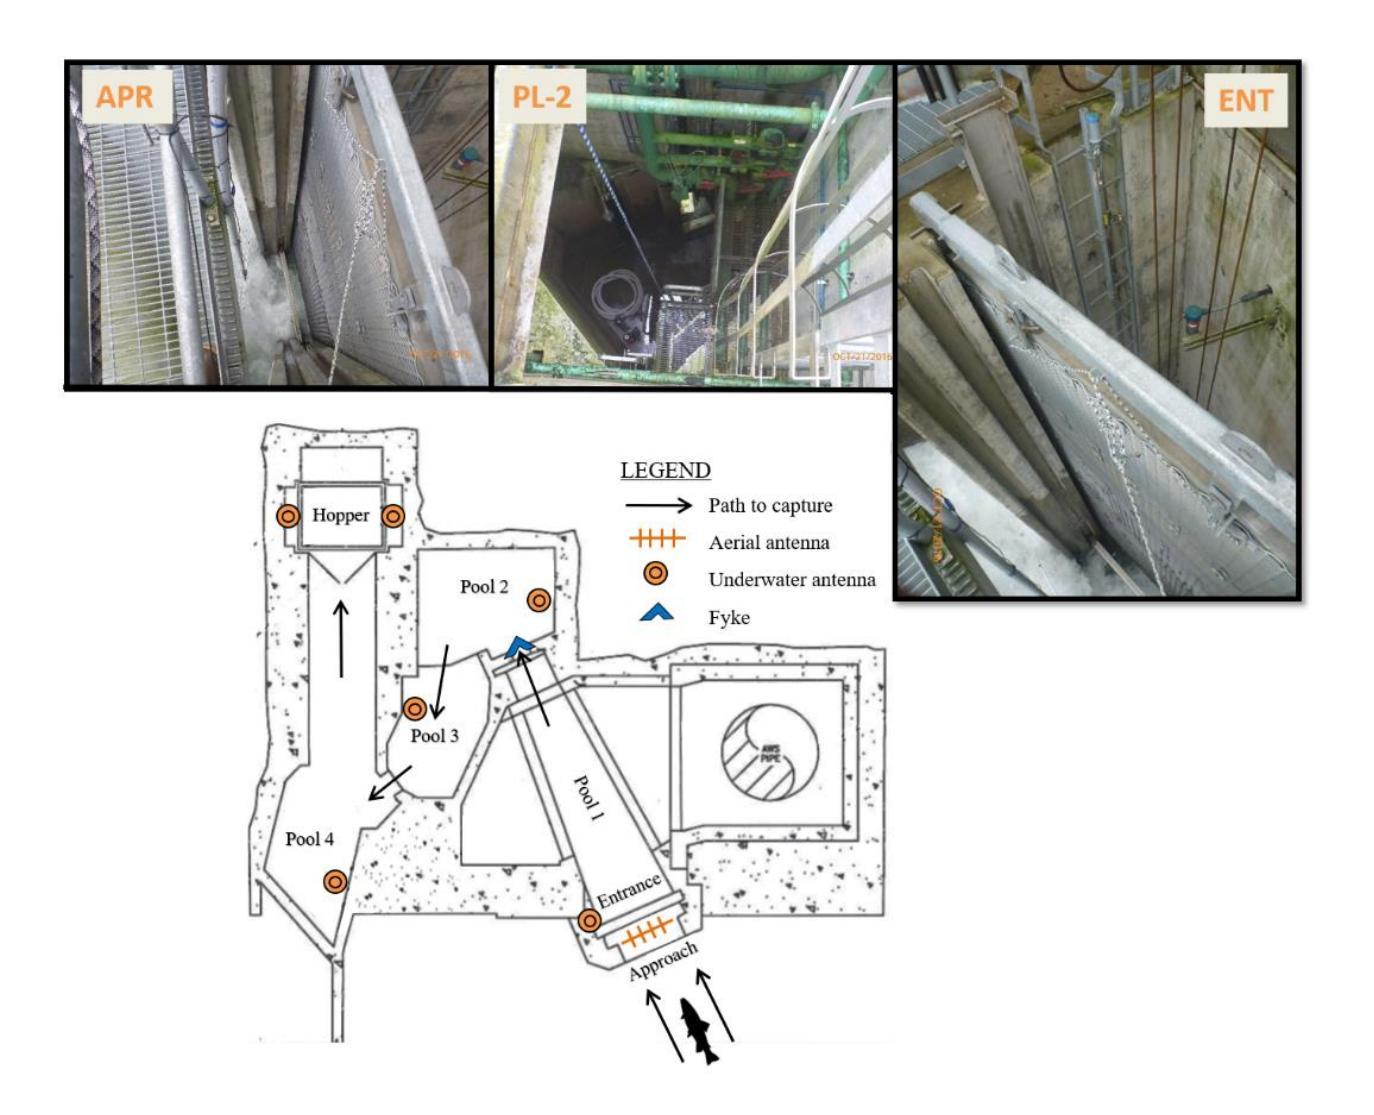
Figure 3. Trap schematic showing the locations of antenna arrays, with arrows showing the progressive movements fish make to reach the hopper and pictures of select antenna orientations. The approach antenna is aerial, and the entrance site comprised two underwater dipole antennas located on the left-hand side within Pool 1-1 at two depths. The hopper site also comprised two-dipole antennas, located outside the path of the ascending and descending hopper. All other trap sites comprised one dipole depth and one dipole location. After moving to the hopper, fish are crowded and then transported toward the Trap antenna at the fish facility (not shown).
The shapes of tag detection regions for each radio receiver were designed for the following endpoints:

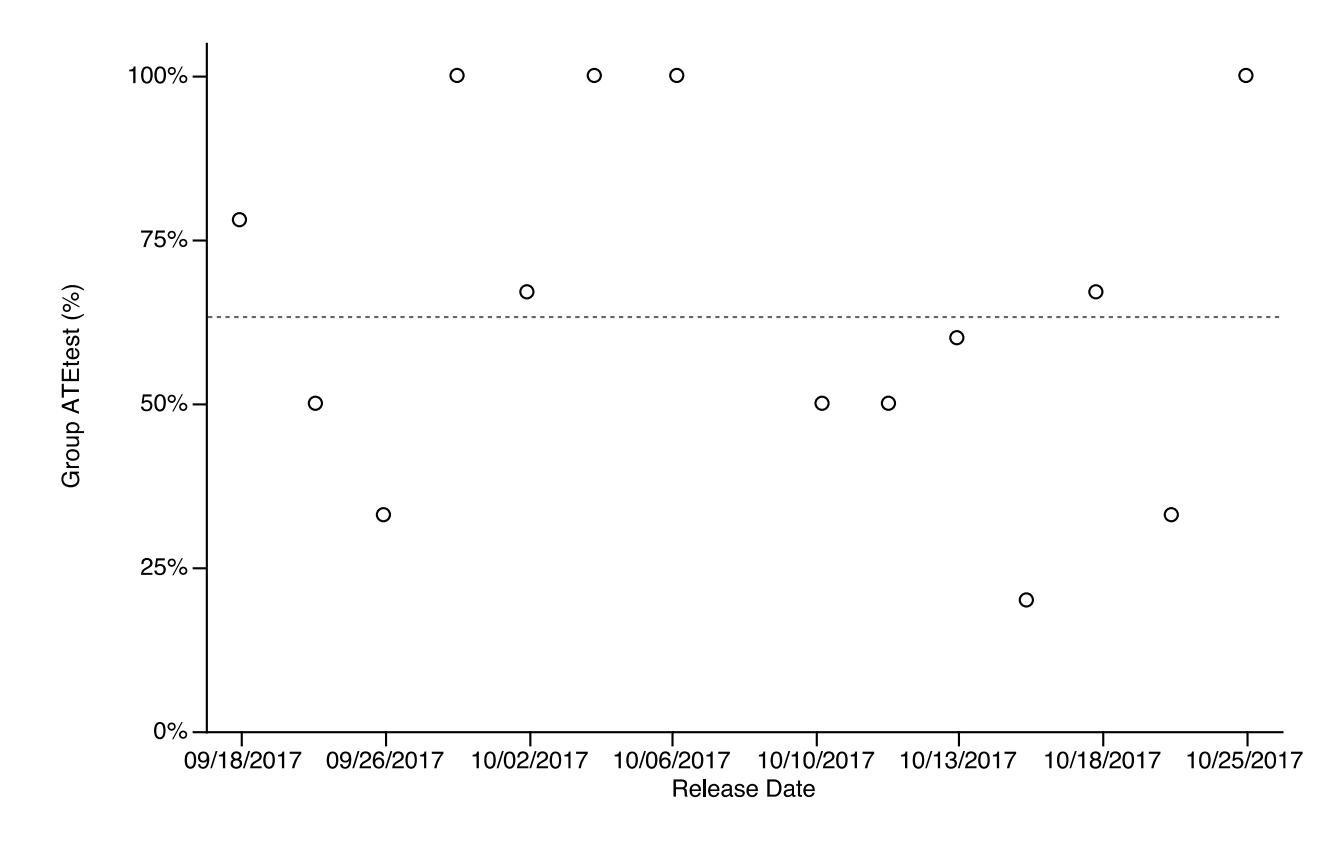
Figure 8. Release group ATE_{test} estimates over time, during 2017 coho tracking study. Dashed horizontal gray line indicates seasonal coho salmon ATE_{test} estimate for 2017.

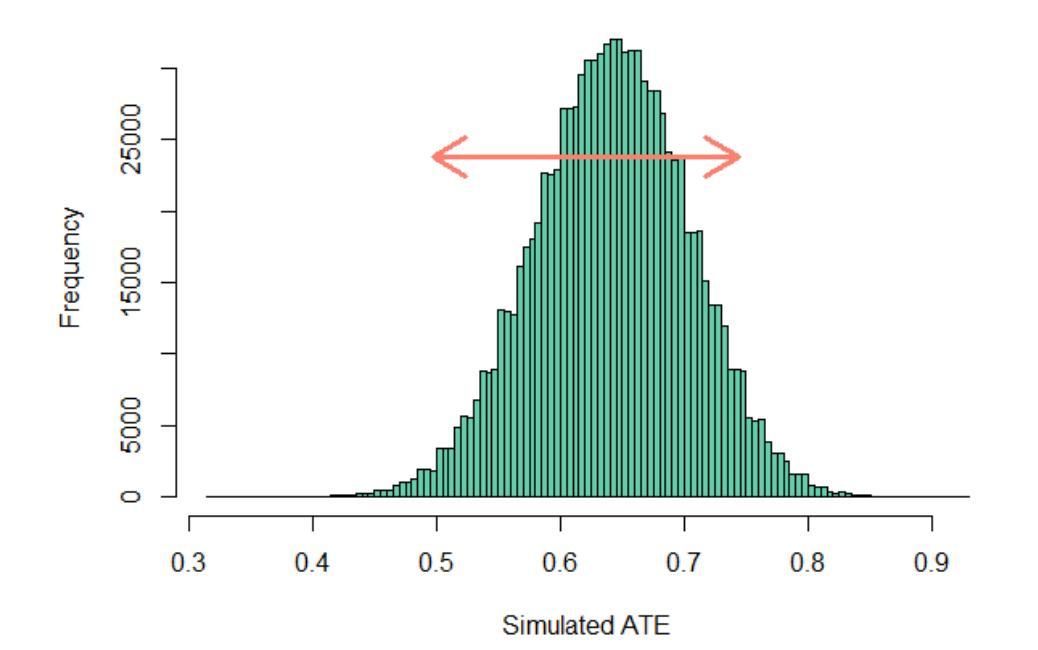
Figure 10. Bootstrap simulated frequencies of *ATE* calculated from one million iterations of randomly resampling (with replacement) the sample of 60 study fish that reached the Merwin Dam tailrace. Horizontal bi-directional arrow indicates BCA 95% CI (49.7 - 74.4%). Note that target *ATE* was reached in zero of one million simulations. A small amount of random noise was added to each bootstrap to create a "smoothed bootstrap".

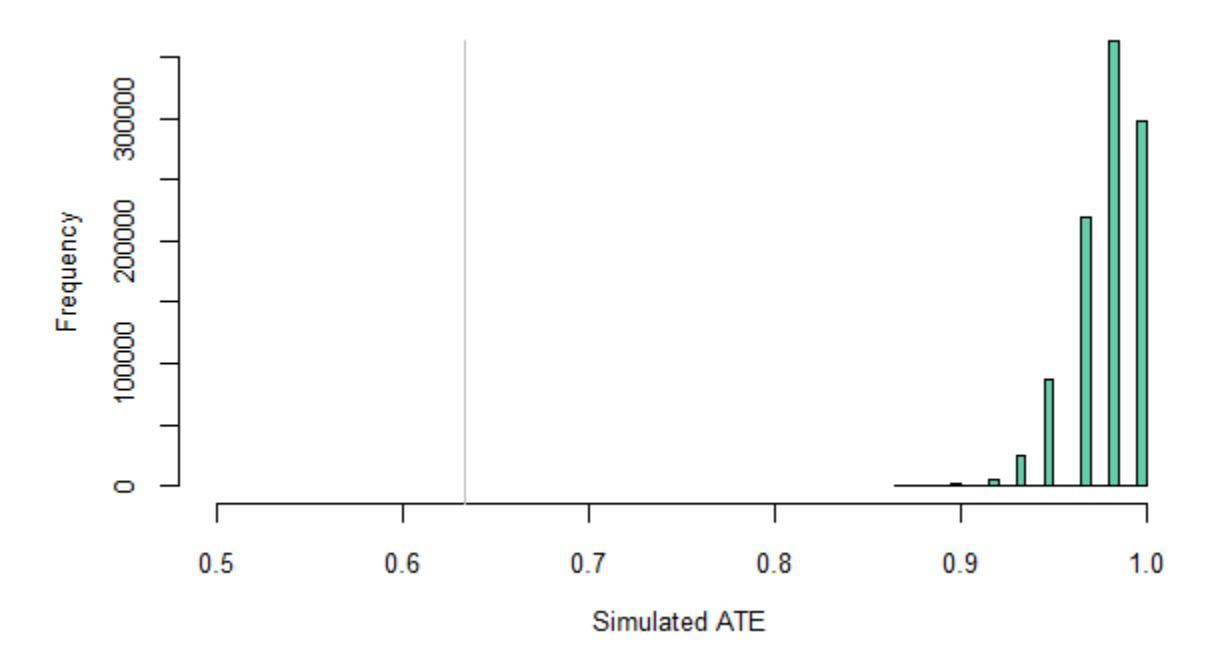
Figure 11. Simulated frequencies of *ATE* calculated from one million iterations of randomly subsampling a set of 60 fish from a simulated "urn" population of 10,000 fish that truly exhibited 98% *ATE*. Vertical gray line indicates observed ATE_{test} of 63.3%. Note that ATE_{test} reported here for 2017 was reached in zero of one million simulated subset samples of 60 fish from the parent population of 10,000.

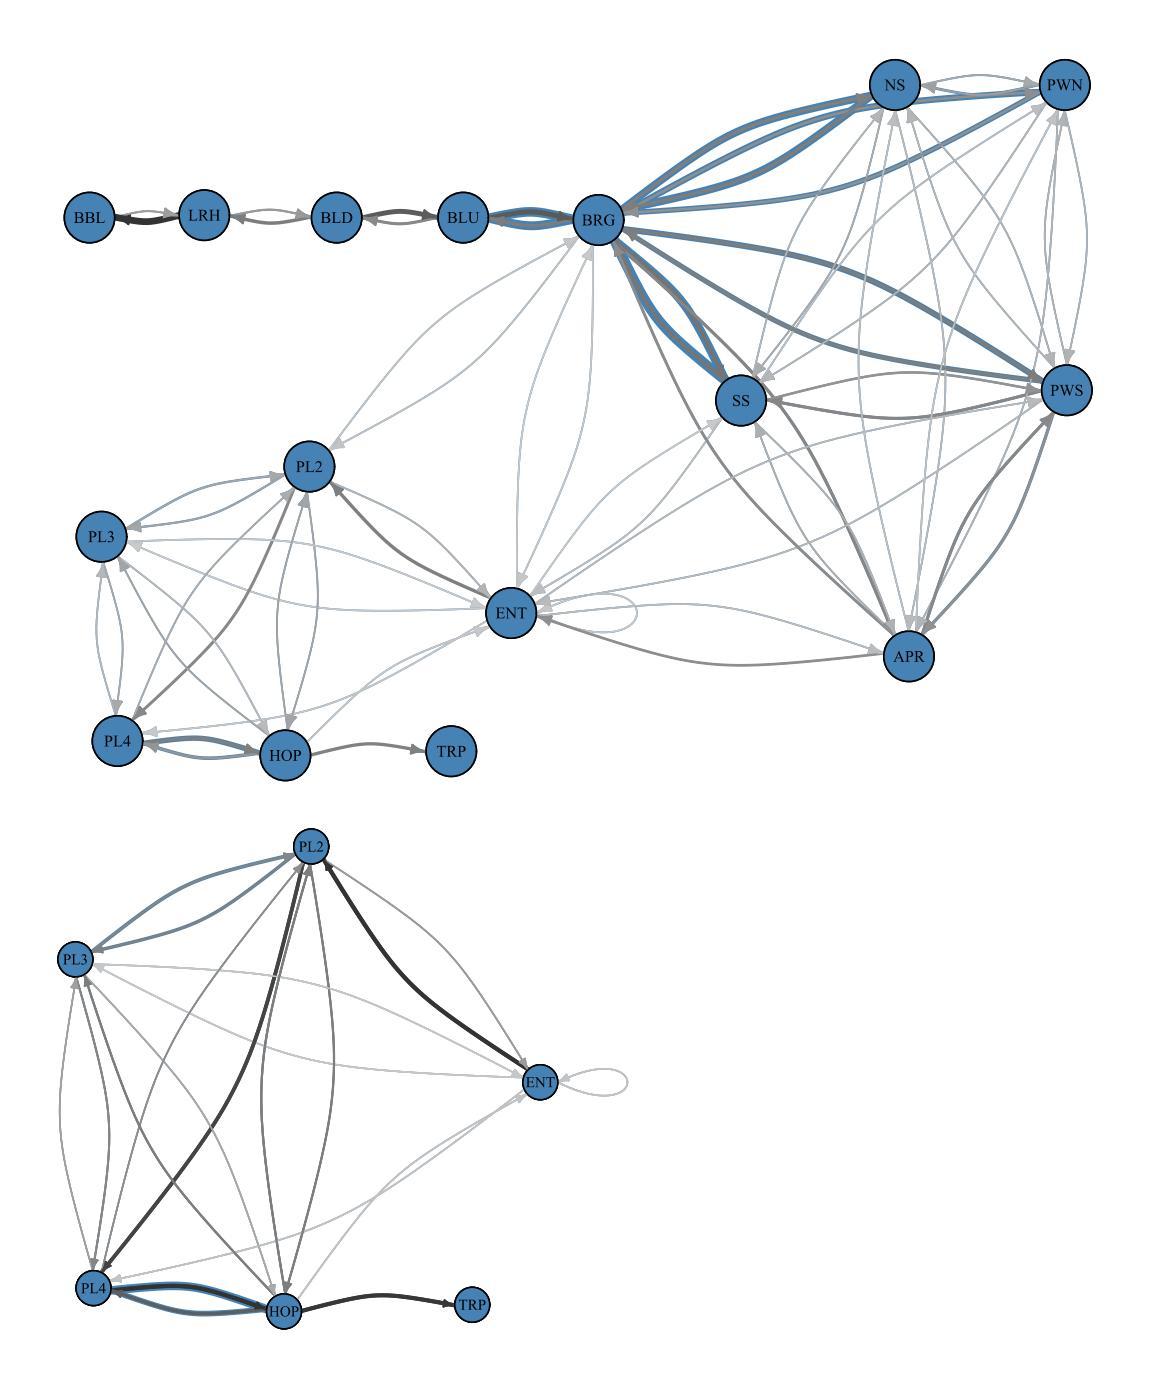
Figure 12. Network diagram of fish movement within study area. Path thickness and color are scaled based on the total number of individual fish traveling the paths (thicker paths represent a higher number of fish taking the path at least one time across their detection history). Grey paths are scaled to represent the total number of fish that traveled between sites (individuals as the sample unit). Blue paths are scaled to represent the total number of times that a path was used (total number of behaviors, with movements as sample units; *non-independent*). Top figure shows all sites; bottom figure shows only trap sites and includes re-normalized transitional probabilities calculated using detections at trap sites only.

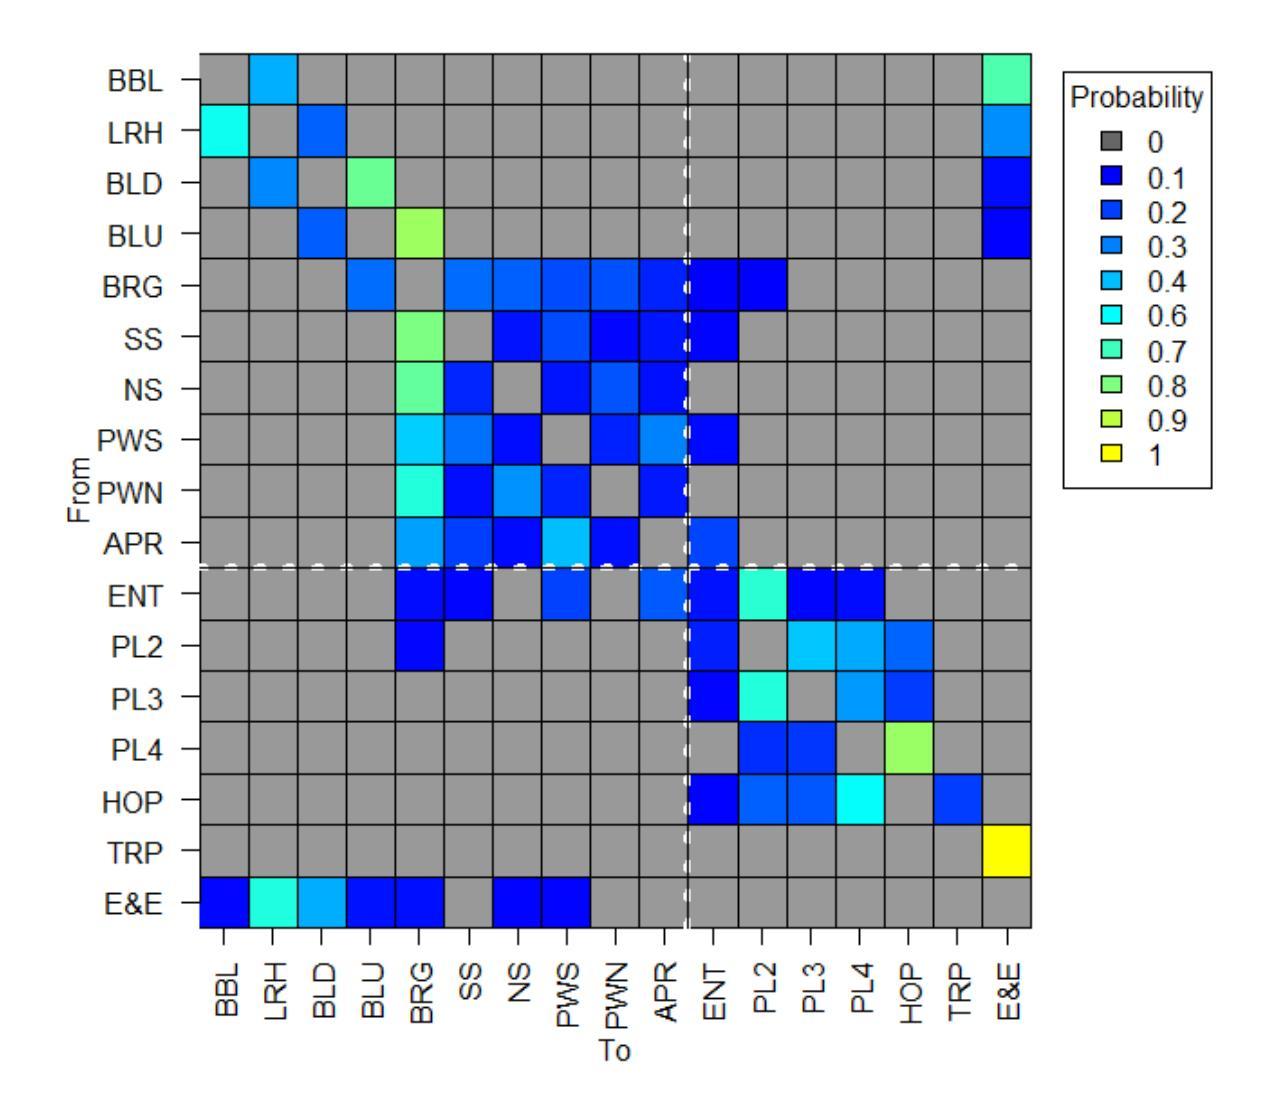
Figure 13. Heat map of the transition probabilities of fish moving from an origin site to all potential destination sites. Each row sums to a probability of 1. Dashed reference lines are added between the Approach and Entrance receivers to show the distinction of a fish being located within or outside of the trap. Matrix quadrants represent categorically distinct behavior patterns: Probabilities in the upper left box represent movements that begin and end in the river or tailrace. Probabilities in the bottom right begin and end in the trap. Probabilities in the lower left box represent paths that begin in the river or tailrace and end in the trap. Probabilities in the lower left box begin in the trap and end in the river or tailrace. E&E represents entrance and exit locations from the study system. For example, fish that are at the Trap always exit the system (e.g., they cannot leave), so there is a probability of 1.0 at the Trap row and E&E column).

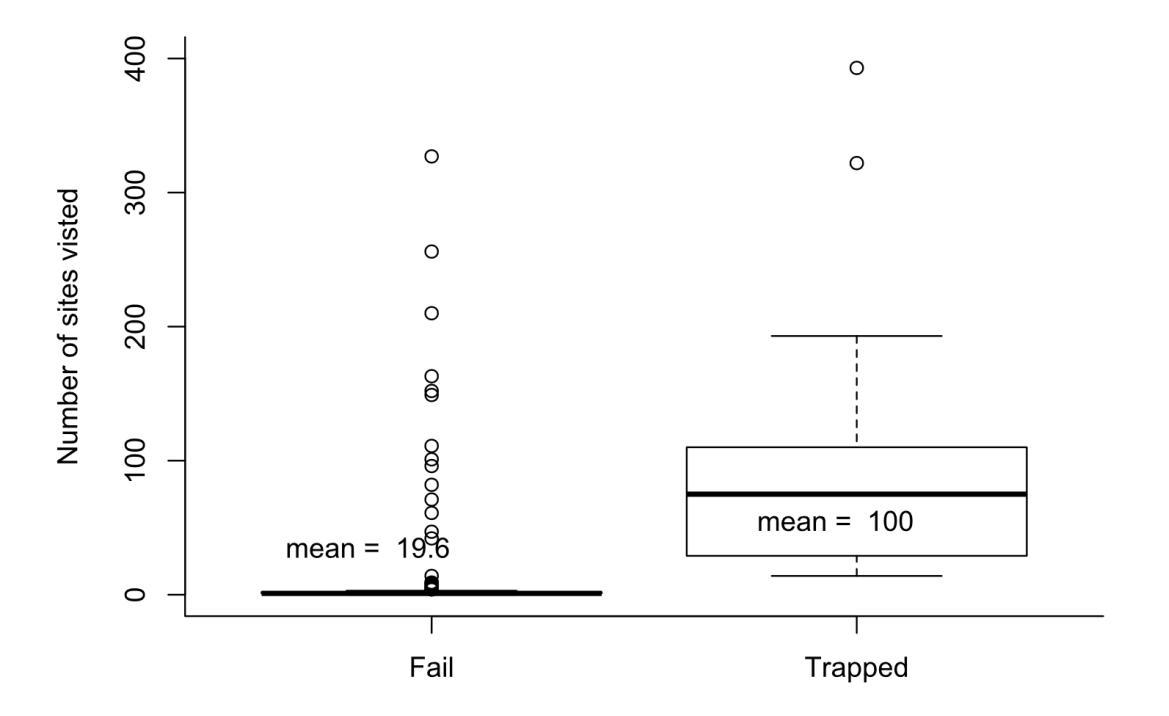
Figure 14. Number of sites visited before being captured (Trapped) or in the case of fish that were not captured, before the end of the study (Fail).

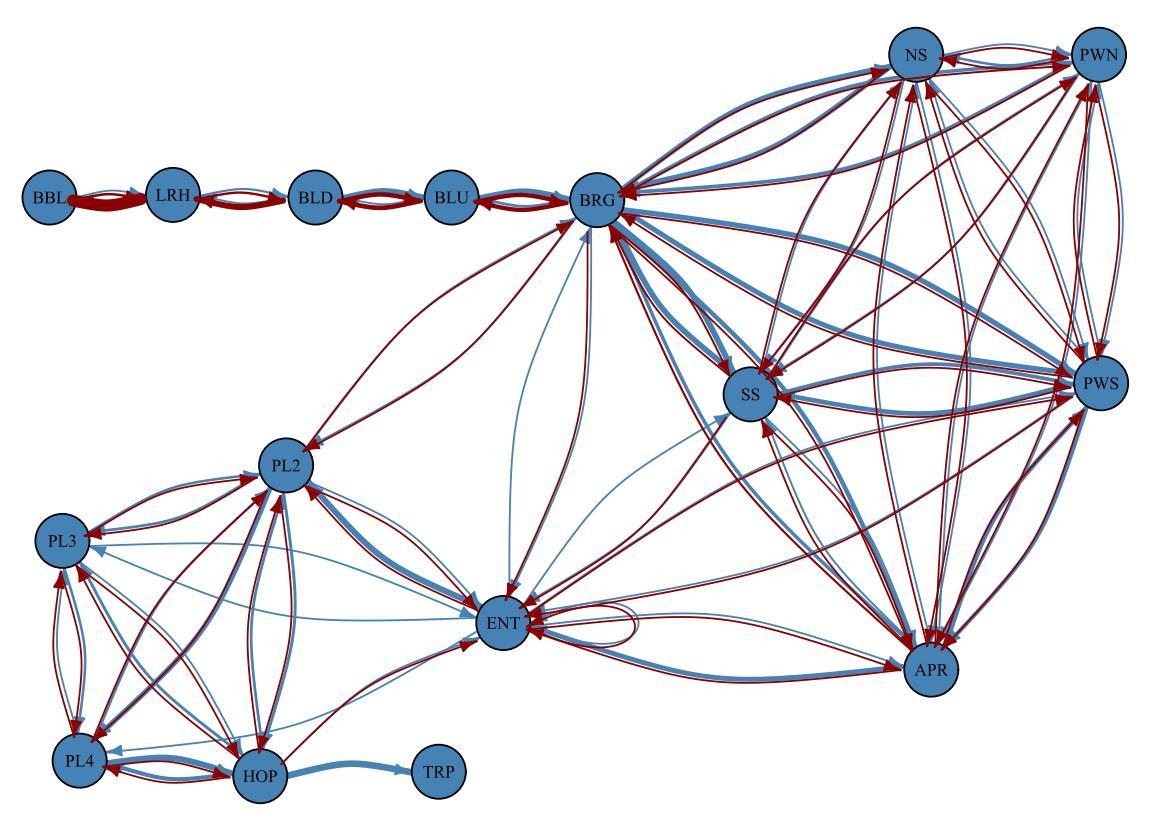
Figure 15. Network diagram of fish movement within the study area at Merwin Dam grouped by fish that ultimately are re-captured (blue) or failed to be re-captured (red) from 2017. Path thickness and color are scaled based on the total number of transitions which occurred between sites with fish as the sample unit. This graphic depicts the movements of 137 fish; 35 that were successfully re-captured (i.e., last detected at Trap) and 102 that were unsuccessful. This figure does not include movements of fish that experienced tag shed or tag failure.

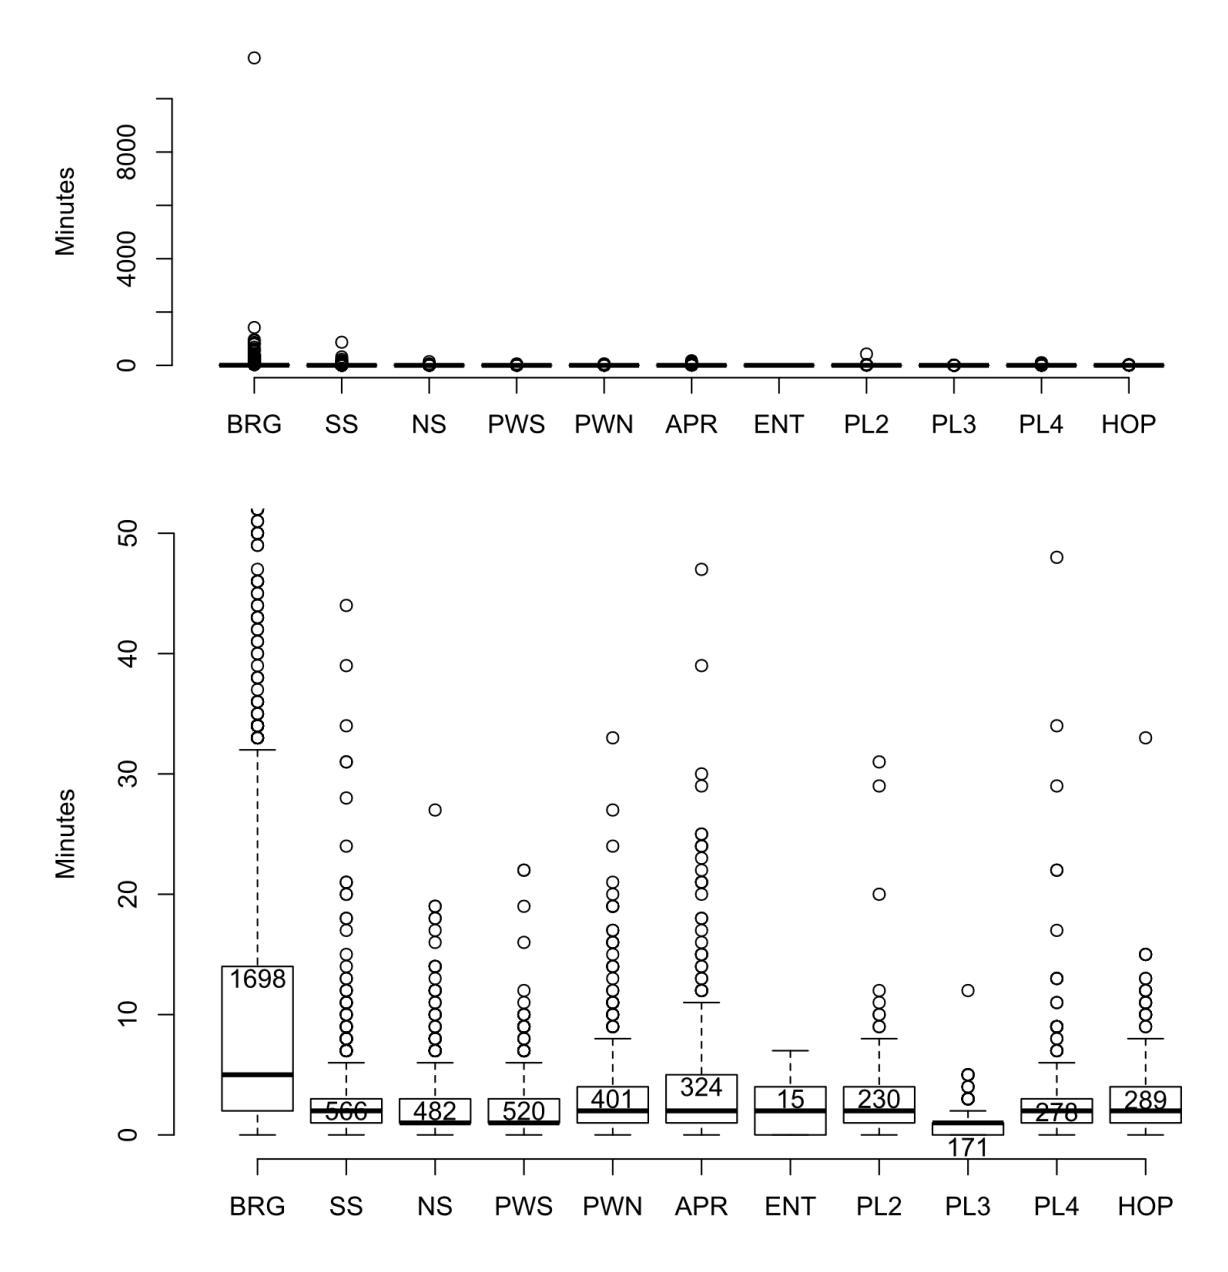
Figure 16. Median residence times by sites in the tailrace and trap. The top figure shows the full range of data, including outliers (open circles), while the bottom figure zooms in to show the box and whisker plots, focusing on inter-quartile range. Number of visits (n) is displayed in the top of the box plots for each site. (*Caveat: these data are not scaled based on the detection ranges of each site.*)

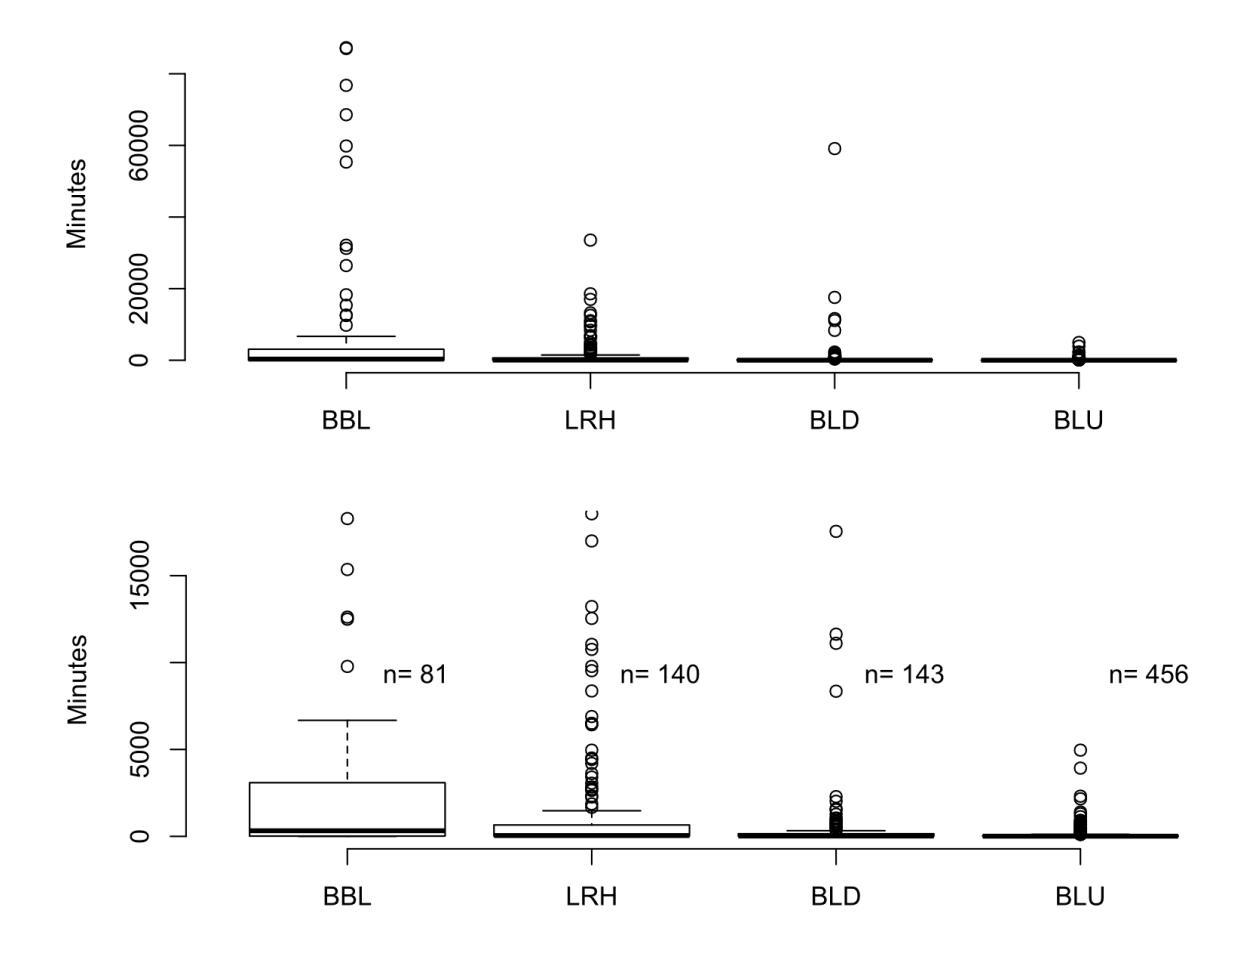
Figure 18. Median residence times for downriver sites. The top figure shows the full range of data, including outliers, while the bottom figure zooms in to show the box and whisker plots, focusing on interquartile range. Sample size (n) is displayed in the top of the box plot for each site. *Caveat: these data are not scaled based on the detection ranges of each site.*
