Lewis River Fish Passage Program 2017 Annual Report (Final)

FERC Project Nos. 935, 2071, 2111 and 2213

PacifiCorp & Public Utility District No.1 of Cowlitz County

April 10, 2018

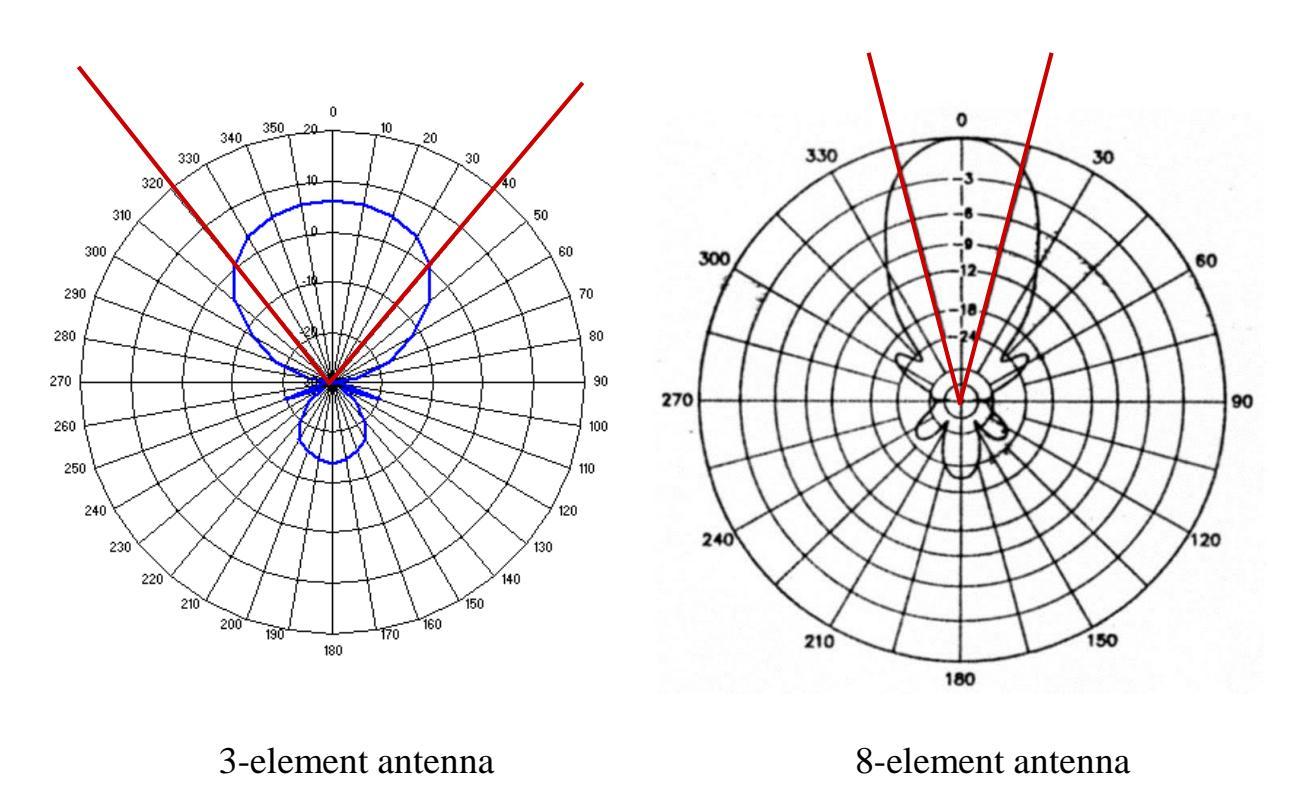
Figure 20. Reception radiation patterns (tag detection areas) for short-range 3-element (6.0dBd) and long-range 8-element (11.8dBd) Yagi antennas. Numbers around the perimeter of each figure represent directional degrees.
