Condit Dam breach successful

Removing the Condit Dam from the White Salmon River

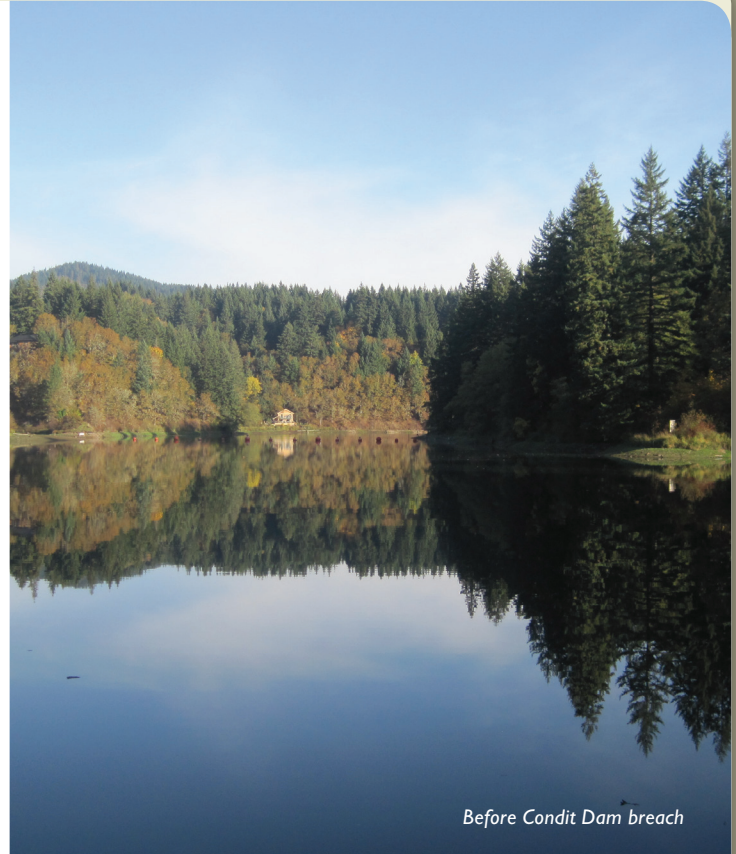
Before Condit Dam breach

As Northwestern Lake drained quickly after the breach, much of the estimated 2.4 million cubic feet of sediment that had built up behind the dam over the years began to move downstream toward the Columbia River. As expected, logs and other debris that had sunk to the bottom of the lake also flowed downstream. Northwestern Lake drained in less than two hours and revealed the river canyon for the first time since April 1913. As the lake drained, the river came to life and began cutting through the sediment, creating a new river channel with steep slopes and exposing the old cofferdam just upstream of Condit Dam.

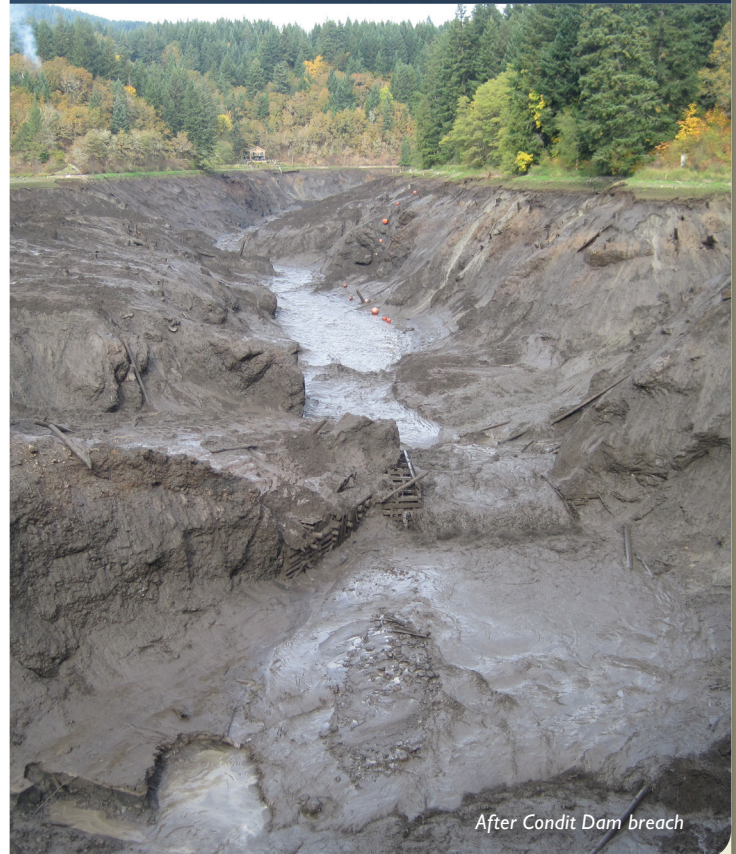
After Condit Dam breach
