# Cutler Hydroelectric Project

*FERC Project No. 2420*

## **Resource Management Plan Five-Year Monitoring Report 2003-2007**

**Cutler Hydroelectric Project  
FERC Project No. 2420  
Box Elder and Cache Counties, Utah**

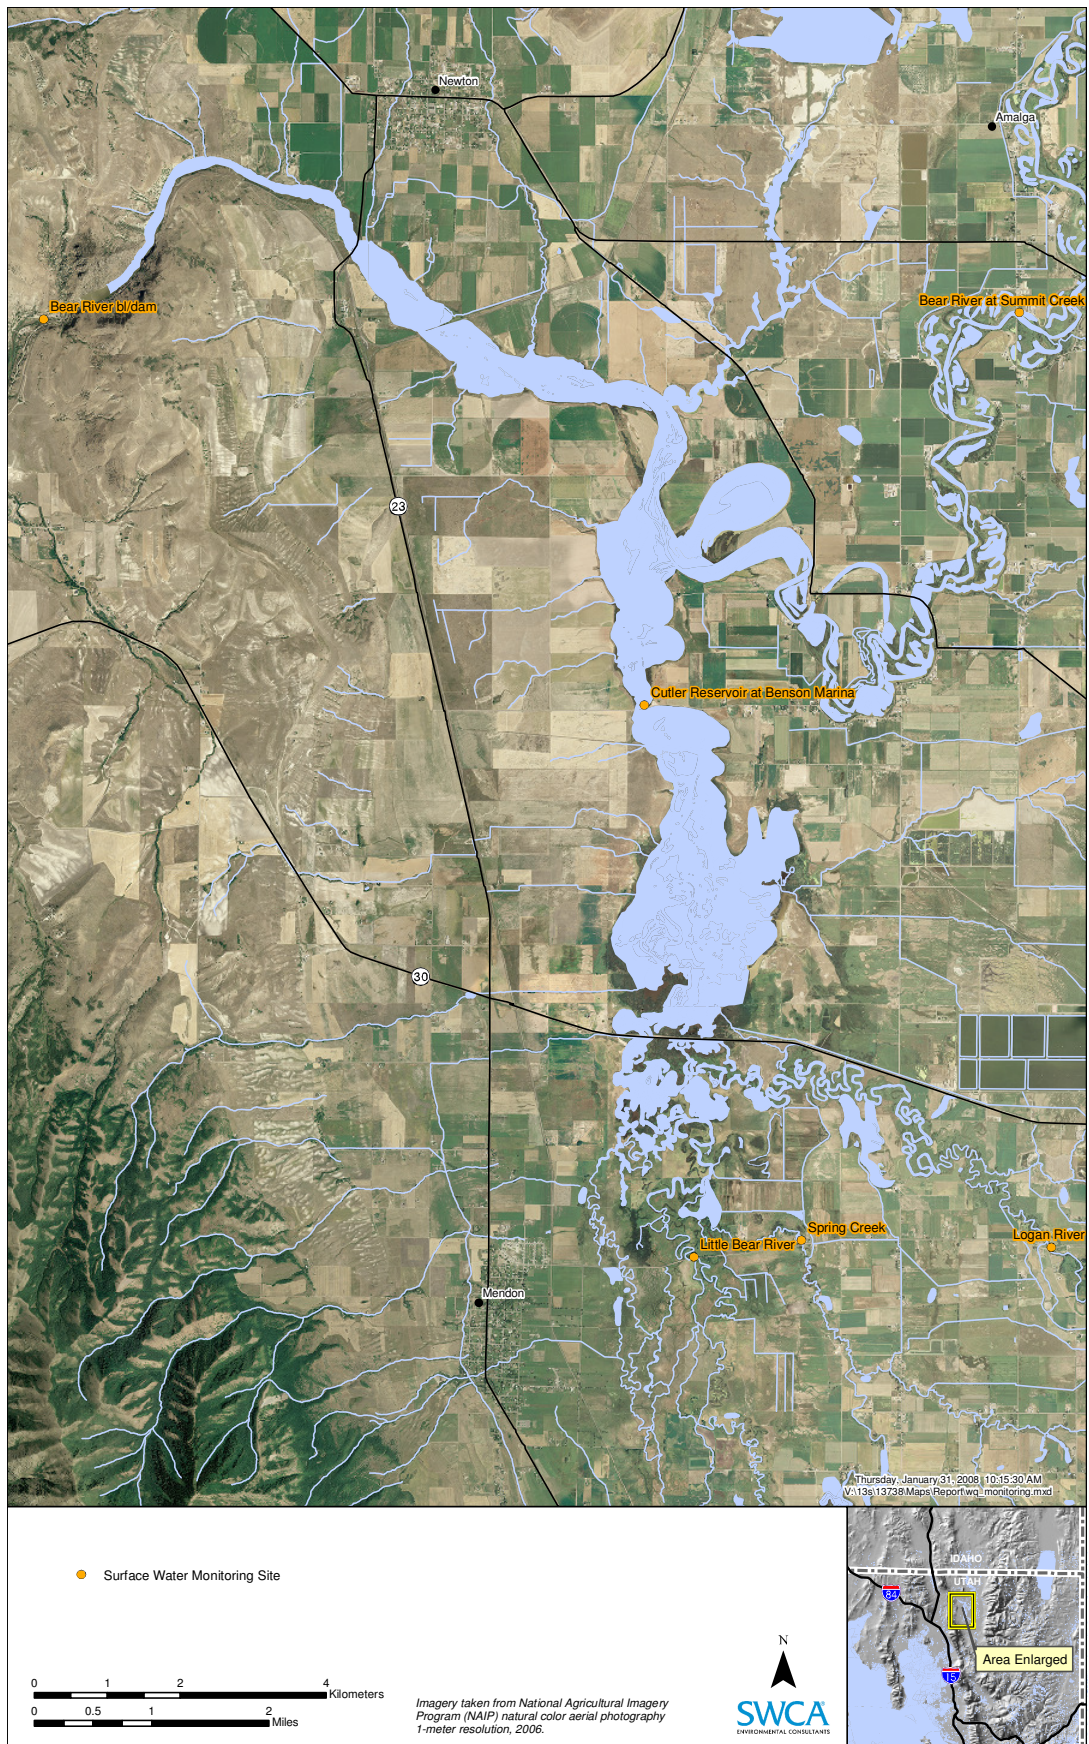
**Figure 1. Cutler Reservoir surface water monitoring sites.**

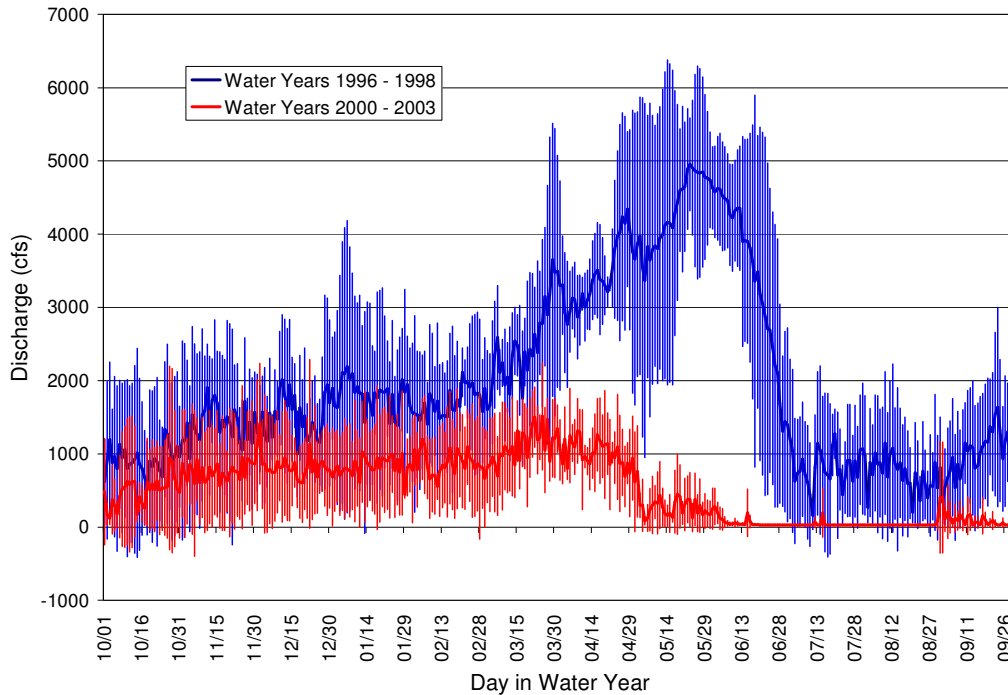
**Figure 2. Hydrograph for average daily releases from Cutler Reservoir (cfs) during two monitoring periods. Solid line shows average discharge surrounded by standard deviation in shaded bars.**

Average daily flow (cfs), recorded at Cutler Reservoir by PacifiCorp, were plotted on individual hydrographs (Figure 2). These hydrographs represent reservoir discharge flows during each monitoring period. The difference in water yield from Cutler Reservoir during each monitoring period between 1996 and 1998 was characterized by wet conditions and high flows, while 2000–2003 was characterized by dry conditions with low flows. This is clearly indicated on the hydrographs in Figure 2. The years identified as wet versus dry years, based on discharge from Cutler Reservoir, are paired with the annual flow in the Bear River above Cutler Reservoir. In the past 20 years 1997, 1998, and 1999 have been the wettest years with historically wetter years occurring only in 1983, 1984, and 1986. Since 1971, the years of 2001, 2002, and 2003 have been the driest years. This is reflective of drought conditions which could influence water quality parameters.

The hydrographs for discharge from Cutler Reservoir water show an annual trend of increasing water delivery rates during the summer and a general trend downward of water releases throughout the late summer and fall. This reflects the reduced delivery of water to the reservoir from the watershed during the dry part of the season. This seasonal pattern tends to replicate itself over the monitoring period. The water release tends to change dramatically during drought years (2000–2003) which reflects both the reduced water delivery to the reservoir and PacifiCorp's maintenance of reservoir water levels even during dry seasons. The water year 2000 hydrograph did not demonstrate the normal late fall/early spring gradual average water discharge that is present within the other years of the hydrographs.

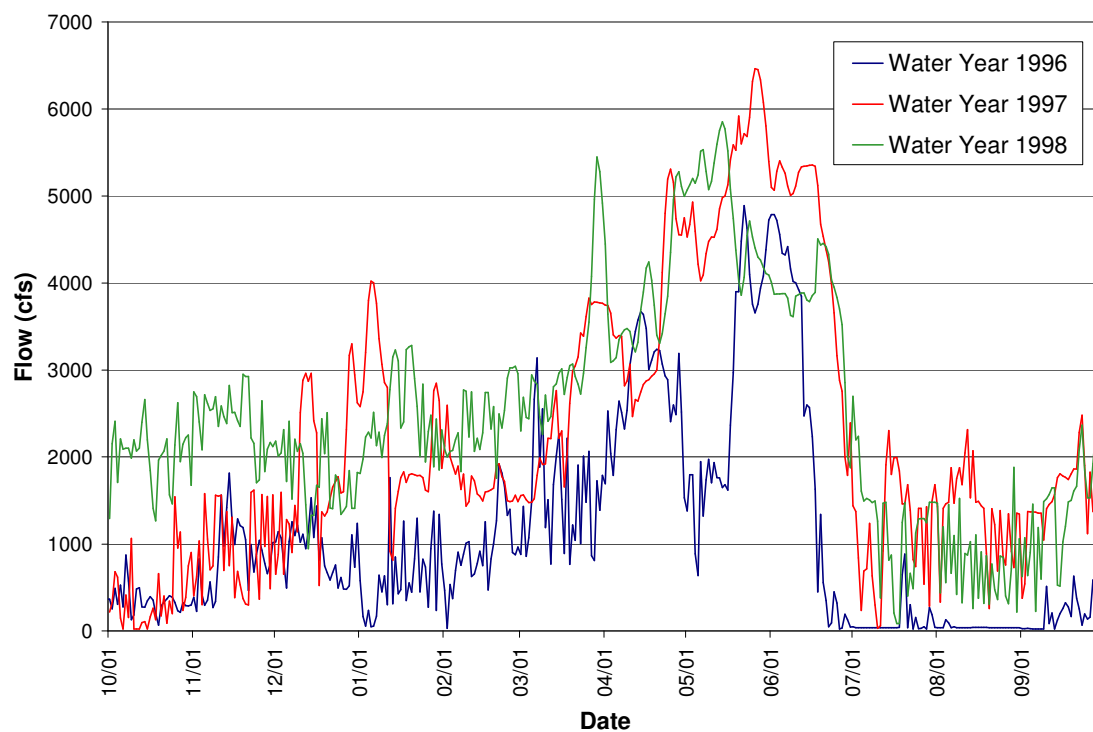
**Figure 3. Hydrograph of discharge from Cutler Dam by water year (1996–1998)**

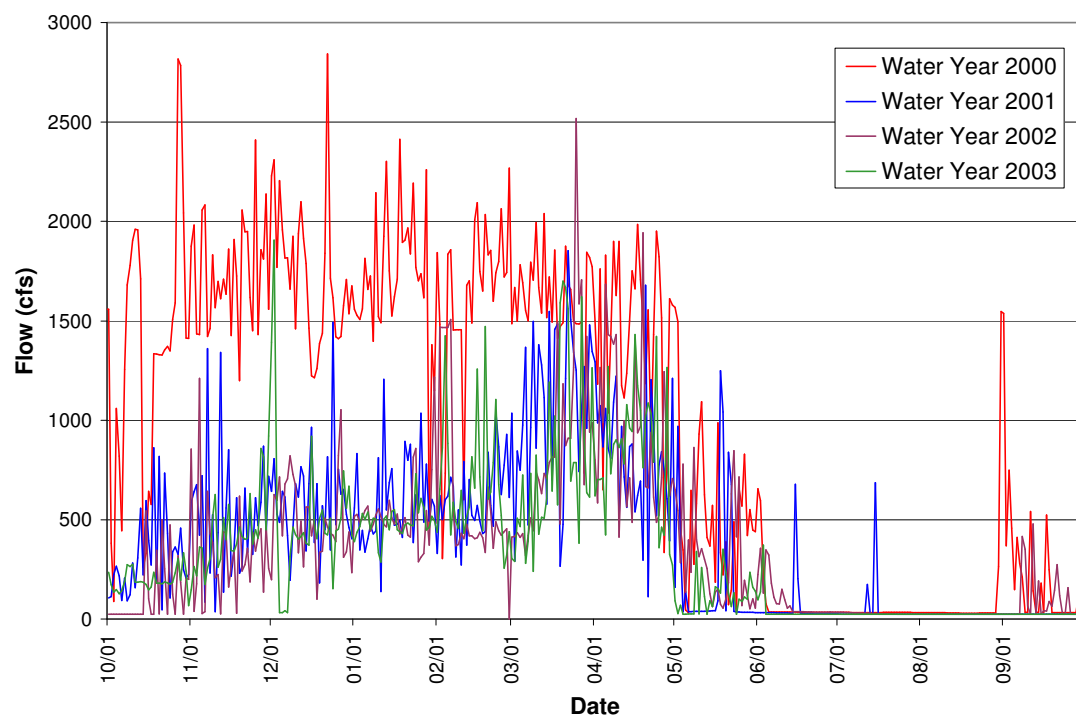
**Figure 4. Hydrograph of discharge from Cutler Dam by Water Year (2000–2003)**

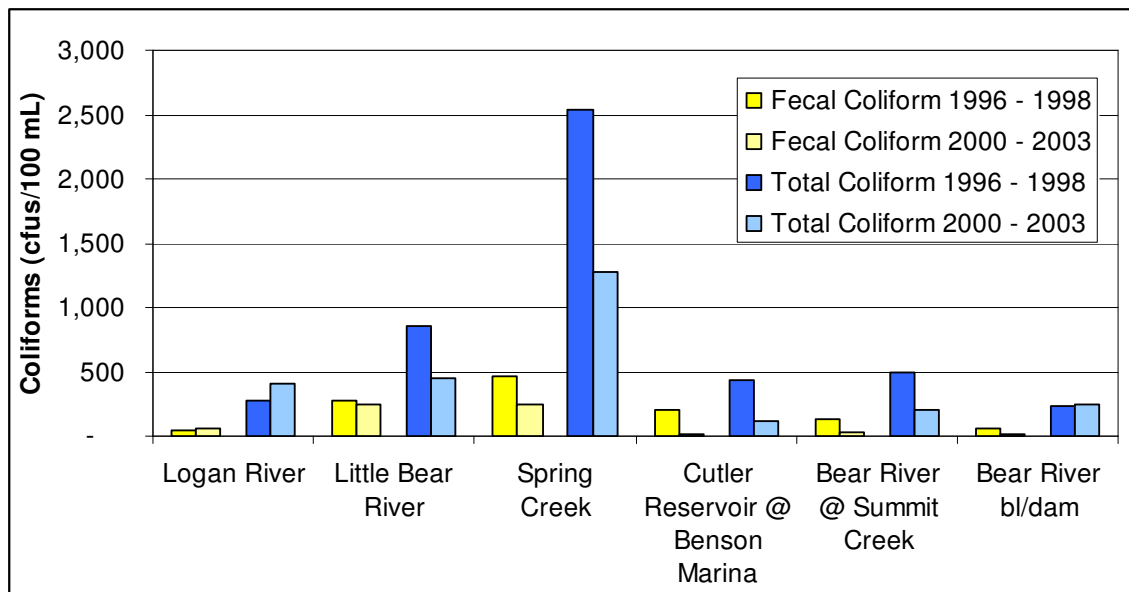
**Figure 5. Change in coliform bacteria in Cutler Reservoir system between first monitoring period (1996–1998) and second monitoring period (2000–2003).**

A comparison of coliform bacteria between the first monitoring period (1996–1998) and the second monitoring period (2000–2003) indicates significant reductions in both fecal coliform concentration and total coliform concentration at all sites sampled except for the Logan River where concentrations were already quite low (Figure 5). Concentrations of fecal coliform bacteria in Spring Creek and the Little Bear River exceeded the 200 cfus/100 mL threshold during both sampling periods despite the observed reductions.

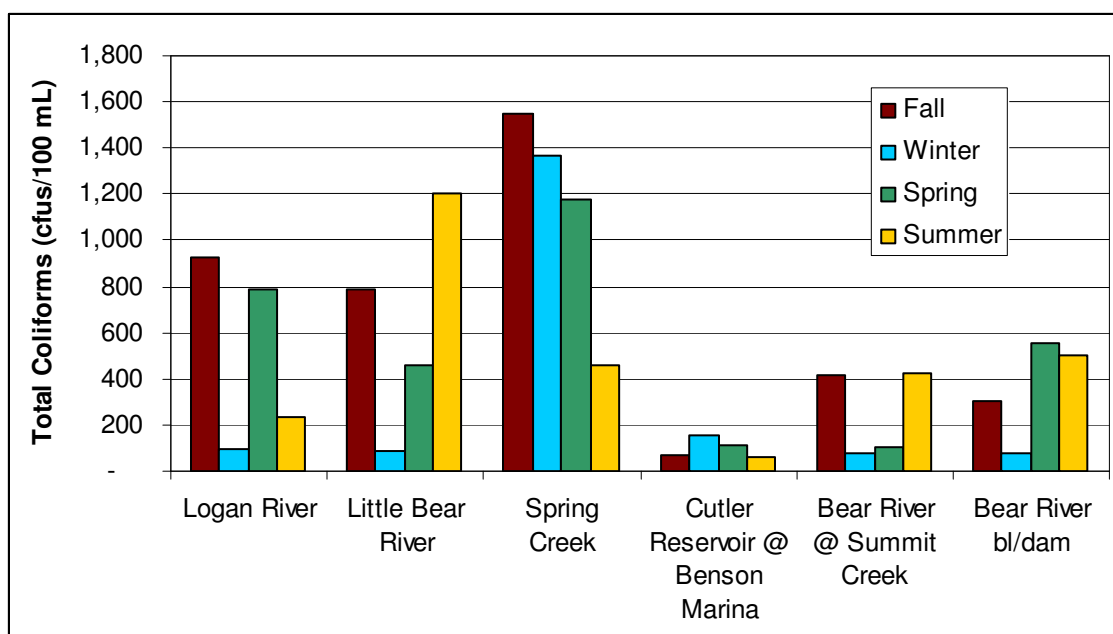
**Figure 6. Total coliform bacteria (cfus/100 mL) for sampling sites by season during the 2000–2003 monitoring period**

Total coliform concentrations are generally lowest during winter months which is expected since surface runoff, the process that transports coliform bacteria to surface waters, is generally not a significant contributor to flow during this time period (Figure 6). High concentrations of coliform throughout the year in Spring Creek indicate a discharging source of bacteria rather than one related to surface runoff. High concentrations of coliform bacteria in the Little Bear and Bear rivers during summer and fall could be reflective of livestock concentrating in streams (for watering purposes) or other nonpoint sources in the watershed during this period.

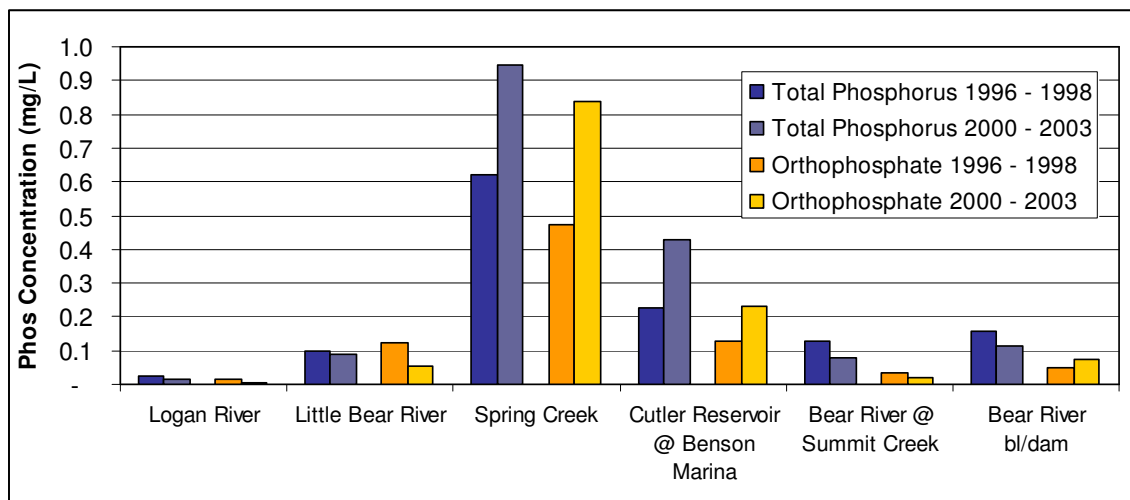
**Figure 7. Change in phosphorus concentrations in Cutler Reservoir system between first monitoring period (1996–1998) and second monitoring period (2000–2003).**

Data from the site within Cutler Reservoir indicate that concentrations of phosphorus (total and orthophosphate) as well as ammonia increased significantly between the two sampling periods whereas nitrate decreased slightly. Since phosphorus is relatively conservative in aquatic systems (there is no gaseous state), increased phosphorus concentrations can be explained in part by drought conditions providing less dilution water for the phosphorus in the system. In addition, longer retention times and periods of water stagnation in the southern end of the reservoir could lead to more prevalent anoxic reducing environments which can lead to the release of phosphorus from precipitated ferric phosphates when the iron is reduced from Fe (III) to Fe (II) (Young and Ross 2001). Anoxia is also a prerequisite for denitrification (Schlesinger 1997), the conversion of nitrate to nitrogen gas ( $N_2$ ), which could explain the slight reduction in nitrate in the reservoir under drought conditions.

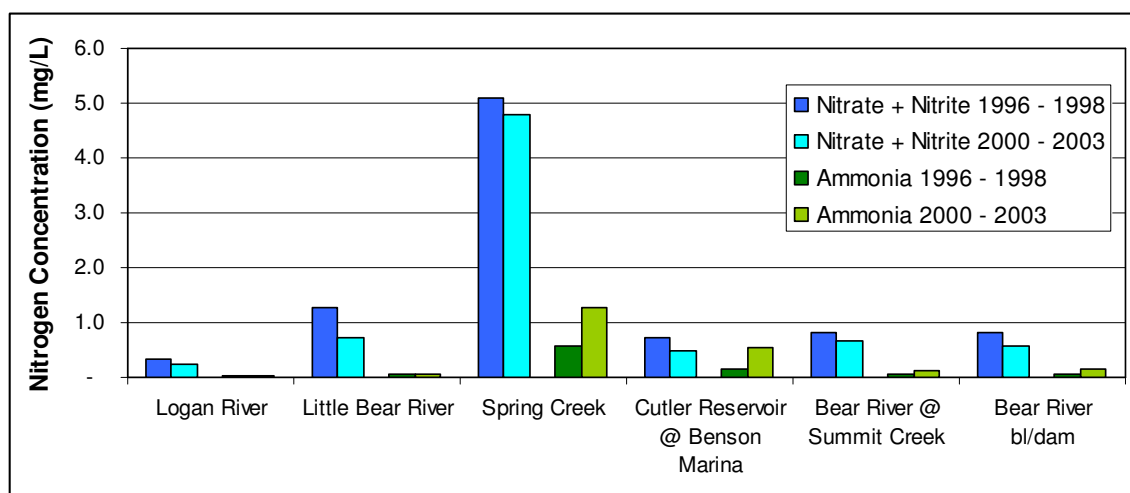
**Figure 8. Change in nitrogen concentrations in Cutler Reservoir system between first monitoring period (1996–1998) and second monitoring period (2000–2003).**

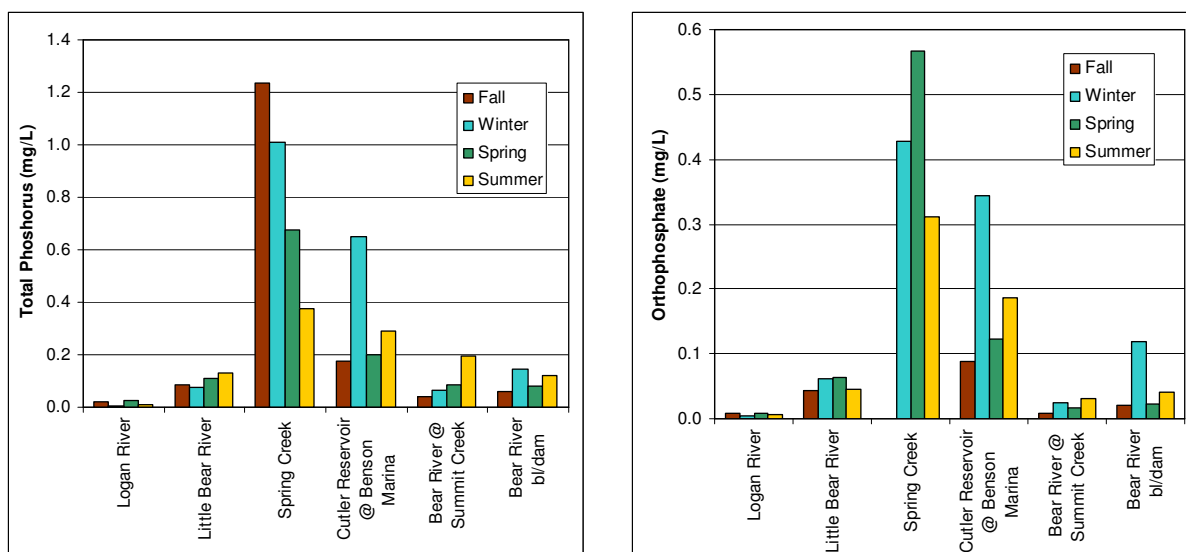
**Figure 9. Phosphorus concentrations for sampling sites by season during the 2000–2003 monitoring period**

Nutrient concentrations in the Logan River, the highest quality river in the study area, do not vary significantly across seasons (Figures 9 and 10). There are, however, seasonal patterns in nutrient concentrations in the more impaired rivers in the area, as well as in Cutler Reservoir itself. Phosphorus concentrations are the lowest in winter whereas ammonia and nitrate concentrations are the lowest in spring and summer. In contrast, the Little Bear River and the Bear River above Cutler Reservoir both exhibit the highest concentrations of total phosphorus during the summer season with orthophosphate concentrations peaking during the winter season. Both of these tributaries drain primarily agricultural watersheds in which phosphorus loads are tightly correlated with spring runoff and storm events. The winter season also accounts for the largest concentrations of nitrogen in the Bear River, Cutler Reservoir, and Spring Creek. The City of Logan does not discharge effluent from the municipal wastewater treatment plant during the summer season, which could explain lower phosphorus and nitrogen concentrations during this season. Without more information related to hydrologic conditions at the time of sampling (i.e. storm events, spring runoff) it is difficult to compare between seasons in these watersheds since data collected during different hydrologic periods represents a significant source of variability.

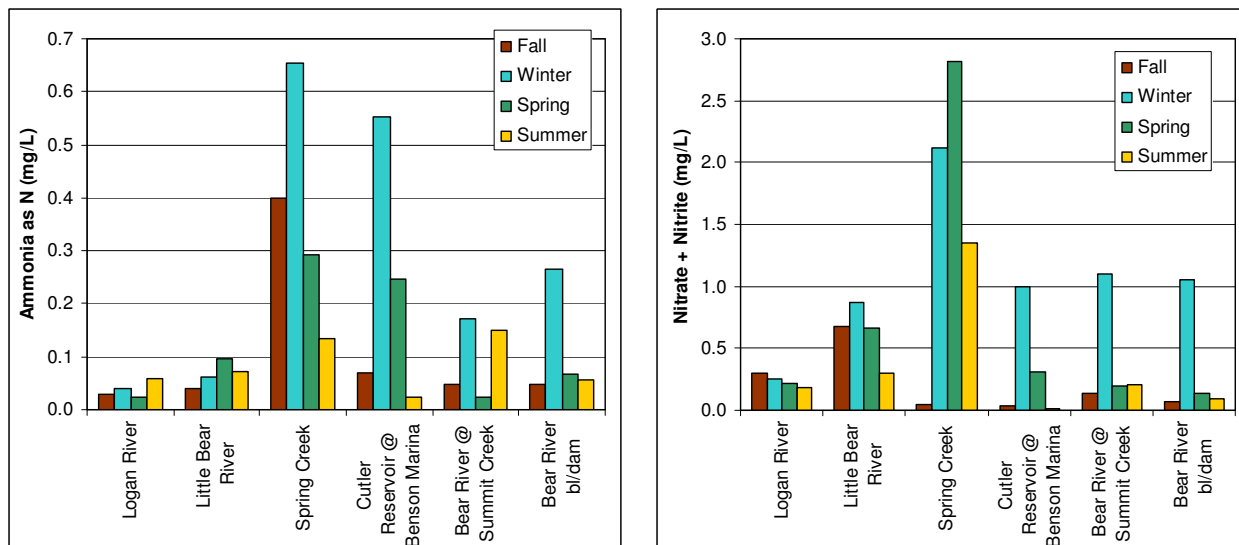
**Figure 10. Nitrogen concentrations for sampling sites by season during the 2000–2003 monitoring period**

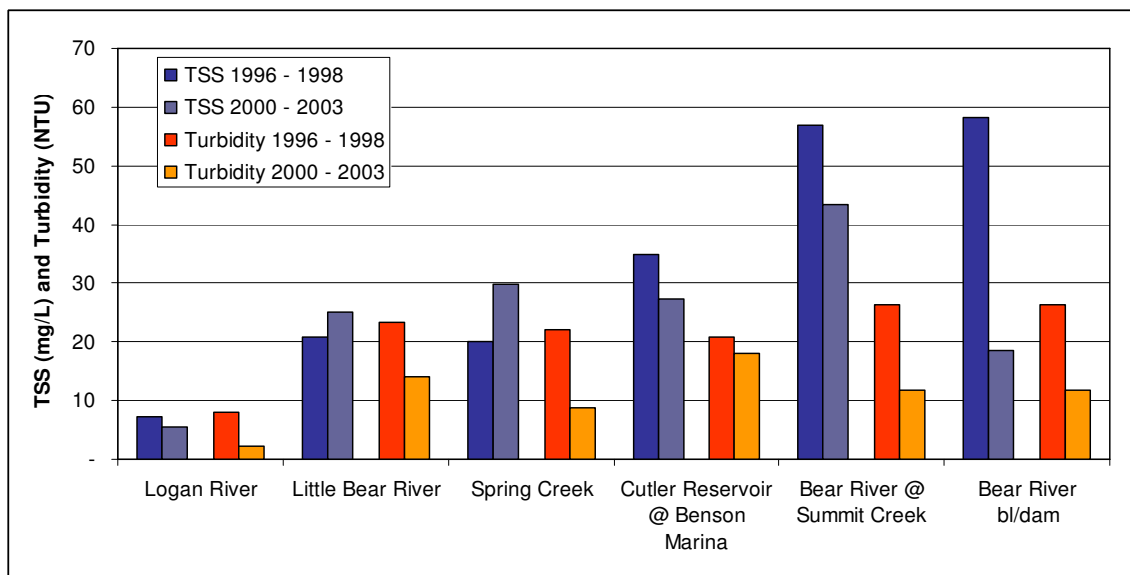
**Figure 11. Change in turbidity in the Cutler Reservoir system between first monitoring period (1996–1998) and second monitoring period (2000–2003)**

Sampling for turbidity and TSS occurred at the six monitoring sites during both monitoring periods. The data illustrate that the turbidity and TSS values are generally low for the watershed. A comparison of the data collected during the two monitoring periods indicates that turbidity decreased at all sites during the 2000–2003 period. Total suspended solids were also lower during this period in the Bear River (above and below the reservoir), in the Logan River, and in Cutler Reservoir itself. These findings are likely related to reduced runoff, and therefore erosion, in the basin during low water years. The increase in TSS in Spring Creek is likely related to the relatively constant industrial discharges in that subwatershed causing reduced flow for dilution. There is no obvious explanation for the slight increase in total suspended solids in the Little Bear River in 2000–2003, however this difference is small enough that it could represent variability and uncertainty in sampling (Figure 11).

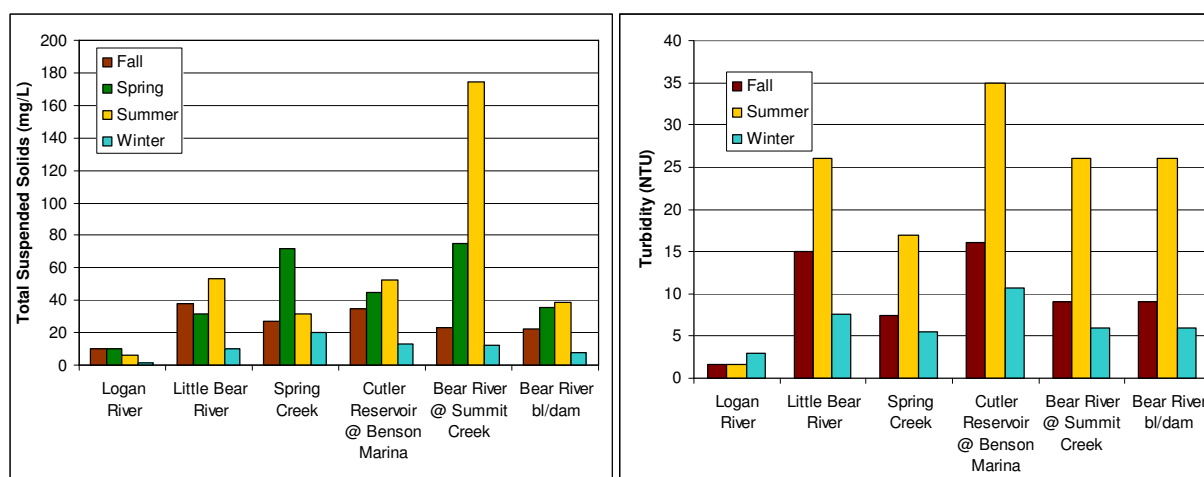
**Figure 12. Average sediment concentration (TSS) and turbidity for sampling sites by season during the 2000–2003 monitoring period**

As with nutrients, sediment concentrations and turbidity do not vary significantly across seasons in the Logan River, whereas seasonal trends are apparent for most of the other sites in the Cutler Reservoir system (Figure 12). In particular, the Bear River above the reservoir exhibits significantly higher levels of turbidity and sediment during the summer season than during all other seasons. This is likely related to erosion during the irrigation season and summer storm runoff. Higher levels of turbidity in Cutler Reservoir, Spring Creek, and the Bear River below Cutler Dam, in the summer season, are not paired with higher levels of sediment (TSS). This suggests that turbidity spikes in the summer season are related to growth of suspended algae rather than increased sediment loads during this period. Unfortunately, no turbidity data were collected during the spring season between 2000 and 2003.

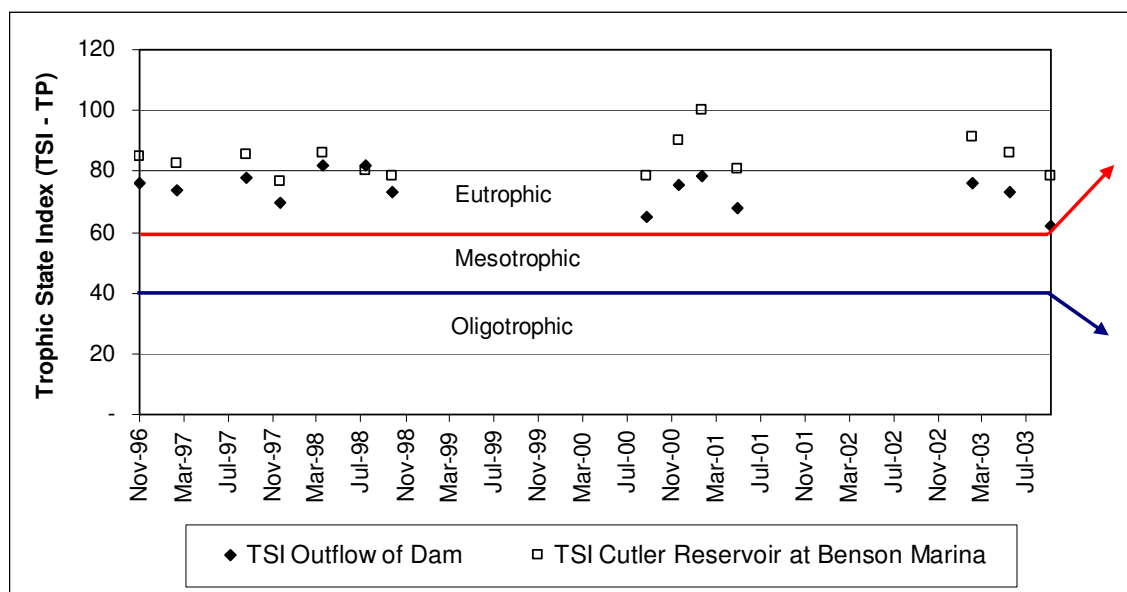
**Figure 13. Trophic state index (TSI) predicted based on total phosphorus concentrations in Cutler Reservoir.**

The trophic scale illustrates these general classifications, as well as the midrange conditions that occur between each major category. However, each water body is unique and will exhibit site-specific characteristics based on the water quality conditions identified within the lake or reservoir and over specific time periods, seasons, or water-flow conditions. The identification of TSI values for a specific water body allows a general classification and provides insight into overall water quality trends and seasonality.

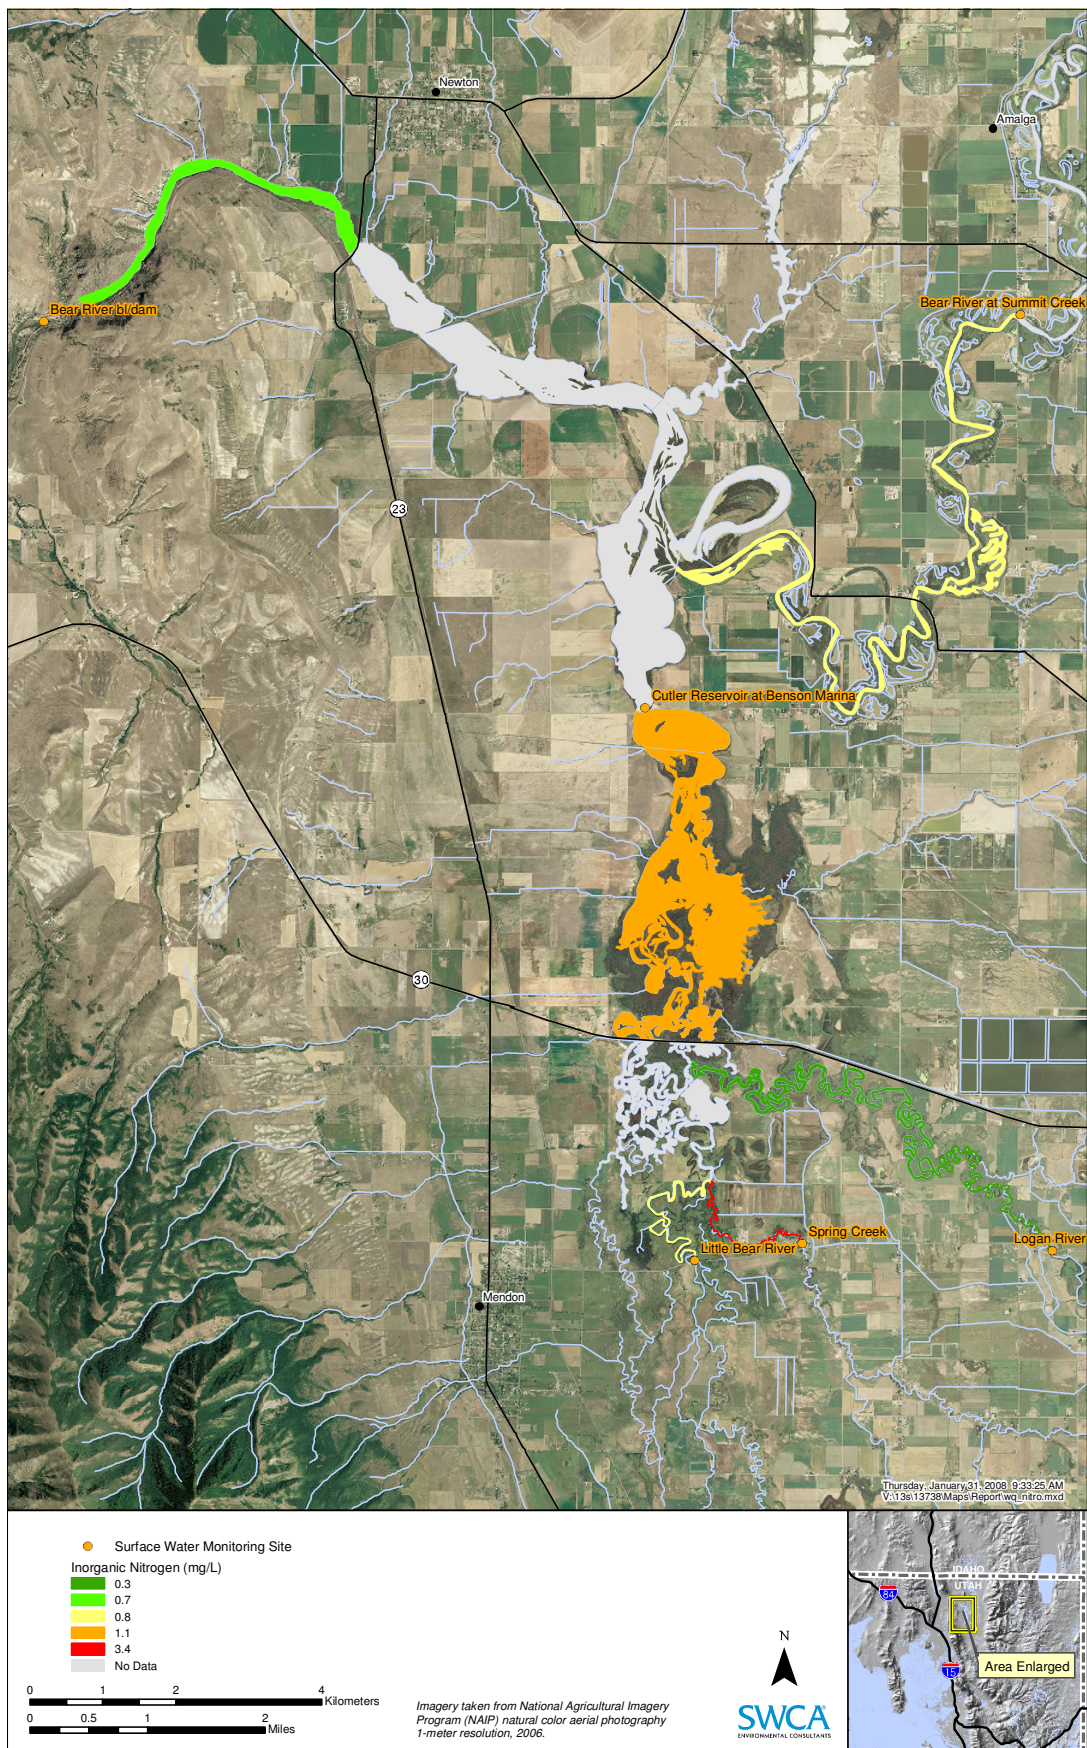
**Figure 14. Inorganic nitrogen levels in the Cutler Reservoir watershed.**

Water quality in the southern and northern sections of the reservoir remains markedly different with the south being characterized by higher nutrient concentrations (Figure 14 and Figure 15), higher turbidity (Figure 16), warmer temperatures, and lower dissolved oxygen. This is due in part to the shallow nature of the reservoir and the limited flow-through that occurs. Based on the preliminary load analysis conducted for the Cutler Reservoir TMDL, the majority of phosphorus load to the southern reservoir during the algal growth period (May – October) comes from Spring Creek (approximately 25%) and the Logan City and Service Area Wastewater Treatment Plant (approximately 30%). In addition, runoff from fields near Cutler Reservoir that are irrigated with Logan City wastewater may account for an additional 15% of the load to the southern reservoir during this season. Additional load during the winter and spring season (November – April) contribute significantly to sediment phosphorus concentrations which release phosphorus during the warmer summer season. The Spring Creek TMDL is currently being implemented and will result in substantial load reductions from the JBS Swift and Company discharge which will translate into significant load reductions from Spring Creek. The load associated with the Logan City and Service Area WWTP will be incorporated into the Cutler Reservoir TMDL currently under development. The limited flow-through is caused by the numerous constriction points and prevalent stands of emergent vegetation that occur throughout the southern section of the reservoir. Due to this slow moving water and the shallow nature of the southern reservoir (0.55 meters mean depth), reservoir sediments are likely to exert a greater influence on water quality than in the faster flowing and deeper northern reservoir (1.1 meters mean depth). Nutrient values within the southern portion of the reservoir are significantly higher with high total phosphorus levels far exceeding levels within the northern portion of the reservoir. The tributary of Spring Creek, which drains directly to the southern portion of the reservoir, contributes a very high concentration of nutrients directly to the Southern Reservoir.

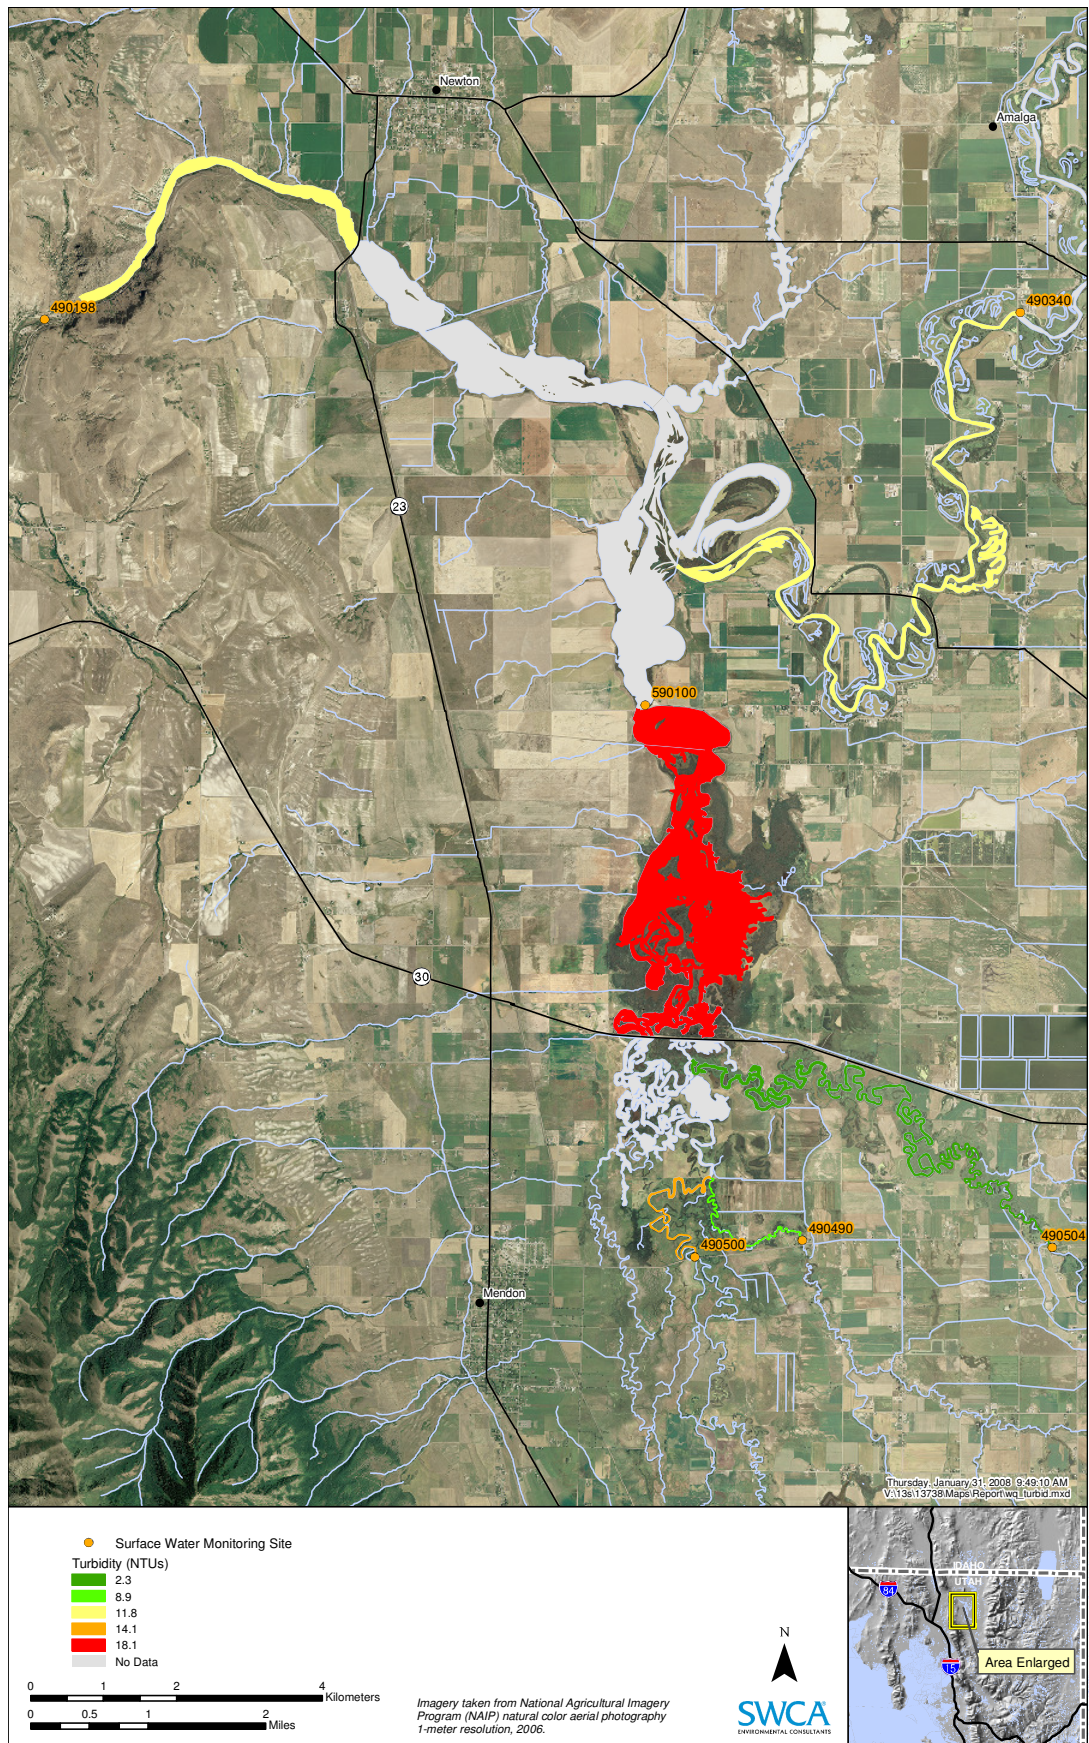
**Figure 16. Turbidity levels in the Cutler Reservoir watershed.**

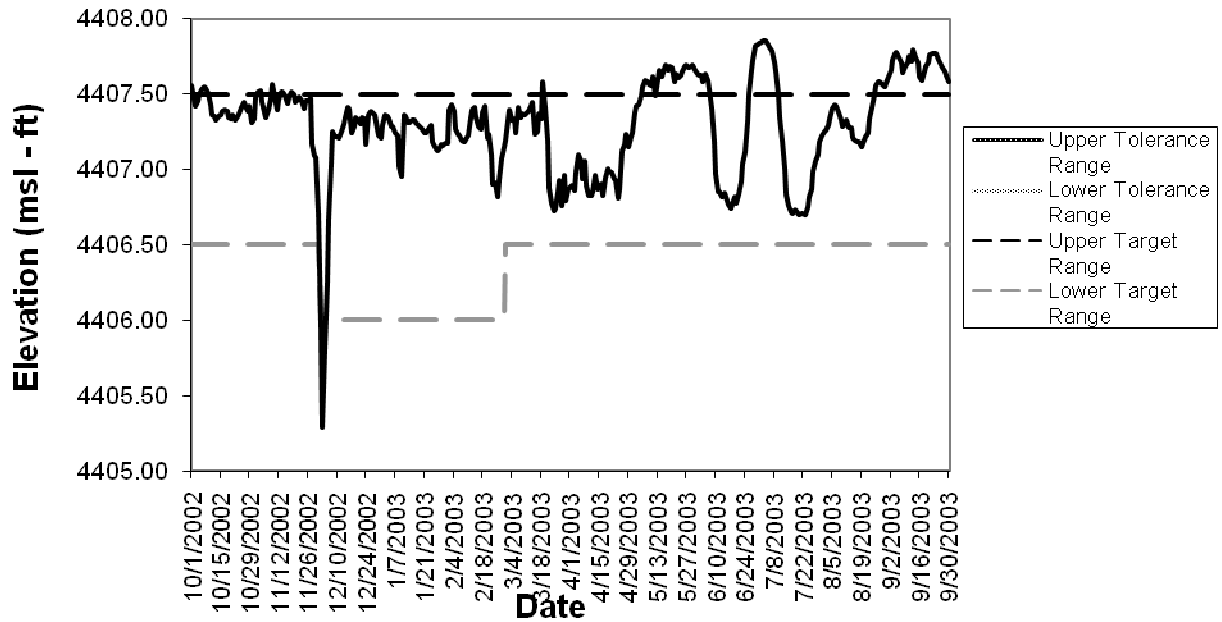
**CUTLER HYDROELECTRIC PROJECT - FERC NO. 2720**  
**Water Year 2003 - Cutler Resr. Daily Average Elevations**

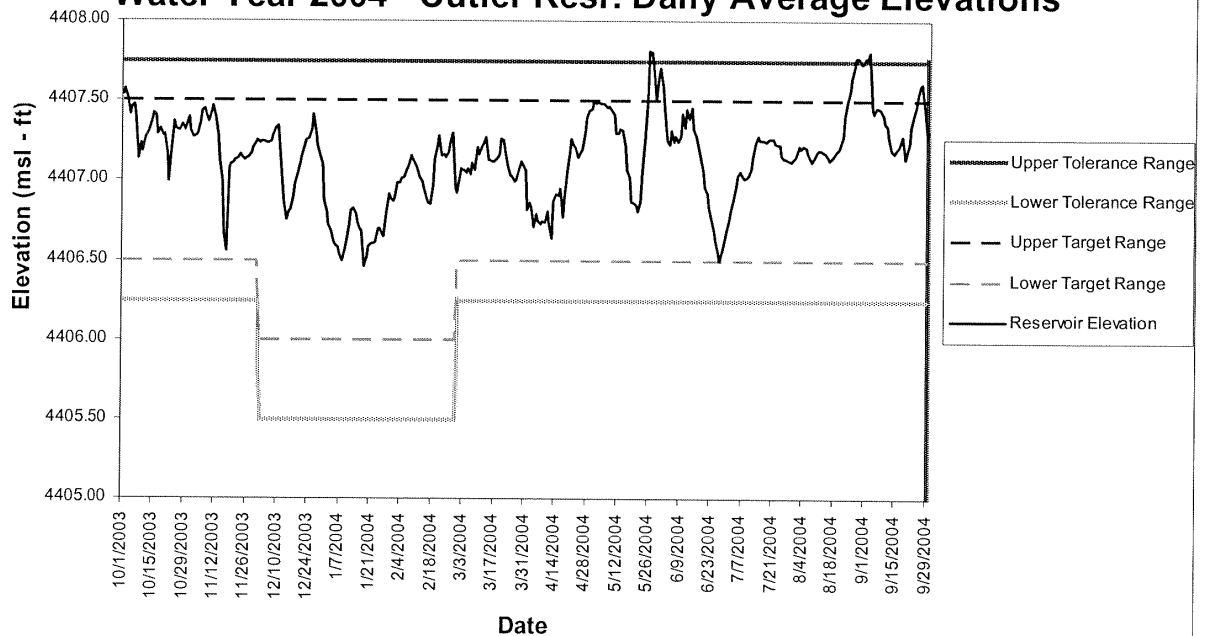
**CUTLER HYDROELECTRIC PROJECT - FERC NO. 2720**  
**Water Year 2004 - Cutler Resr. Daily Average Elevations**

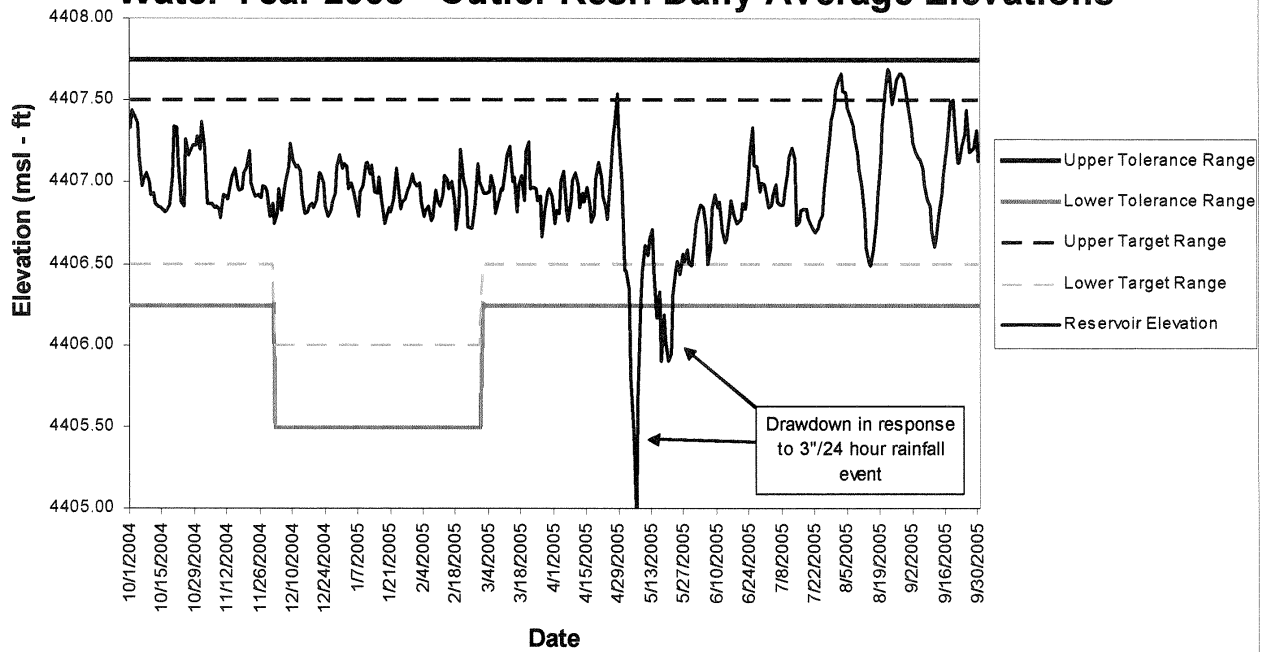
# **CUTLER HYDROELECTRIC PROJECT - FERC NO. 2420** **Water Year 2005 - Cutler Resr. Daily Average Elevations**

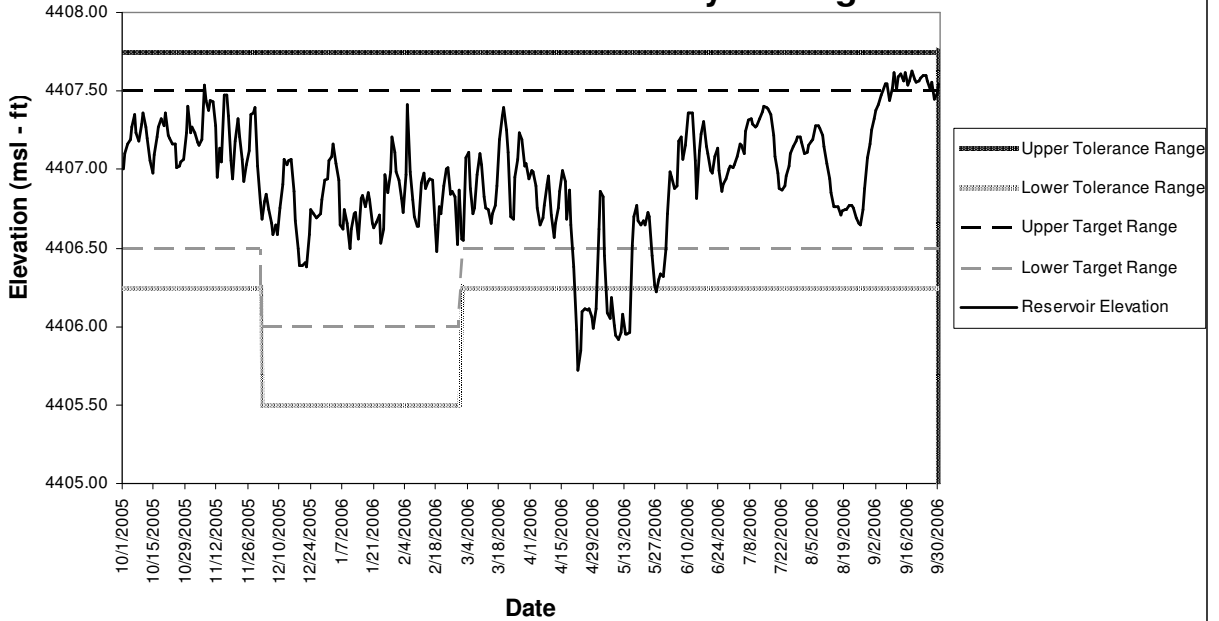
# **CUTLER HYDROELECTRIC PROJECT - FERC NO. 2420** **Water Year 2006 - Cutler Resr. Daily Average Elevations**

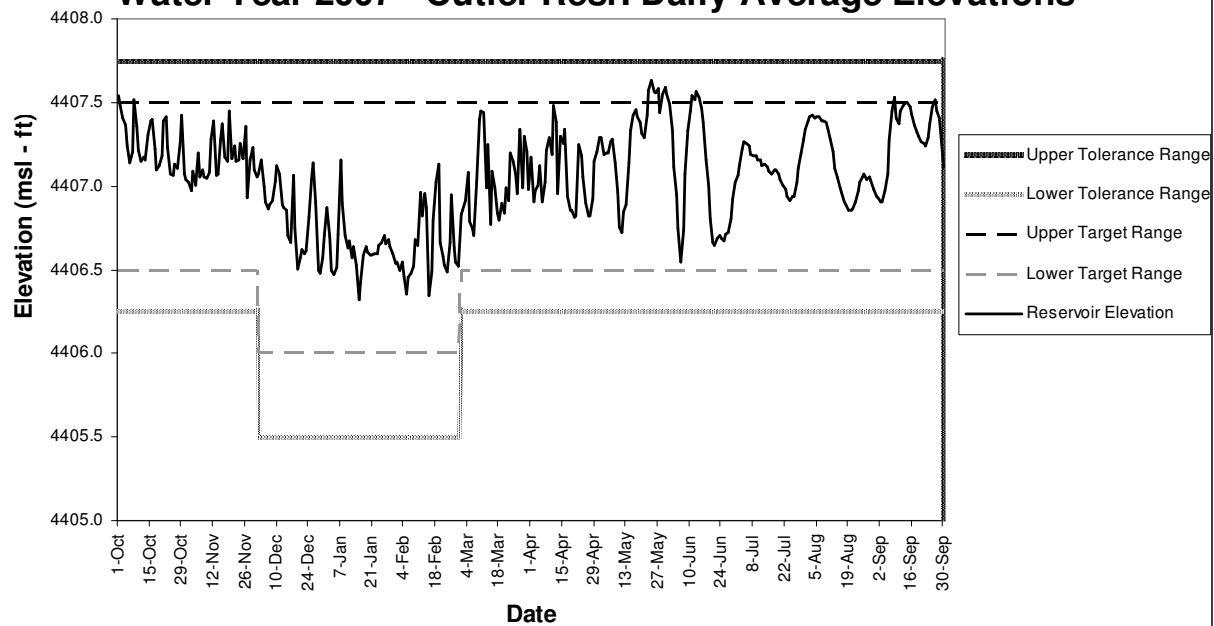
**CUTLER HYDROELECTRIC PROJECT - FERC NO. 2420**  
**Water Year 2007 - Cutler Resr. Daily Average Elevations**
