Meeting Notes Lewis River License Implementation Aquatic Coordination Committee (ACC) Meeting December 9, 2010 Ariel, WA

To:	Frank Shrier, PacifiCorp	Project:	Lewis River Acclimation Ponds
From:	Derek Nelson, PE	Cc:	Nathan Higa, Mort McMillen, File
Date:	December 8, 2010	Job No:	1039.05
Subject:	Lewis River Acclimation Pond – Crab	Creek Evalua	ation

To:	Nathan Higa PacifiCorp	Project:	Speelyai Hatchery Water Intake Design Project
From:	Derek Nelson	Cc:	Mort McMillen, McMillen LLC Chris Boyd , McMillen LLC
Date:	December 8, 2010	Job No:	Contract No. 3000067697
Subject:	Speelyai Intake Assessment

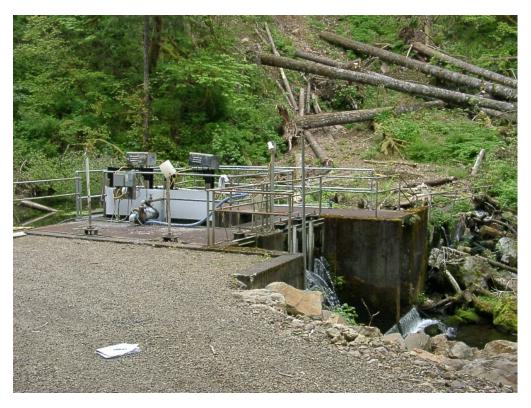
Photograph 1. Downstream View of the Intake

Speelyai Creek is divided into two reaches, Upper and Lower. Lower Speelyai Creek is fed from the local watershed and flows to Speelyai Bay where a small concrete intake and sheet pile dam is located that supplies water to the hatchery. The intake consists of a concrete structure with trash rack, a sluice channel, and a flashboard controlled overflow section. Flow is conveyed from the intake to the hatchery ponds by a pair of steel pipelines, one 20 inch and one 30 inch, each approximately 860 feet long.

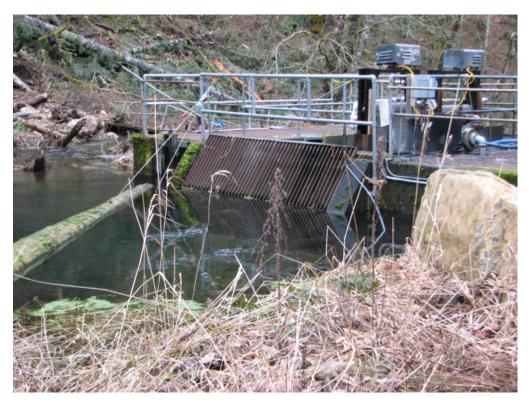
Photograph 2. Upstream View of the Intake

In 2008, a landslide damaged the sheet pile dam and walkway across Speelyai Creek. The slide occurred on the steep slope south of the intake structure and dam. The slide filled the forebay with soil, rock and debris. The slide restricted creek flow causing the creek to discharge on the north side of the intake structure. Speelyai Creek eroded several feet of backfill, exposing the water supply pipes. The backfill was replaced with a mixture of rip rap and soil.
