**Weber Hydroelectric Project  
FERC Project No. 1744**

**Revised Draft Study Plan  
Water Resources Quality**

**March 2016**

PacifiCorp

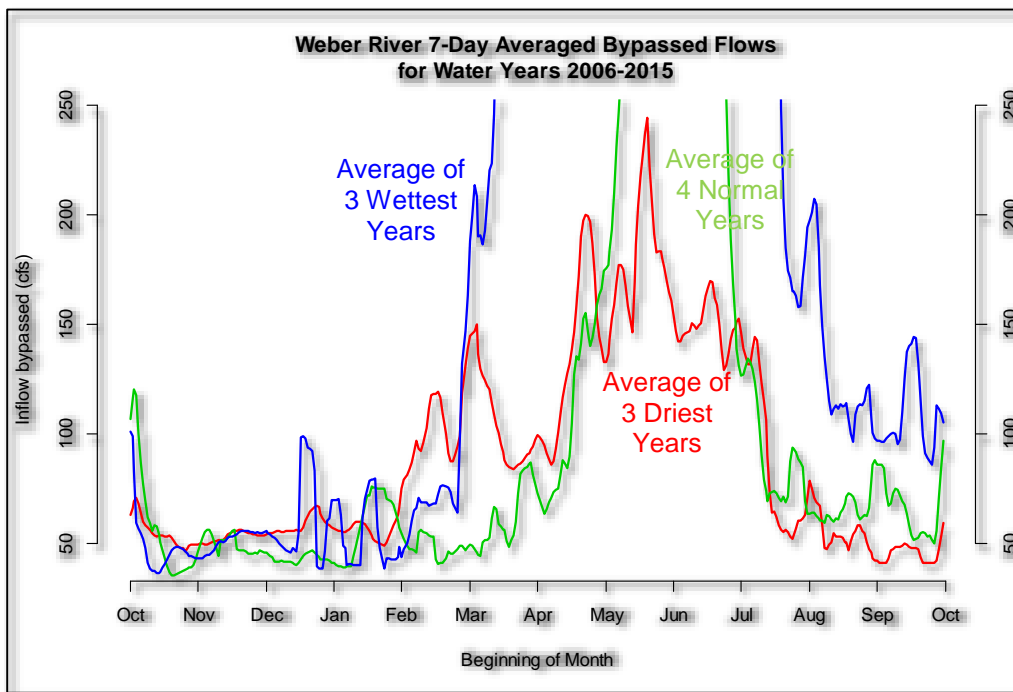
Figure 11. Daily bypass flows (7-day rolling-average) summarized by tercile. The highest flows are truncated to allow detail at lower flows. Detail for these periods is available in Figure 12.
