UTAH POWER AND LIGHT COMPANY
GRACE DAM RECONSTRUCTION 1949-1950
CONSTRUCTION PHOTOGRAPHS

UTAH POWER & LIGHT COMPANY
GRACE HYDRO-ELECTRIC STATION
1950 ROCK FILLED CRIB DAM

CROSSOVER CONNECTION

FLOWLINES THREE TO ONE.

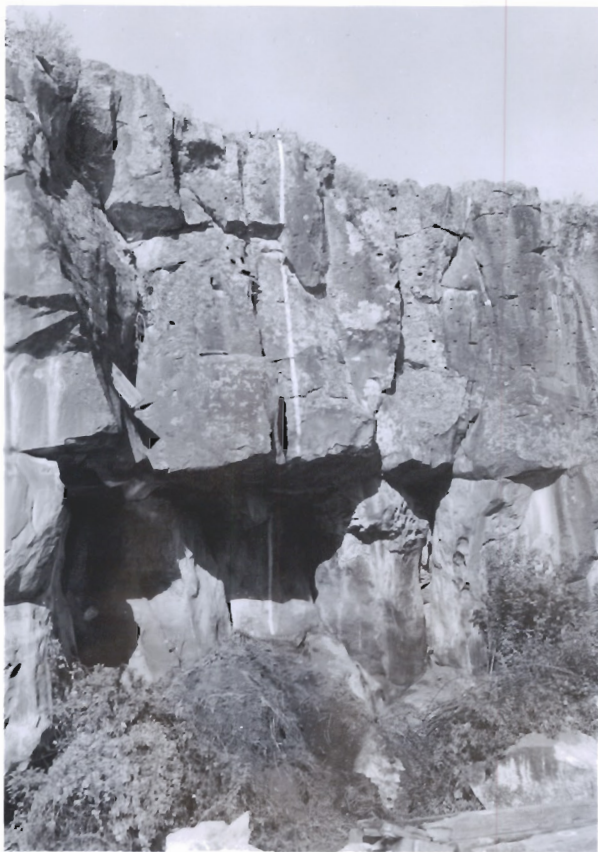
#1

Shows nature of formation at
contact with west cliff.
White line indicates original
position of upstream face of
dam - later moved downstream
10 ft. to avoid endangering
old ice chute crib supports
during construction.

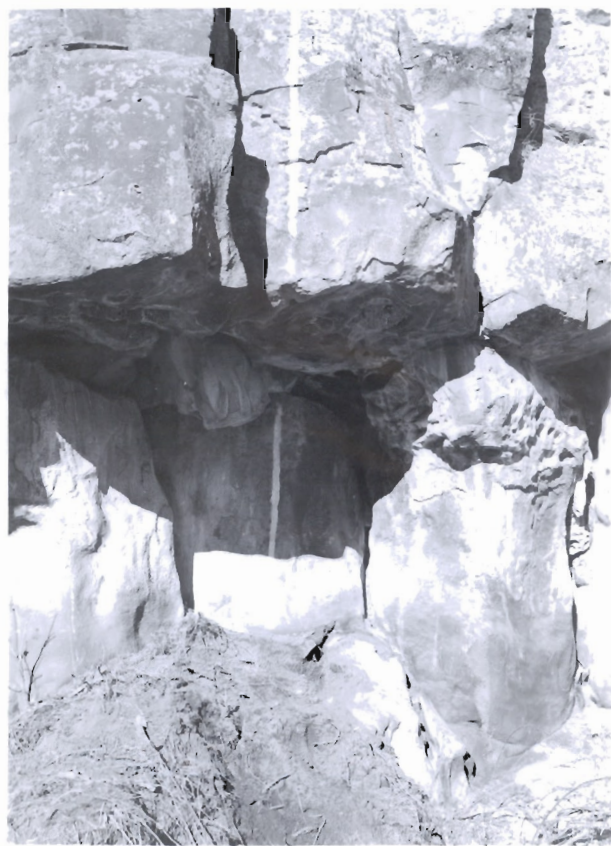
#2

Closeup of west abutment.
White line is upstream face

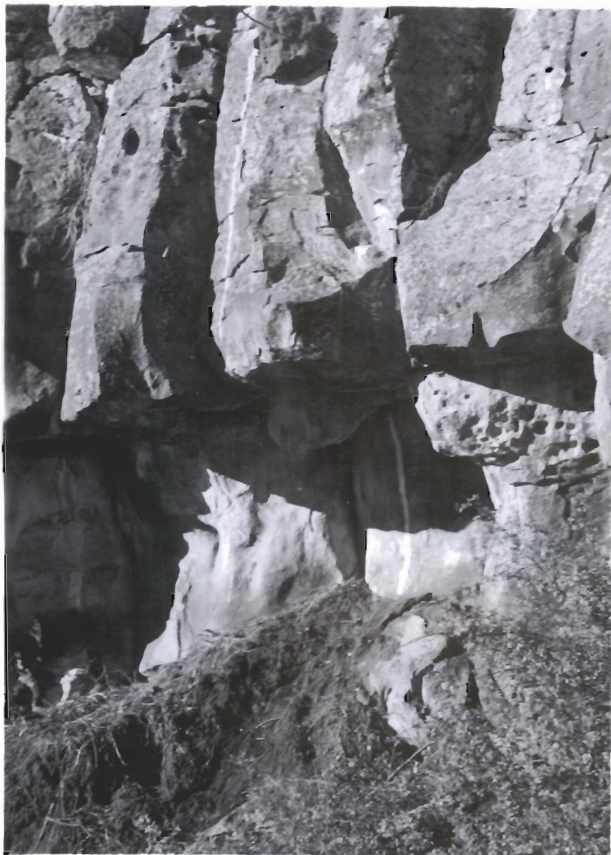
#3

Shows nature of formation at
contact with west cliff.
White line indicates original
position of upstream face of
dam- later moved downstream
10+ ft. to avoid endangering
old ice chute crib supports
during construction.

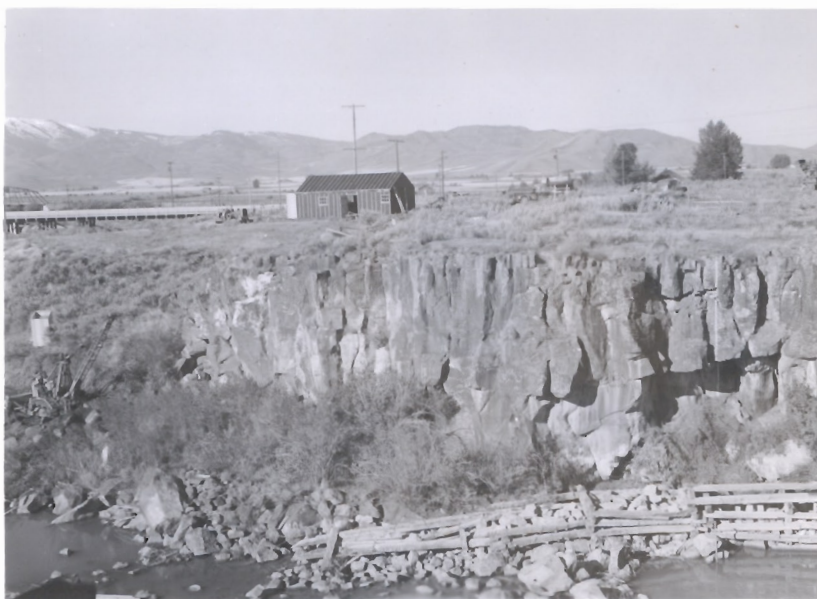
#4

General view of west abutment area.
White line indicates originally intended
upstream face.
Utah Construction Co. compressor house
and tool shed in upper center.

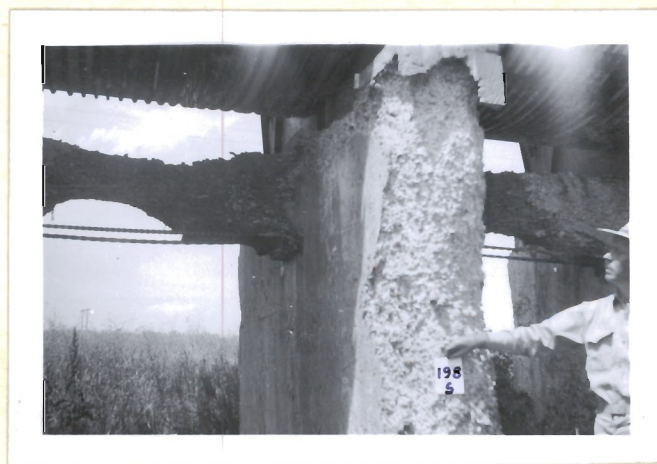
5

Condition of old saddle bases in sections rebuilt with steel saddles in 1937 and 1939. Note exposed reinforcing of tie-beams between bases. Base 198 south.

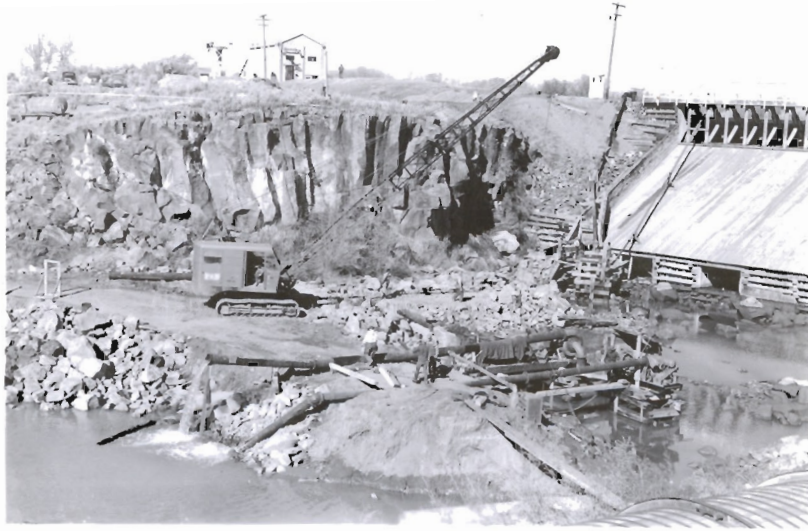
10-31-49 Shows progress to date. 6" and 10" #11
high head pumps are on crib below old dam apron
and discharge over dam into reservoir.

Two unwatering pumps in lower right. Man
in white shirt on coffer dam is by discharge pipe
of 14" pump. Note small discharge. On following
date 11-1-49 one man was kept busy pouring oil into
hot bearing and water over hot bearing housing on
this pump and one other was busy applying belt dress-
ing to belt. Bottom of sump for these two pumps too
high to permit unwatering of construction area.

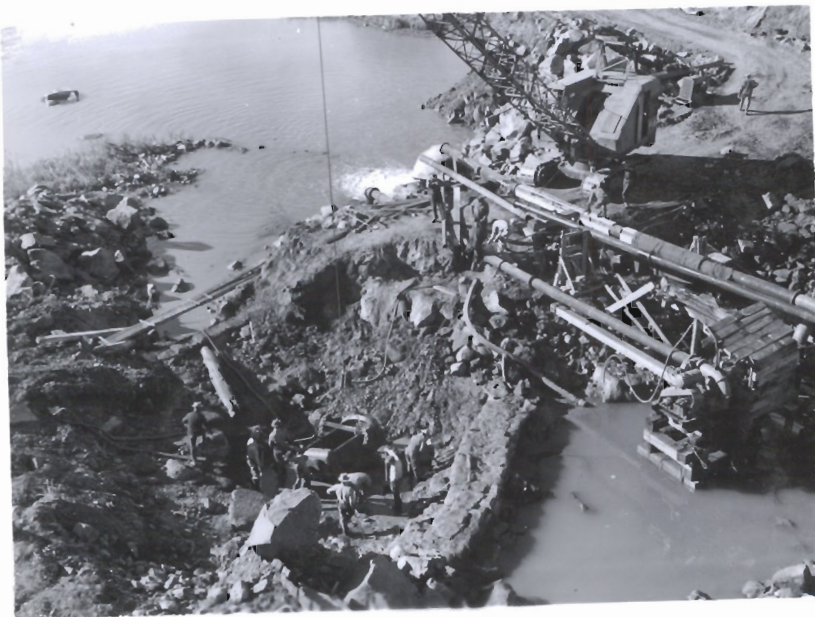
12
Excavating sump to depth to permit unwater-
ing of construction area. Sump where
pumps now located too high.

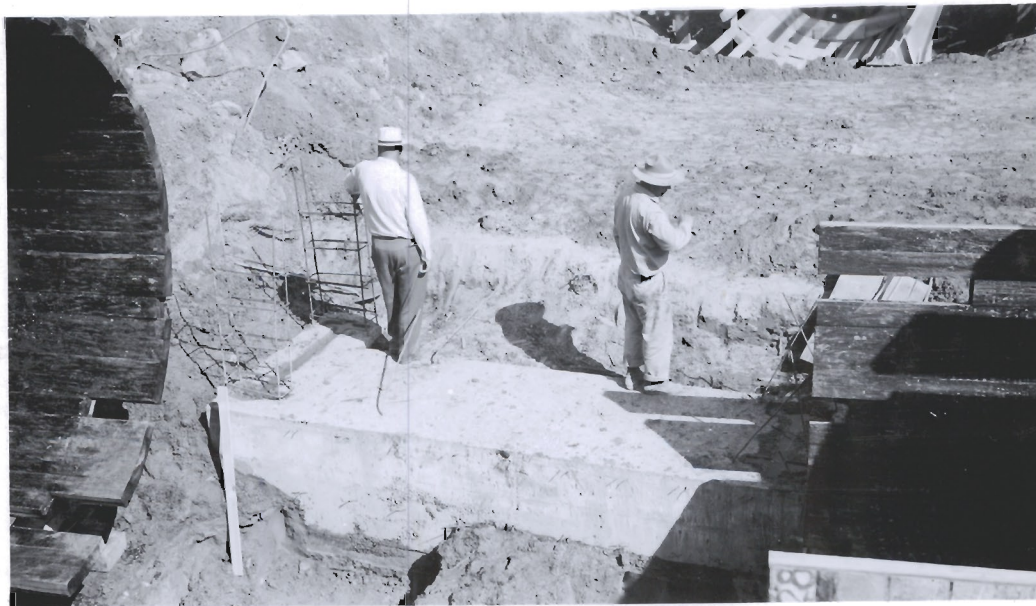
17

Looking from Flowline 2 through cut in Flowline 3 at footing for butterfly pedestals. North end of wood stave construction in right background.

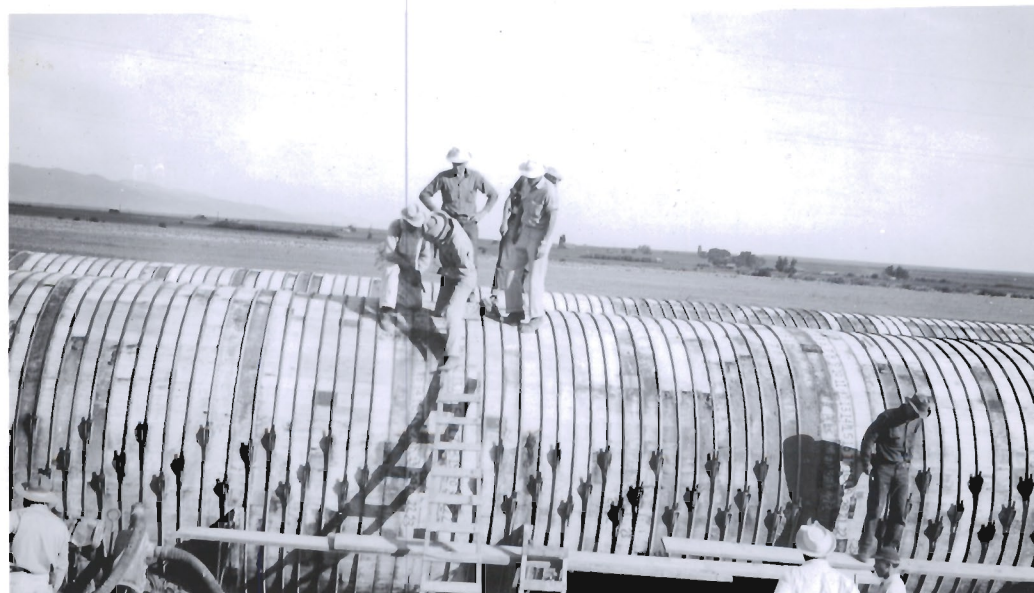
18

Starting cut in Flowline 3 for insertion of steel tee.

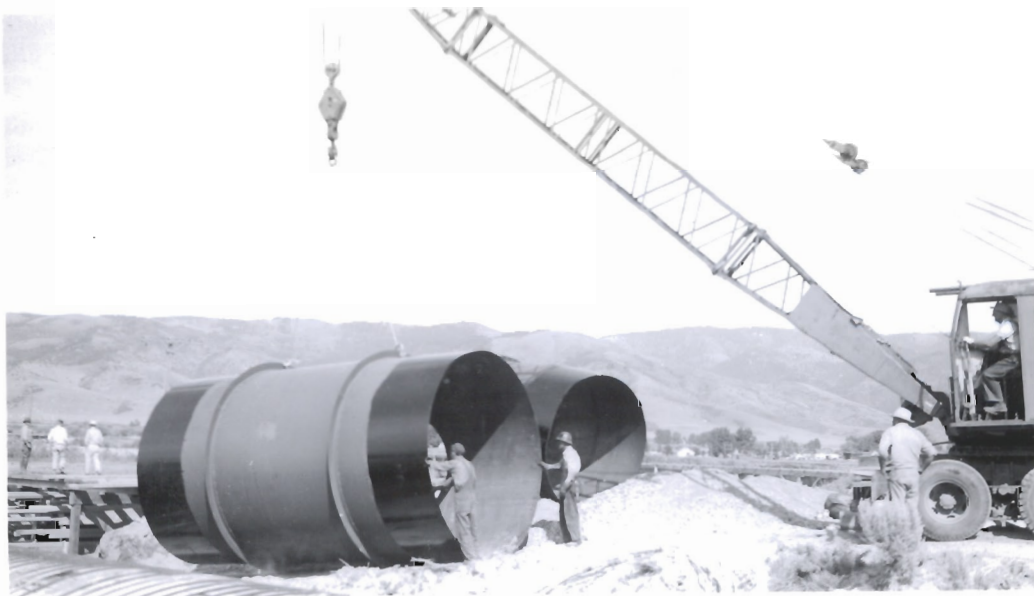
20

Moving steel tee down grade to be in position for installation. Transition section behind tee on gravel pile.

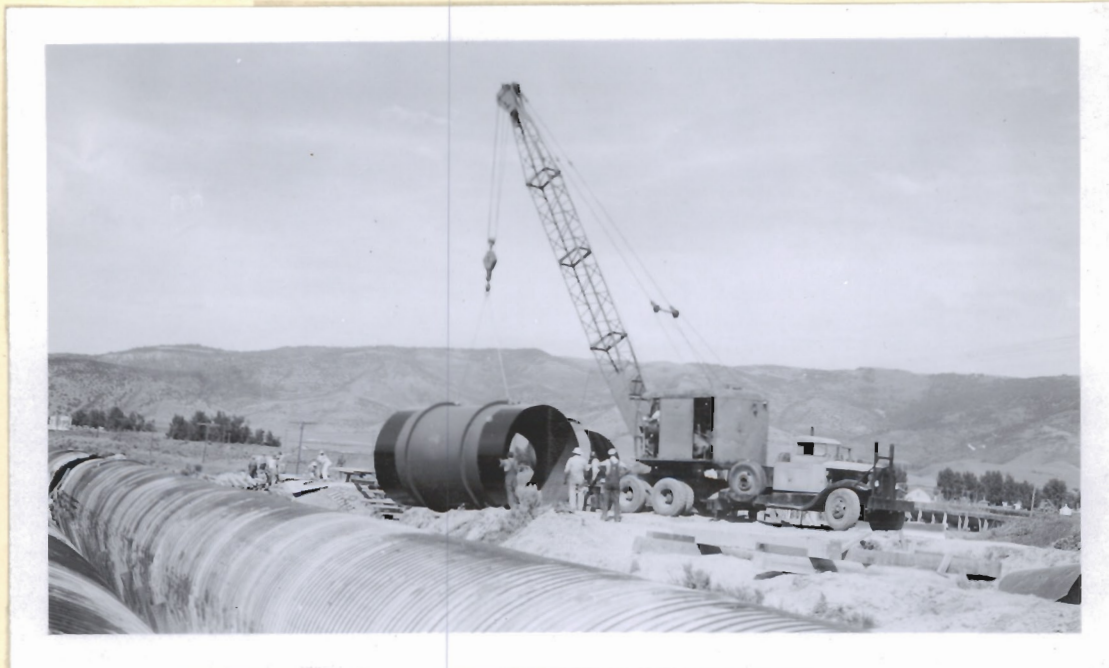
21

Moving steel tee toward final position in Flowline 3.
Transition section behind tee.

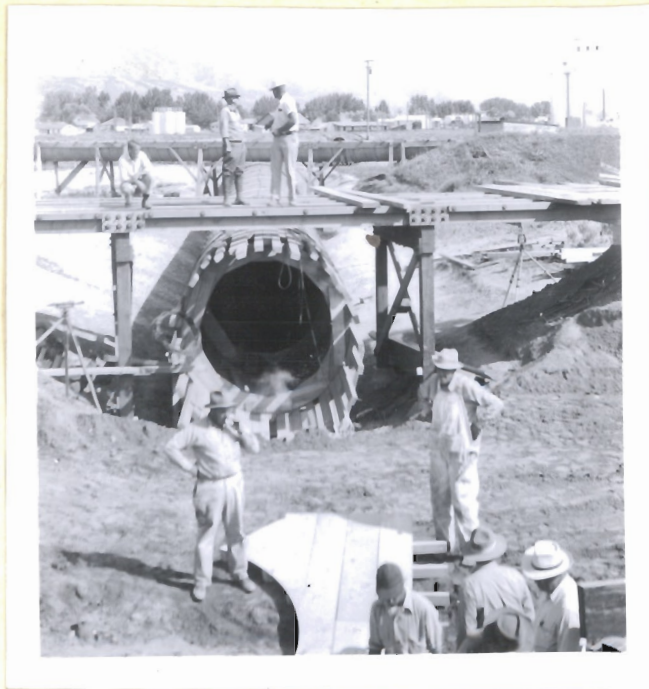
23

Looking southerly from Flowline 2 toward unfinished end of new 8' 6" wood stave pipe, wagon bridge and irrigation flume crossing. One side of form for tee anchor block in center foreground.

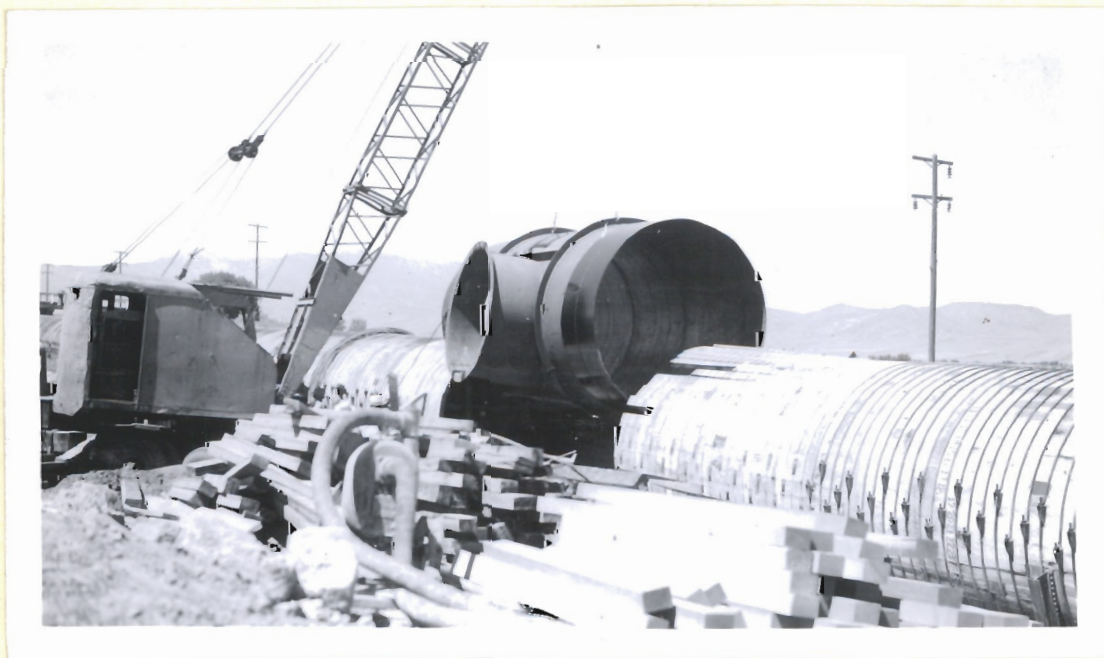
24

Placing tee in flowline 3.

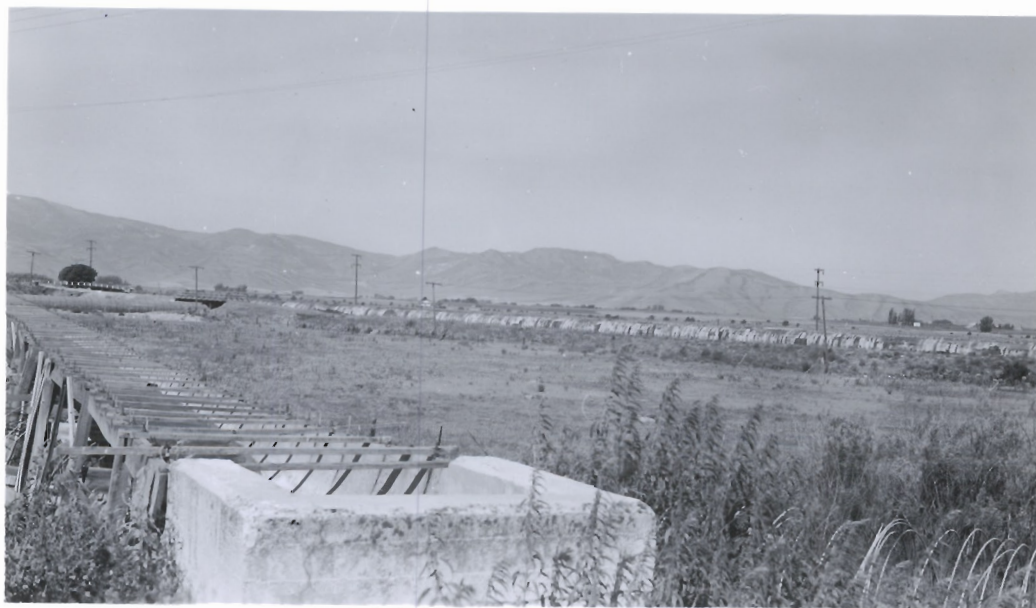
29

View from railroad track east of crossover. Irrigation flume on left. Flowline #3 on right. Bands of collapsed wood section of Flowline 1 in right foreground. Crossover takeout from Flowline #3 in left background.

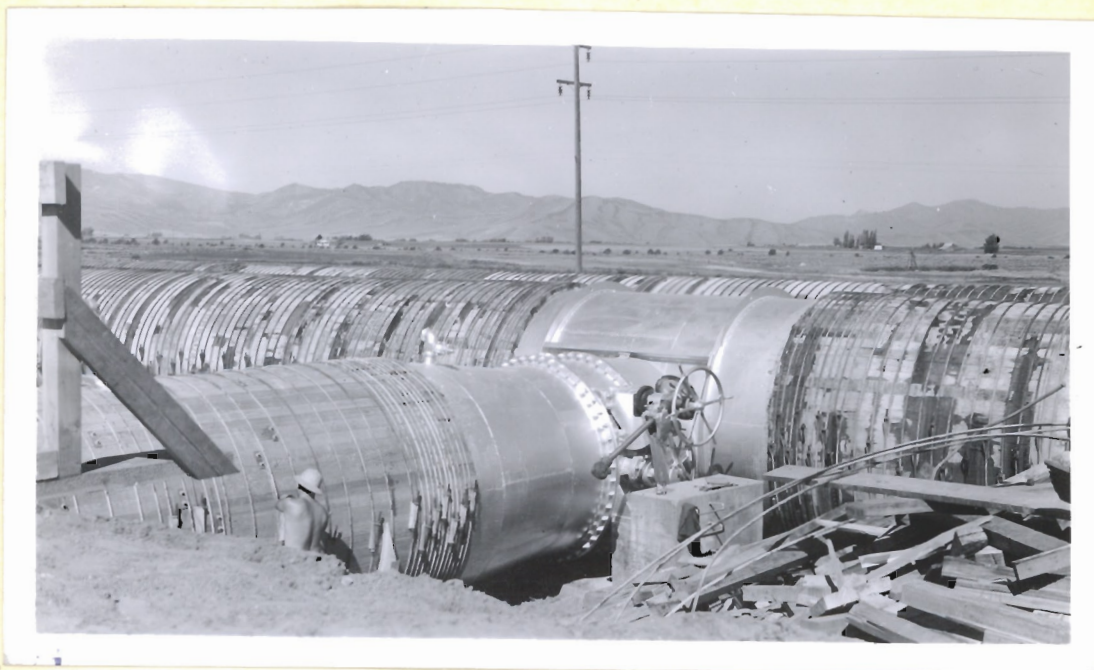
31

Tee, valve and transition section at takeoff from
Flowline #3.

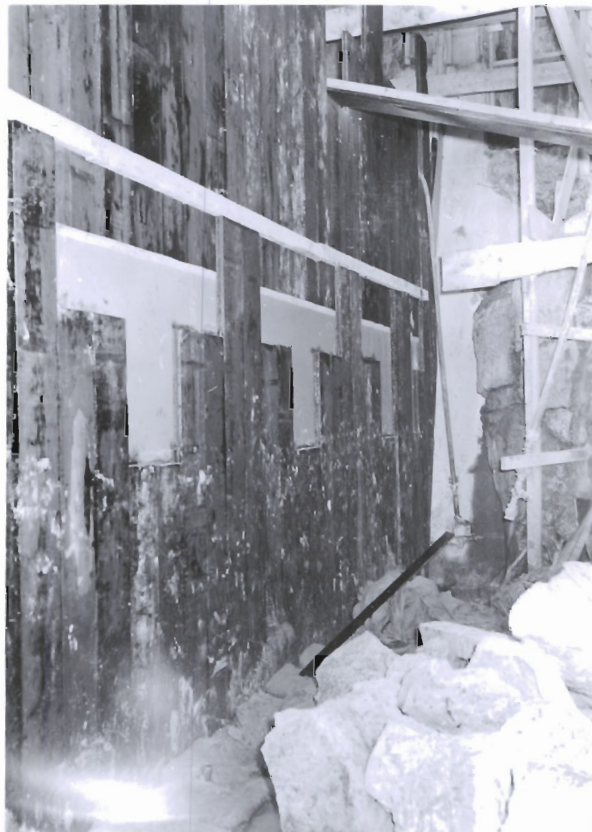
#39

Upstream double sheathing facing
at west abutment.

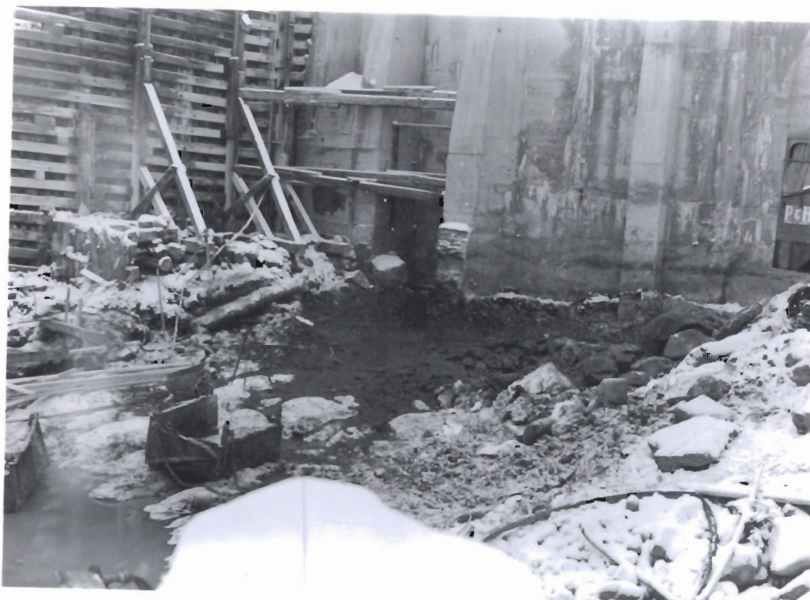
#40

Excavation at east side under old ice chute crib bracing. Note stulls from crib to buttress No. 3 intake structure replacing diagonal bracing removed.

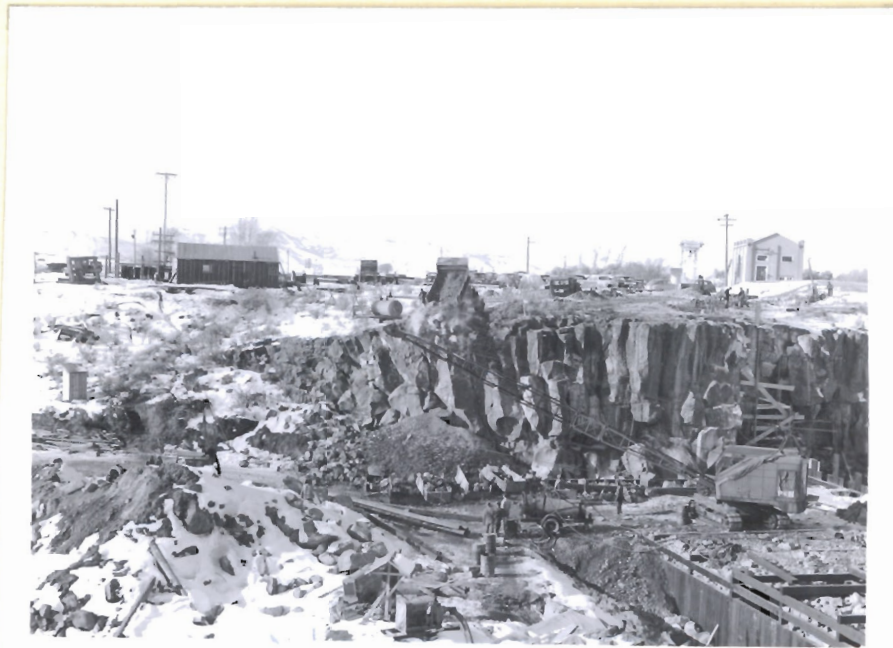
#44

Shows method of handling rock for fill. Dumped from trucks over cliff to storage pile, hand loaded into skips and placed in cribs by crane.

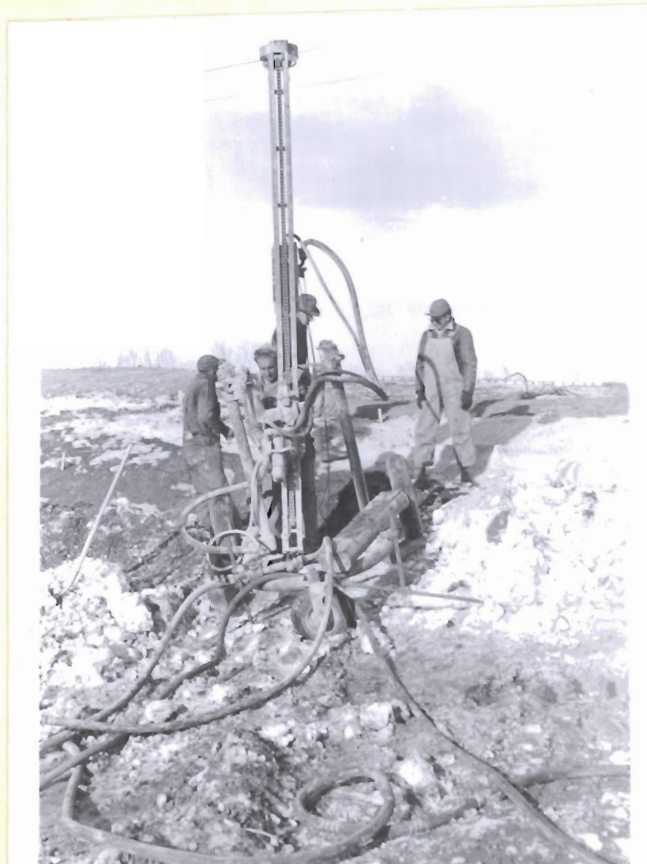
#45

Shows wagon drill in use drilling grout holes on west dike line.

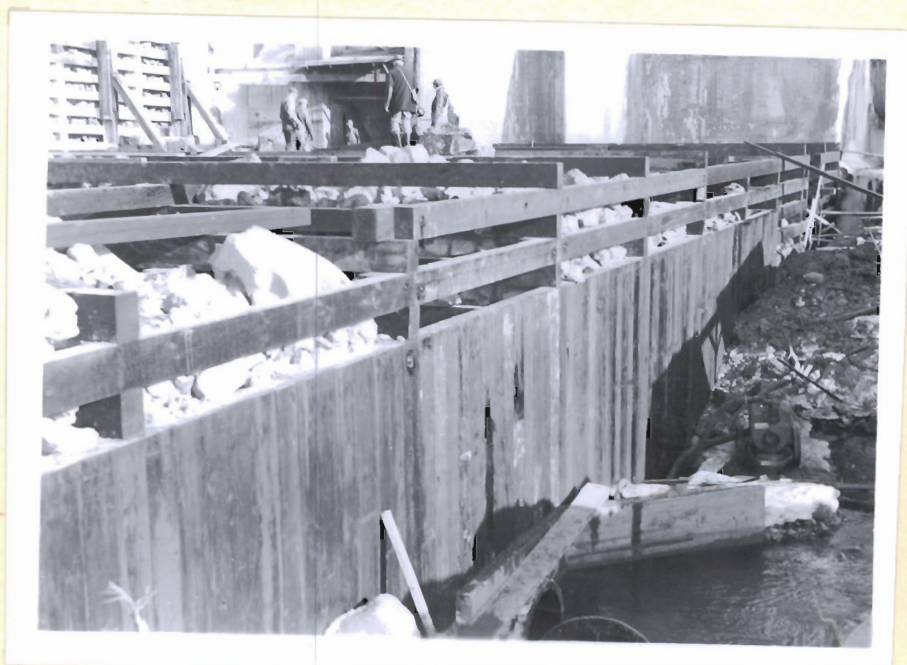
#47

Shows downstream facing.
View easterly.

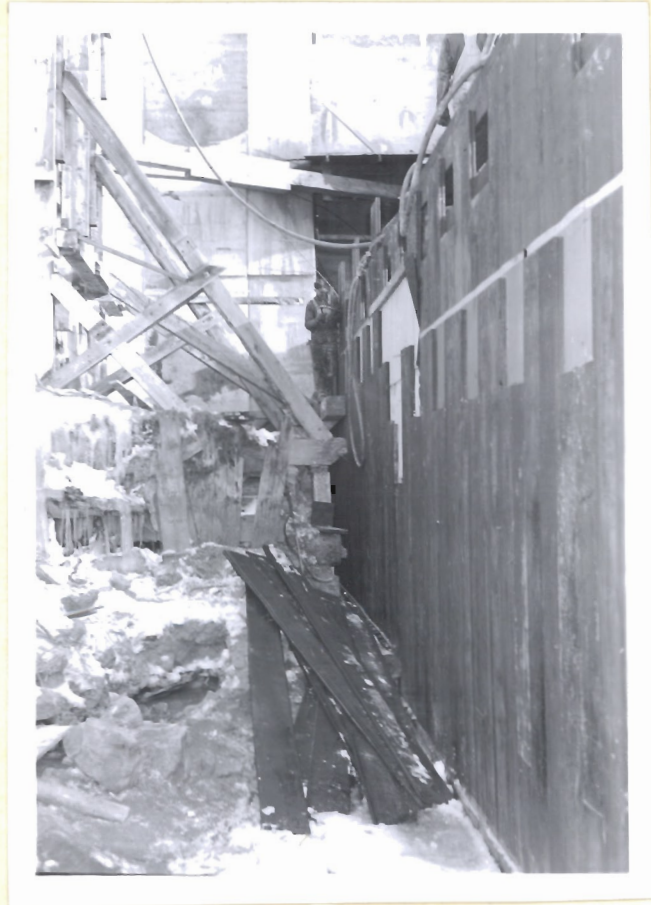
#48

Shows bracing of old cribwork to
new dam face.

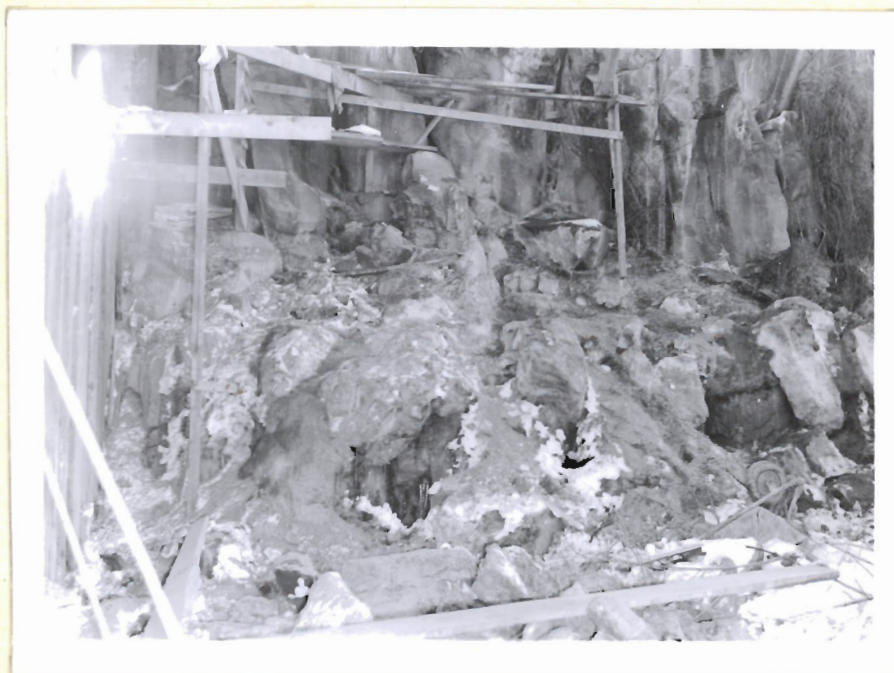
#49

Shows nature of formation uncovered
upstream at base of west cliff.

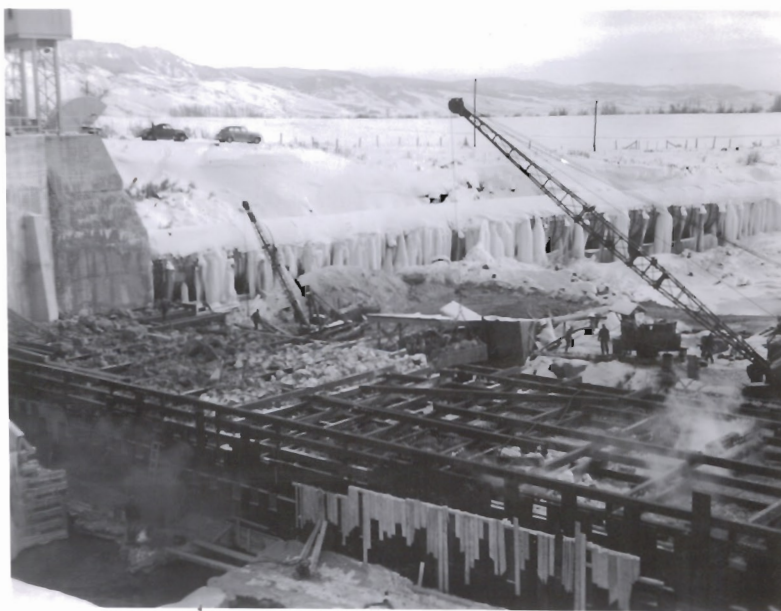
#52

View downstream shows rock filling in progress.

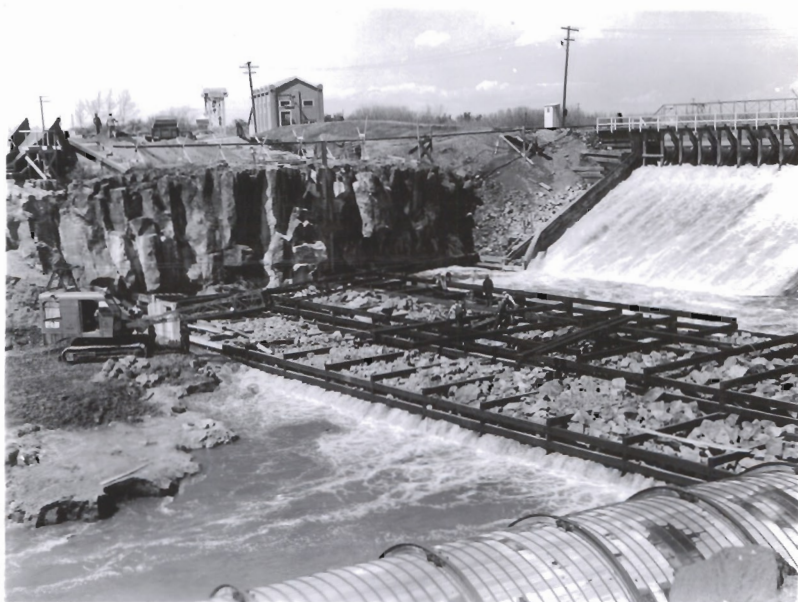
#53

630 cfs spill water passing through new construction. Spring runoff handled through new dam without interrupting crib erection or filling.

Top upstream timber at approx. elev. 1019; water elev. at face of new structure approx. 1016. Water spilling at lower face at approx. elev. 1010.

Grizzly for cleaning rock being installed on top of cliff at extreme upper left.

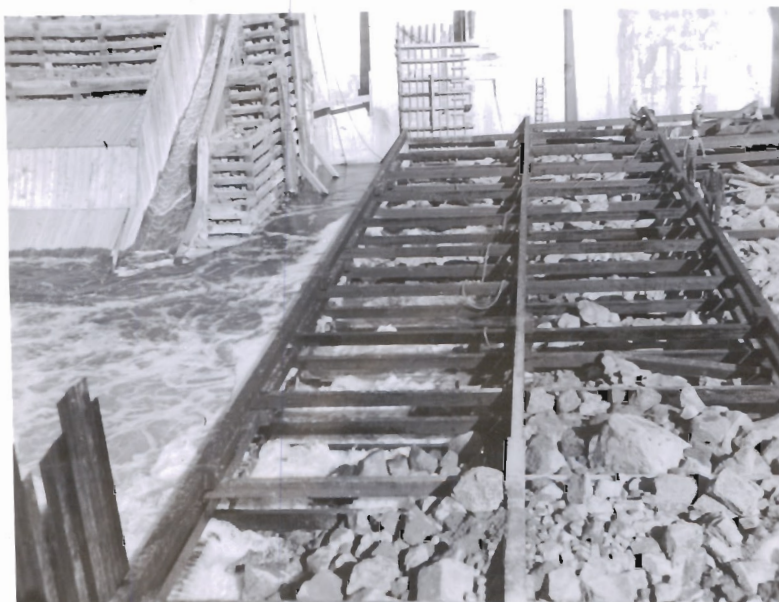
#55

Looking easterly along dam construction now at approx. elev. 1021. Water on upstream side at approx. elev. 1016. Approximately 900 cfs passing through cribs

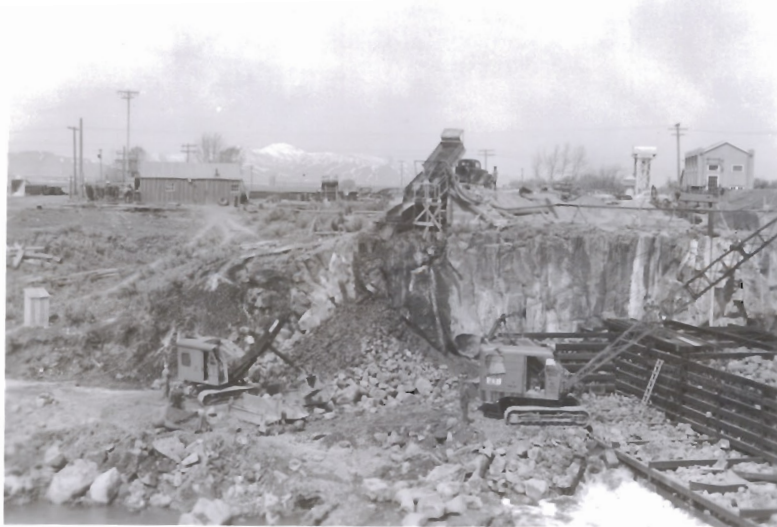
#56

Shows rock handling facilities with vibrating grizzly set up on west cliff. Small northwest shovel filling skips which in turn were picked up and dumped into cribs with the larger P&H Crane.

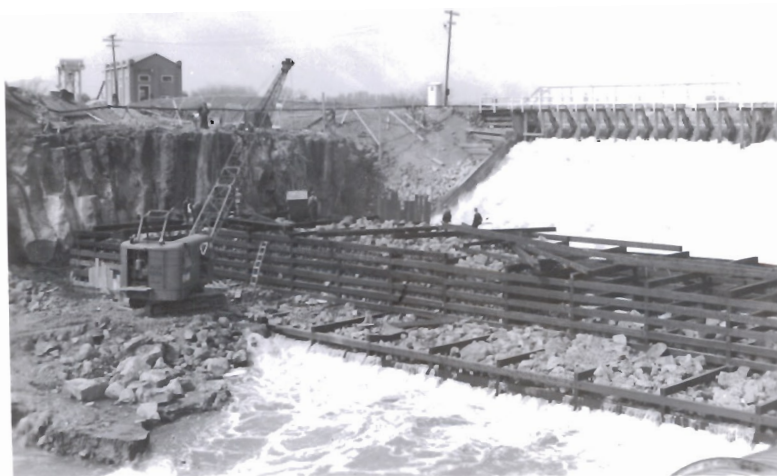
56-A

Top timbers in cribbing are at elev. 1025.78-
top of second lift.
Passing approximately 900 cfs through new structure.
View northwesterly.

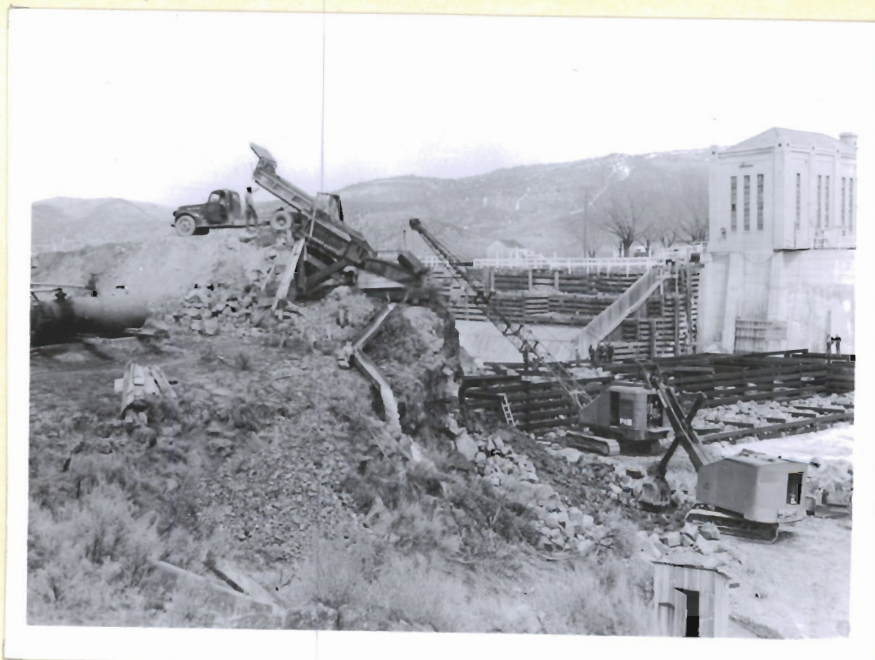
#56-B

Dumping rock, hauled from spoil banks
along flowline, over cliff where it can be
used for filling cribs.

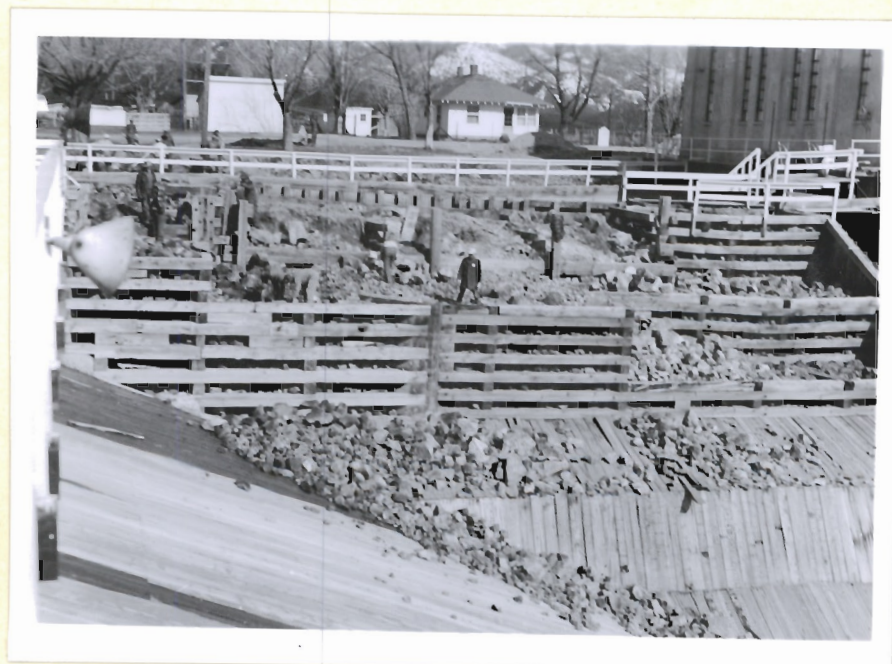
#57

Removing old dam structure cribs west of
Intake No. 3 Flume down to Elev. 1038.
View easterly.

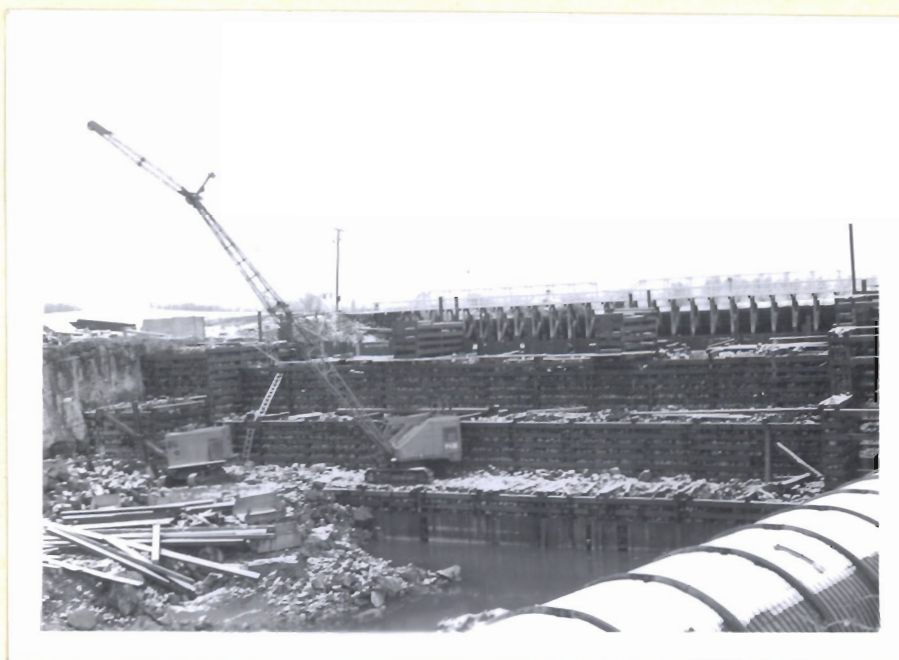
#57-A

Marion shovel loading skips and P&H sitting on top of lower step, approx. elev. 1014, lifting and dumping skips into higher cribs.

Light snow covering, about 3" on level.

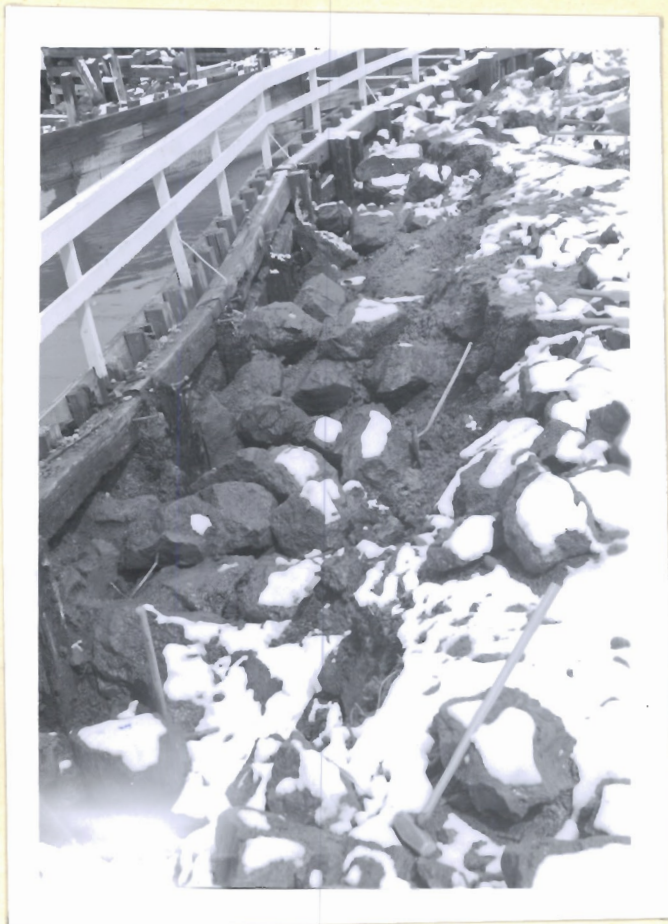
#59

Looking northerly along
east side of Intake No. 3
Flume.
Rock rip-rap place east
of flume.

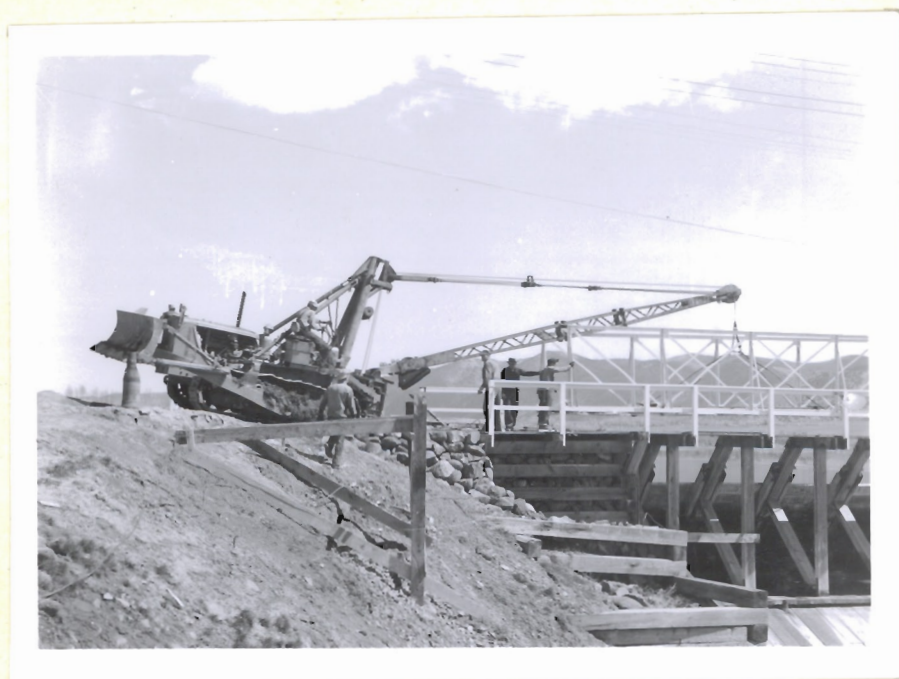
#62

Shows dozer with beam removing section of structural steel foot bridge from old dam.

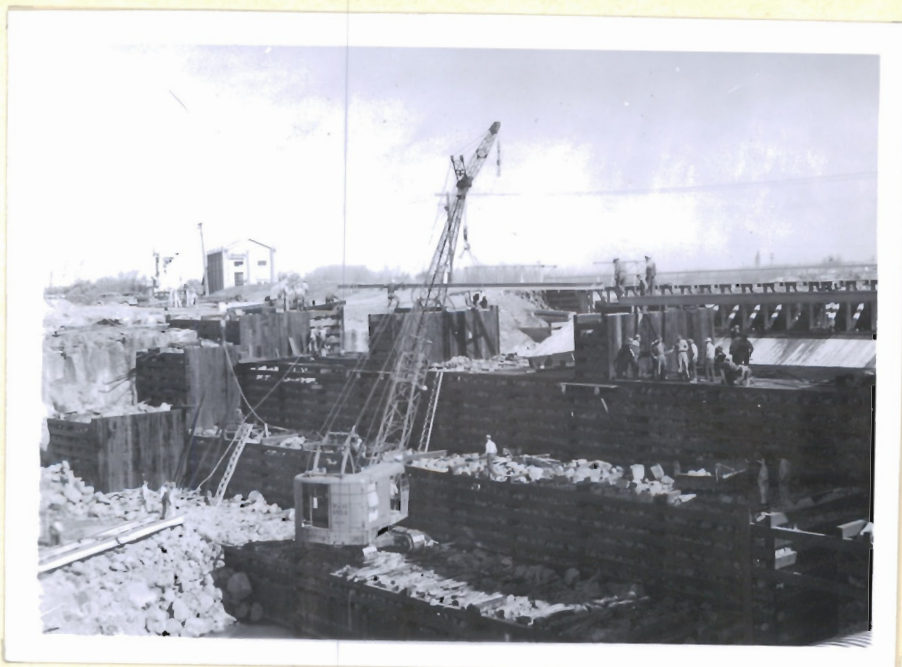
#63

P&H crane erecting structural steel foot
bridge on new dam. Eastern span beams in
place.

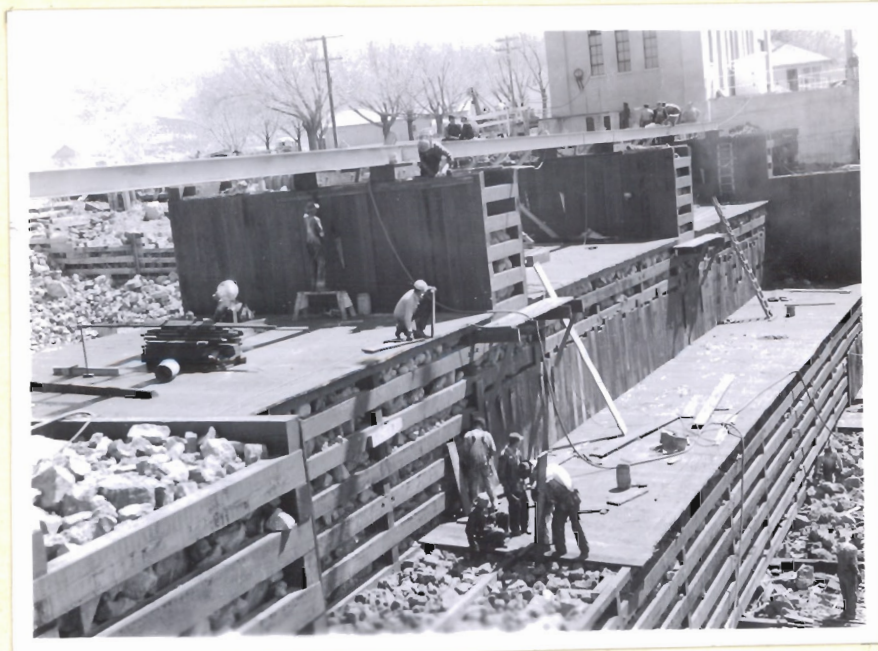
#65

Placing downstream sheathing and decking.
View northeasterly.

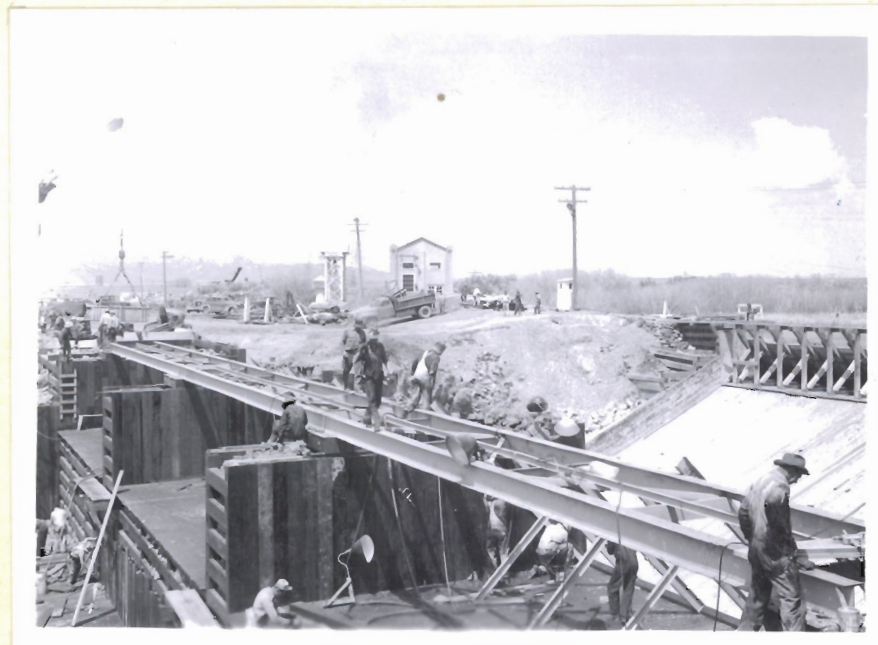
#66

Flashboard steel supports can be seen in
nearest spill section,- right foreground.
View northwesterly.

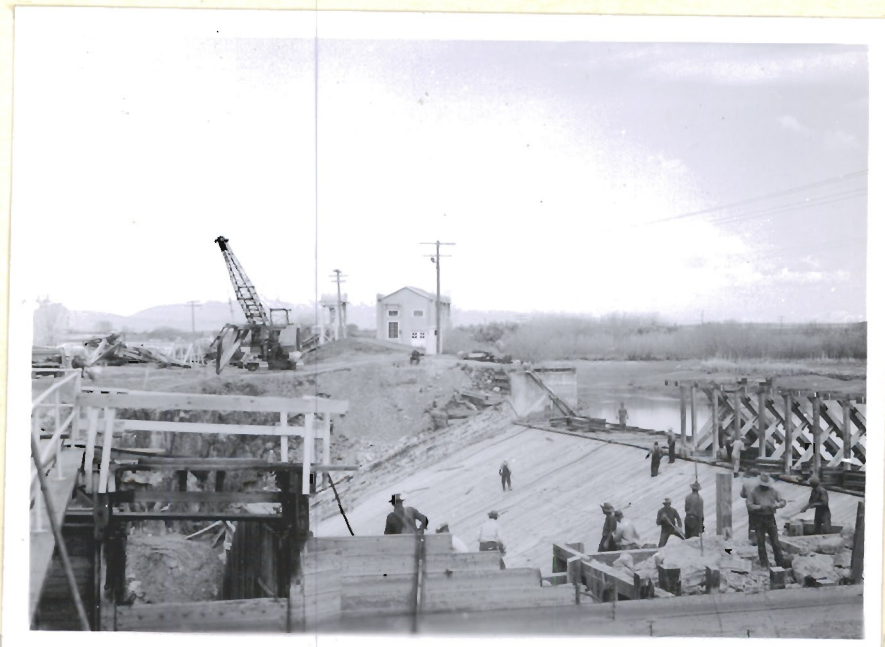
#68

Shows demolition of old flashboard structure in progress.

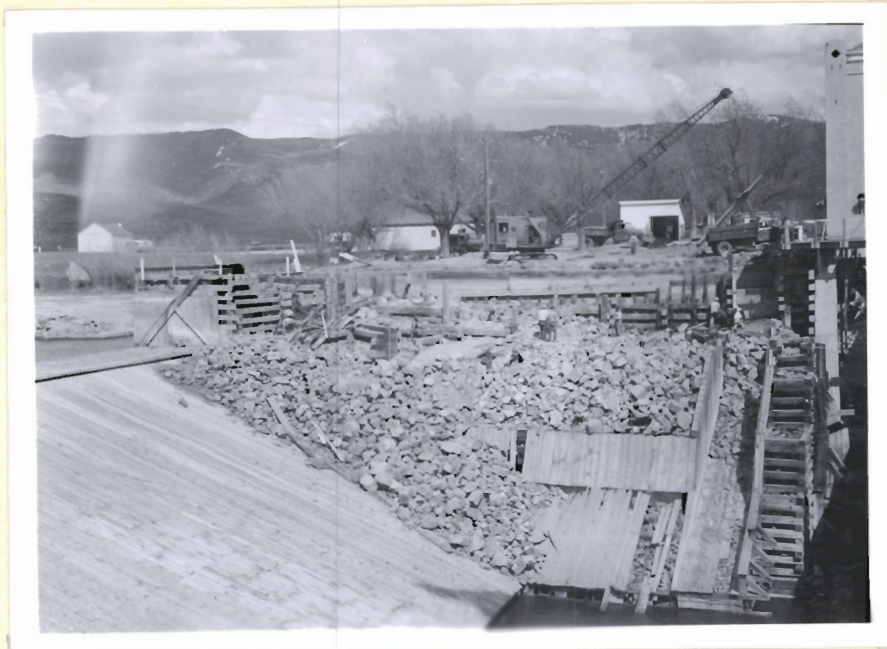
5-17-50 39/07 #71
Demolition of old dam down to elev. 1038
in progress.
View easterly.

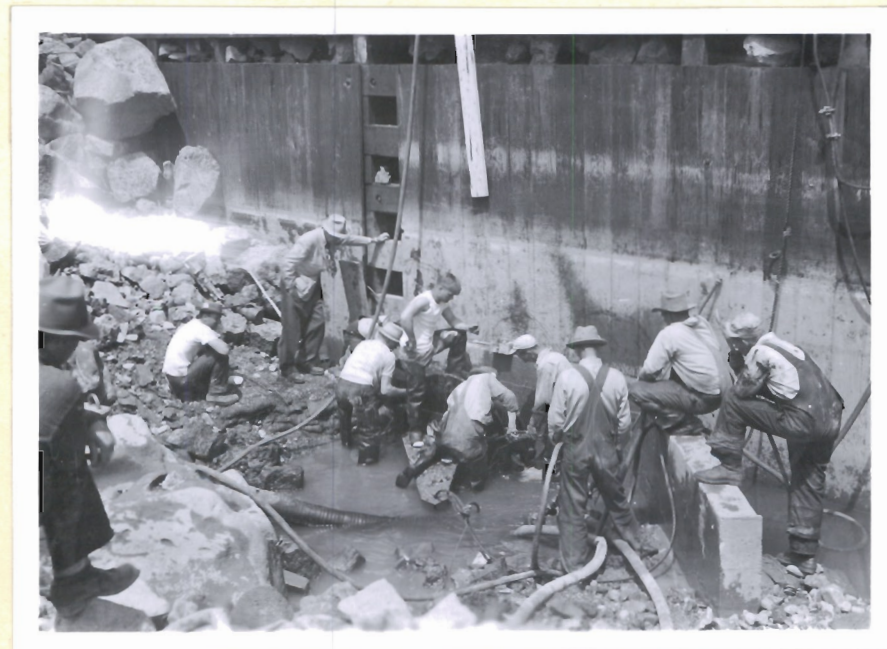
5-17-50 39/08 #72
Closing sluice gate on downstream face
of dam.
View northwesterly.

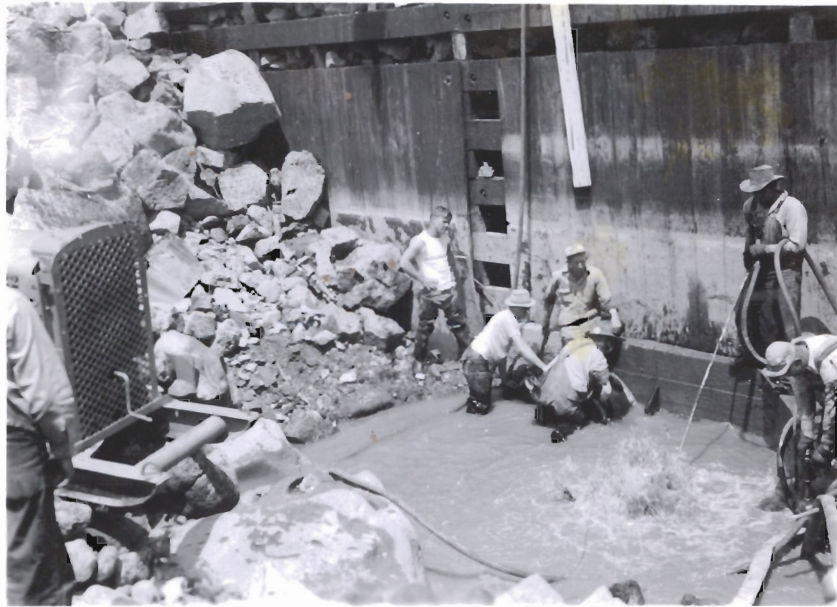
5-17-50 39109 #73
Closing sluice gate on downstream face of dam.
View northwesterly.
