UTAH POWER AND LIGHT COMPANY
GRACE DAM RECONSTRUCTION 1949-1950
CONSTRUCTION PHOTOGRAPHS

UTAH POWER & LIGHT COMPANY
GRACE HYDRO-ELECTRIC STATION
1950 ROCK FILLED CRIB DAM

CROSSOVER CONNECTION

FLOWLINES THREE TO ONE.

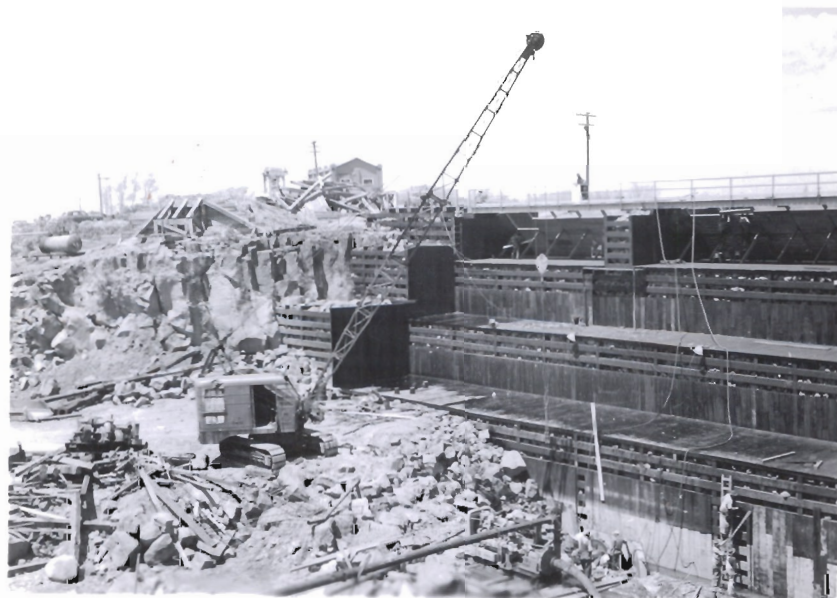
5-17-50 39110 #74
General view shows dam nearing completion.
Sluice gate being bolted in place- lower right.

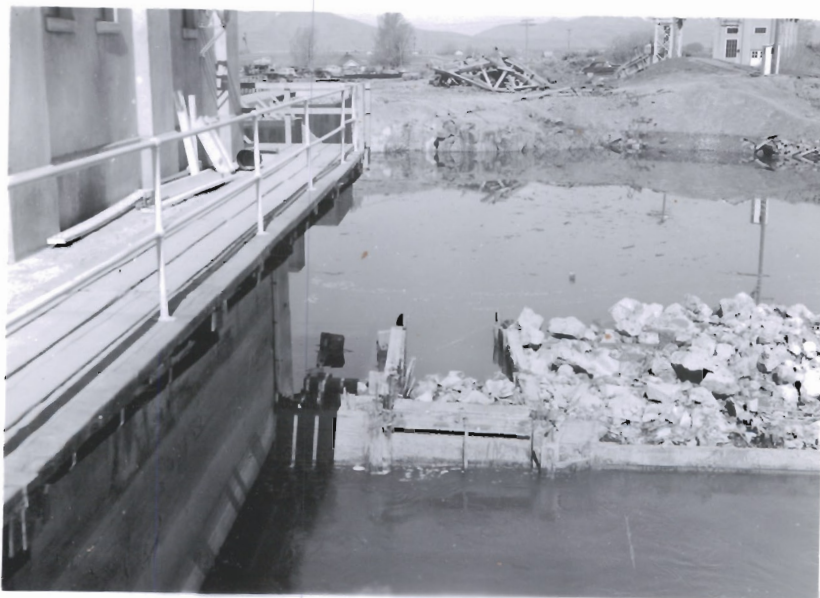
#75

Looking westerly from point north of and east of Intake No. 3.

Shows demolition complete in old ice gate area and water equalized between the two dams at elev. 1036.- 1037.

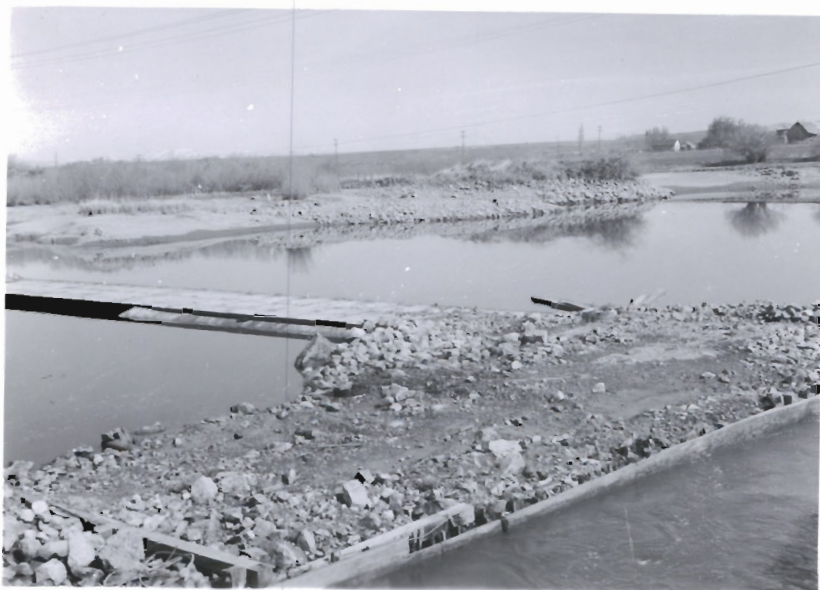
#76

Demolition of old dam complete to elevation 1038 - water at 1036 - 1037.

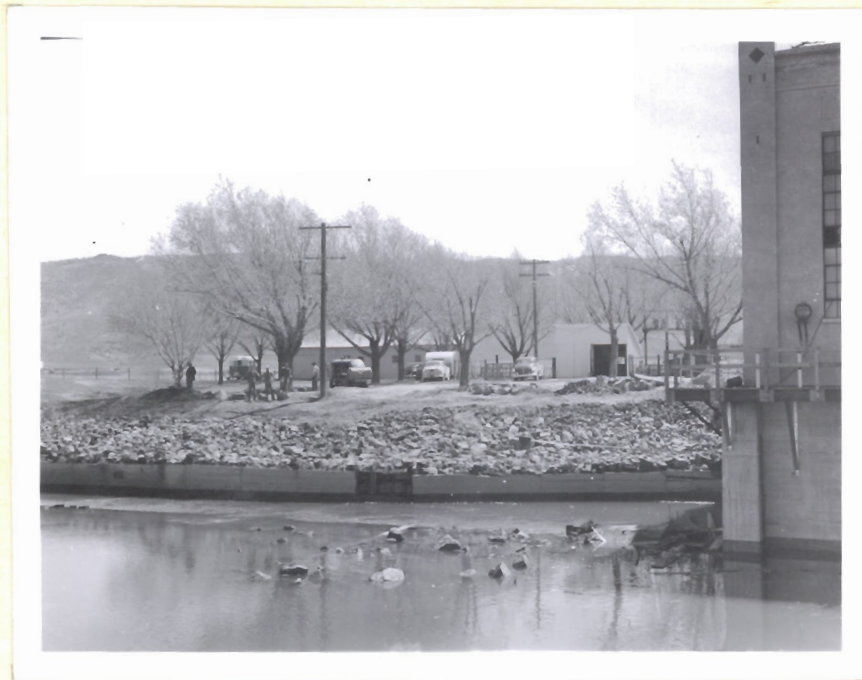
#77

Shows completed work east side of flume.

Top of east wall of flume approx. elevation
1041. Water elevation 1038+.

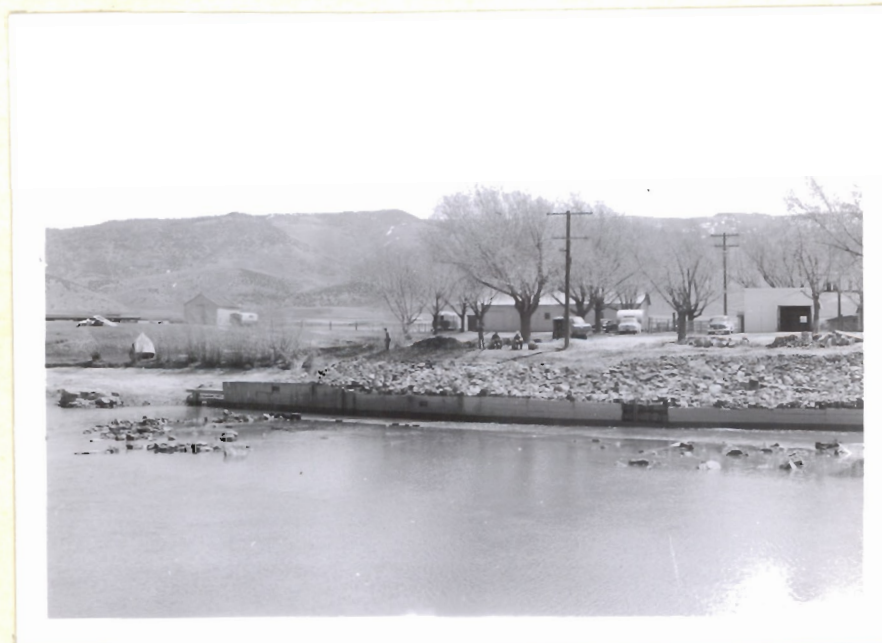
#78

Shows completed work east side of flume.

Top of east wall of flume approximate elevation
1041. Water elevation 1038+.

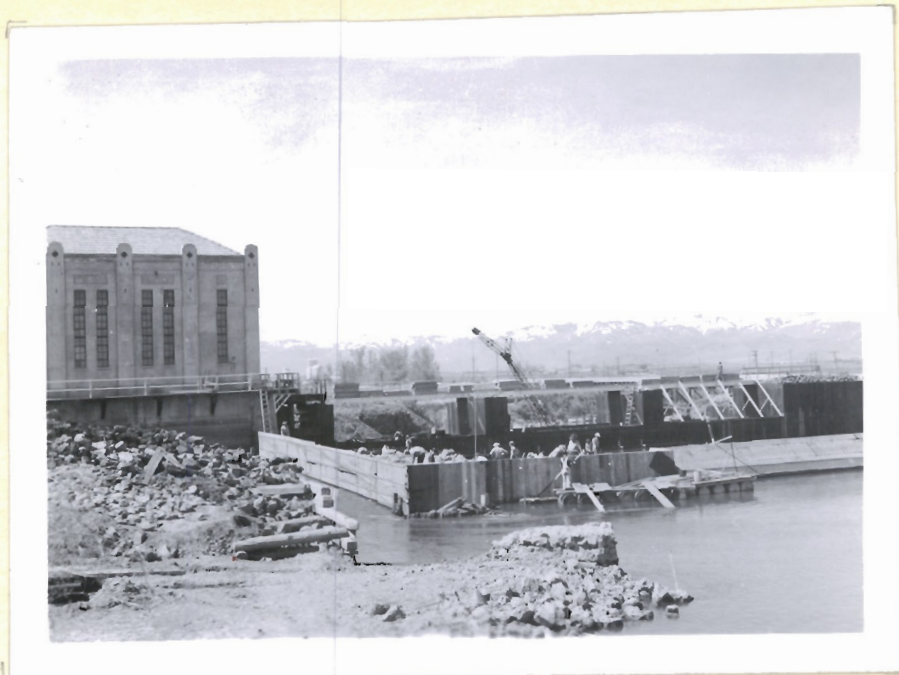
#79

Shows temporary raising of old dam in order
to supply water to irrigators from old forebay.

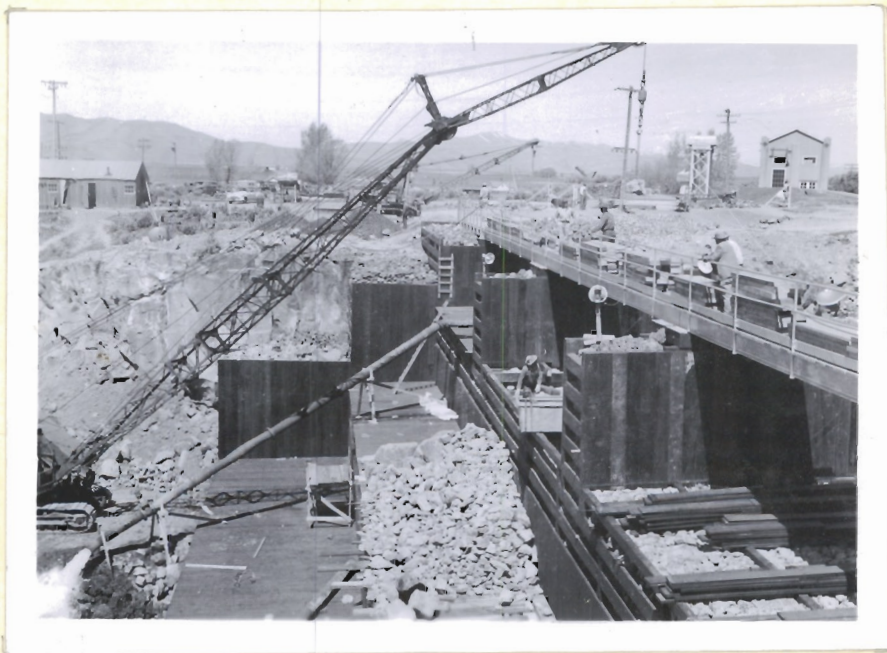
#80

Lowering 2 eastern spillway decks approximately
2 ft. Lowering undertaken to reduce head against
new dam in case it becomes necessary to spill water
over it. Note 12" syphon discharging water in back-
ground.

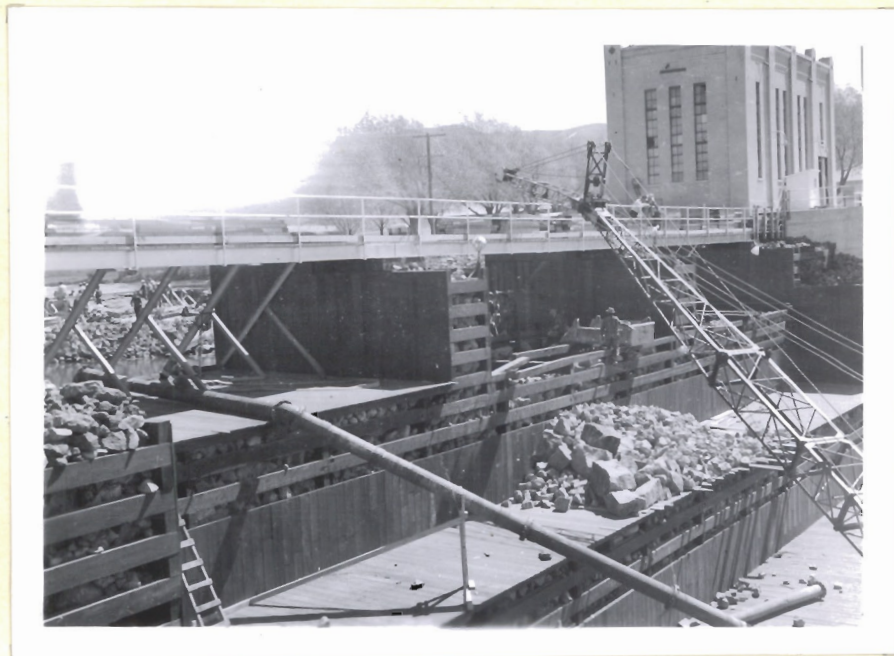
#81

Lowering 2 eastern spillway decks approximately 2 ft. Lowering undertaken to reduce head against new dam in case it becomes necessary to spill water over it. Note 12" syphon in foreground. View easterly.

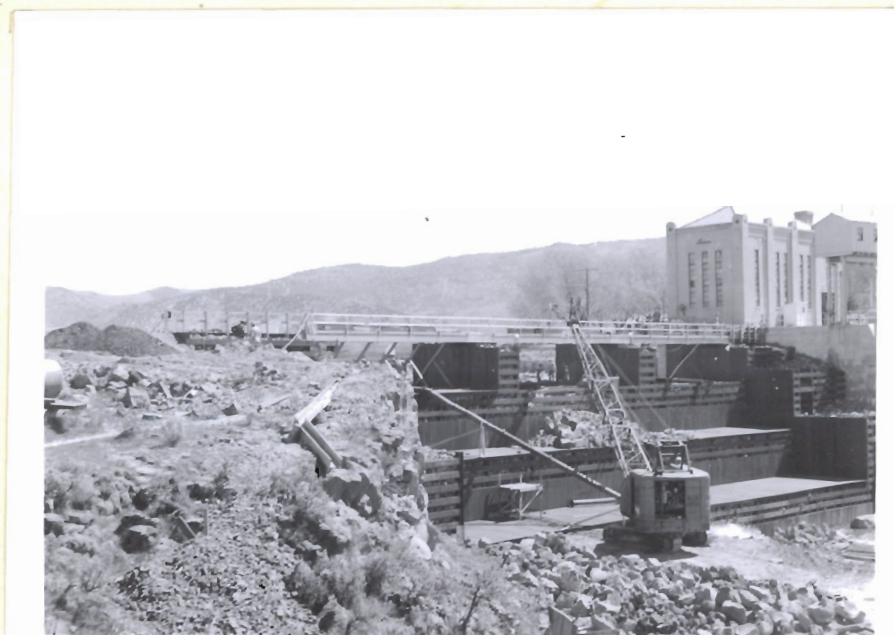
#82

Lowering 2 eastern spillway decks approximately 2 ft. Lowering undertaken to reduce head against new dam in case it becomes necessary to spill water over it. Note 12" syphon in left spillway section of dam. View northeasterly.

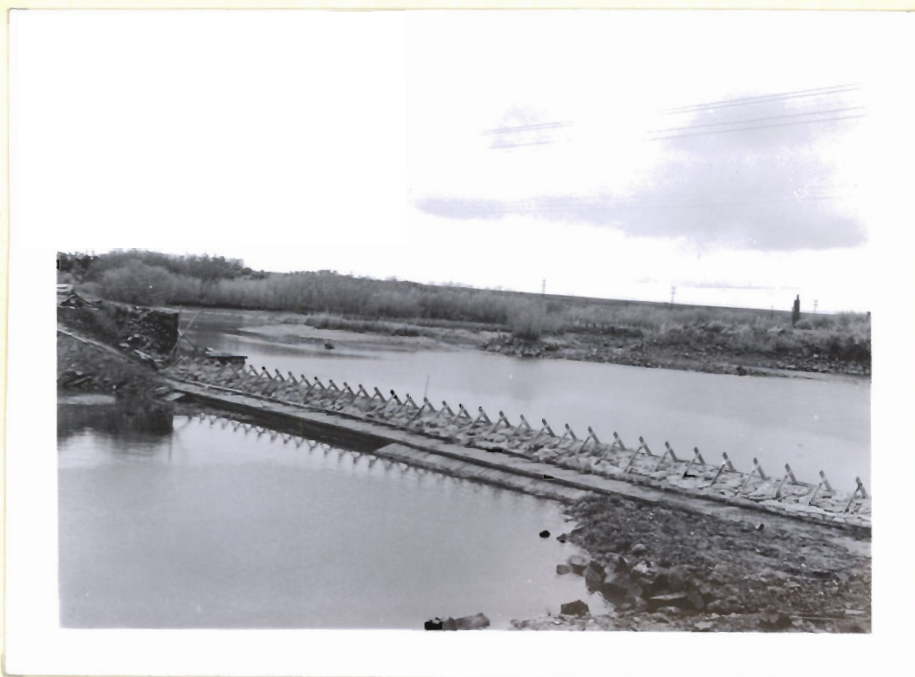
#85

Temporary flashboard structure across old dam.
Water down to facilitate removal of flashboard pre-
paratory to spilling 1000 cfs. Approximate eleva-
tion upper forebay 1040.25.
View northwest.

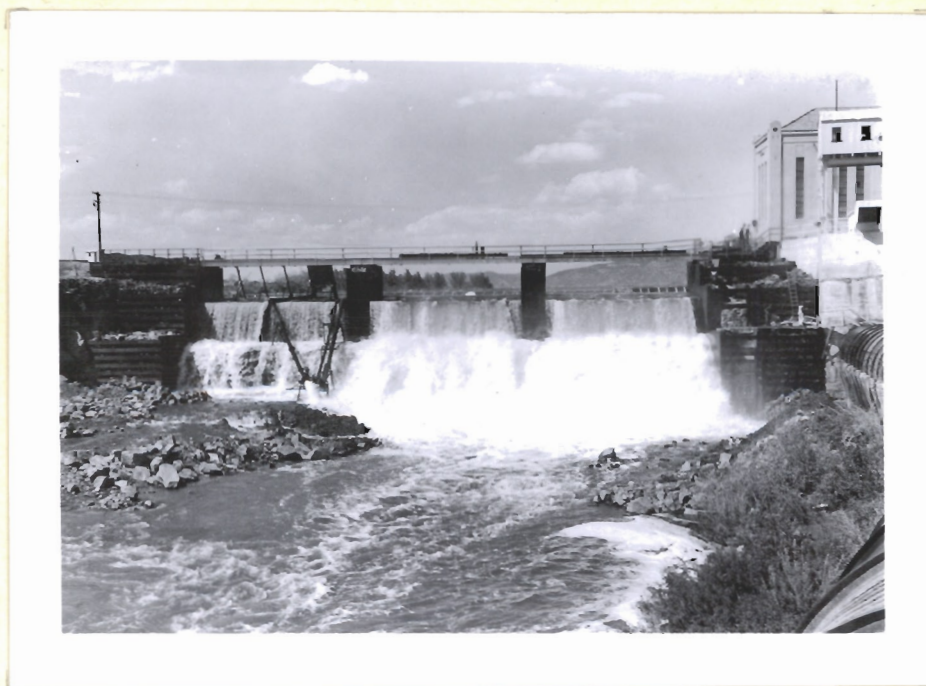
#89

Dam spilling 750 cfs center and east bays lowered
to approximate elevation 1036.
View north.

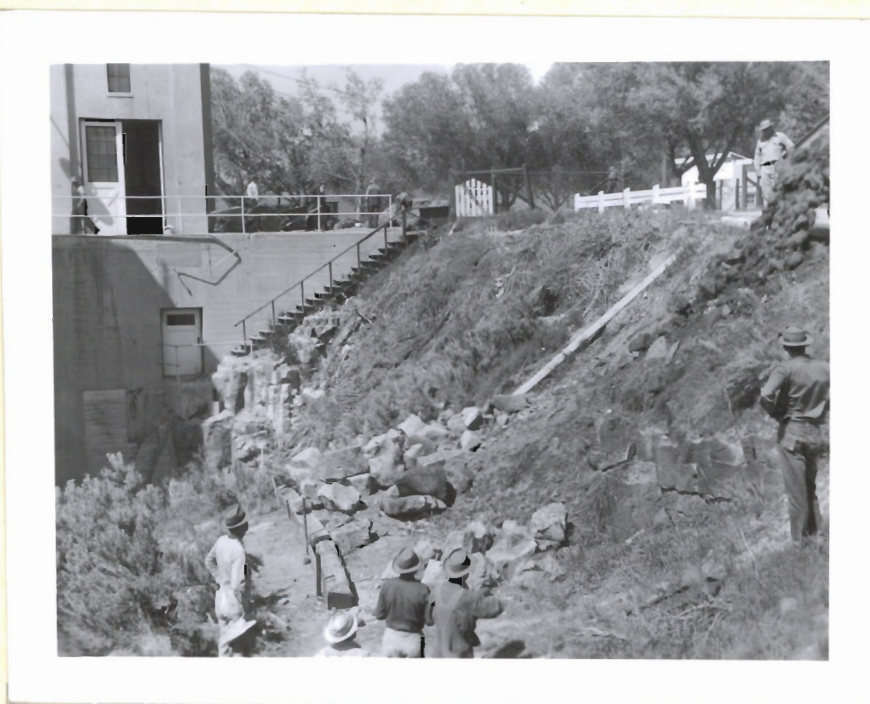
#90

Truck unloading rock over east bank south of
No. 3 Intake structure for backfill at downstream
toe of dam on east end.
View northeast.

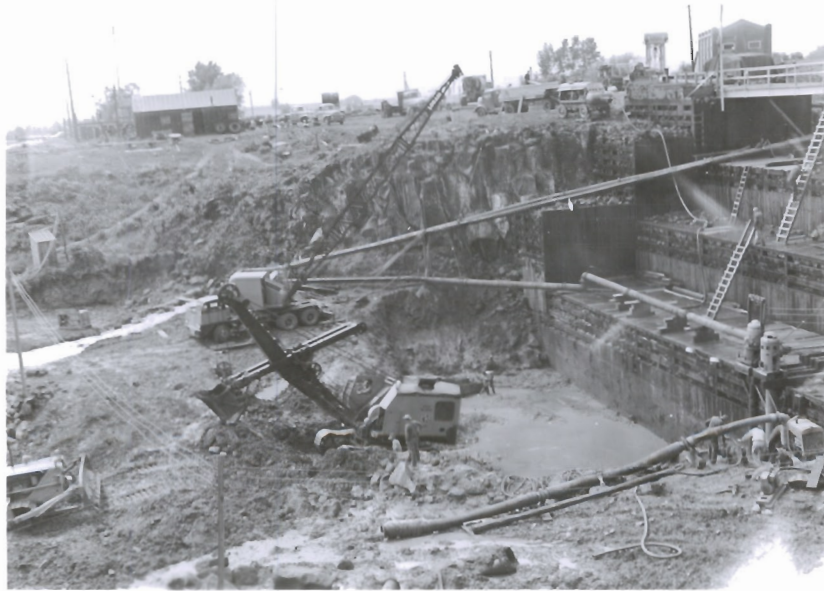
#91

Shows excavation for concrete block in progress.
Northwest $1\frac{1}{2}$ yd. shovel has been withdrawn to
permit final hand mucking.
Looking westerly.

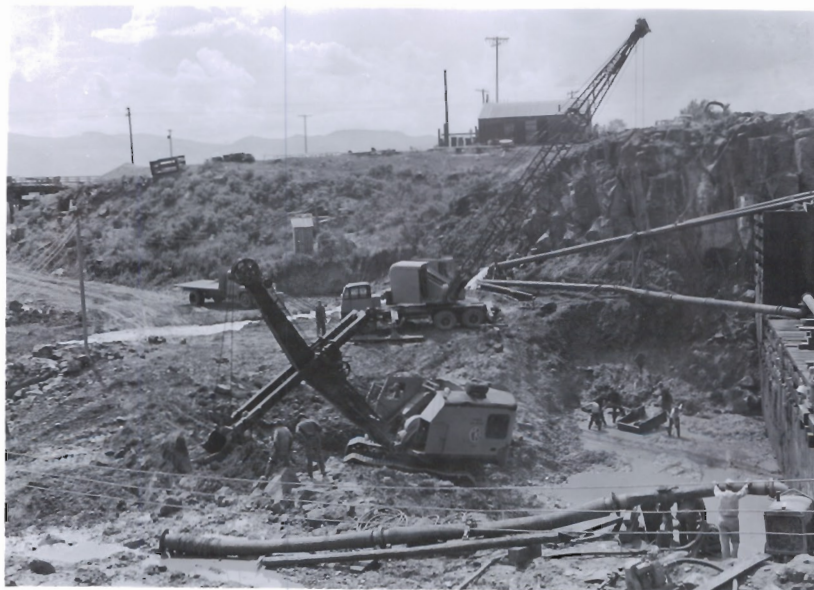
#92

General view of excavation activity. Shows equip-
ment used. Hand mucking in progress. Elevation at
this point is approximately at 1000.0.
Looking westerly along downstream toe of dam.

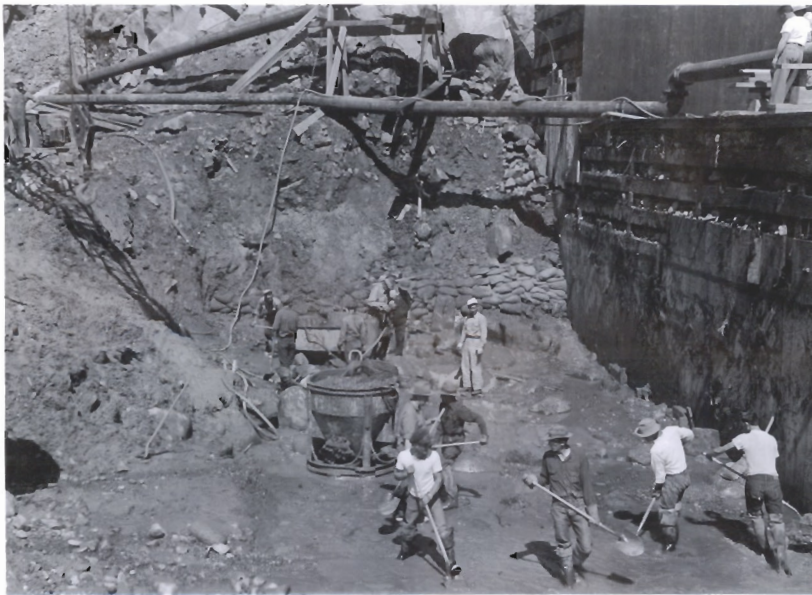
#93

Shows hand excavation for concrete thrust block in progress. It was later found that the formation at this elevation (1000.0) was not satisfactory for developing a key in solid rock for the block.

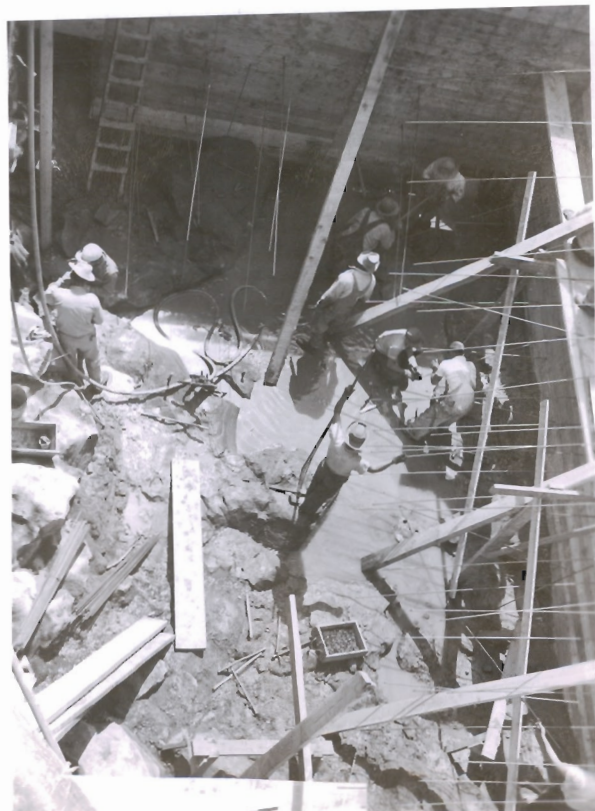
Tie rods and bracing being installed on forming for first 30 ft. section of concrete thrust block. Tie rods were welded to 1 1/4" sq. reinforcing drilled into rocks. East wall of form at top is at sta. 1+21.6.

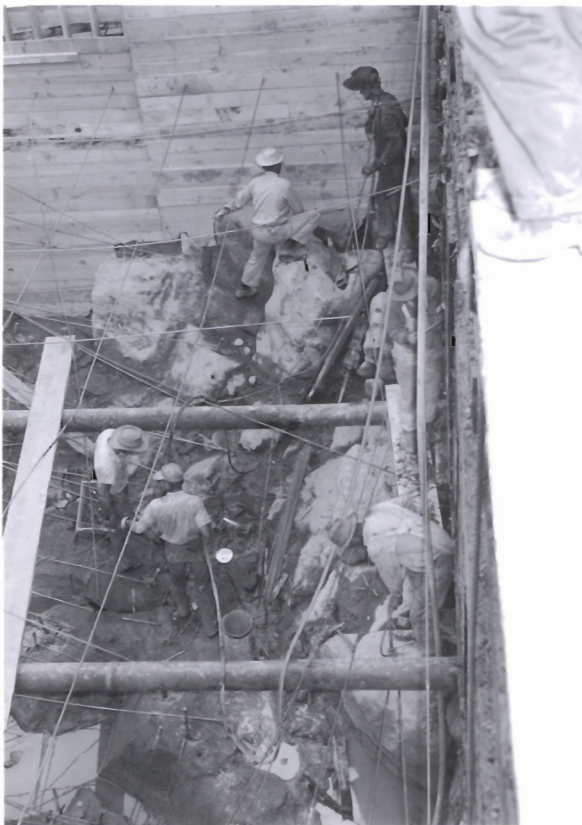
#98

Shows nature of formation at final excavation for first section of thrust block.

View westerly - forms are the west end panel - sta. 151.6.

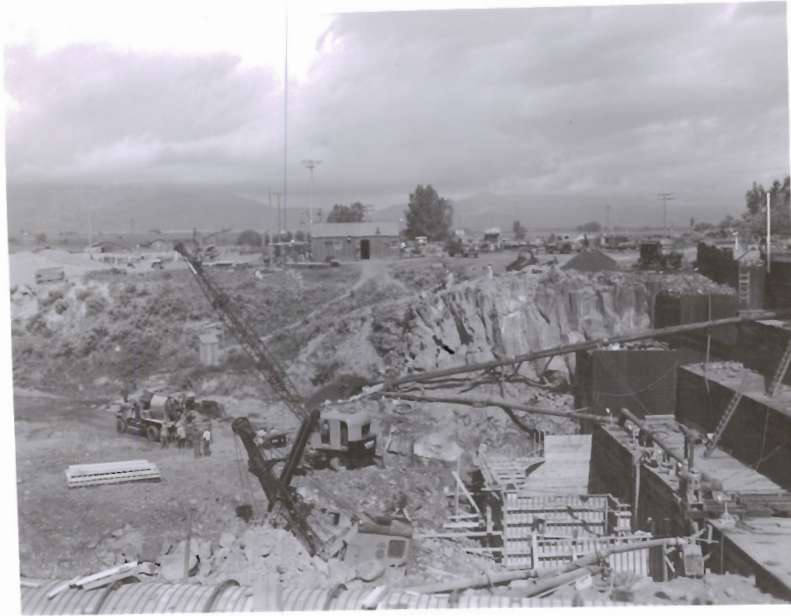
#99

General view looking westerly. Area downstream from dam. Shows progress to date.

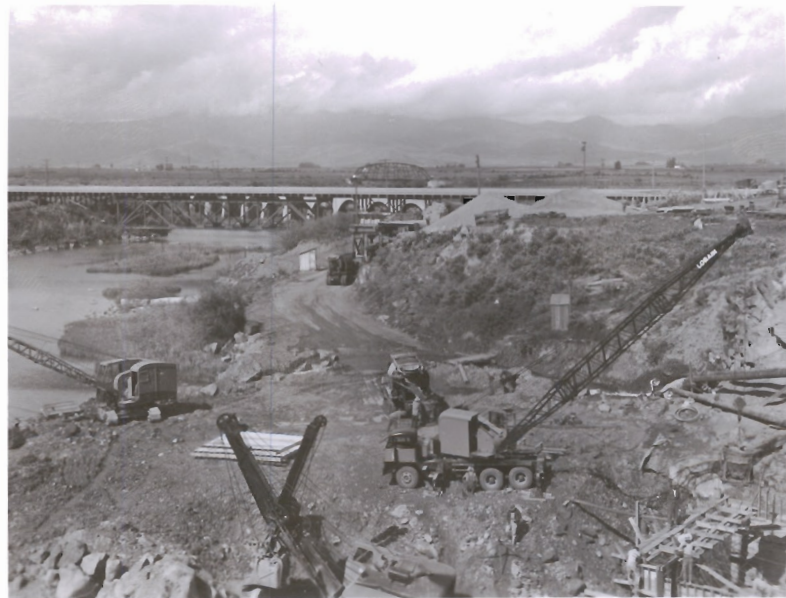
#100

General view shows concrete mixing and placing facilities. 3-4 yd. truck mixers were used. Looking downstream along right bank of river.

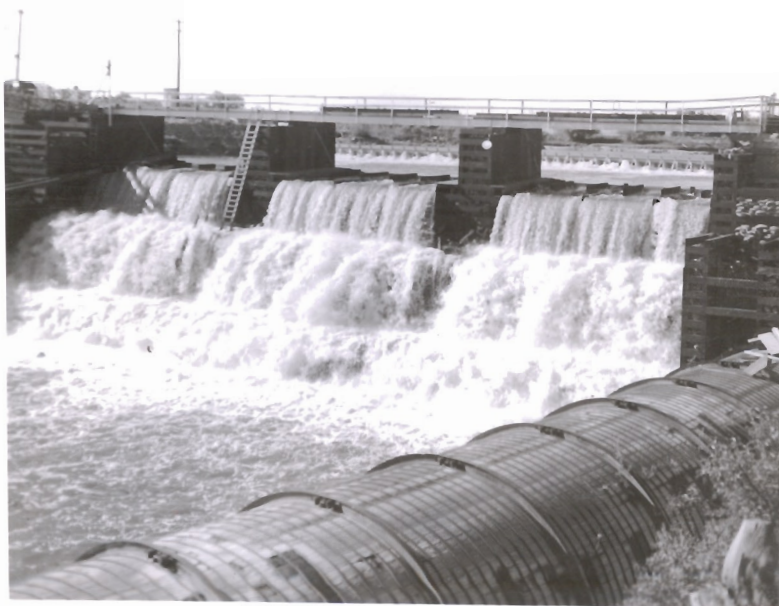
#101

Shows new dam spilling 750 cfs flood water.
Spill decks temporarily lowered 2 ft. below
final elevation.

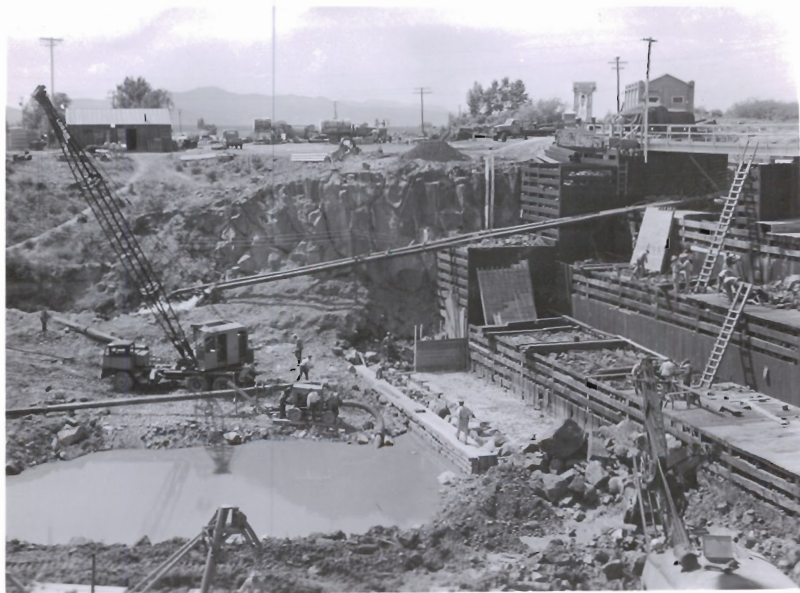
#103

General view looking westerly shows resumption of work after period of spilling flood water June 27 to July 5.

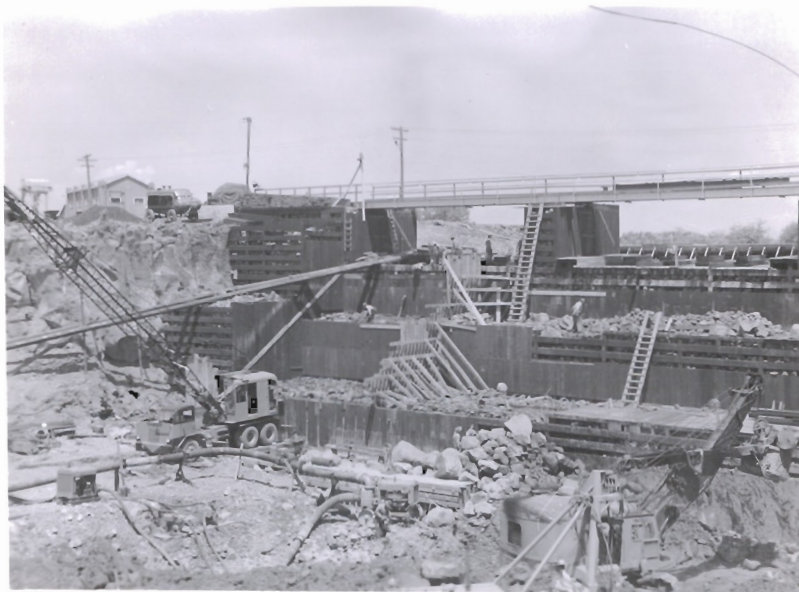
#106

General view shows progress to date- note forms
for rubble concrete.
Looking northwesterly.

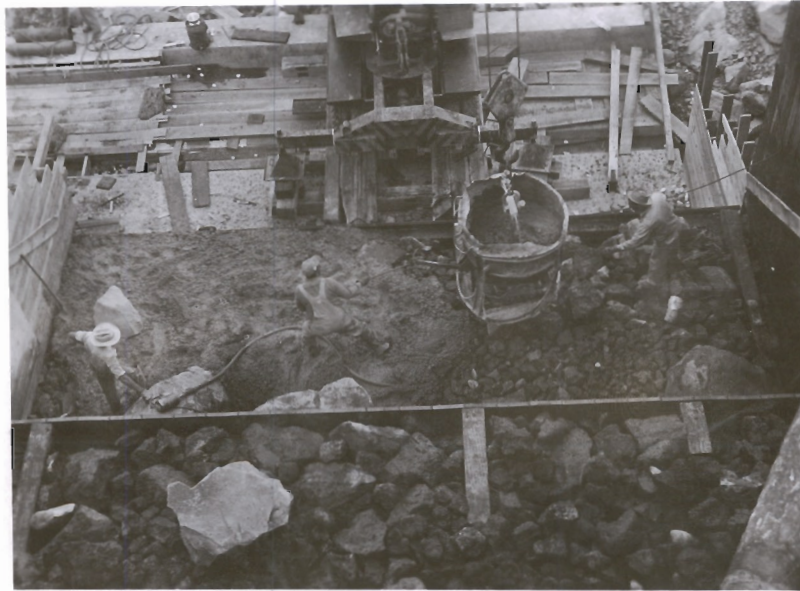
#107

Applying seal in preparation for placing rubble concrete.

Looking down downstream face of dam from above.

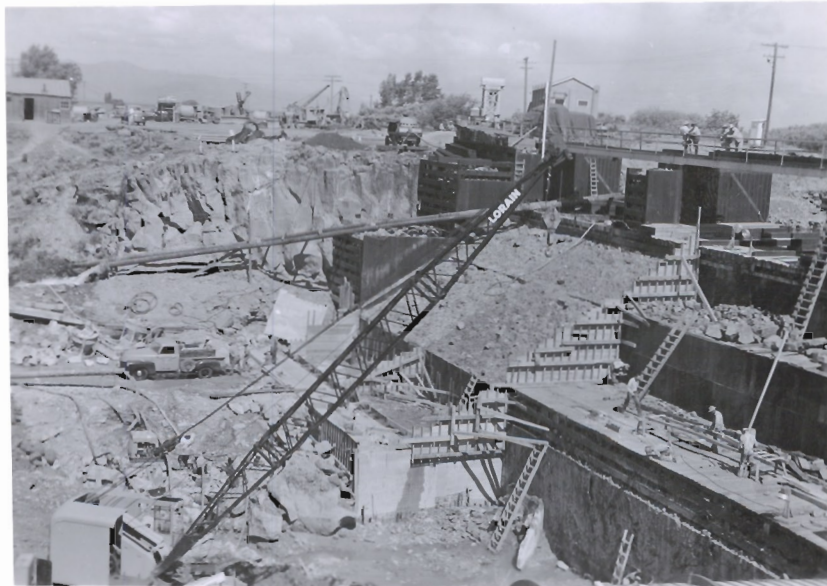
#108

Shows rubble in place in 2 -30 ft. sections on the 1014 and 1026 levels. Excavation for 3rd and 4th sections of thrust block nearing completion.

Note progress since resumption of work July 5.

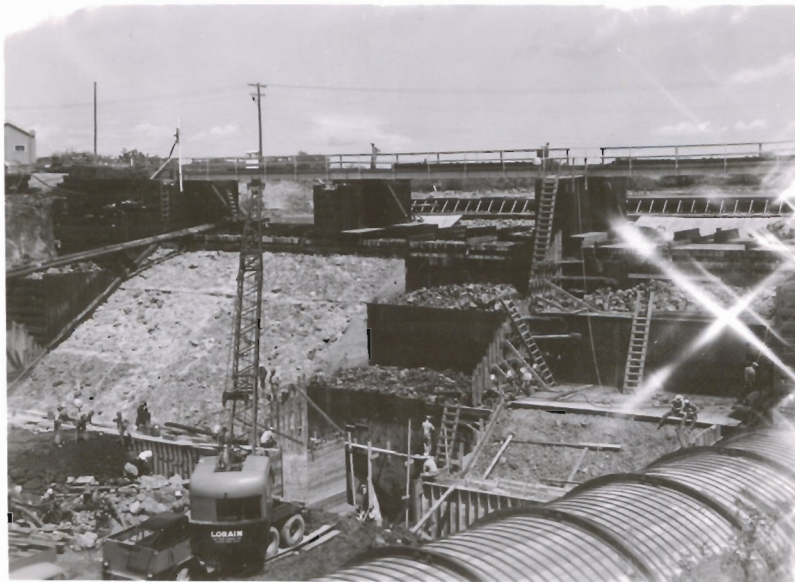
#110

General view shows progress to date. Rubble concrete at left and lower right. Rock piled preparatory to concreting in center.

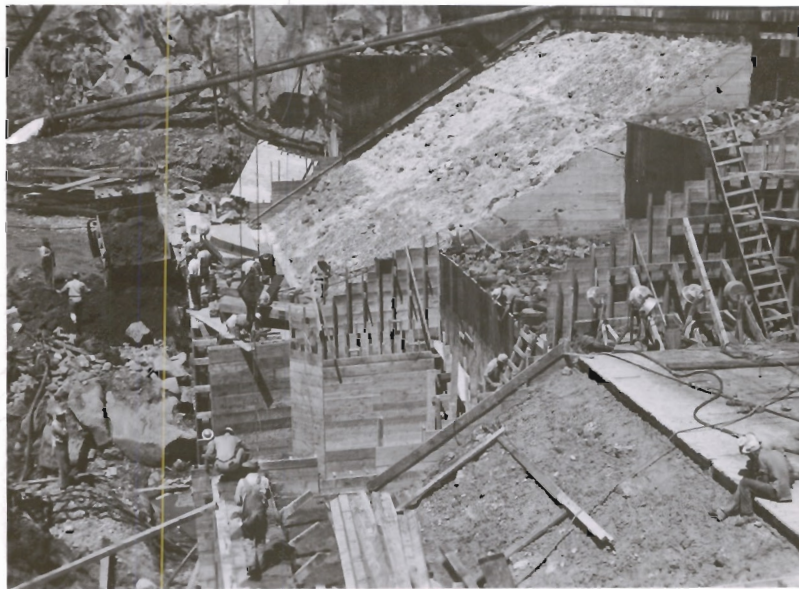
#111

Forming for sluice valve chamber in progress.

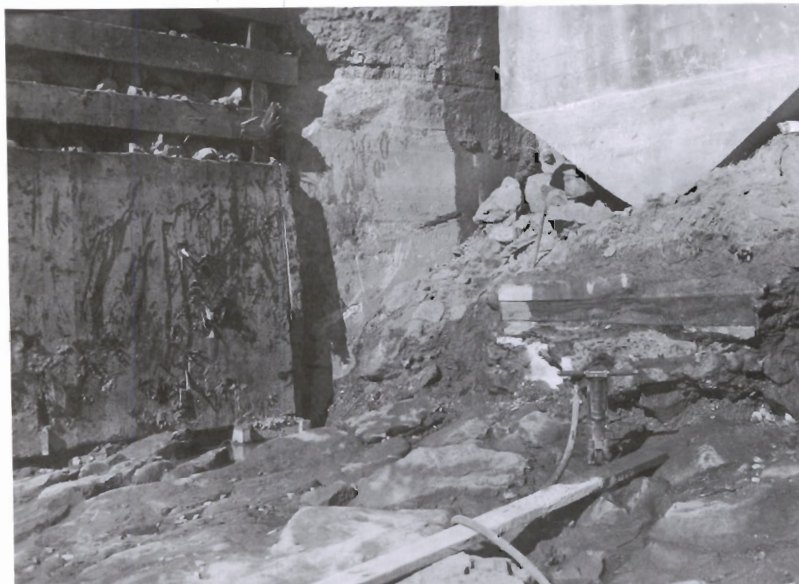
#112

Shows solid ledge rock at east end excavation.
for thrust block east of ice chute.
Note footings of flowline structure.

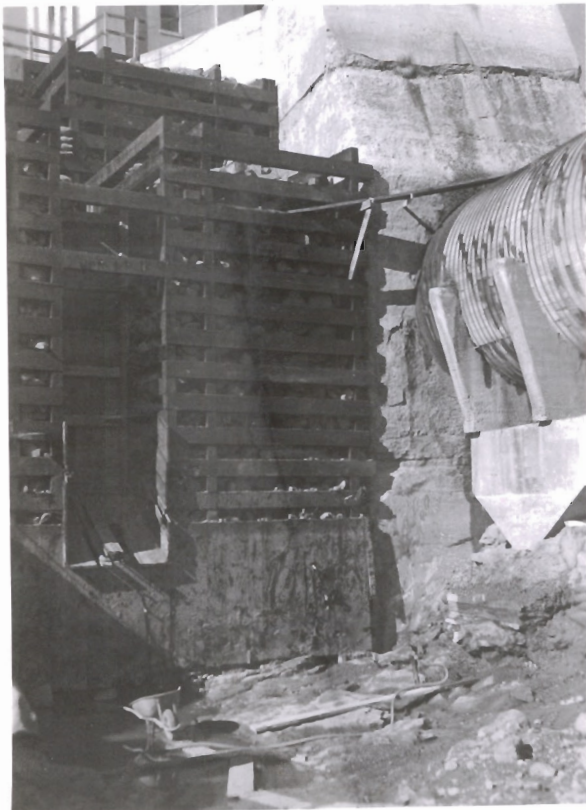
#113

Excavation down to solid
ledge rock at east end of
thrust block under ice chute.

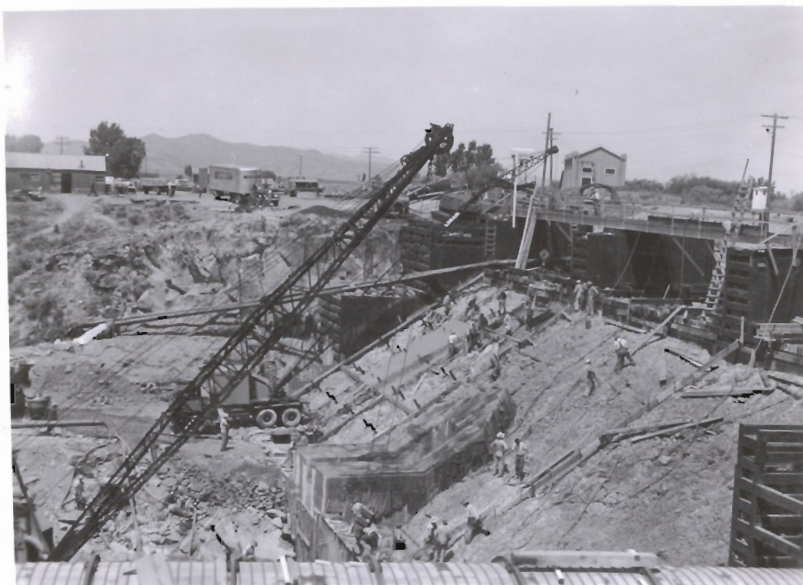
#114

Shows general progress to date.

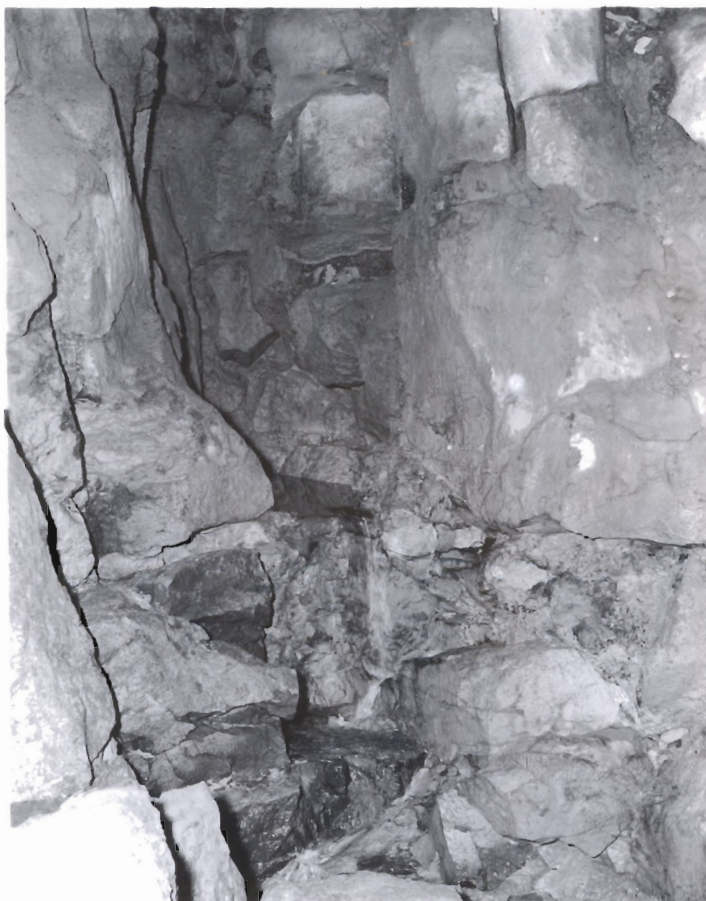
11-12-49 39053 #23

Contact point of west
cliff abutment shows
broken up lava and
wet volcanic cinder
and clay seam. Approx.
elev. at bottom of
picture 1001.

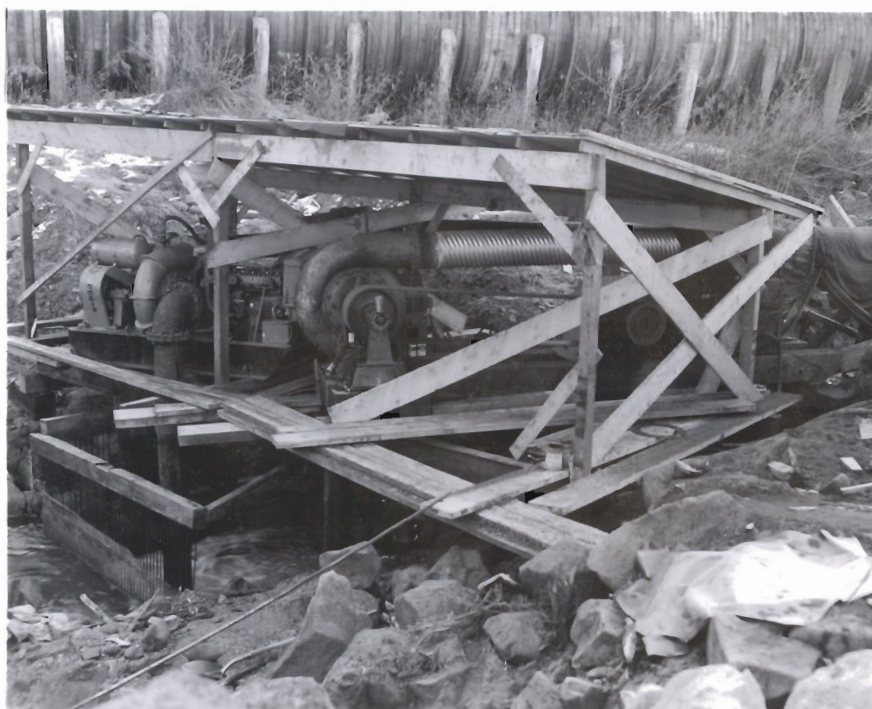
11-12-49 39054

Unwatering pumps housed by temporary shed

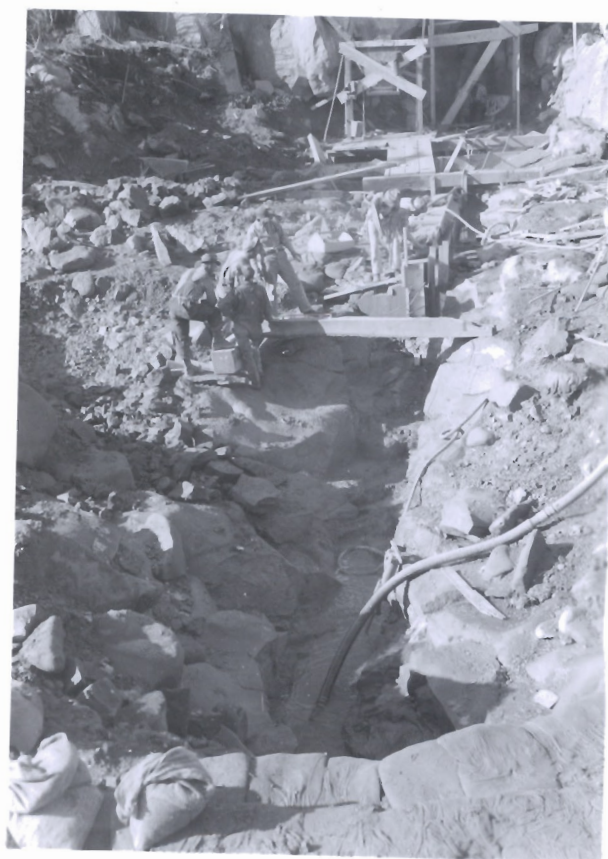
11-18-49 39056 #26

Shows completed excavation for cutoff wall- sta. 0+80 to 1+15.

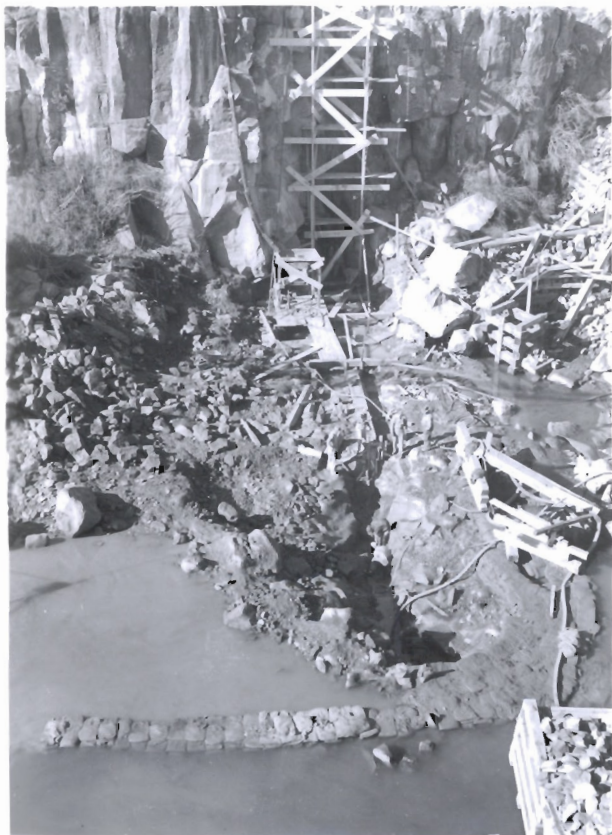
#27

Sand bag coffer dam in foreground.
Cutoff trench and western portion of
concrete cutoff wall toward back.
Scaffolding up face of cliff for
forming and pouring west abutment seal.
View westerly.

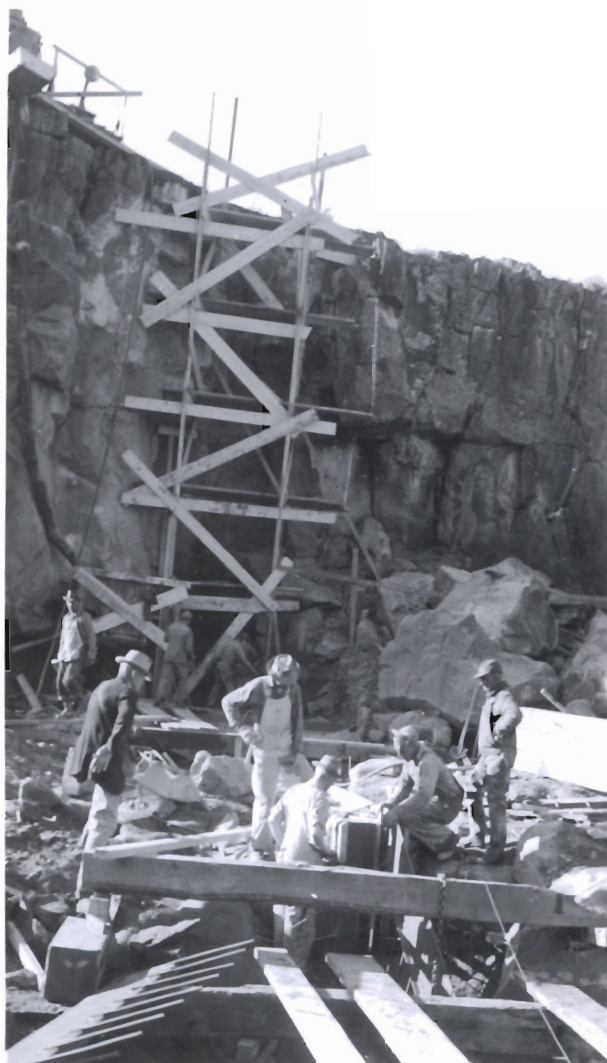
#27-A

Forming and preparing sluiceway
section of cutoff wall. Note steel
cutoff plate running down from elev.
approx. 1000 to elev. 996. Forms,
reinforcing and embedded plate sus-
pended from heavy timbers spanning
trench in solid rock.

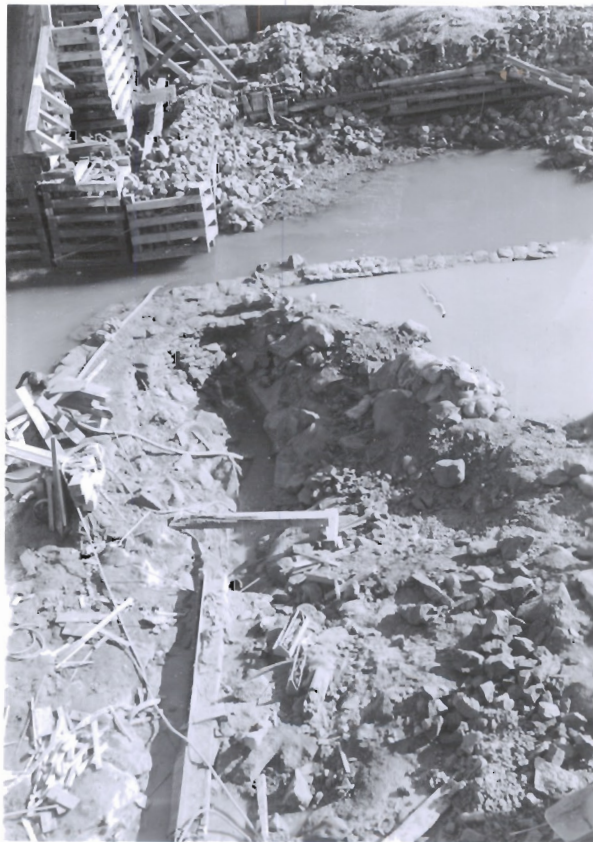
11-18-49 39059 #28
Shows finished excavation for cutoff
wall to sta. 1+15 with end of poured
wall to sta. 0+80.
View east.

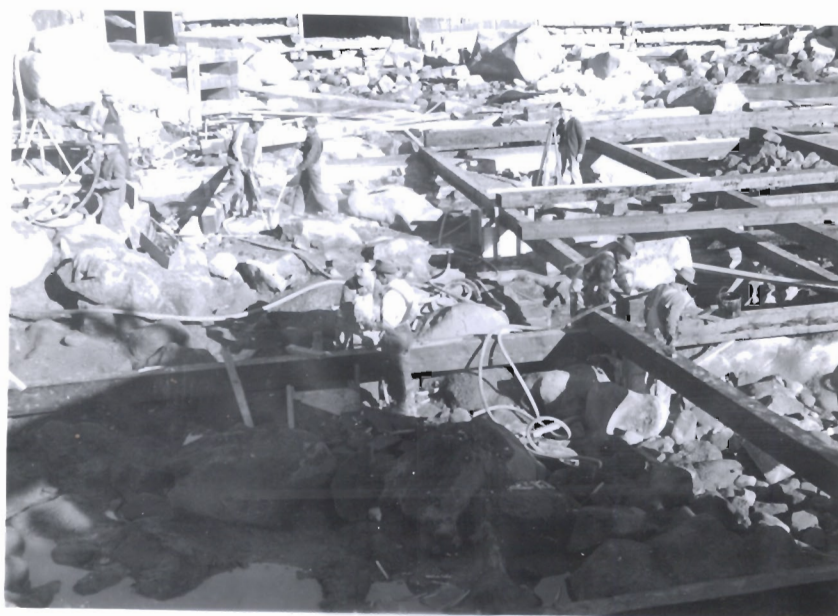
#30

Shows commencement of crib erection and nature of
rock formation at final excavation.
Looking upstream toward old dam.

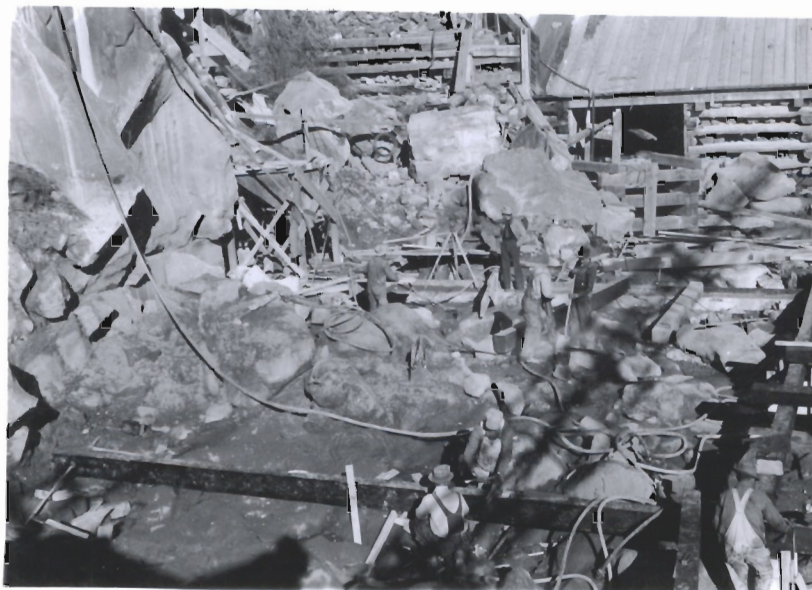
#31

Shows crib erection in progress. Nature of
final excavation in river bottom at west end.
Looking upstream.

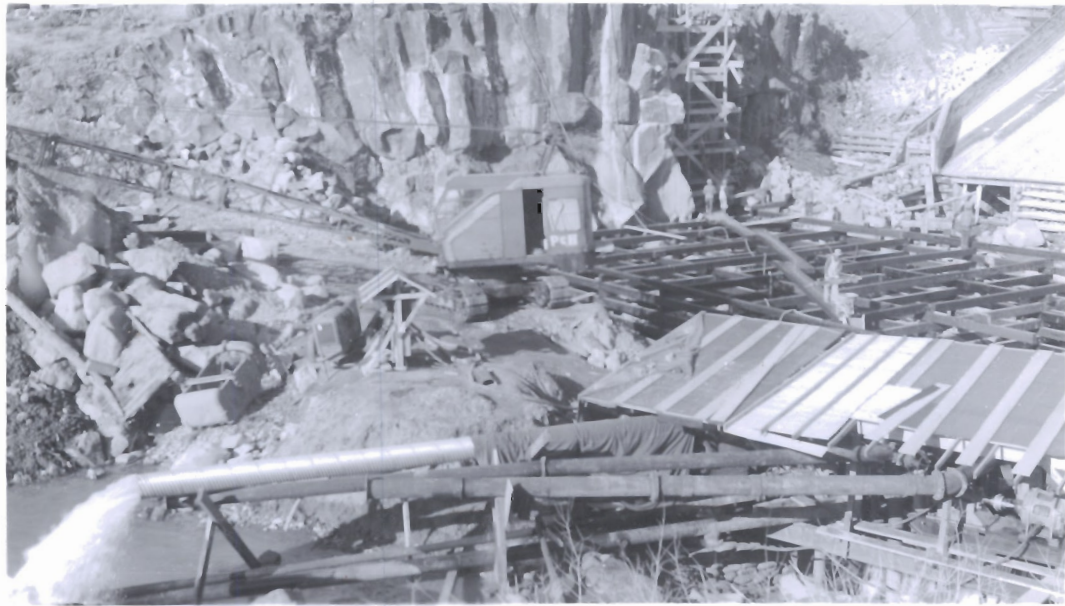
#31-A

Scaffold west abutment cutoff in right background.
Cribbing timbers at elevation 1007.6 at right center.
Unwatering pumps under shed in right foreground.

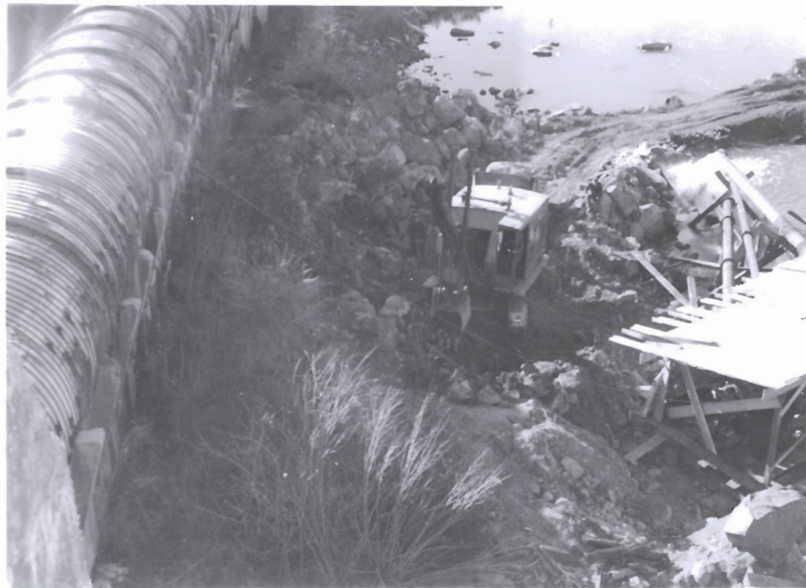
#32

Shows small shovel in approach to east
bank excavation.

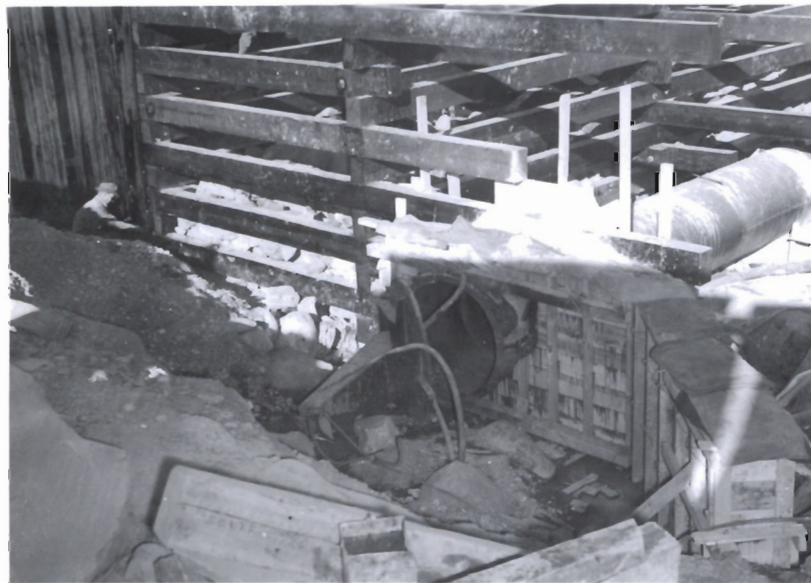
#33

Shows construction at sluice pipe tail wall.
Wing at right was added to aid in subsequent diver-
sion of water.

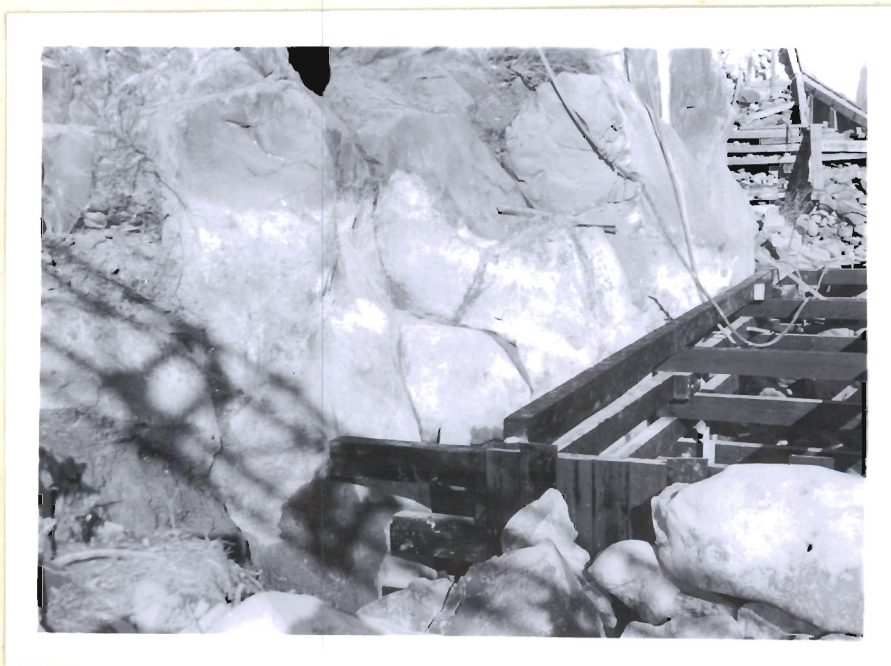
#35

Shows crib construction along west cliff
near bottom.
