UTAH POWER AND LIGHT COMPANY
GRACE DAM RECONSTRUCTION 1949-1950
CONSTRUCTION PHOTOGRAPHS

UTAH POWER & LIGHT COMPANY
GRACE HYDRO-ELECTRIC STATION
1950 ROCK FILLED CRIB DAM

CROSSOVER CONNECTION

FLOWLINES THREE TO ONE.

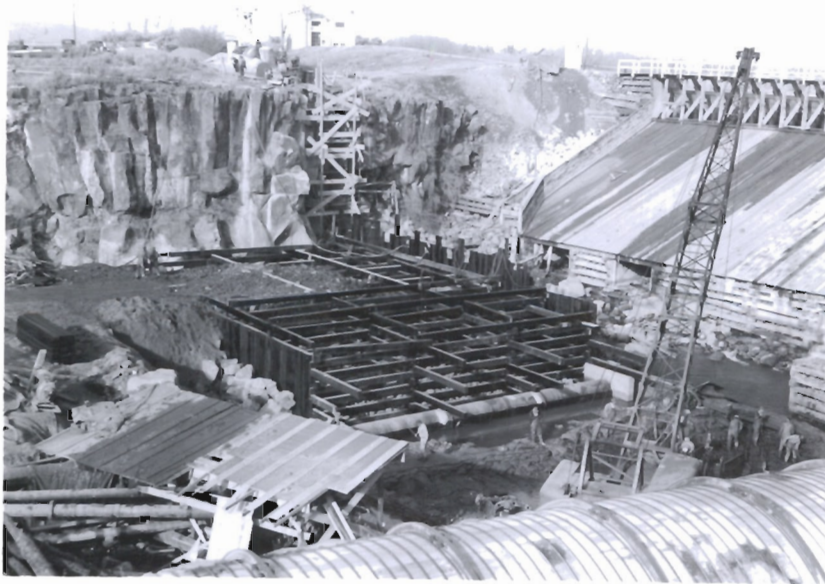
#36

General view shows progress to date. East side unwatering complete and excavation in progress.

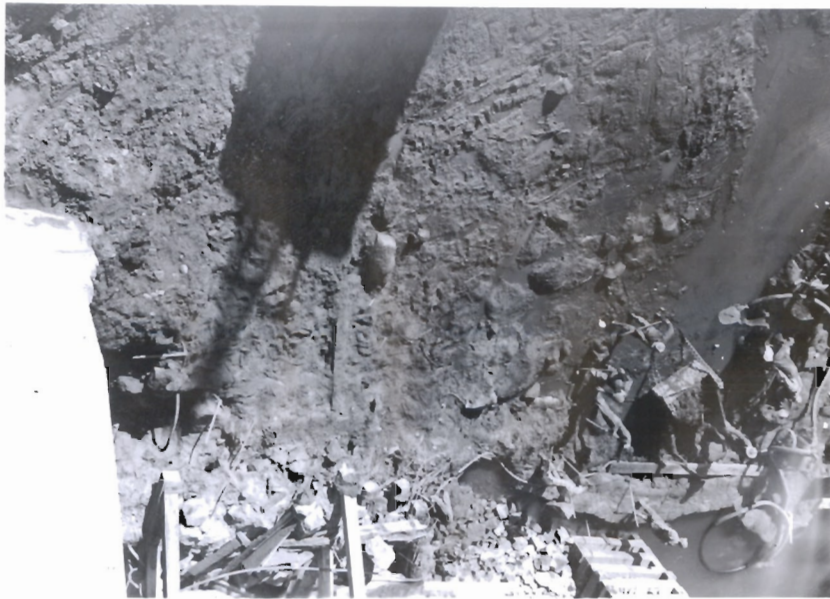
#37

Shows excavation in progress at east side. Bedrock exposed left center where men are working. Looking into pit from above.

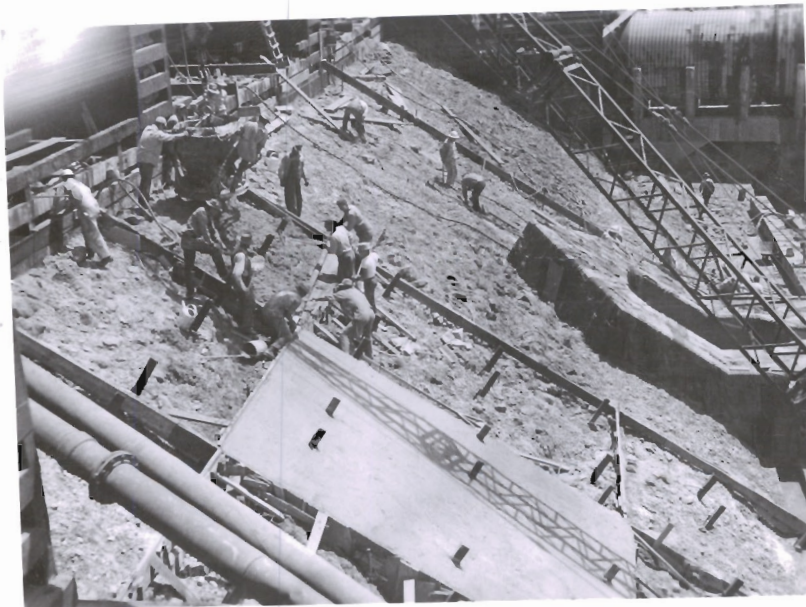
#115

Pouring finish slab over rubble concrete on
downstream face of dam.

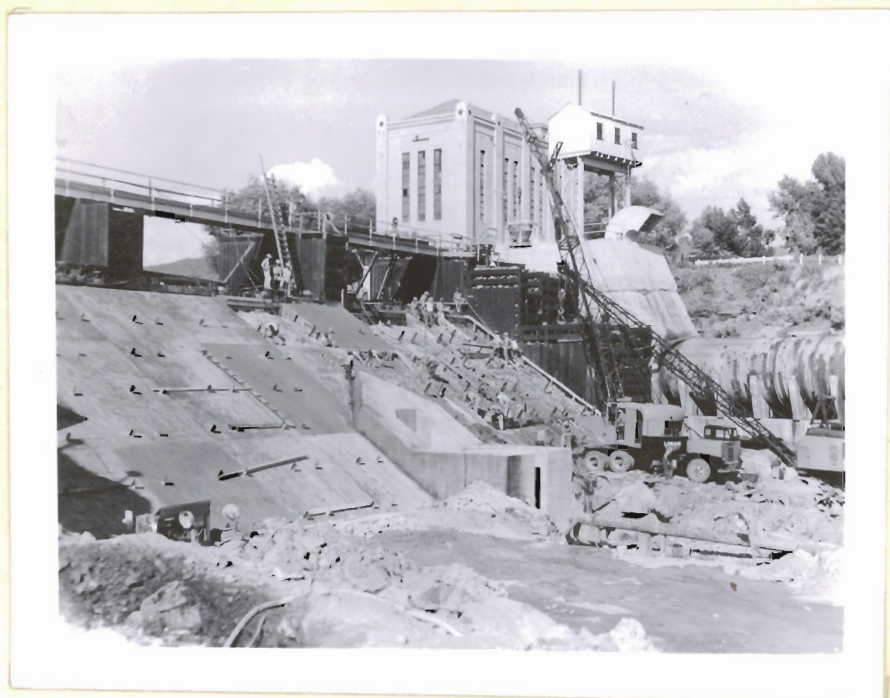
#117

Pouring finish slab over rubble concrete on
downstream face of dam.
Looking northeasterly.

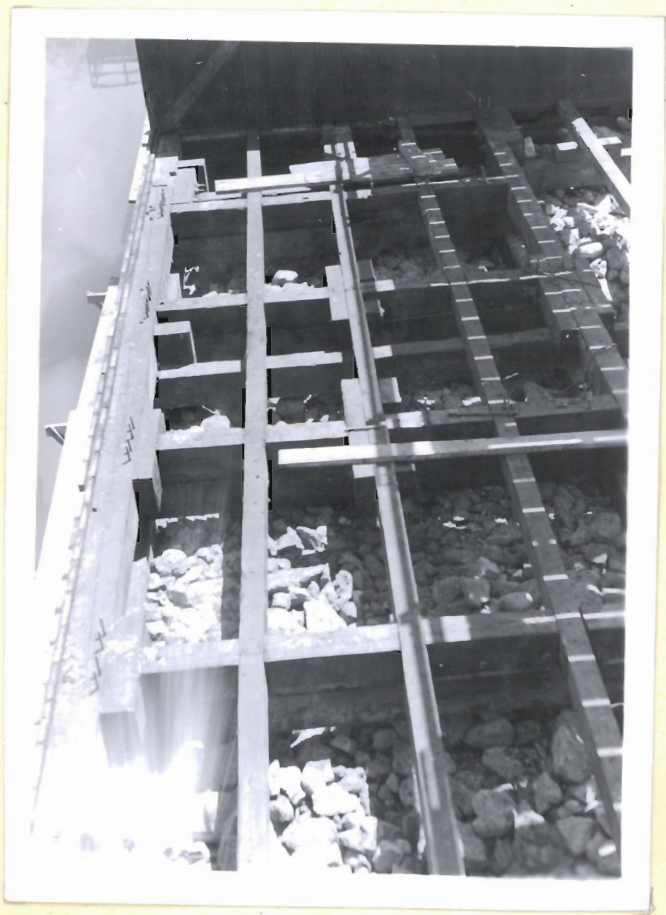
#118

Shows timbering under spill
deck restored after cut down 2
ft. to pass flood water.
Looking easterly across dam.

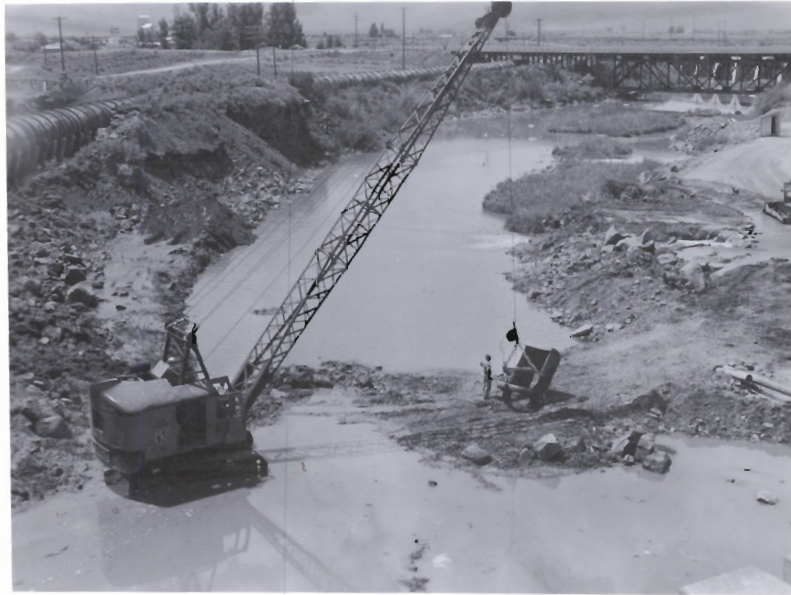
7-26-50 3/953 #119
Shows downstream channel excavation in progress.

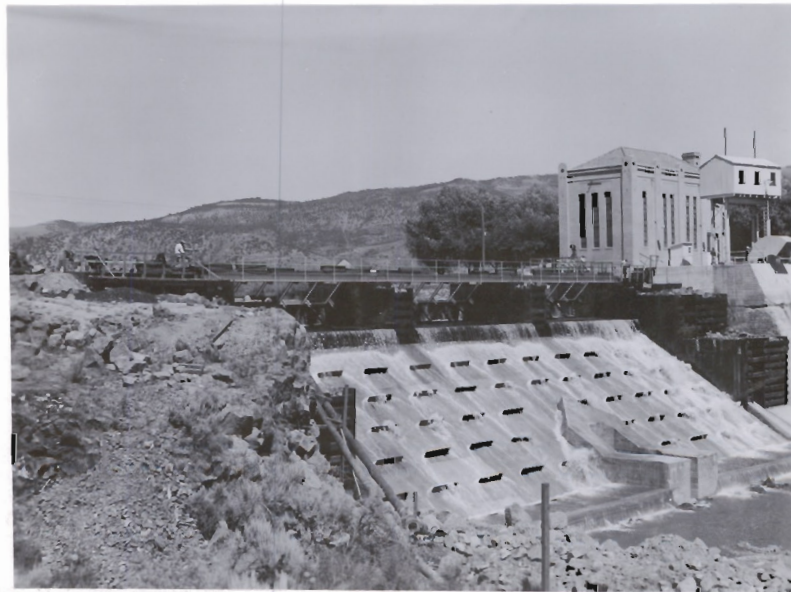
7-29-50 39157 #119-A
View northeast of completed dam. Water just beginning to spill due to gates closed on pipes preparatory to taking No.2 flowline out for reconstruction.

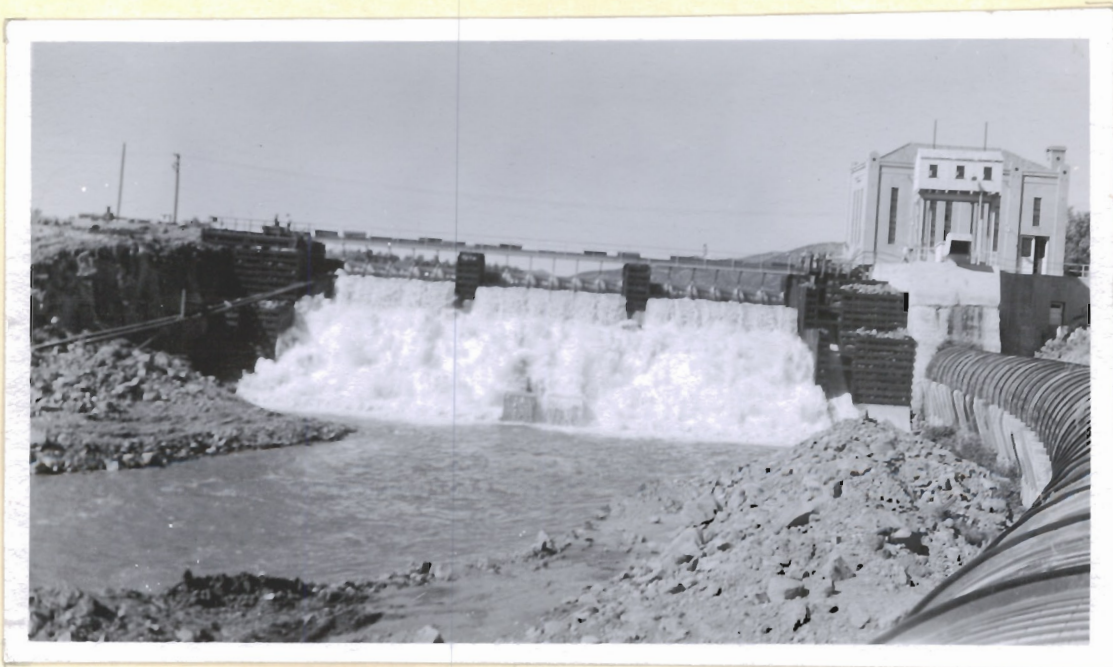
#122

Spilling approximately 500 cfs. Spill occasioned by closing intake #2 gate preparatory to draining #2 flow-line for 1950 reconstruction.

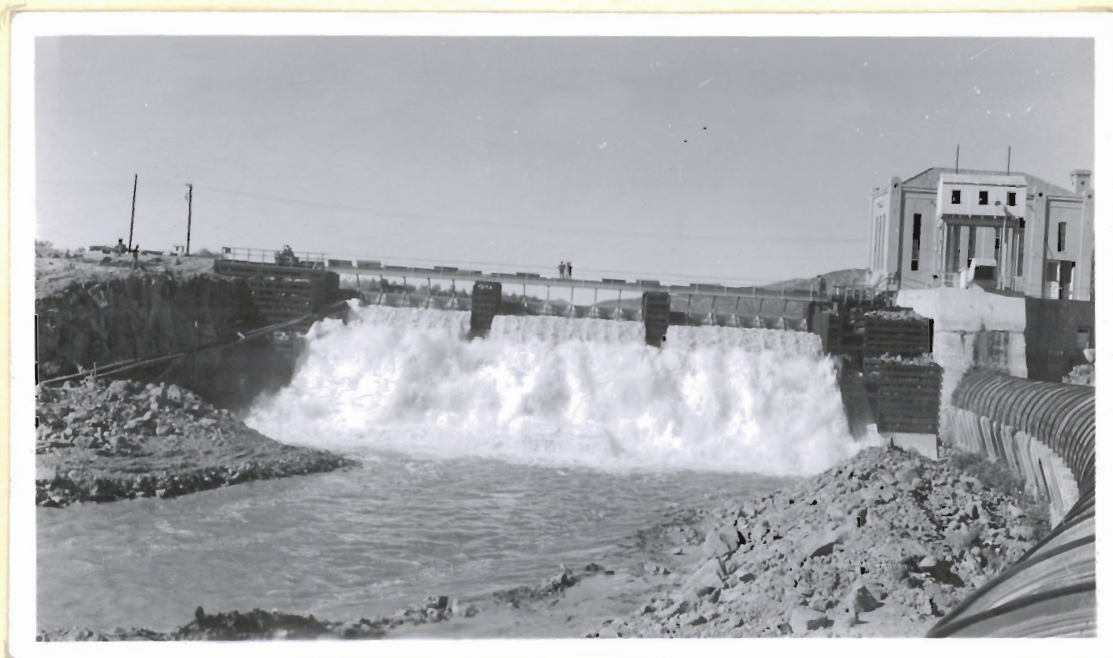
#124

Spilling approximately 1000 cfs. Spill due to closing
#2 intake gate preparatory to draining #2 flowline for 1950
reconstruction.

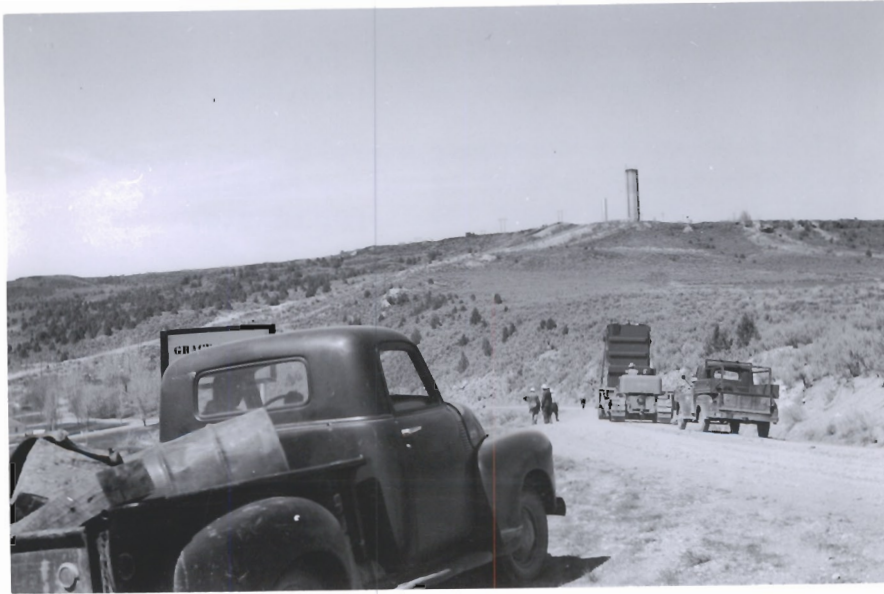
#5 - 132-161 Kv auto transformer starting down dugway with A.C.H.D.15 in rear as safety hold-back. Speed down dugway about 100 ft. per minute.

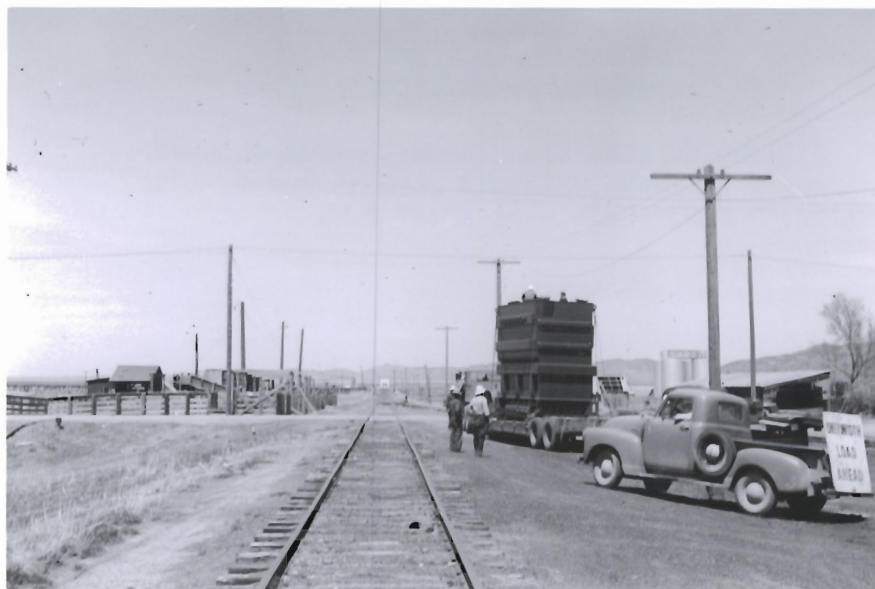
#1 - 132-161 Kv auto transformer loaded on transport ready to
leave railroad yard at Grace, Idaho 12:50 P.M.
Left yard 12:52 P.M. 5-10-55

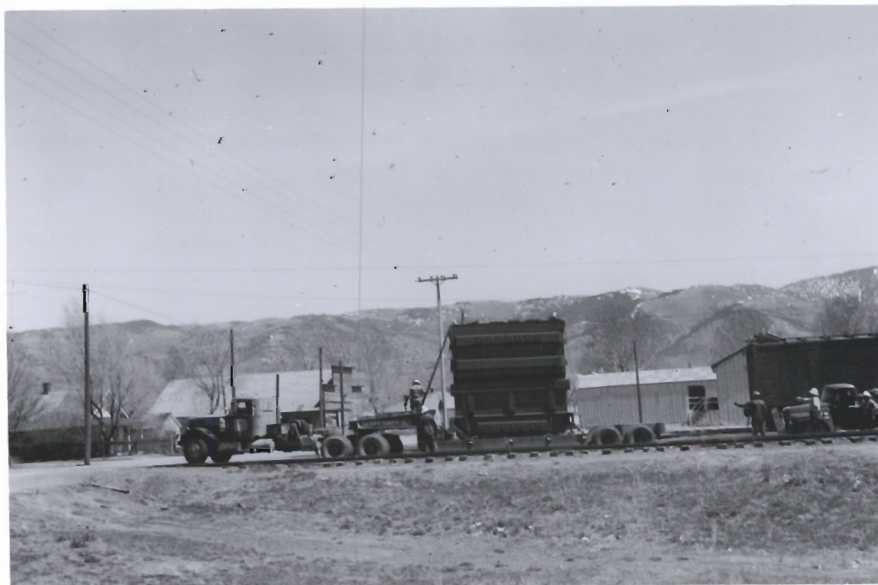
#2 - 132-161 Kv auto transformer loaded on transport ready to
leave railroad yard at Grace, Idaho 12:50 P.M.
Left yard 12:52 P.M. 5-10-55

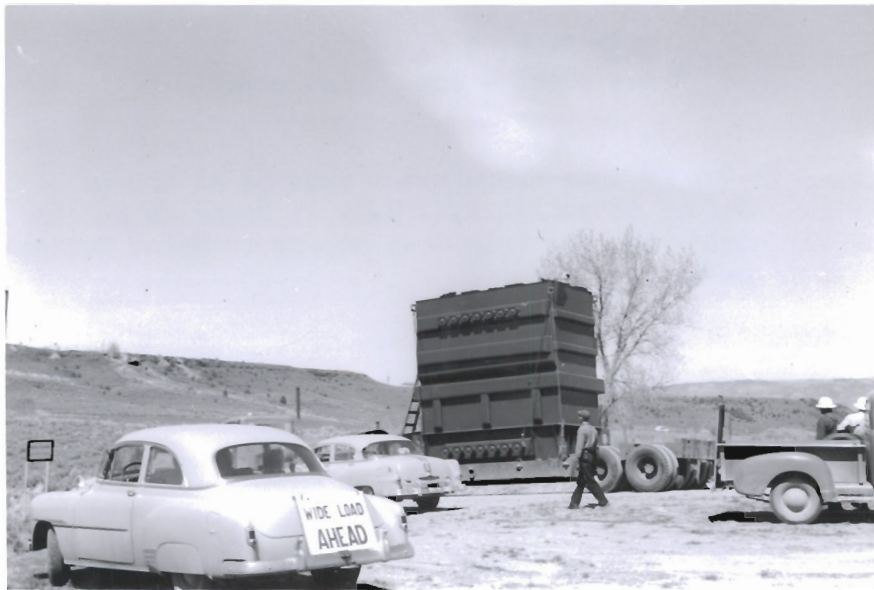
#3 - 132-161 Kv auto transformer stopped at top of dugway to attach A.C.H.D. 15 Dozer as safety hold-back for trip down dugway to Grace Switchyard. 5-10-55

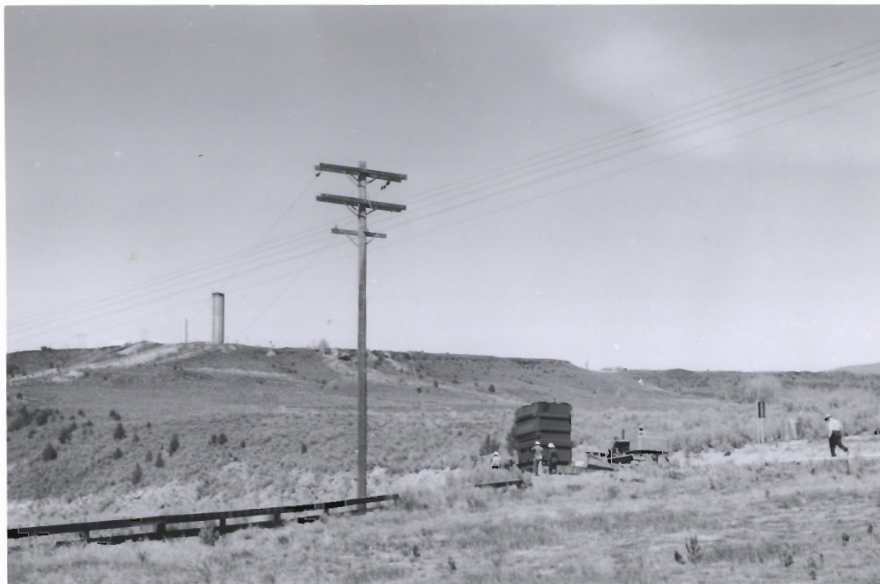
#4 - 132-161 auto transformer starting down dugway with A.C.H.D. 15 in rear as safety hold-back. Speed down dugway about 100 ft. per minute. 5-10-55
