# Lewis River Aquatic Fund Projects (SA 7.5.3.2)

## Project Closeout Report

<b>Project Title:</b>	<b>Lewis River Hydroelectric Project Cedar Creek Reach 1A Restoration</b>
<b>Project Approved By:</b>	Aquatic Coordination Committee March 27, 2013
<b>Original Project Sponsor:</b>	Lower Columbia Fish Enhancement Group
<b>Project Funding</b>	Aquatic Coordination Committee - \$53,000 + \$12,931.00 (insurance expense) -
<b>Project Description (work completed):</b>	<ul style="list-style-type: none"><li>• Installed 150+ pieces of large wood in stream channel</li><li>• Installed 15+ logjams</li><li>• Installed 4 floodplain roughness logs</li><li>• Excavated a 100' long alcove rearing channel</li><li>• Re-directed perennial tributary to increase habitat function</li><li>• Removed/ controlled 2 acres of invasive non-native vegetation</li><li>• Installed 2,000 native trees and shrubs</li><li>• Installed boater safety sign upstream of project site</li></ul>
<b>Workforce:</b> <ul style="list-style-type: none"><li>○ <b>Personnel (by craft)</b></li><li>○ <b>Contractors:</b></li></ul>	<ul style="list-style-type: none"><li>• Bill Norris, P.E. Interfluve</li><li>• Peter Barber, LCFEG Project Manage

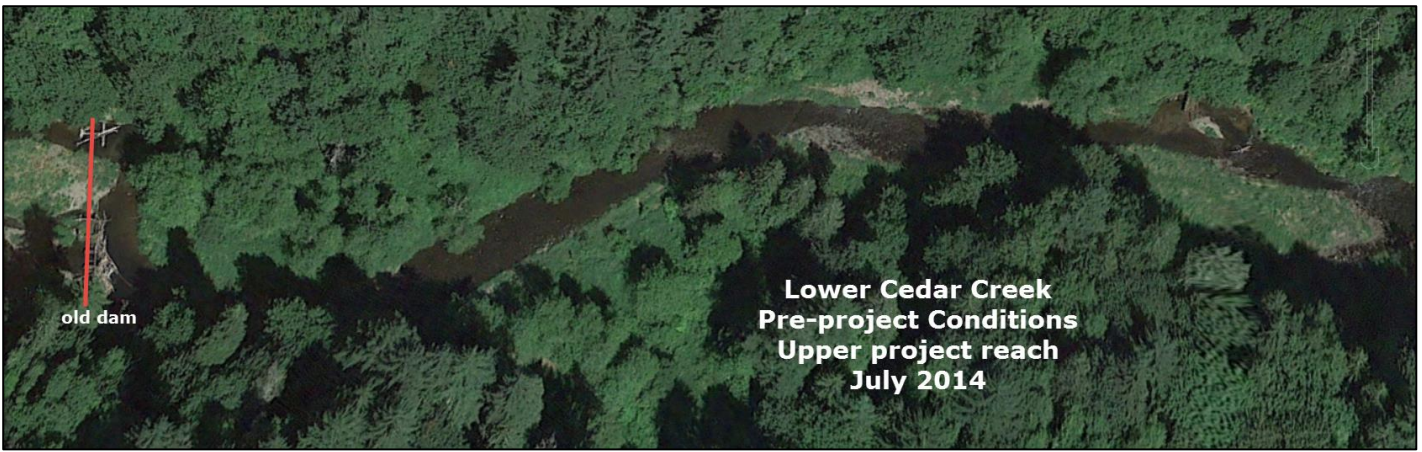
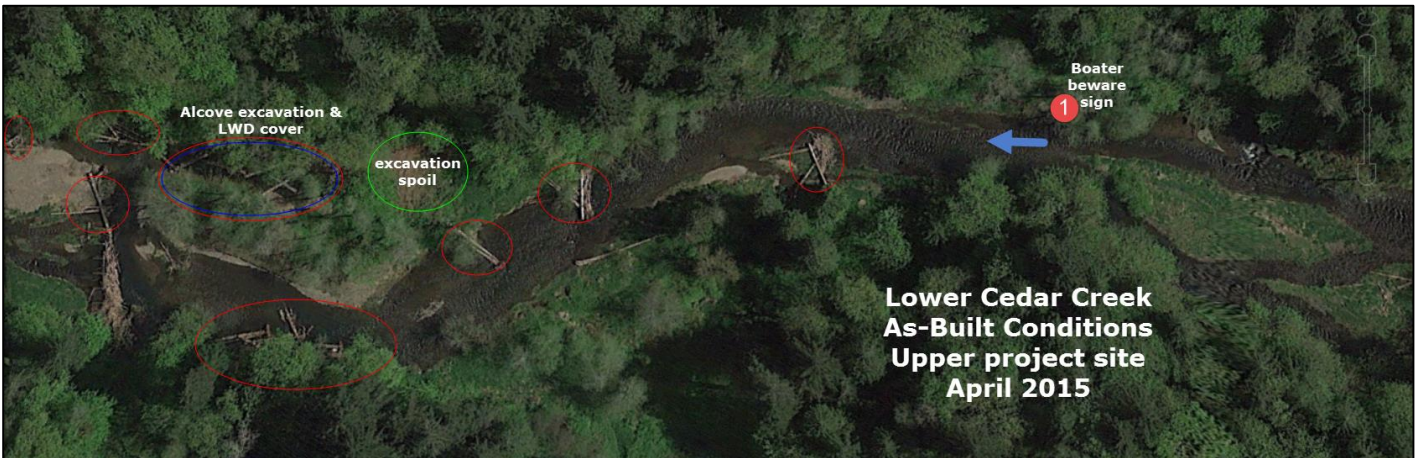
- Deleted floodplain roughness wood due to cost
- Added 1 log on end of dam to direct flow, added 1 root-wad to increase scour
- Deleted lower left bank structures due to concern with lamprey habitat
- Did not complete pump test due to cost, vegetation impact and low likelihood of future need

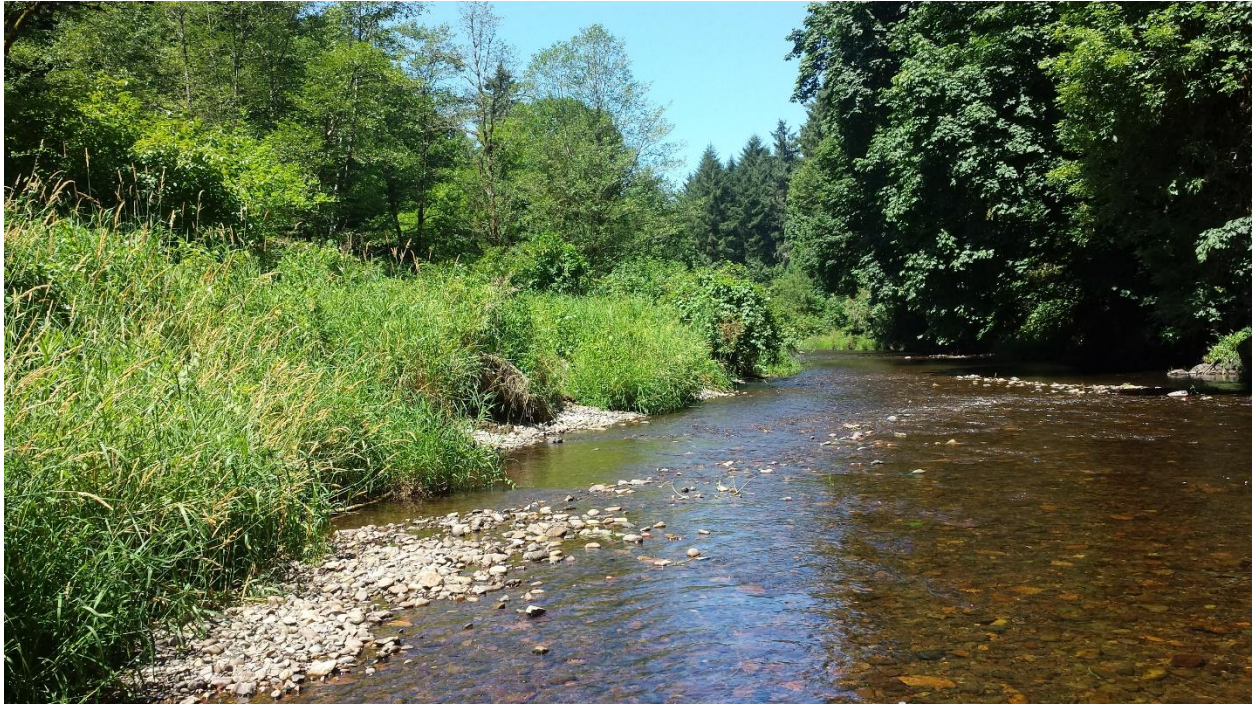
Summer 2014

Pre & Post Project view d/s

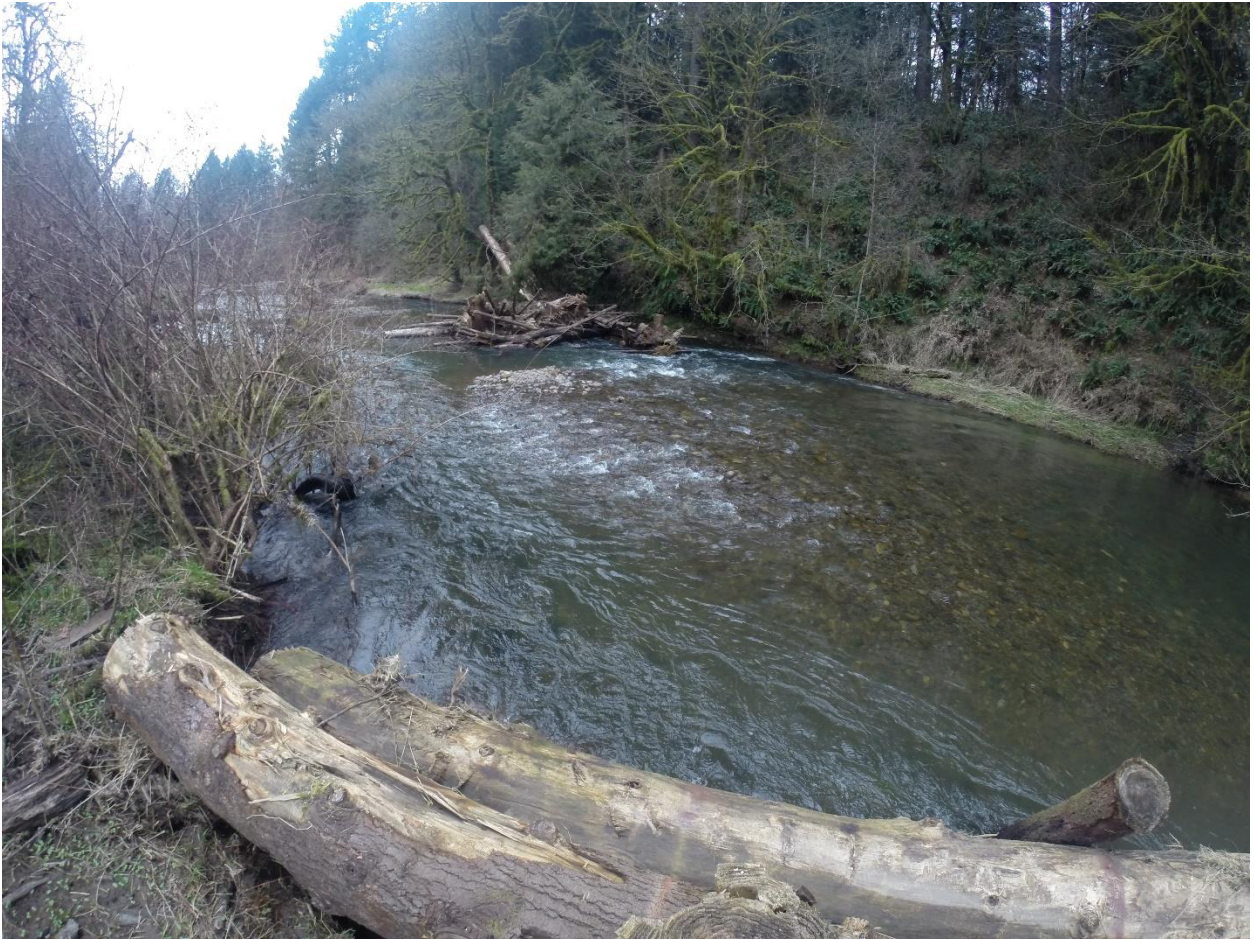
View downstream at OHW and OLW

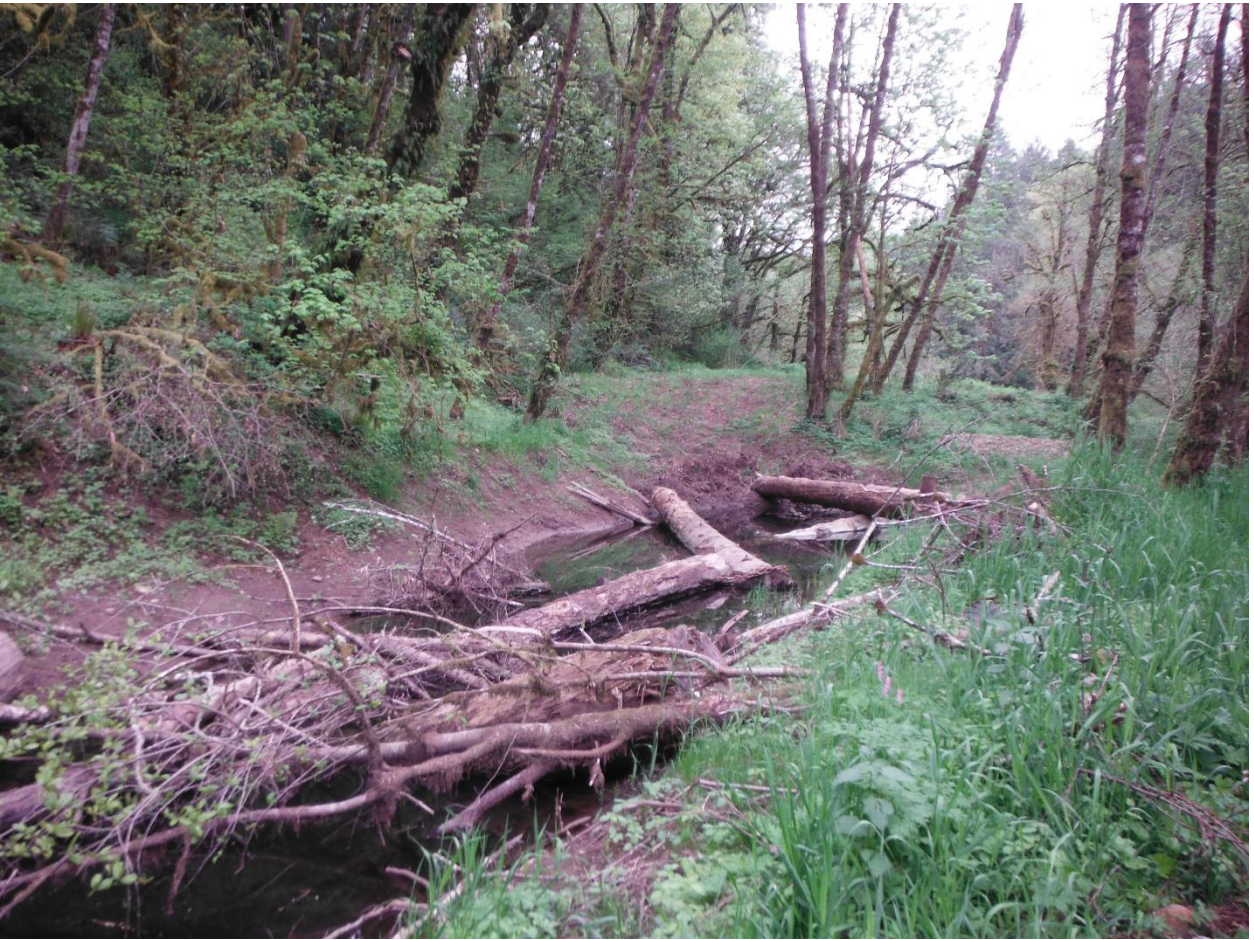
Alcove rearing pond contains juvenile salmon, lamprey and beaver

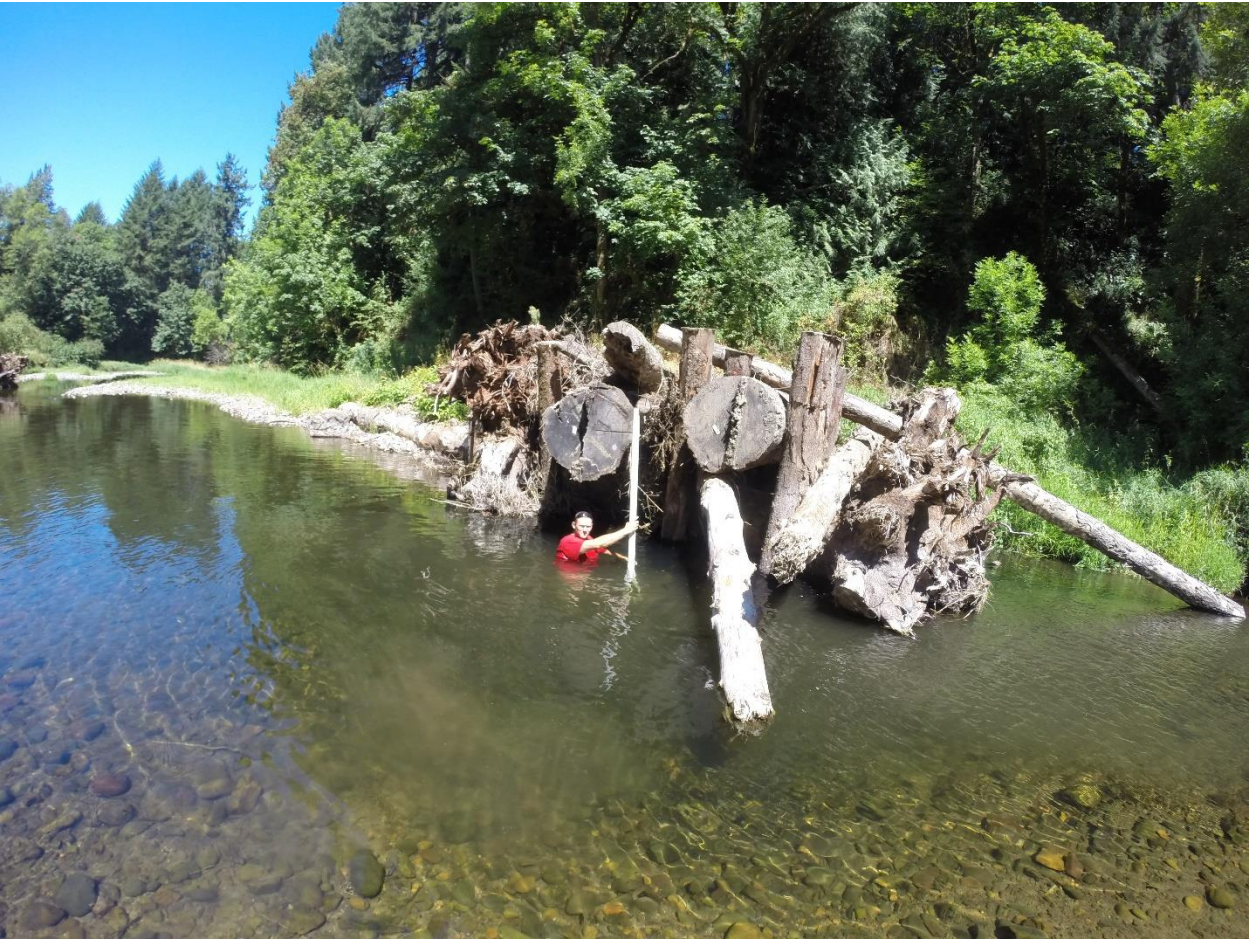
Checking post project pool depth

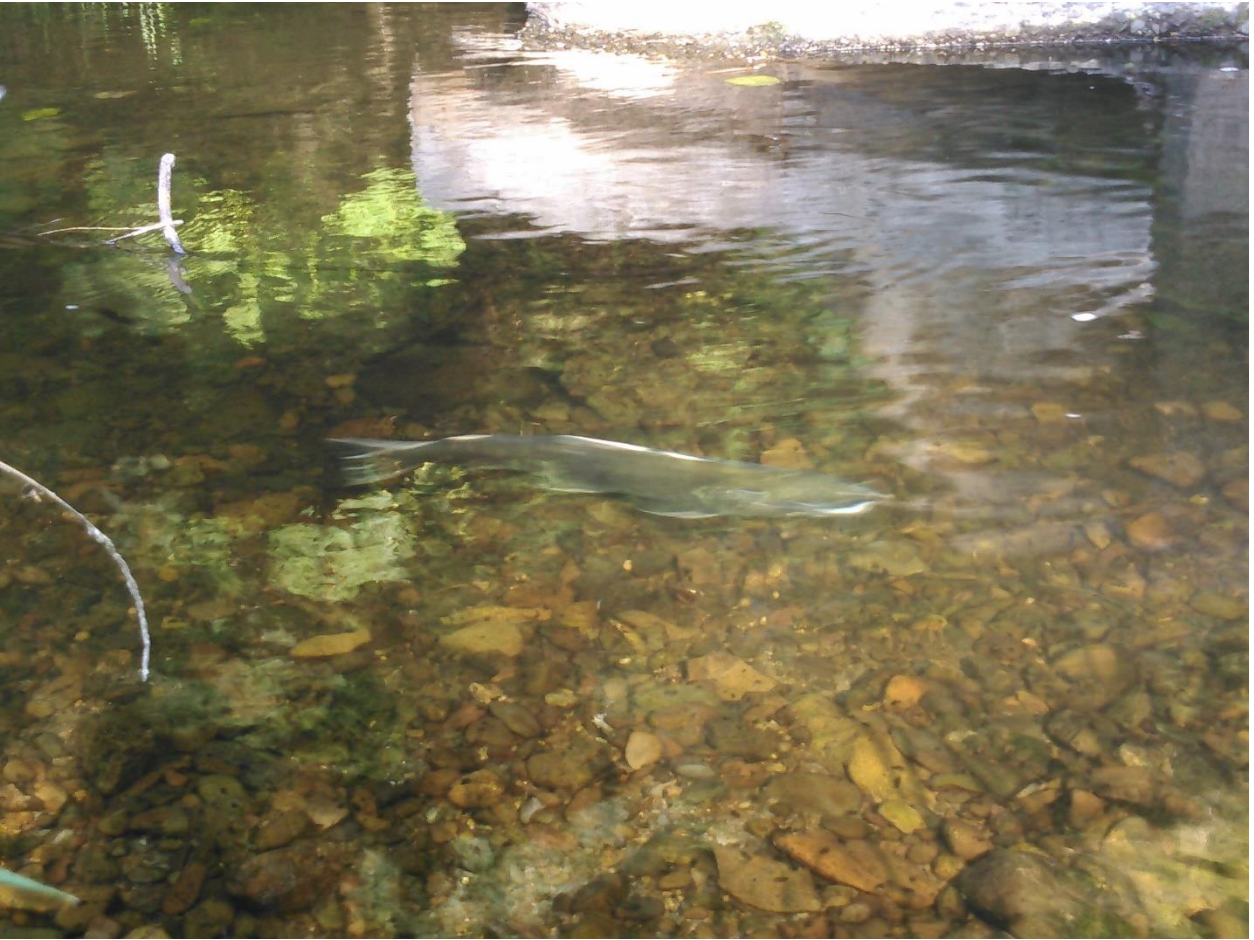
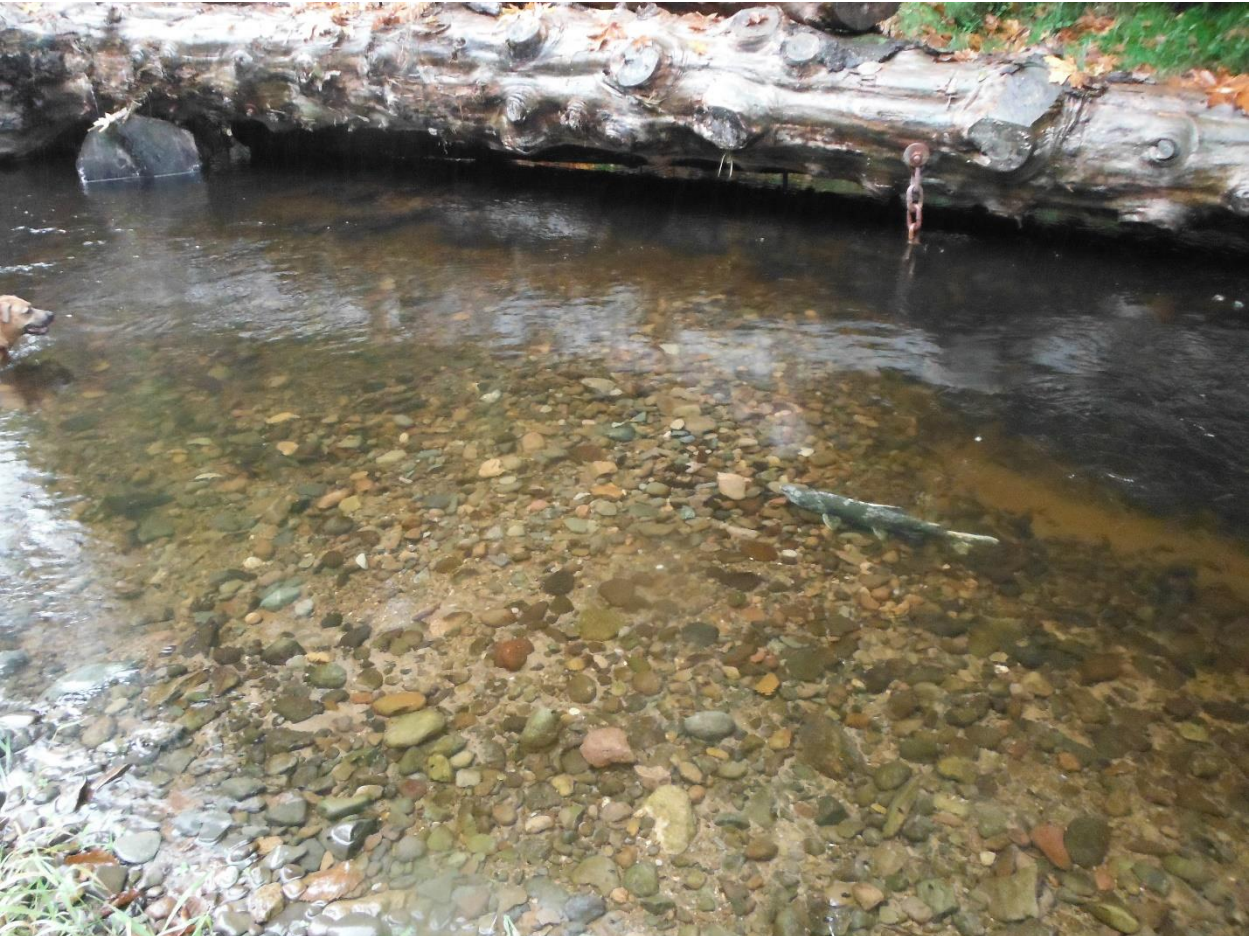
Fall Chinook and coho observed spawning on 10-19-2015

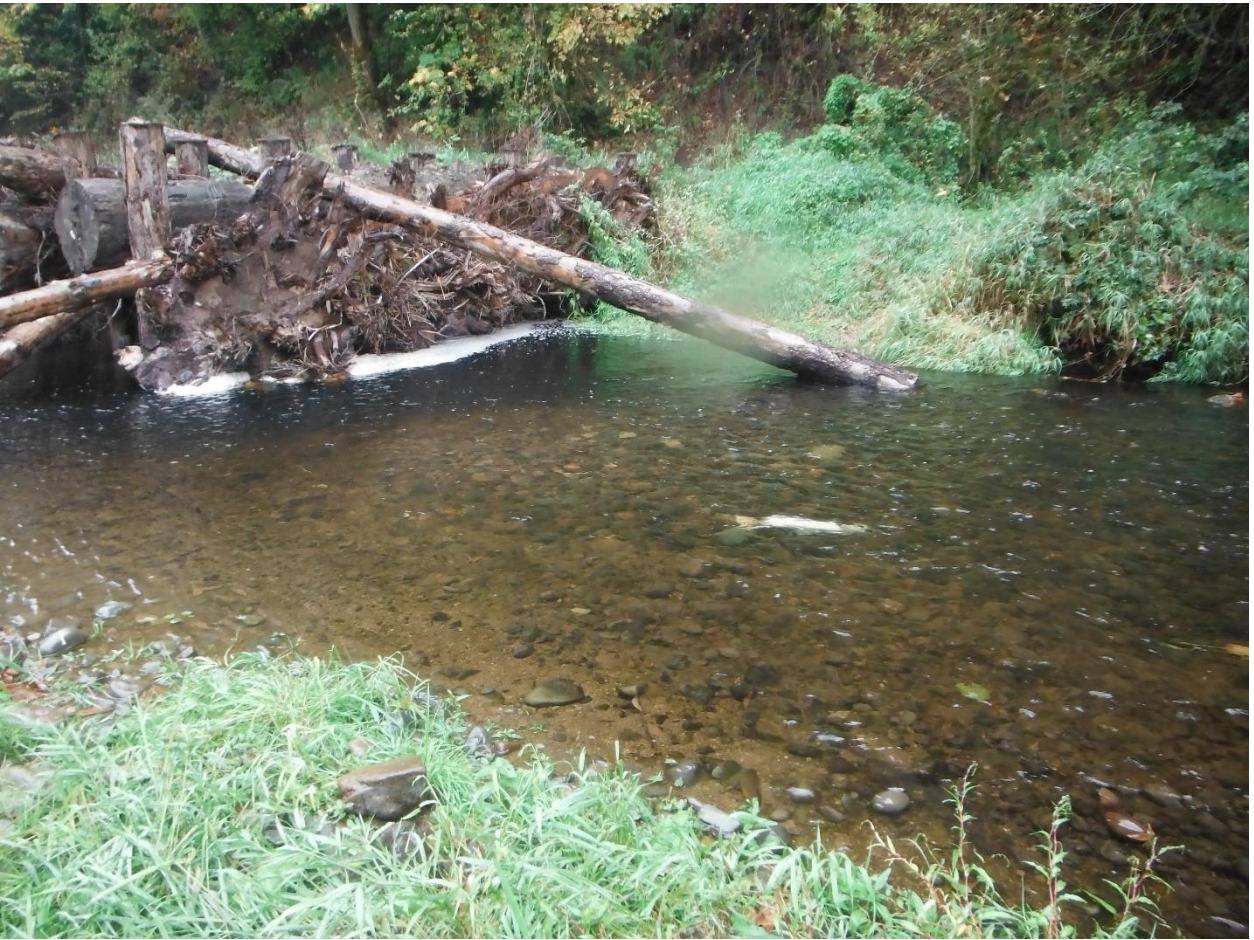
Spawned out Chinook

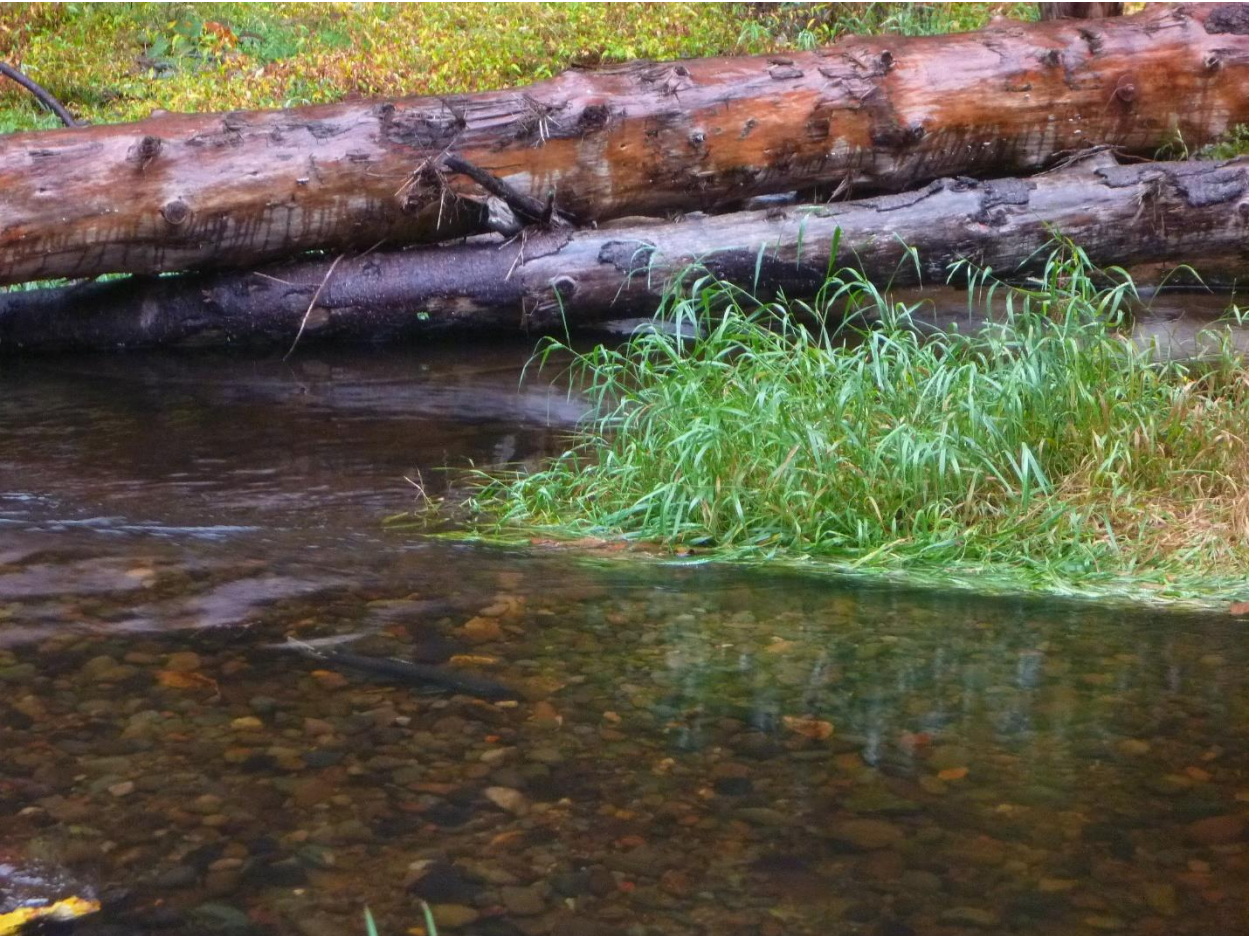
Spawning Chinook

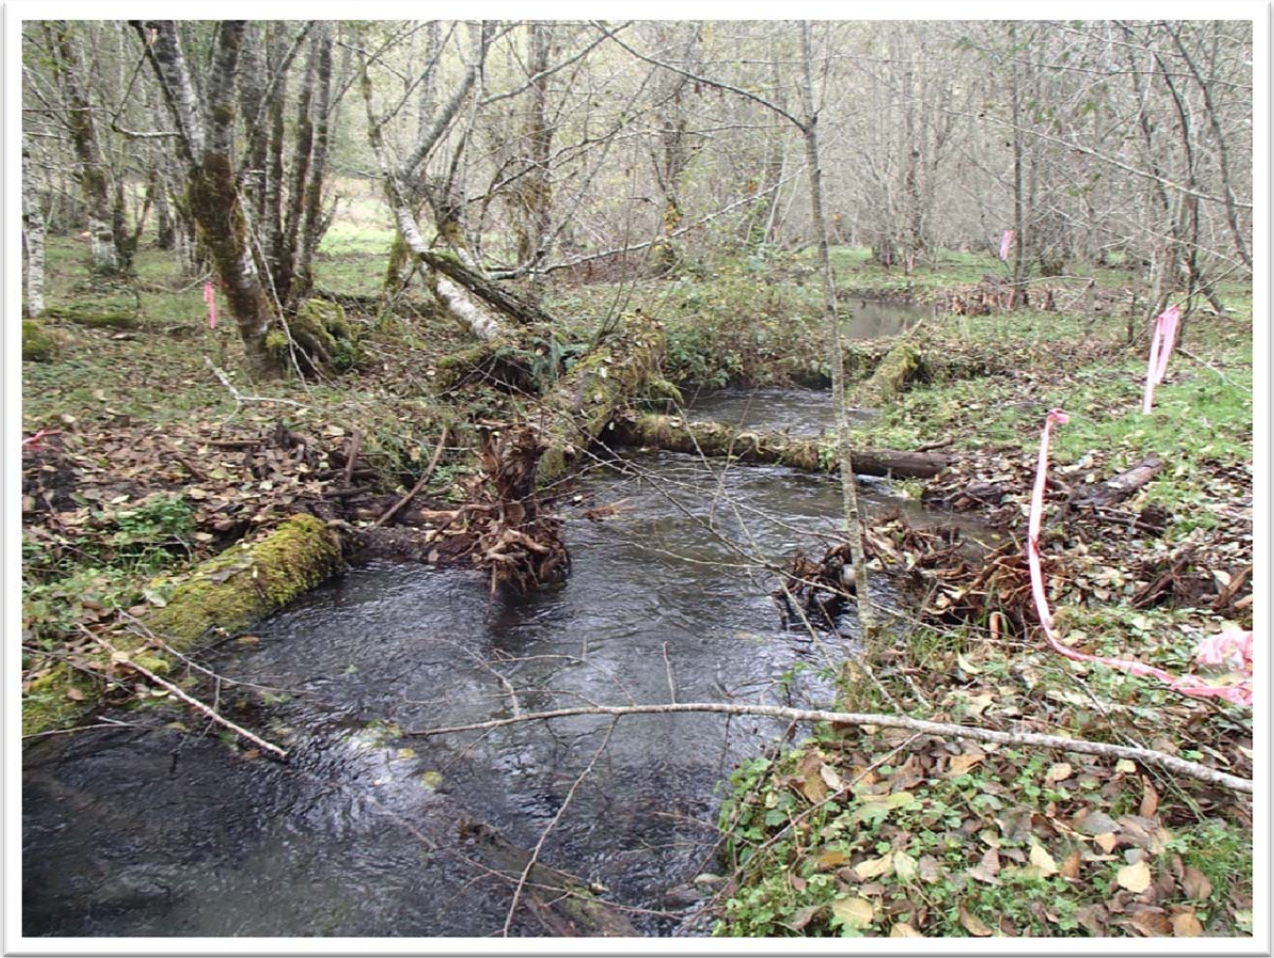
St 14 2015

***Water is too deep/swift for accurate pebble count***

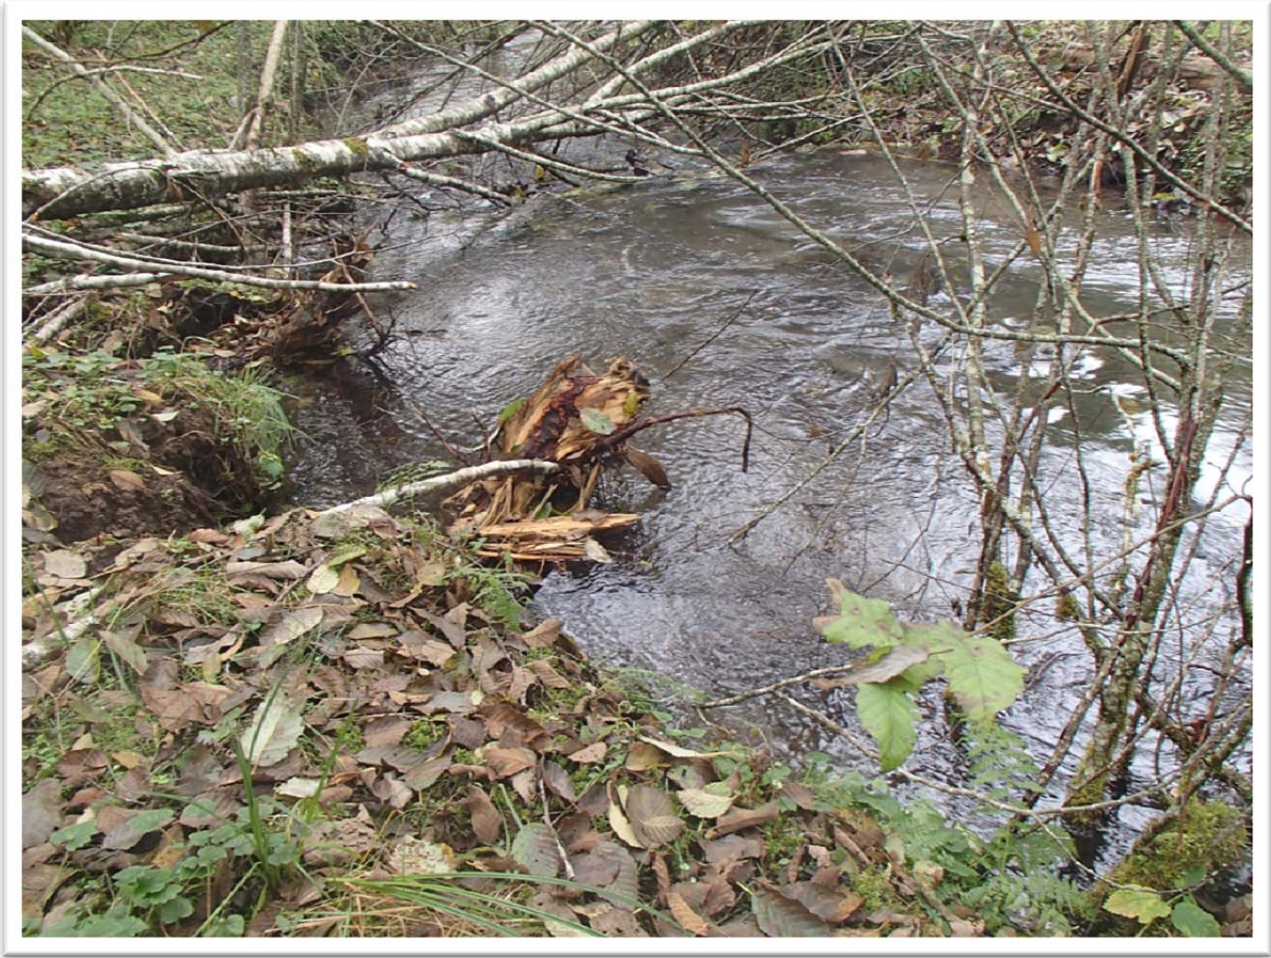
St 17 2015

***Water is too deep/swift for accurate pebble count***
